**River Avon Tidal De Facto Flood
Defences Investigation**

**Visual Walkover Structural
Assessment**

REP/042/16

Rev1 | 03 May 2016

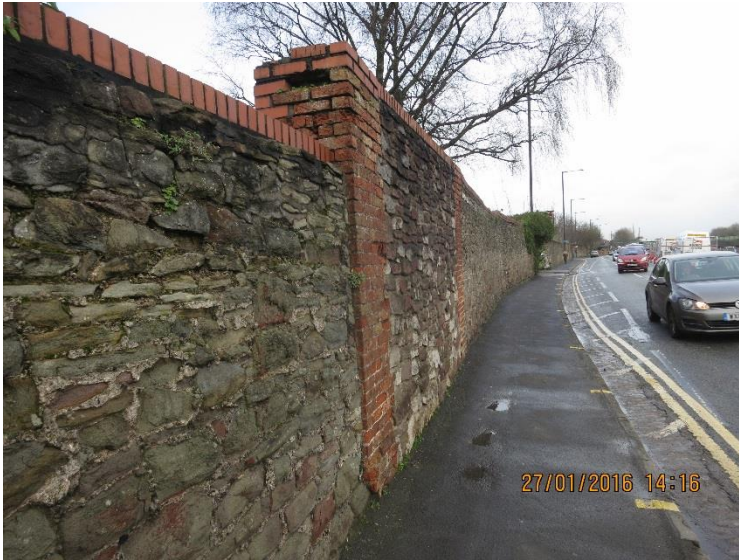
Most of the wall is a combination of random stone masonry and clay bricks. The wall is not continuous and has 4 gaps in it, these can be seen on figures 4 and 5 above. There are several places where former doors have been in-filled and a few where vegetation is growing on the wall. There are some signs of cracking and movement in the wall. While none of these suggest the wall is likely to collapse in the near future, there is a possibility that during a flood a small amount of water could seep through. It was also noted that particularly at the west end, there were numerous potholes in the adjacent road that could indicate soft ground in the area.

Figure 6 - Photo of the wall taken between the entrance to Underhill Yard and Cottage Inn car parks

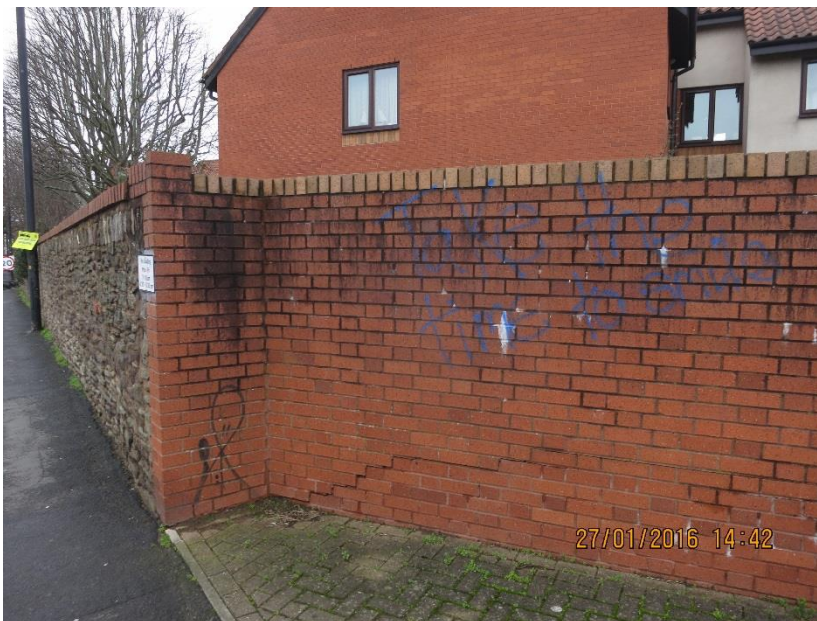
Heading east towards Vauxhall Bridge, the wall becomes a clay brick wall. This wall has several cracks in it that could allow water to pass through in a flood. It is also narrower and shorter than the random stone masonry walls.

Figure 7 - Photo of the clay brick wall close to Vauxhall Bridge

Because of the cracks, condition of the wall is considered to be condition grade 4.

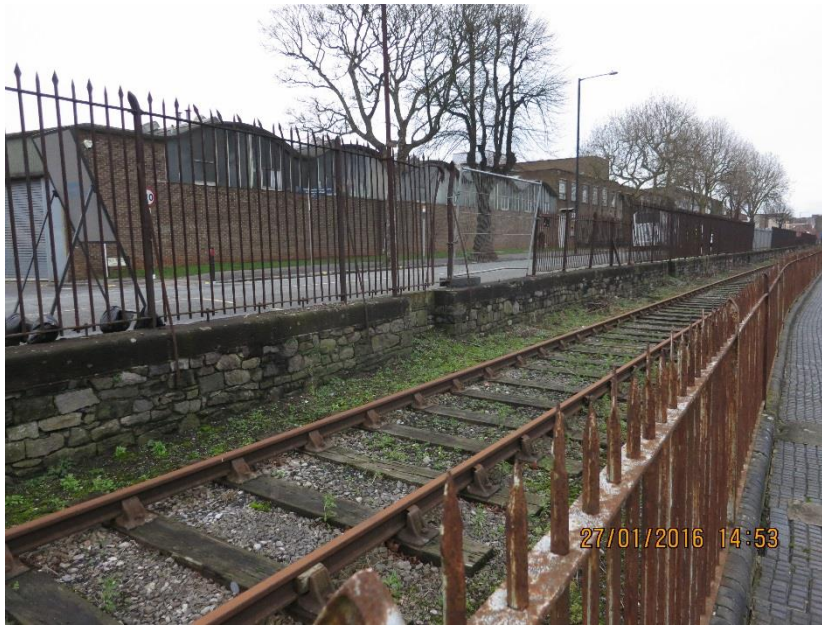
Figure 8 - Photo of the wall from the Chocolate path on the riverside
The top of the wall extends above the road level by 150-250mm.
Best estimate as to the condition of the wall is condition grade 3.

Table 2.3 of the EA guidance report SC060078/R1 suggests that for a masonry wall in a coastal environment, the expected time for deterioration to progress from CG3 to CG5 is 30-60 years. However, if the wall is to be relied on to act as a defacto flood defence asset, it would be advisable to inspect it annually at the same time as the Cumberland Road North walls are inspected.

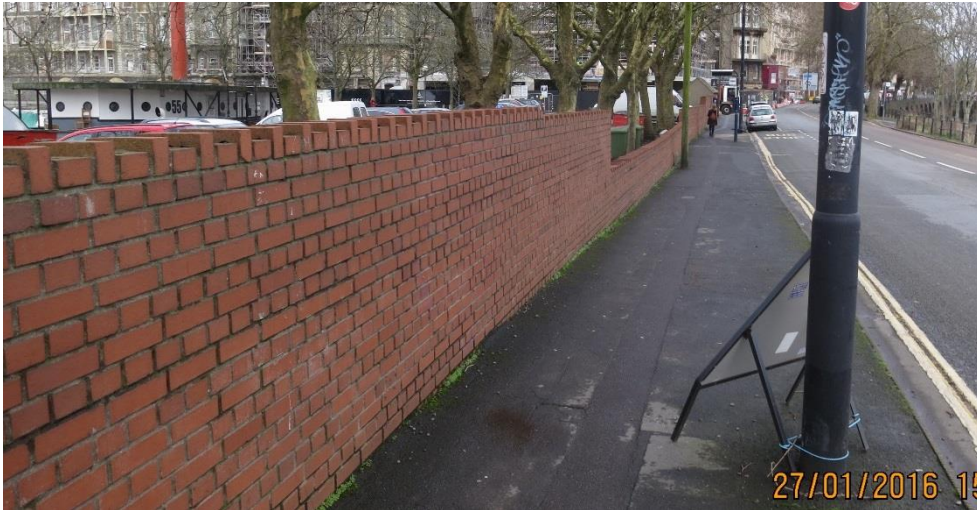
Figure 10 - Photo taken near the west end of the wall, looking east. The railing on the right of the road are on the alignment of the Environment Agency's definition of top of the bank.

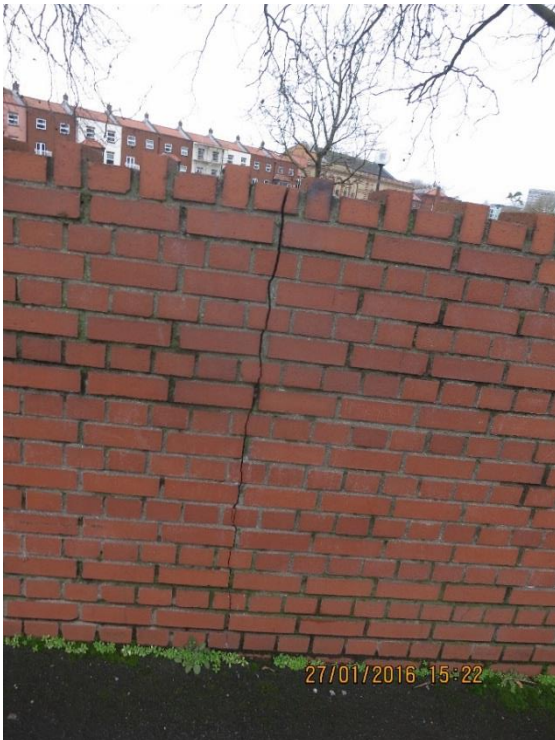
The wall has several vertical or near vertical cracks, probably caused by the lack of movement joints in the masonry. The lengths of wall with no vertical cracks in them vary from approximately 6m to approximately 20m, and some of them pass all the way through the wall. These cracks are wide enough to allow a small amount of water to flow through in a flood. There is also a narrow joint that is not filled in, this joint could also allow a small amount of water to flow through in a flood.

Figure 11 – typical vertical crack in the wall

Because of the cracks, condition of the wall is considered to be condition grade 4.

In any flood, a small amount of water would pass through the cracks in the wall. To prevent this, the cracks and joints should be filled with a suitable waterproof sealant.

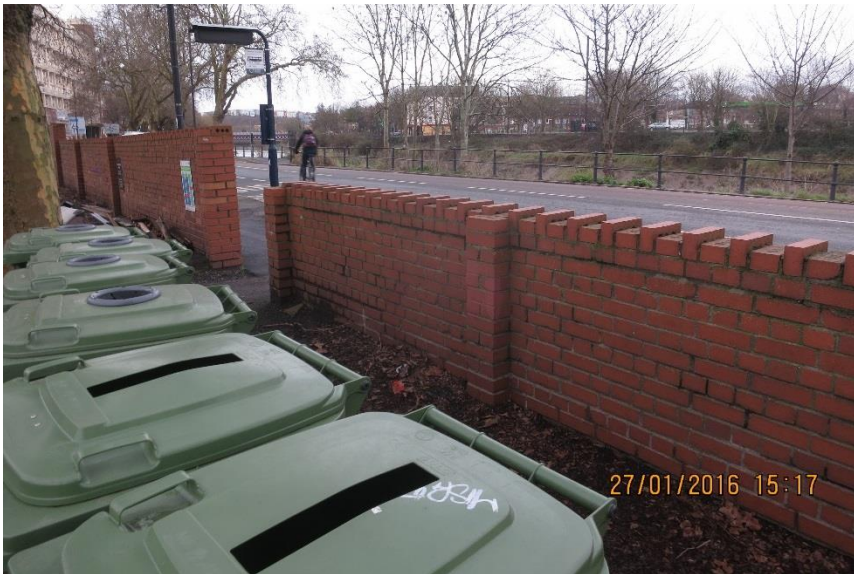
In a flood, the first section to fail is likely to be the lowest and most narrow section of the wall, where it is approximately 0.9m high x 215mm thick. This section is approximately 25m long and shown below.

Figure 12 - The lowest part of the wall is on the right of this photo, this photo also shows the only gap in the wall

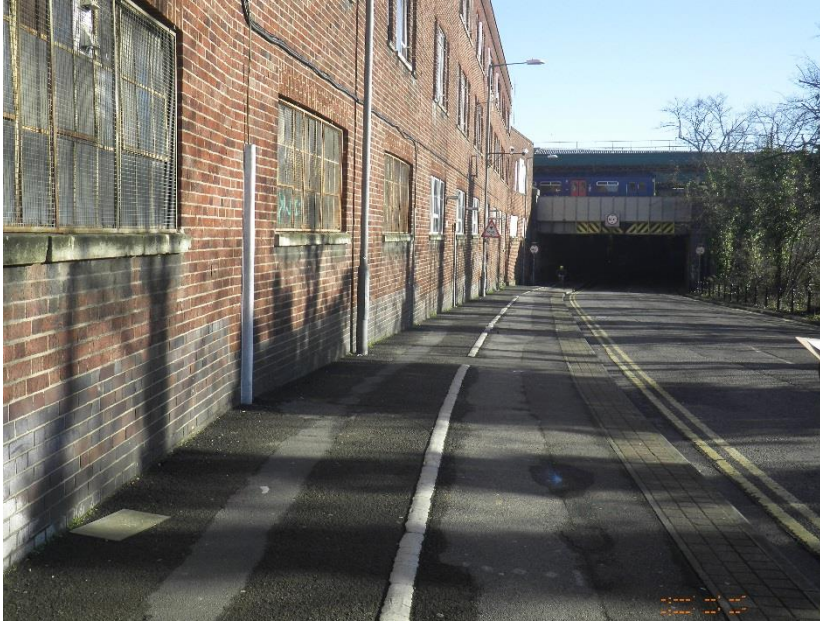
This is the wall of a building that is currently unoccupied. The lowest window, that would probably be a weak link in terms of flood defence, is around 2.4m above ground level. The wall is in a reasonable condition with no major defects visible. To comply with BS requirements on panel sizes it is likely that the wall is buttressed by either piers or internal walls at approx. 6m c/c, it is also likely that the wall is a cavity wall. These could not be confirmed without entering the building.

Figure 14 - Photo taken looking east along Cattle Market Road

The wall is considered to be condition grade 2.

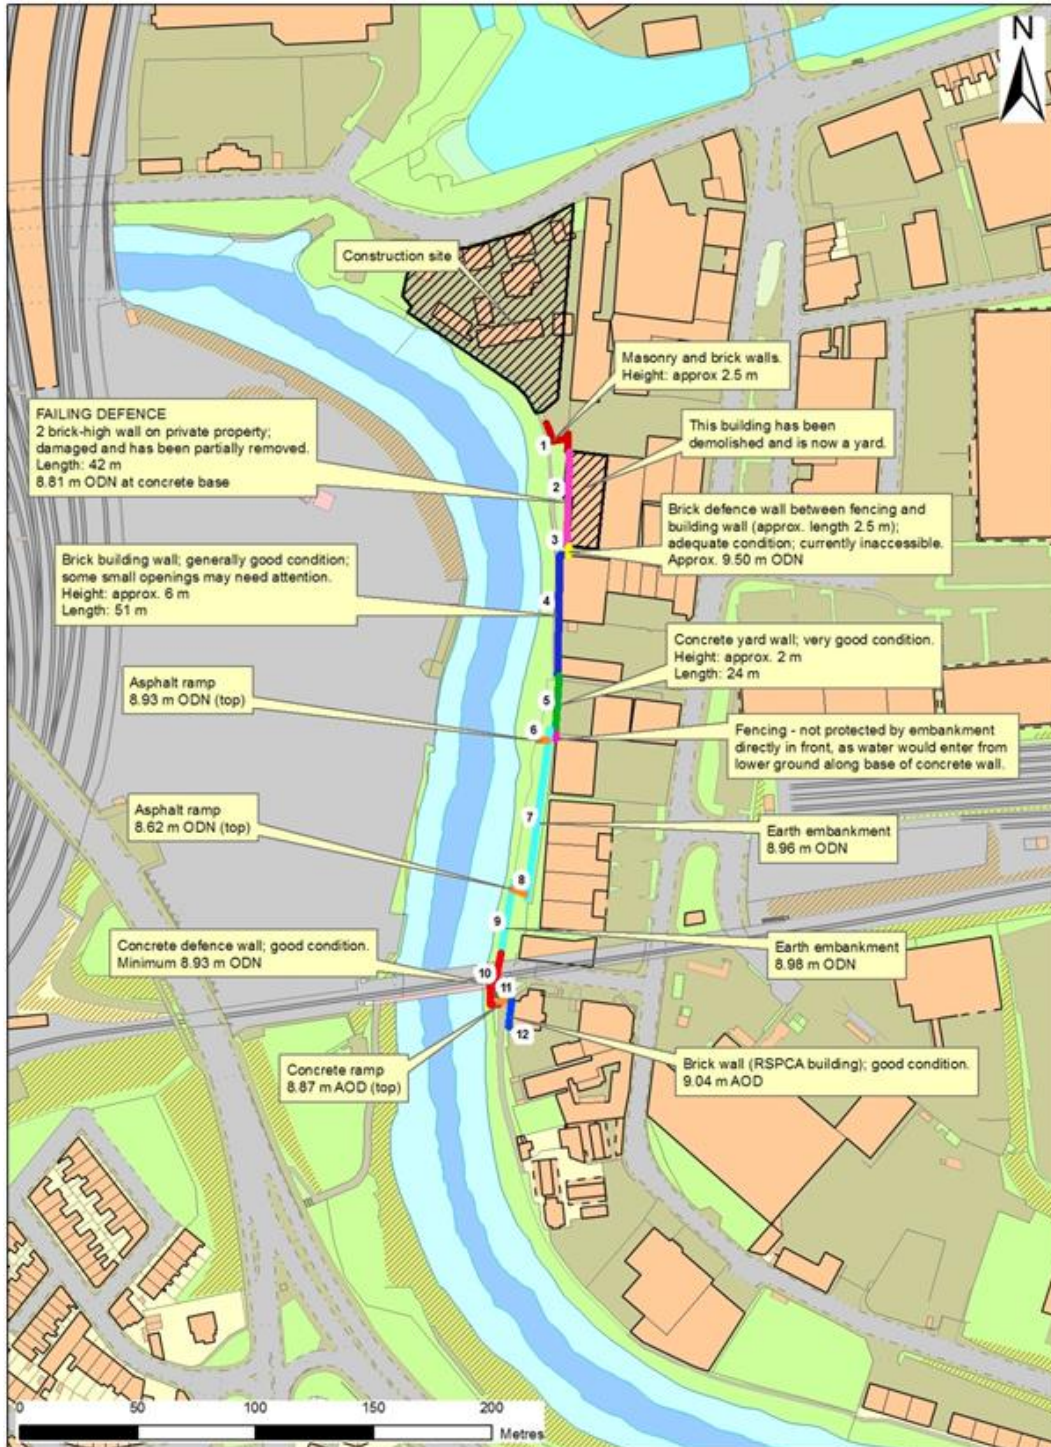
- Low wall (Section 2 in Figure 16 and the wall in Section 5.2.3.3) is damaged.
- Low wall (Section 3 in Figure 16) inspection is prevented as access is blocked by fencing and the wall is surrounded by vegetation.
- A pathway for outflanking is present to the south of the concrete wall (Section 5 in Figure 16 and the wall in Section 5.2.3.5) as the wall does not tie into the adjacent formal flood defence embankment.
- The asphalt ramp (Section 8 in Figure 16) is below the defence design level.
- The earth embankment (Section 9 in Figure 16) is in poor condition, with erosion, brambles and exposed patches with low grass cover.
- The concrete ramp (Section 11 in Figure 16) is also lower than the flood defence design level.

Figure 16 - Extent and condition of the current flood defences (source: EA)

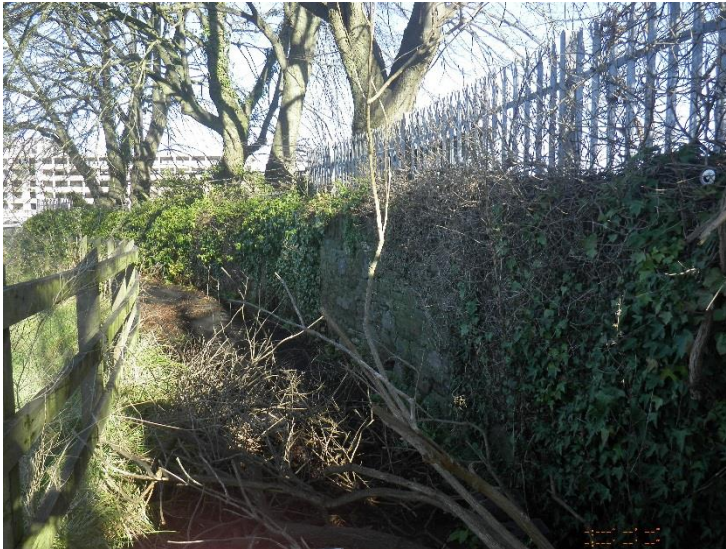
Due to the construction of the Arena bridge no direct access was available to this wall and the observations are estimated from viewing from a few metres away. In some places this wall is heavily overgrown and in some others the mortar in the joints is in poor condition. Because of this, the wall is considered to be condition grade 4.

Figure 17 – Photo showing stone wall looking downstream.

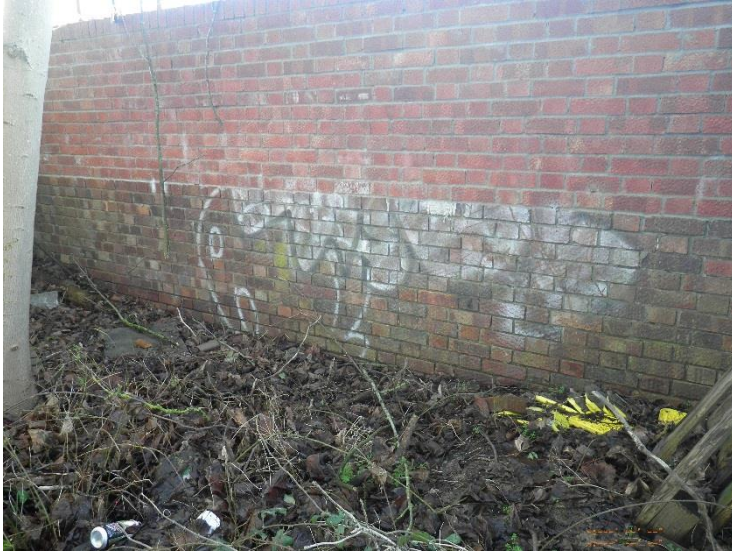
This wall has no obvious major defects and is considered to be condition grade 2.

Figure 18 – Photo showing brick wall

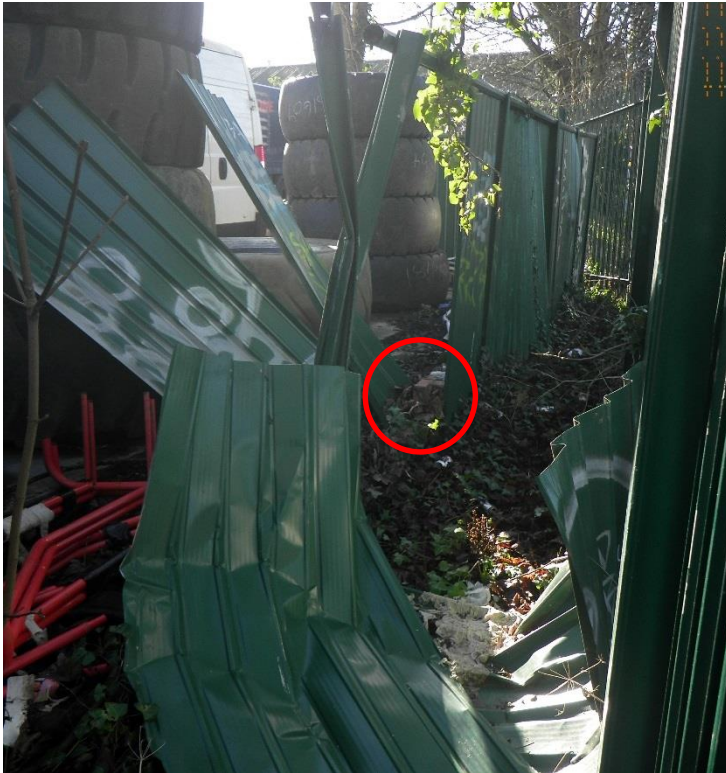
This wall is difficult to see due to being obscured behind steel panels and tyres. In some places the steel panels are in very poor condition, and in some places the wall is also in a poor condition with bricks having been knocked off.

Figure 19 - The brick wall can be seen immediately behind the steel panels

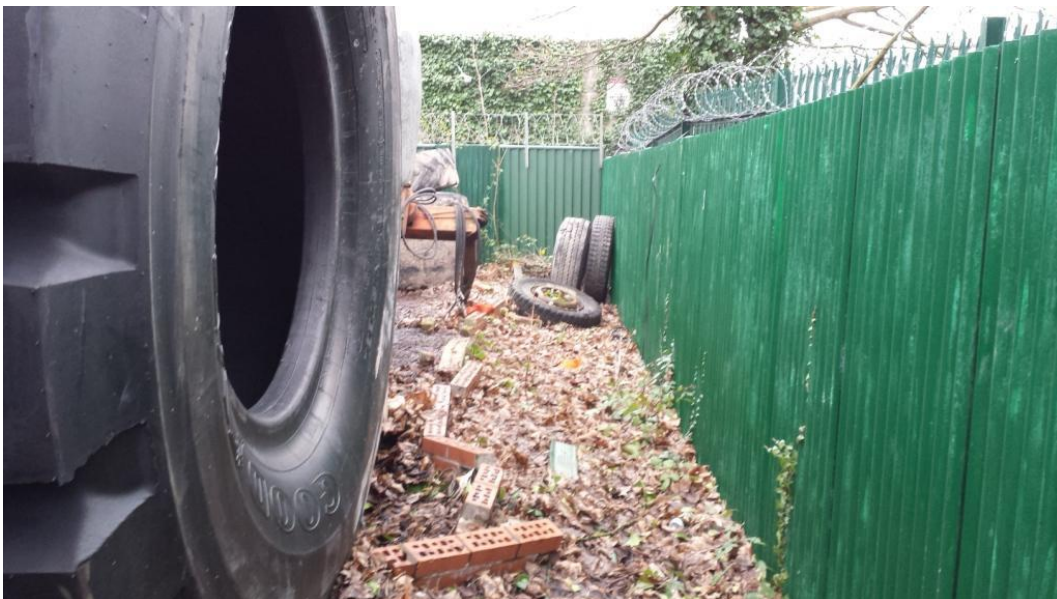
Figure 20 – Removed brick wall (source: EA 2014)

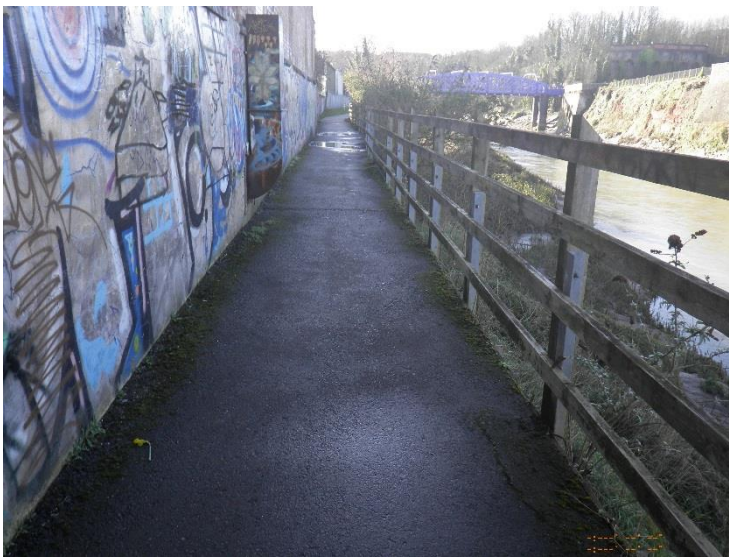
This wall is partly covered with render and also graffiti, making it very difficult to estimate its condition. There are several cracks in the render but it was impossible to determine if these are only in the render or a result of cracking in the walls. Condition grade of the wall could be considered grade 2, 3 or 4.

Figure 21 – Wall of building, looking upstream.

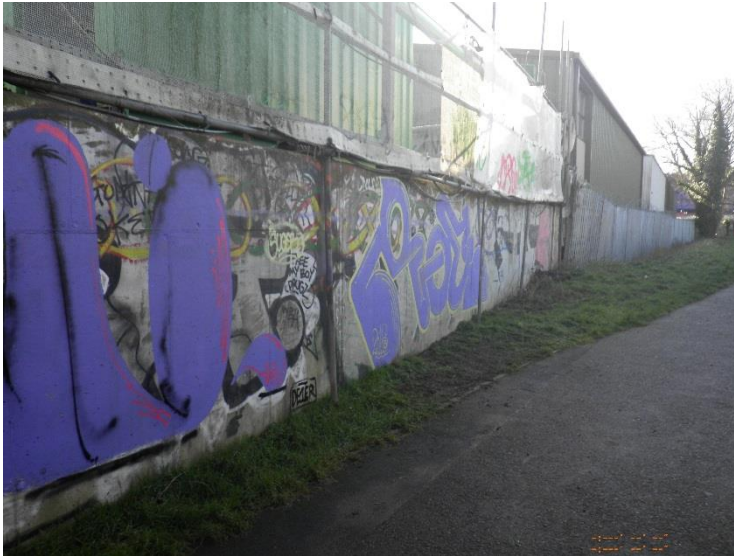
This wall also has a large amount of graffiti on it making it difficult to accurately assess. It appeared to be in reasonable condition so it is likely to be condition grade 2, but could possibly be grade 3 or 4.

Figure 22 - Concrete wall, the tie in to the embankment can be seen on the right

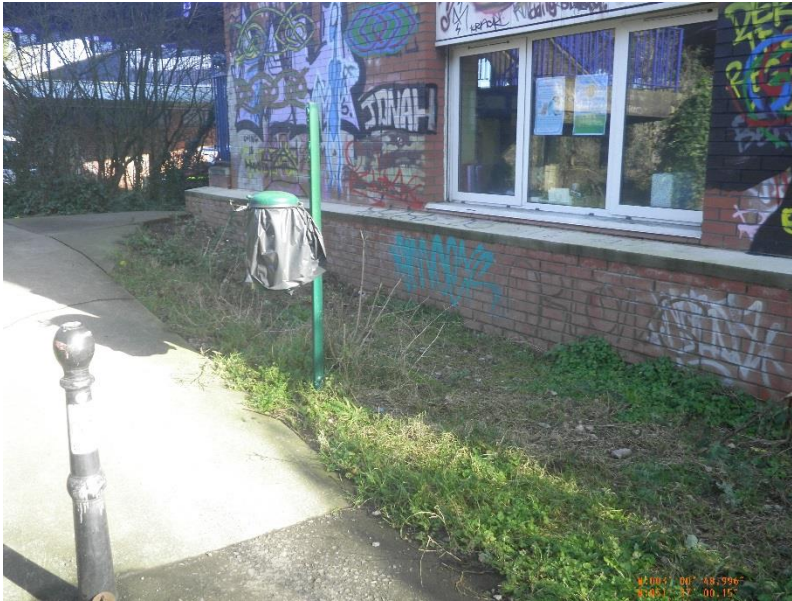
The wall has movement joints at approx. 6m spacing that are sealed. This wall also appears to be in good condition, condition is considered to be condition grade 1.

Figure 24 - Wall of RSPCA Bristol Dogs and Cats Home, adjacent to the flood defence asphalt ramp can be seen on the left

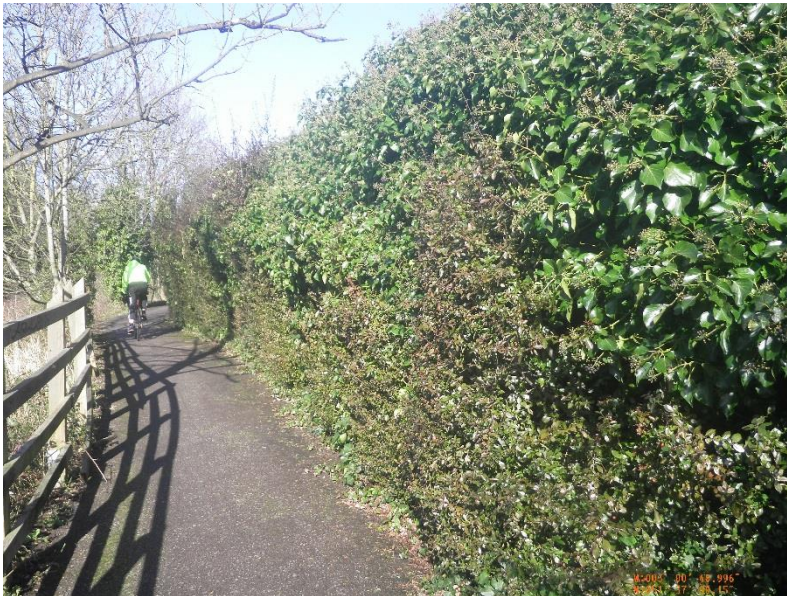
In terms of flood defences the hedge / palisade fence is the weak link in this area and will not act as a defacto defence. The ground here is around 0.2m higher than the ground adjacent to the walls described above.

Figure 25 - Hedge and palisade fencing

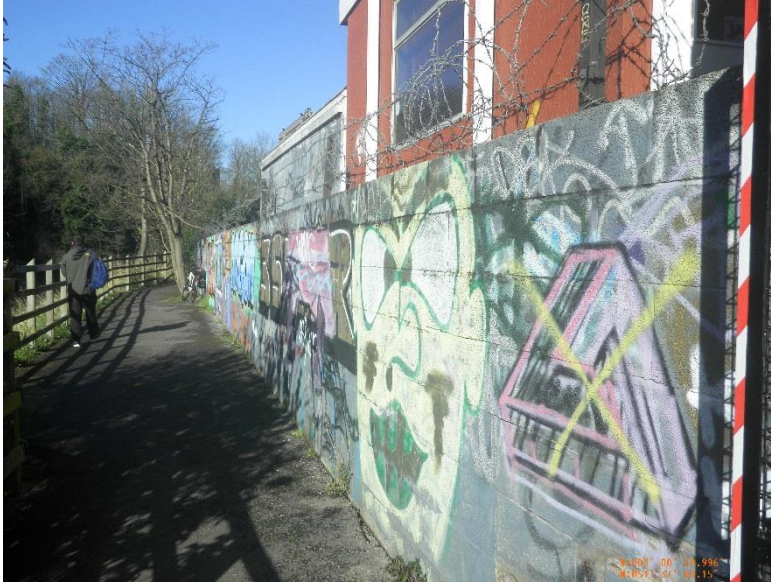
The wall also has graffiti on it making assessment of its condition difficult. In general condition appears to be good, there are small vertical cracks on the upper part of the wall. Because of these cracks, condition is considered to be condition grade 3.

Figure 27 - Concrete block wall

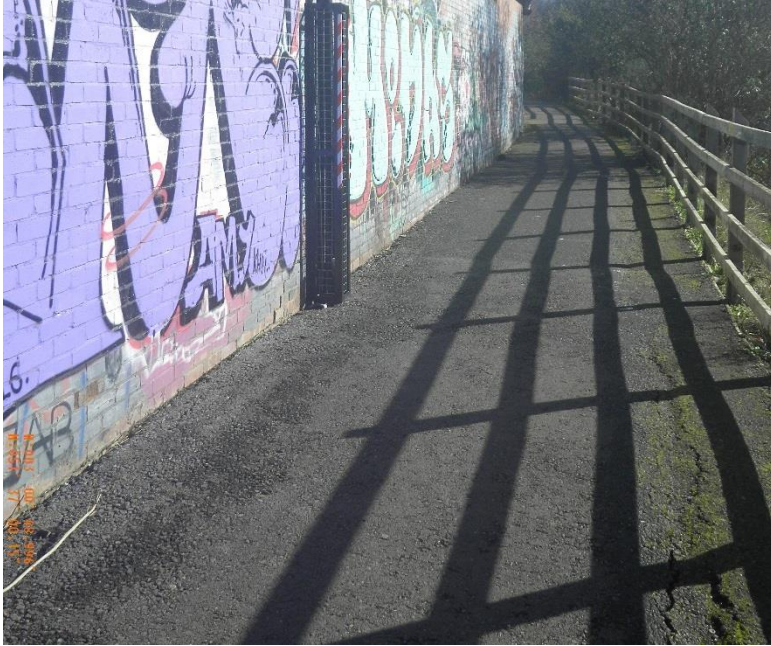
The downstream end of this wall is mostly in reasonable condition, but there are several cracks that could pass all the way through the wall and let water through. The upstream end of wall is random size stone and appears to be considerably older. This part has considerably more cracks that also could pass through the wall and let water in. There are also 3 small circular holes of dia. approx. 60mm that could pass all the way through the wall, a stick approx. 35cm long could be pushed all the way into a hole without meeting any resistance. Because of the cracks and holes, this wall is considered to be condition grade 4.

Figure 28 - Venture Tyres Wall

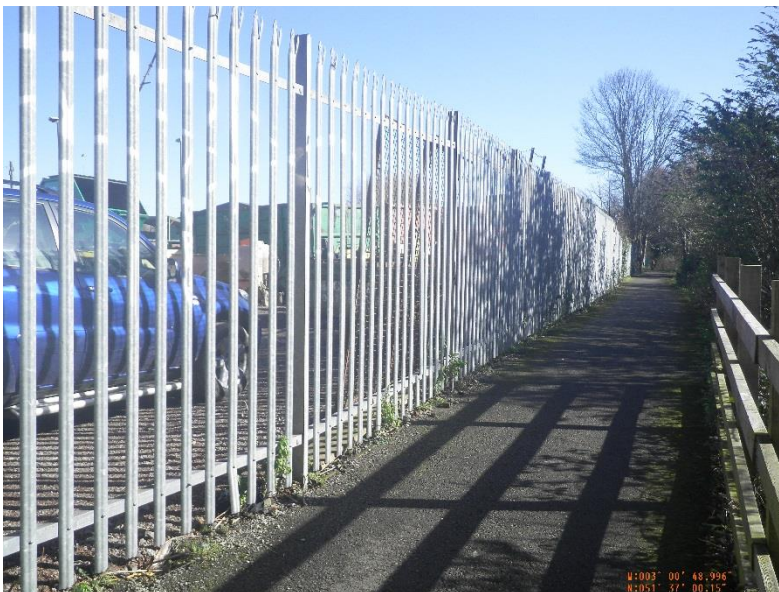
There are several areas of palisade fencing, these are all similar enough to each other to be described in the same section here. None of these fences have any value as flood defences.

Figure 29 - Palisade fencing adjacent to Venture Tyres building

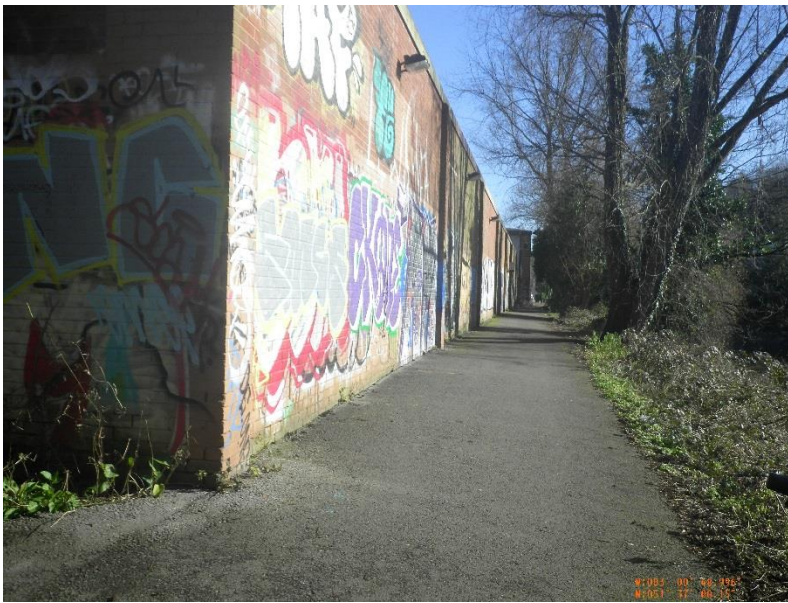
The walls appeared to be in good condition with no visible defects, and are considered to be condition grade 1.

Figure 30 - Leitz tooling building

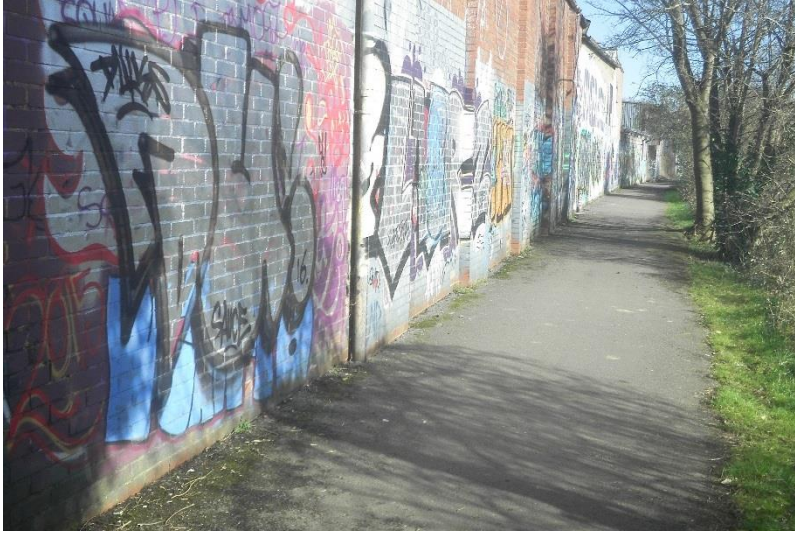
Figure 32 - Example of a wall considered to be condition grade 2

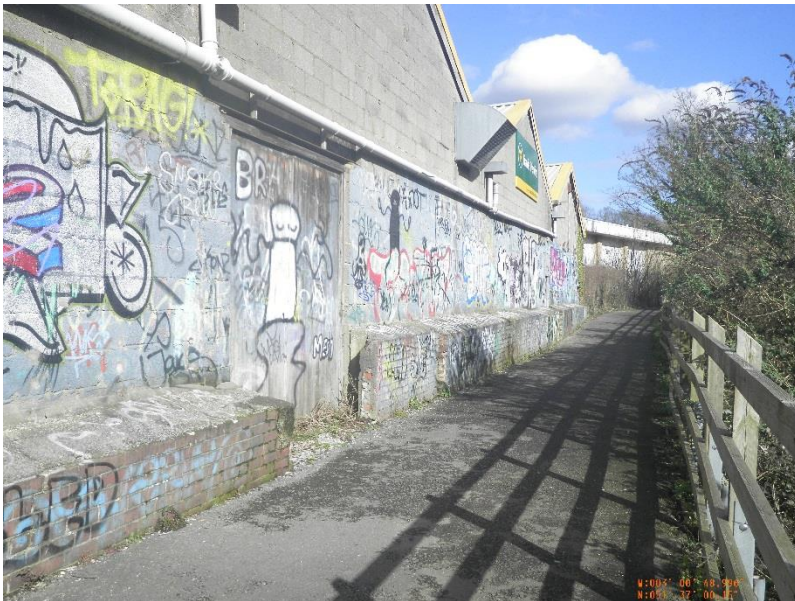
Several of these walls have doors, these doors all appear to be robust but they are probably not completely watertight. Some of them also have windows or vent blocks that could allow a path for flood water. Condition of the walls varies, from condition grade 2 to condition grade 4.

Figure 33 - Example of a wall considered to be condition grade 4

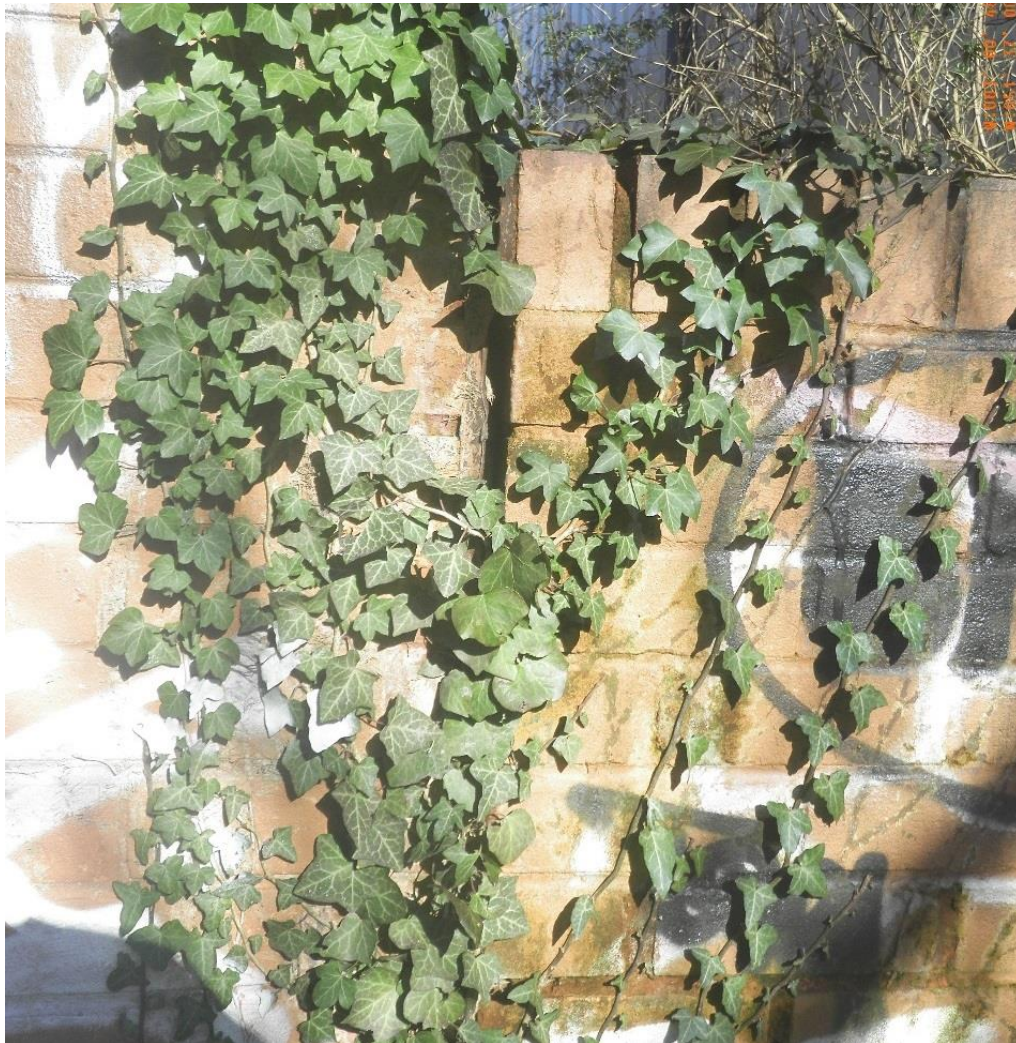
One of the walls, marked * on fig. 31, is leaning towards the river. The gap between this wall and the adjacent building varies from around 15mm at the top to 0mm at the bottom.

Figure 34 - Wall marked *, condition grade 4

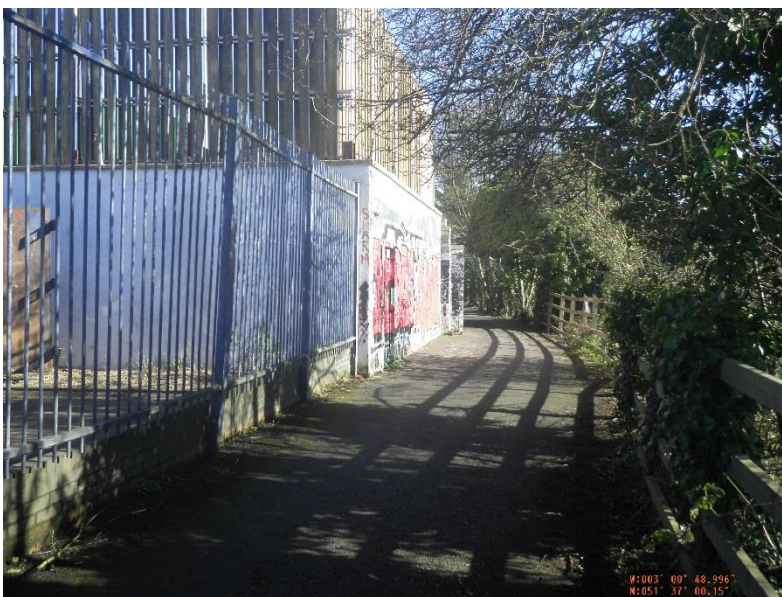
This wall is generally in a good condition, condition grade 2.

Figure 35 - Dwarf wall

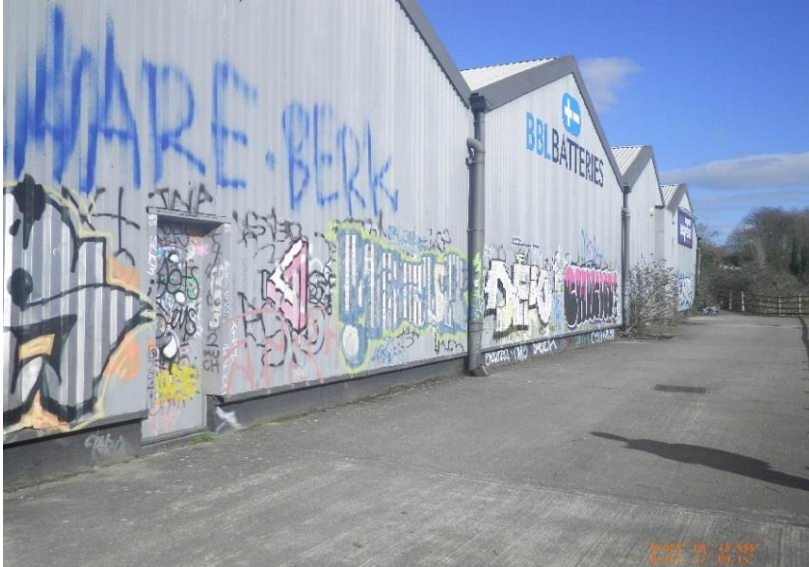
It is understood (from discussions between the EA and the building occupiers) that for extreme tidal events, the occupiers of the buildings put temporary flood resilience measures in place.

Figure 36 – Panel clad wall

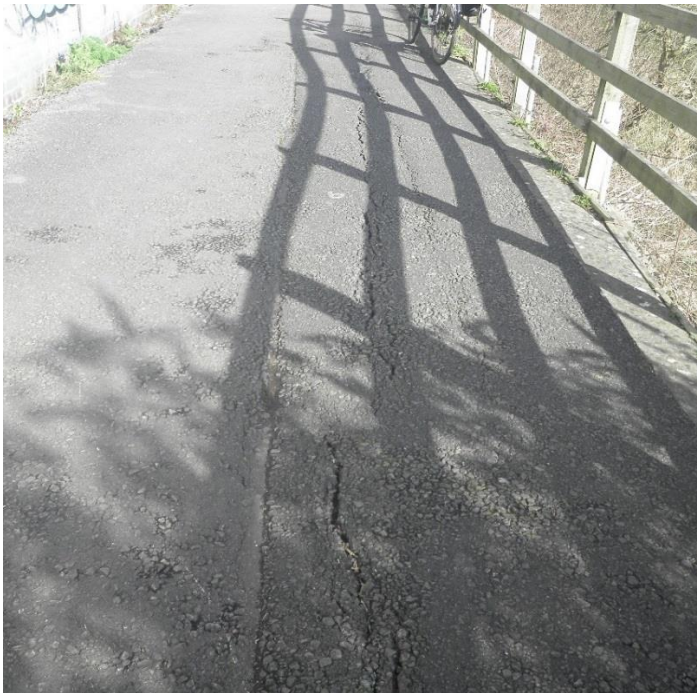
In some places this coincided with a location where the riverbank appears to be kept stable by the roots of trees. If these trees were damaged or removed, there is a risk that parts of the path could fall into the river within a short timeframe, in geomorphological terms. This could lead to the foundations of the walls being undermined.

Figure 37 - Cracks in path
