# Investigation and review of external cladding and internal fire separation at

**Barton House**  
Aiken Street  
Hill  
Bristol  
BS5 9SJ

October 2019

MTD//P8119

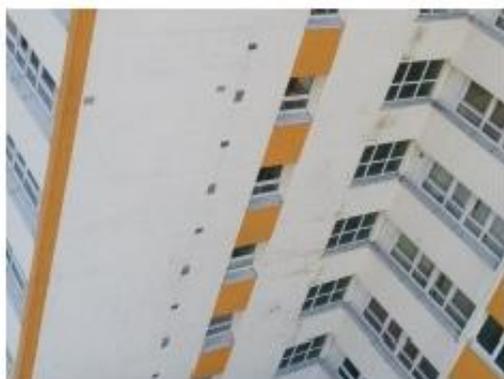
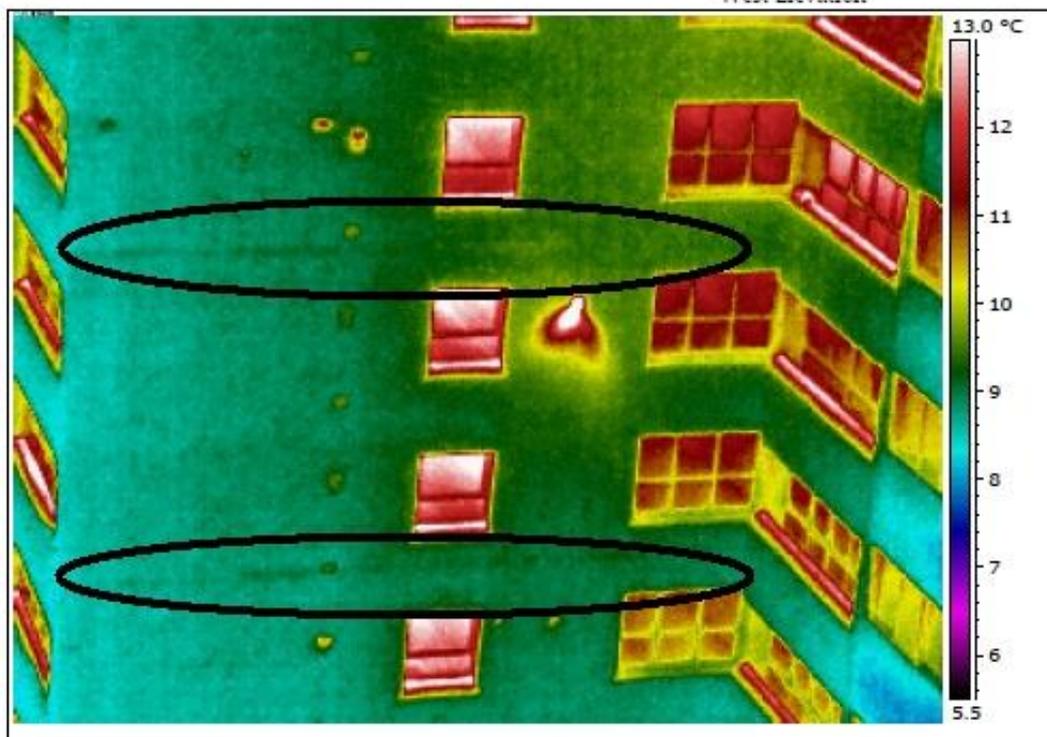
West Elevation

- Elevation 3, over the exit from the main staircase – Barriers were found only at 3<sup>rd</sup> and 5<sup>th</sup> floors. Thermal images suggest this alternate spacing continues for the remainder of the elevation.

1, 2 and 3. Thermal image of typical elevation 3 showing defined thermal signature for barriers at alternate floor slab levels as confirmed in photo below.

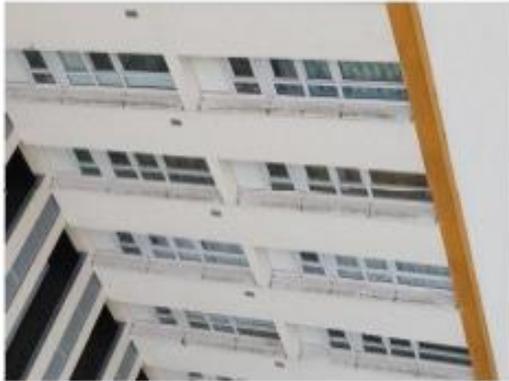
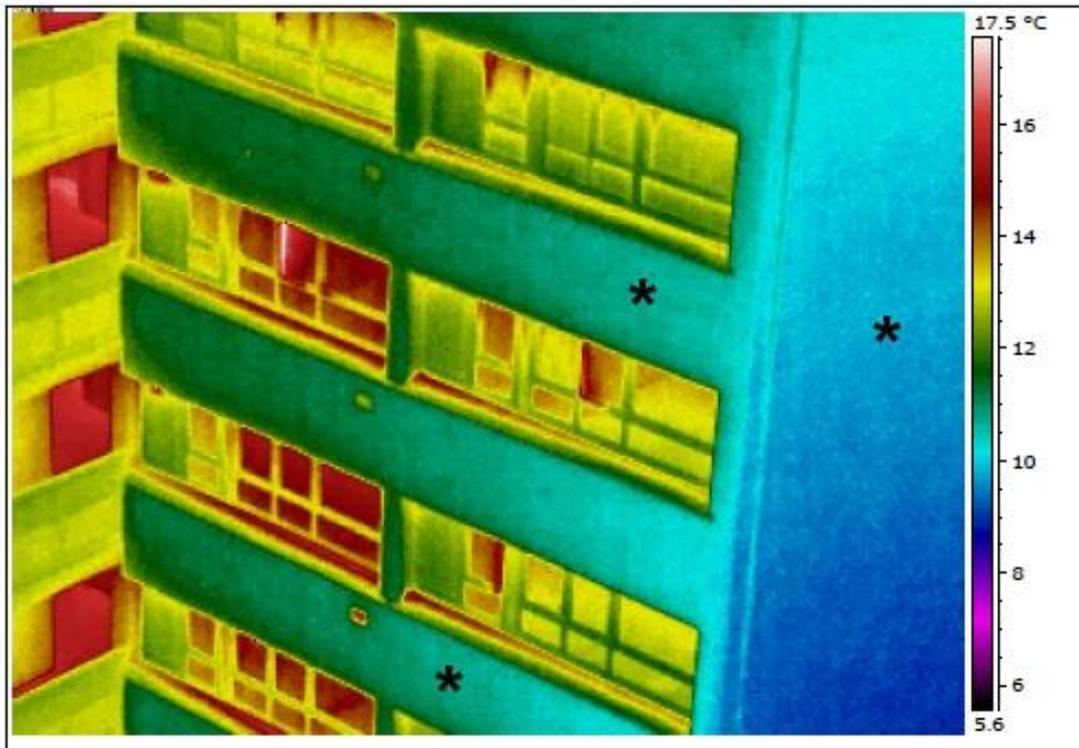
West Elevation

- Elevation 7 over the main entrance – Barriers found only at 3<sup>rd</sup> and 5<sup>th</sup> floor levels, but were positioned around 400mm above floor slab level. Thermal images are inconclusive in both identifying this pattern and confirming it at higher levels.

4, 5 and 6. Thermal image of elevation 7 (and 8) showing poorly defined thermal signature for barriers. Notably above slab level to elevation 7 as shown below.

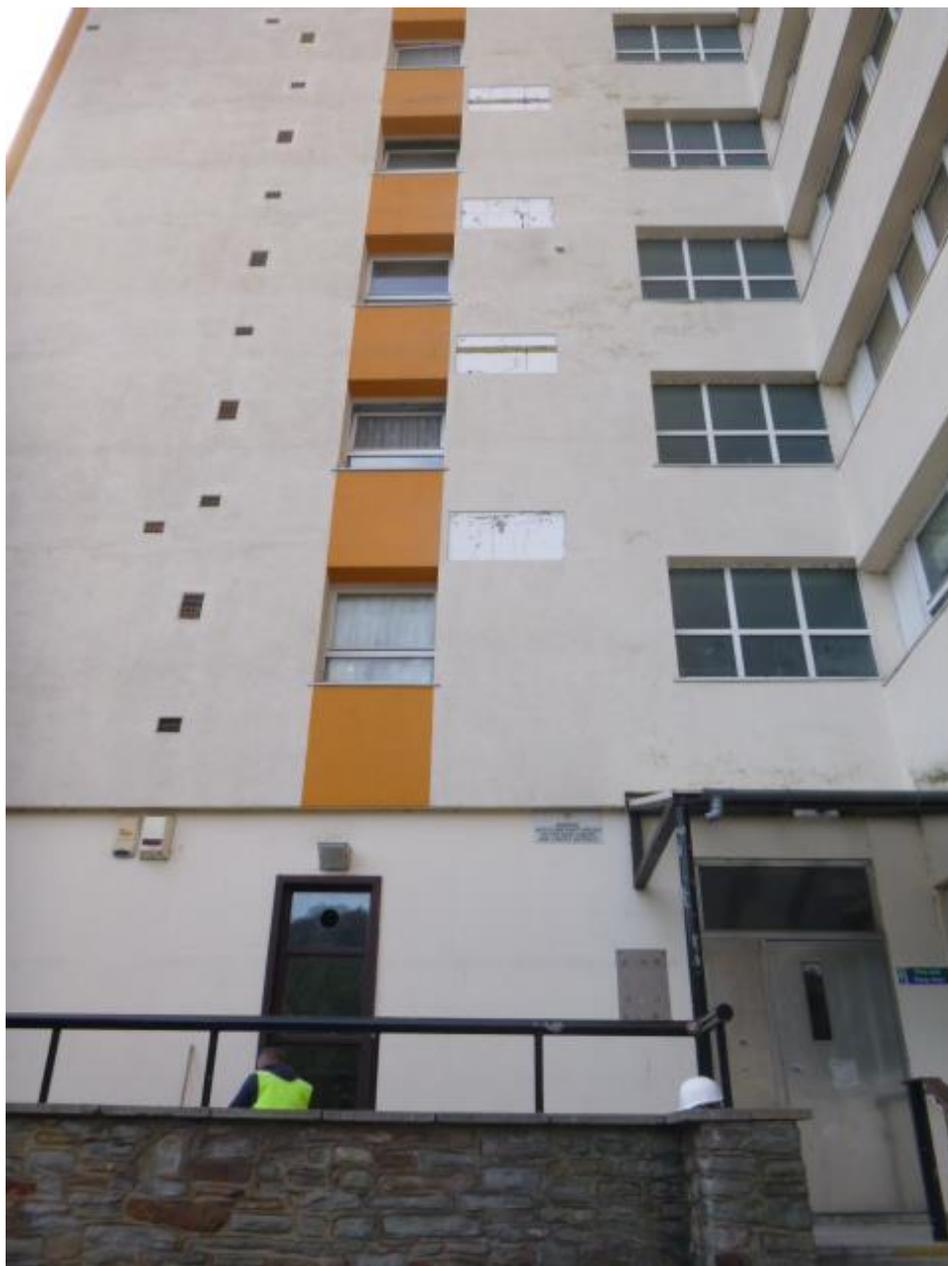
- 4.9 The installation at alternate levels has no logical or regulatory justification. Compartmentation needs to be maintained and this is required at every floor level.

**7. Elevation 3 with fire barrier found at alternate levels from third floor upwards.**

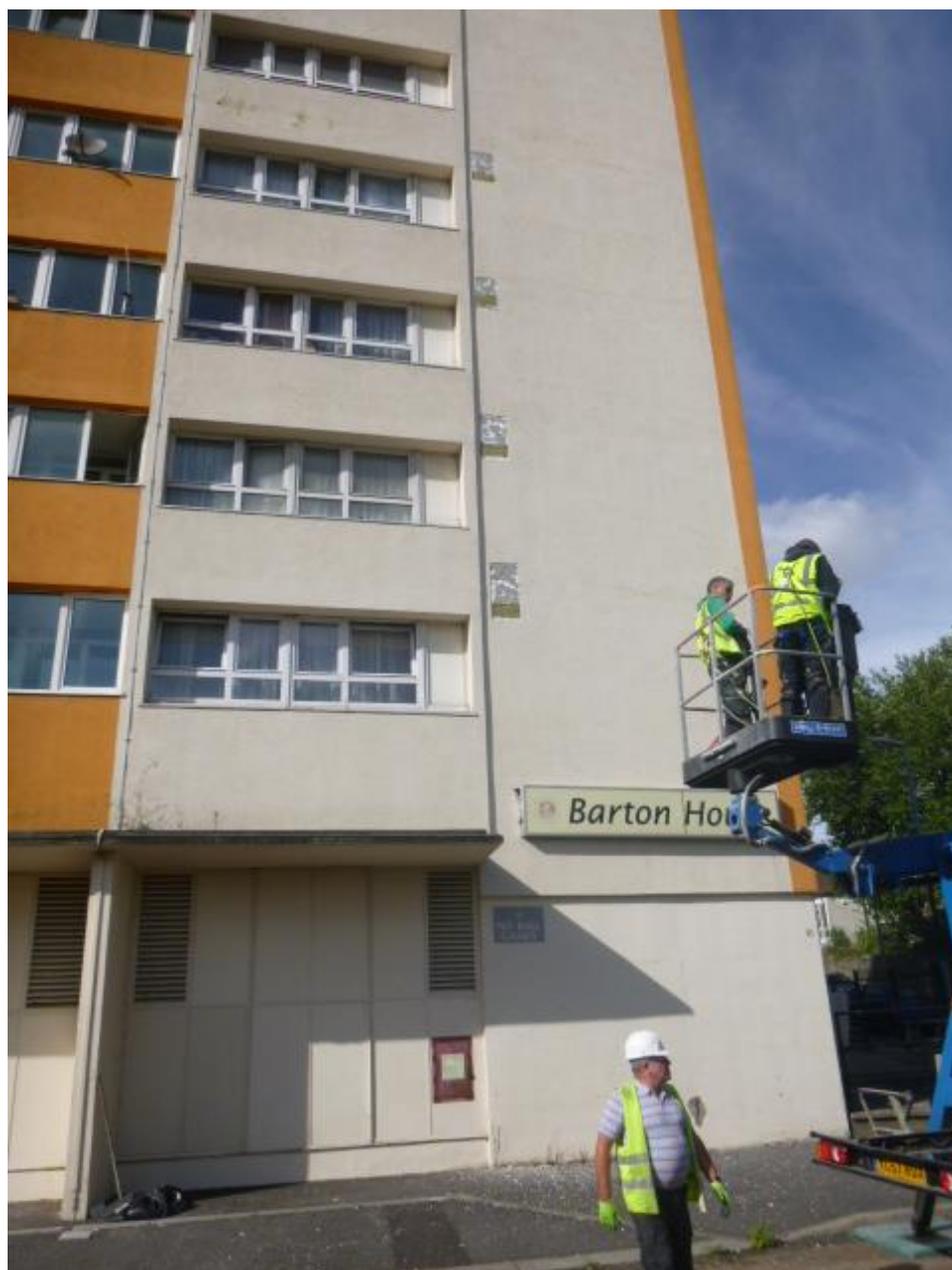
- Elevation 4, adjacent to the secondary staircase/refuse chutes – Barriers were found at each floor level from 2<sup>nd</sup> to 5<sup>th</sup>. Thermal images confirm this spacing over the whole elevation.

**8. Elevation 4 with fire barriers at each floor level around the stairwell enclosure.**

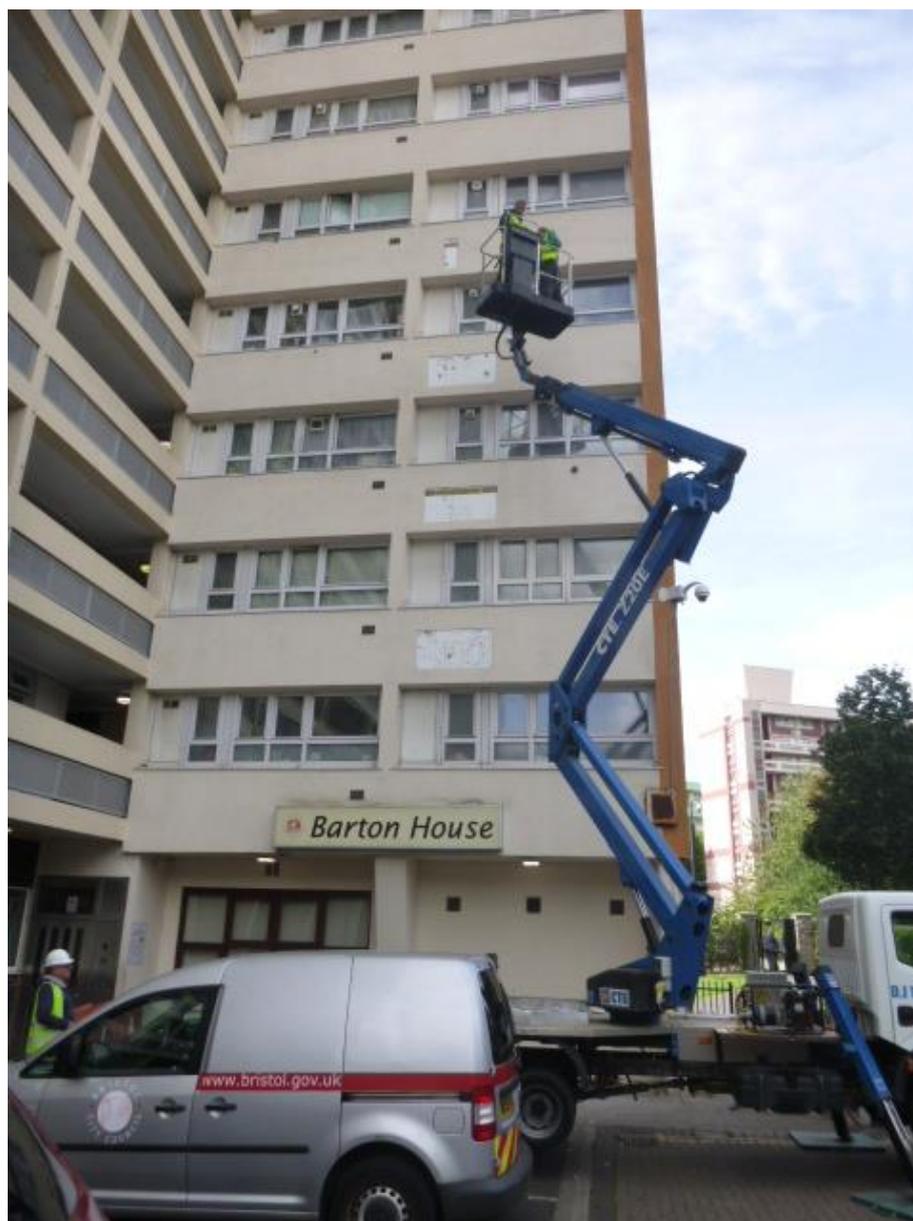
- 4.10 The barrier installation on elevation 7, some 400mm above floor slab level has no logic. The stopping short of the corners with the adjacent elevation is equally nonsensical. But even if they had been extended they would not have been continuous around the corners with those on elevation 7.

**9. Elevation 7 note barriers only at alternate levels and approximately 400mm above floor slab level**

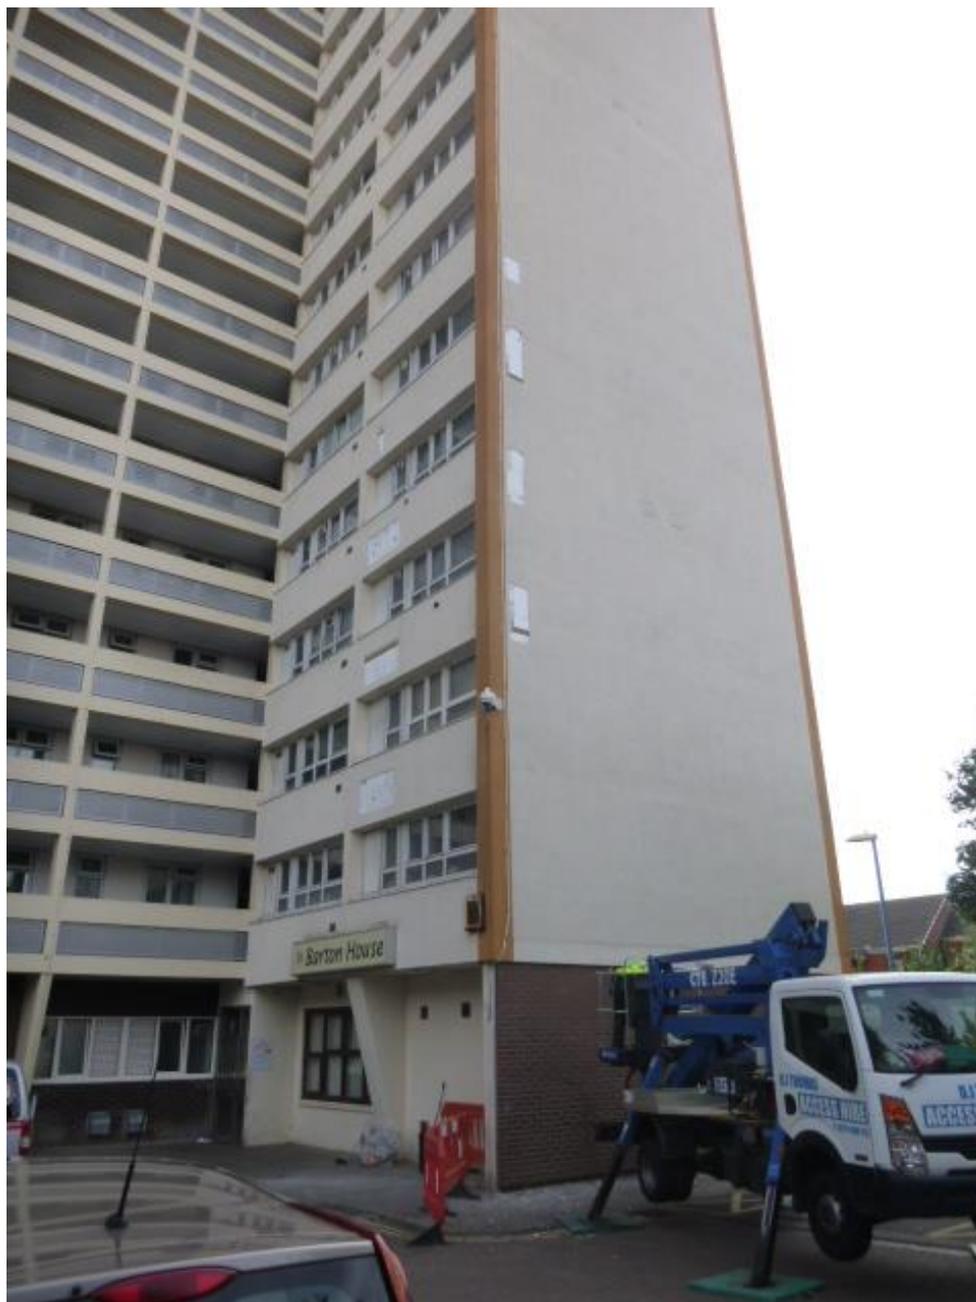
- Elevations 8 to the right side of the main entrance- Barriers were again found only at 3<sup>rd</sup> and 5<sup>th</sup> floor levels. They are at slab level but did not extend to the corner with elevation 7 whose barriers are set around 400mm higher.

**10 Elevation 8 note fire barriers still at alternate levels but installed at slab level and therefore not continuous with elevation 7**

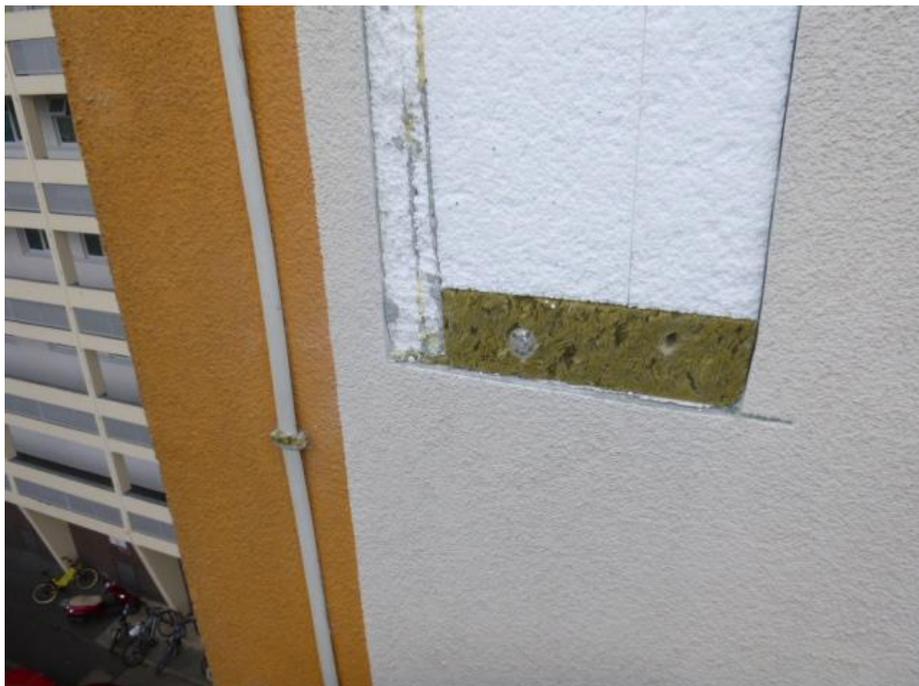
**11 Elevations 8 note fire barriers stop approximately 900mm short of the corner with elevation 7 and therefore would not be continuous even if installed at the same level**
