**Flood Investigation Report for the flooding on
Cheltenham Road on 27th November 2018**

April 2019

FLOOD INVESTIGATION

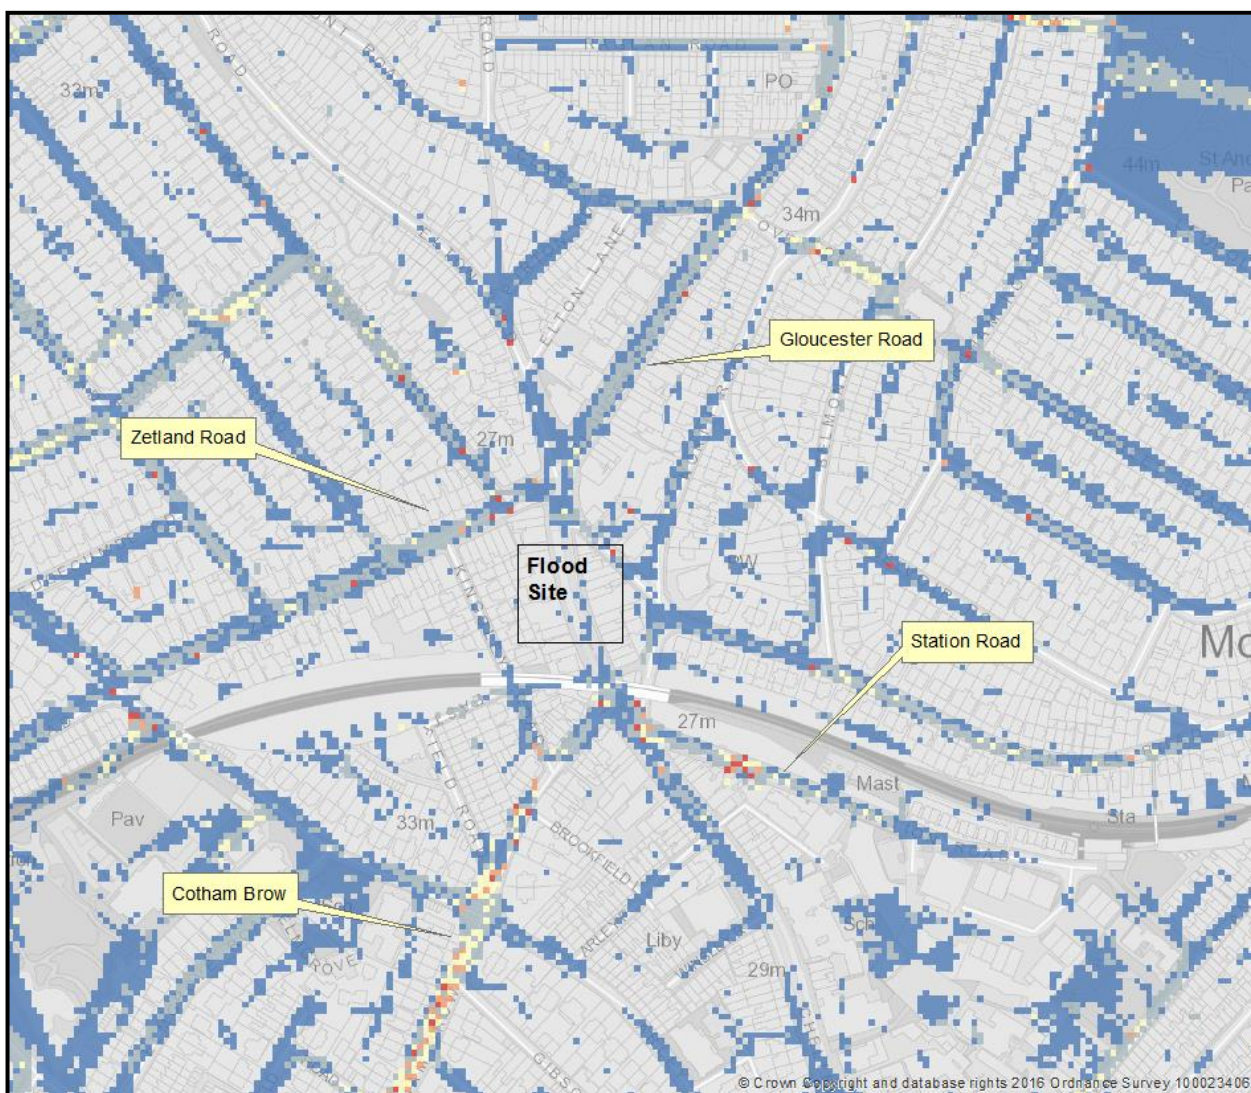
Figure 2: Surface water velocity results extract from the Bristol Surface Water Management Plan. Figure demonstrates the overland flow routes of surface water with the red and yellow representing the areas where the water is moving at highest velocity. The labelled roads slope downhill onto the site and the figure indicates that there is very little water movement on the flood site as it is mostly clear from any colour, this shows that water is collecting here.

Heavy rainfall led to increased surface water. This was exacerbated by the fact that the site is low lying with several roads sloping downhill onto it, causing a lot of surface water to collect here. As shown by figure 2 above. The drainage infrastructure may have had a lack of capacity as a result of increased surface water in the area. However, whilst the rainfall was heavy it was not deemed sufficient to result in sewer capacity exceedance. As explained in section 3.1, the return period of the rainfall was low and has been experienced many times in recent years. If sewer capacity was the cause, we would expect to have received significantly more reports of flooding than has been received.

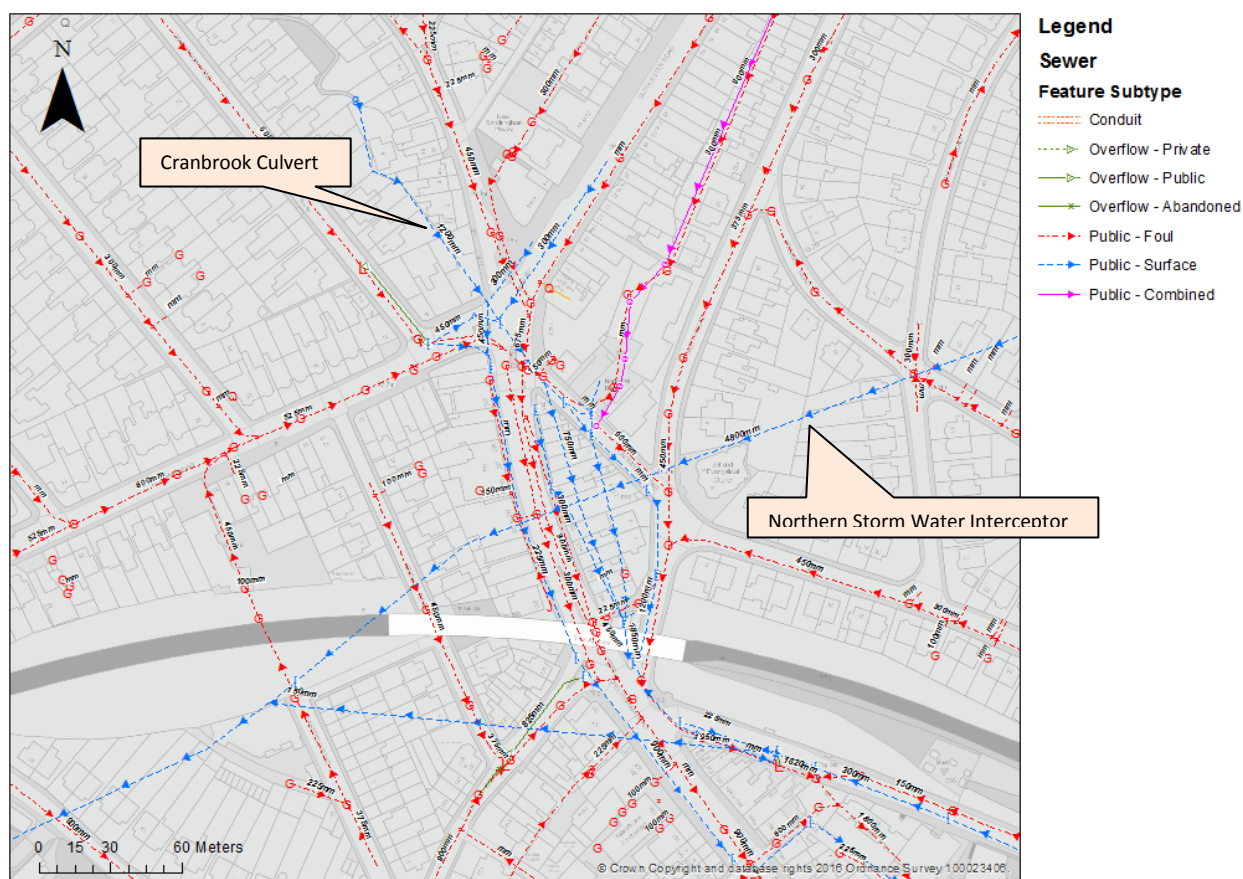
Figure 3 shows the site's drainage system. The immediate catchment is heavily urbanised and therefore predominantly served by positive drainage systems (highway gullies/drains as well as run-off from properties connecting in to public surface water sewers). The area has a significant amount of drainage infrastructure because it has historically been an area known to have drainage issues. A number of the sewers connect directly into the Northern Storm Water Interceptor, which is 4800mm in diameter, or into the combined sewers.

The Cranbrook is culverted (1200mm diameter) within the vicinity of the investigation area, this culvert also connects into the Northern Storm Water Interceptor downstream of the site.

Figure 3: Public sewers and highway drainage for Cheltenham Road

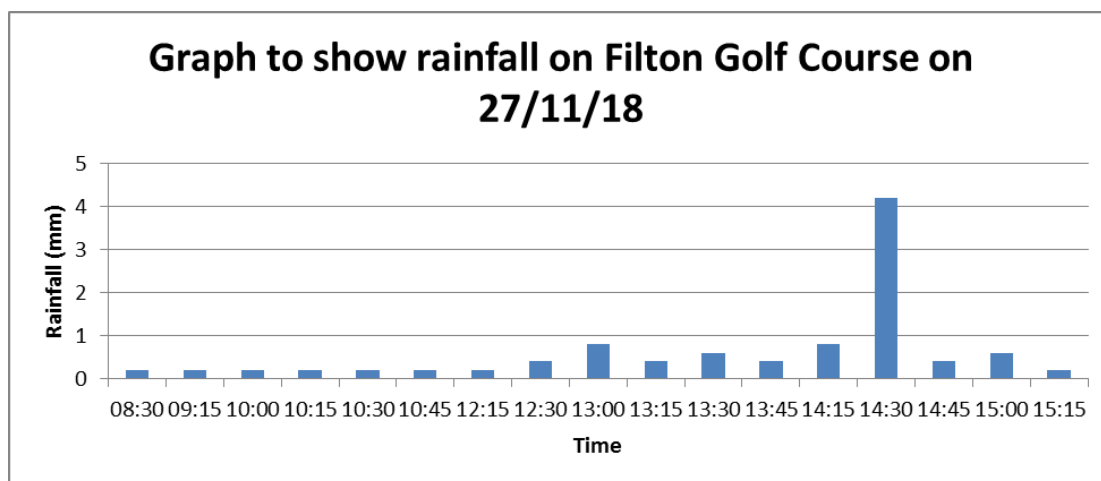
On 27th November 2018, during a wet and stormy day, Bristol suffered heavy rainfall across the city. Despite no weather warnings being issued, about 10mm of rain fell from 8:30 – 15:15, according to BCC's rain gauge on Filton Golf Course, which is approximately 5km from the site. Almost half of this fell between 14:30 and 14:45, as shown by figure 4 below. Our calculations show that the amount of rain that fell has a return period of 0.5 years. Given the time of year and the weather on the day (stormy and windy), a significant amount of debris was on the ground, which will have exacerbated the problem.

Figure 4: Graph showing the rainfall on 27/11/2018, taken from the tipping-bucket rain gauge at Filton Golf Course

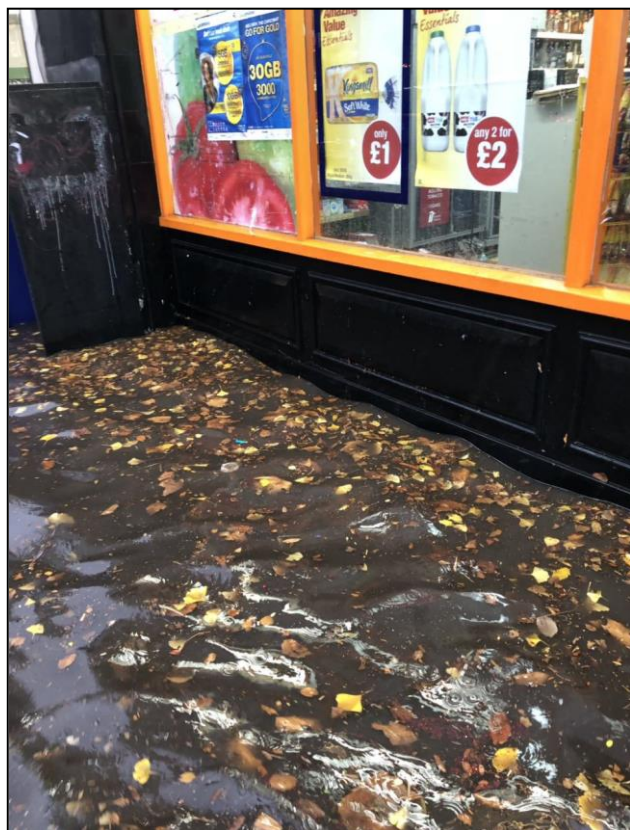
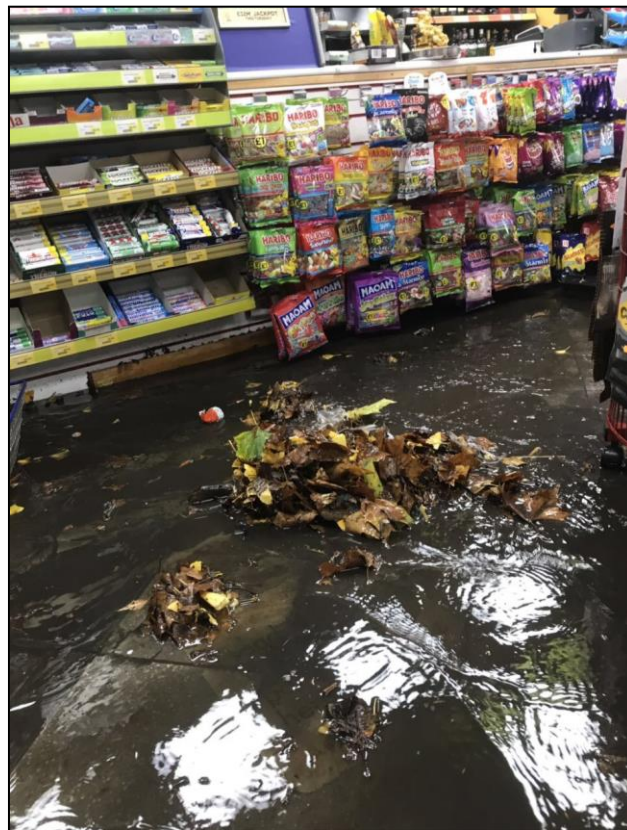
The entirety of the road was flooded with reports that it was 300mm in depth in some places, this disrupted traffic as cars and buses had to slow down to travel through. Approximately 10 commercial properties were flooded internally as a result of this event. The internal flooding varied in severity with some residents suffering more damage than others. Some occupants reported that their stock was damaged as a result of the flooding, and others were forced to close their shop for several hours in order to clear away the water and leaves, causing them to lose business as a result to the flood. An additional three properties were flooded in their doorways and other occupants reported that had they not taken action to clear the gullies themselves, they would have also suffered from flooding.

Plates 1 and 2 showing some of the flooding inside and outside properties on Cheltenham Road

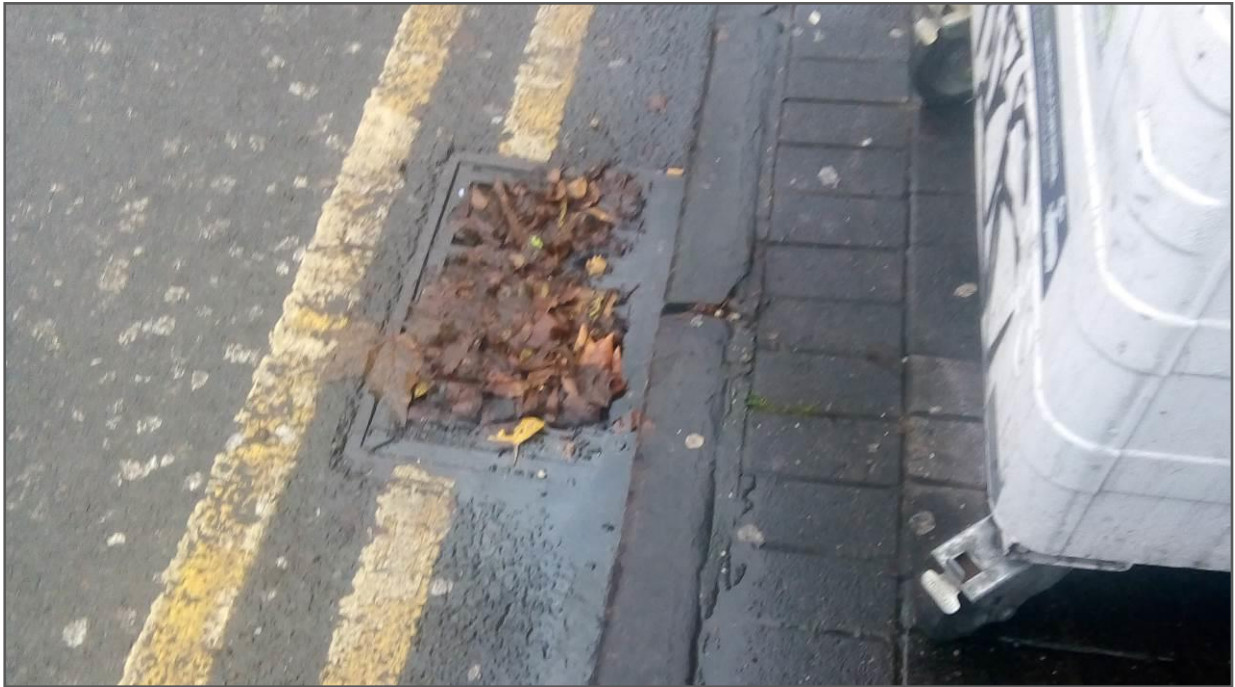
When carrying out post-event investigation, officers observed that some of the gullies along Cheltenham Road were blocked with silt, as shown by plats 3 and 4, this is likely because our team only cleared the ones that were reported or due to them becoming blocked again.

Plate 3: A blocked or blinded gully within the flood investigation area on Cheltenham Road, taken on the 30th November 2018.

In line with section 3.4, the predominant cause of flooding was blocked or blinded gullies, which is the responsibility of the Highway Authority. According to our systems the majority of the gullies were cleared in November 2017 which is considered to be an appropriate amount of time between cleanses. It should be noted that managing leaves is difficult because on a wet and windy day there is a constant supply of vegetation, meaning that it is unreasonable to expect the Highway Authority to keep the highway network across the city completely clear of debris. In addition, as soon as the Highway Authority became aware of the flooding problem they instructed maintenance crews to clear the debris. As a result it is deemed the Highways Authority has discharged their duty under the FWMA. However, despite reasonable efforts, a number of gullies were observed to be blocked as shown by figures 6 and 7, demonstrating that the frequency at which the gullies block may be more than once a year.

The flooding on Cheltenham Road occurred as a result of heavy rainfall in the area combined with a series of blocked/blinded gullies on Cheltenham Road and the surrounding roads, causing the surface water to continue flowing downhill and collect on the site. Therefore, it is recommended that BCC reviews its frequency of checking and clearing the gullies along Cheltenham Road. BCC could also work with Bristol Waste to review the frequency with which they clear debris off the road. They currently clear Cheltenham Road using a mechanical sweeper once every two weeks, as well as doing daily litter picks. If they were to increase the frequency of this during the autumn, when leaf fall is at its highest, then this would help prevent gullies becoming blocked/blinded. It is noted that BCC is moving towards a risk and data based gully cleansing programme, as such they are putting reasonable measures in place to reduce the risk of future

occurrences across the city. The Highway Authority will regularly and formally report the progress of this data and risk based approach to the LLFA to ensure the risk of future similar flood events is reduced. It is also recommended that BCC consider a highway drainage scheme to reduce the risk of future blockages.

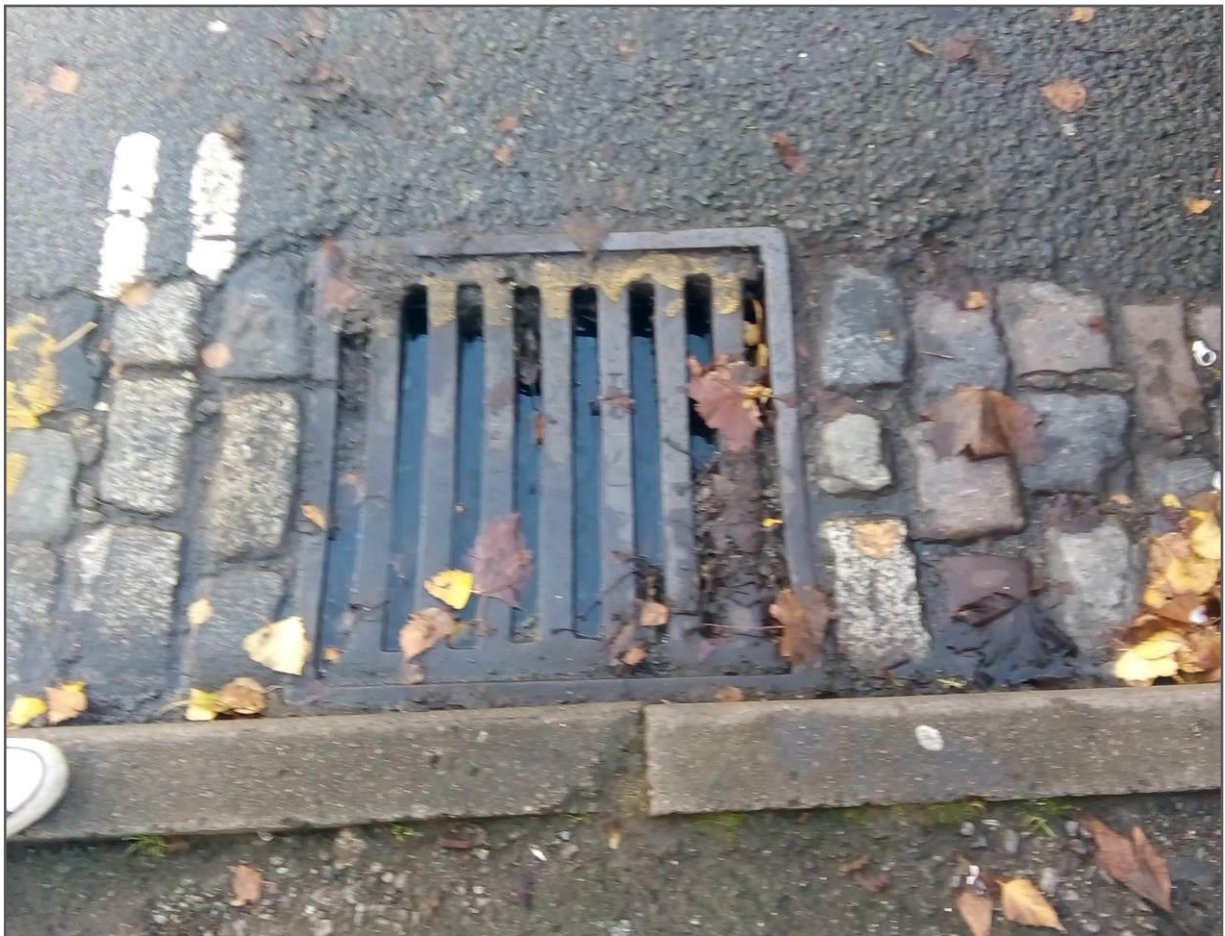
Plate 4: A blocked gully within the flood investigation area on Cheltenham Road, taken on the 30th November 2018.
