**Flood Investigation Report for the flooding on  
Cheltenham Road on 27<sup>th</sup> November 2018**

**April 2019**

## FLOOD INVESTIGATION

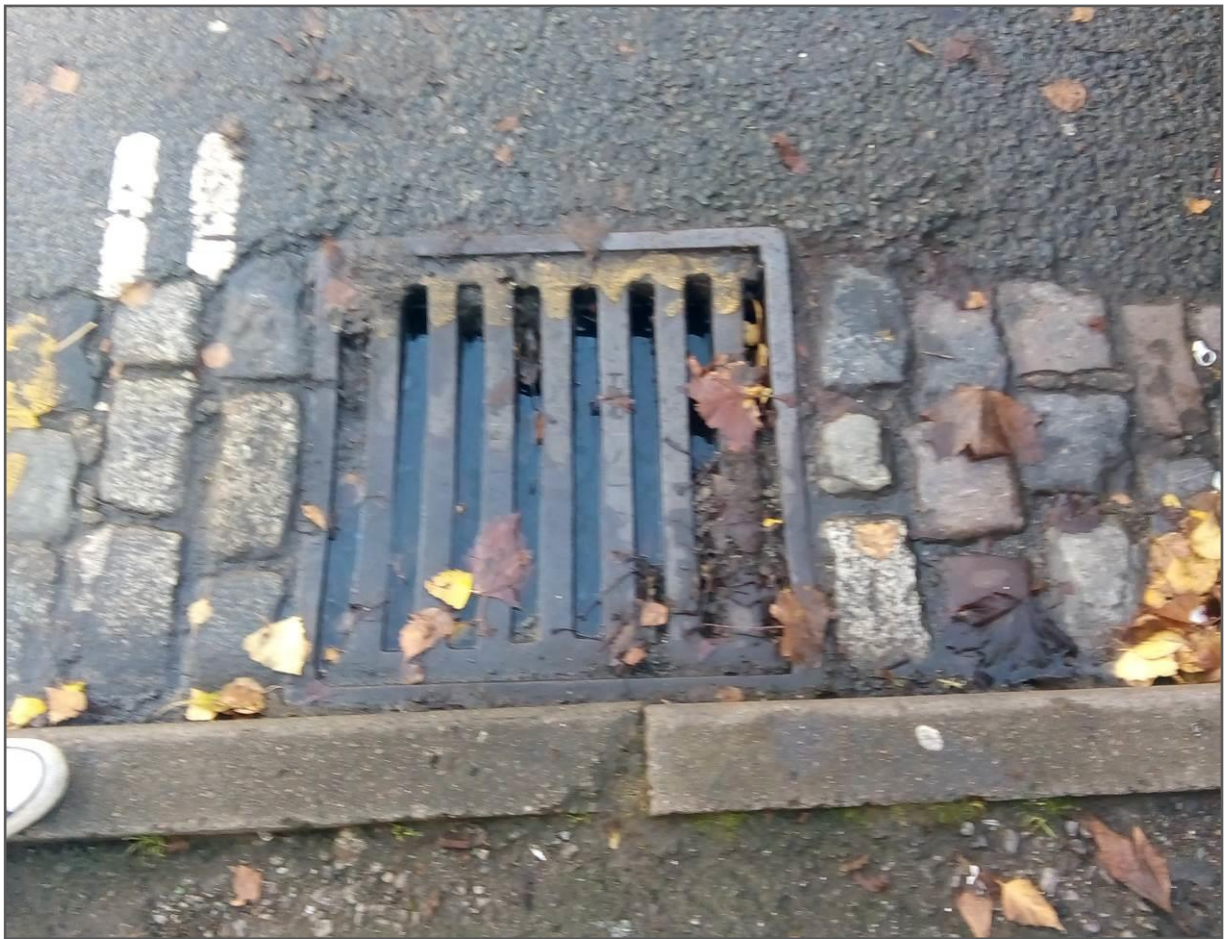
When carrying out post-event investigation, officers observed that some of the gullies along Cheltenham Road were blocked with silt, as shown by plats 3 and 4, this is likely because our team only cleared the ones that were reported or due to them becoming blocked again.

**Plate 4: A blocked gully within the flood investigation area on Cheltenham Road, taken on the 30<sup>th</sup> November 2018.**

In line with section 3.4, the predominant cause of flooding was blocked or blinded gullies, which is the responsibility of the Highway Authority. According to our systems the majority of the gullies were cleared in November 2017 which is considered to be an appropriate amount of time between cleanses. It should be noted that managing leaves is difficult because on a wet and windy day there is a constant supply of vegetation, meaning that it is unreasonable to expect the Highway Authority to keep the highway network across the city completely clear of debris. In addition, as soon as the Highway Authority became aware of the flooding problem they instructed maintenance crews to clear the debris. As a result it is deemed the Highways Authority has discharged their duty under the FWMA. However, despite reasonable efforts, a number of gullies were observed to be blocked as shown by figures 6 and 7, demonstrating that the frequency at which the gullies block may be more than once a year.

The flooding on Cheltenham Road occurred as a result of heavy rainfall in the area combined with a series of blocked/blinded gullies on Cheltenham Road and the surrounding roads, causing the surface water to continue flowing downhill and collect on the site. Therefore, it is recommended that BCC reviews its frequency of checking and clearing the gullies along Cheltenham Road. BCC could also work with Bristol Waste to review the frequency with which they clear debris off the road. They currently clear Cheltenham Road using a mechanical sweeper once every two weeks, as well as doing daily litter picks. If they were to increase the frequency of this during the autumn, when leaf fall is at its highest, then this would help prevent gullies becoming blocked/blinded. It is noted that BCC is moving towards a risk and data based gully cleansing programme, as such they are putting reasonable measures in place to reduce the risk of future

occurrences across the city. The Highway Authority will regularly and formally report the progress of this data and risk based approach to the LLFA to ensure the risk of future similar flood events is reduced. It is also recommended that BCC consider a highway drainage scheme to reduce the risk of future blockages.
