**ST JUDE'S RESIDENTIAL BLOCKS
BRISTOL CITY COUNCIL
BUILDING SAFETY RISK ASSESSMENT**

April 2025

BRISTOL CITY COUNCIL

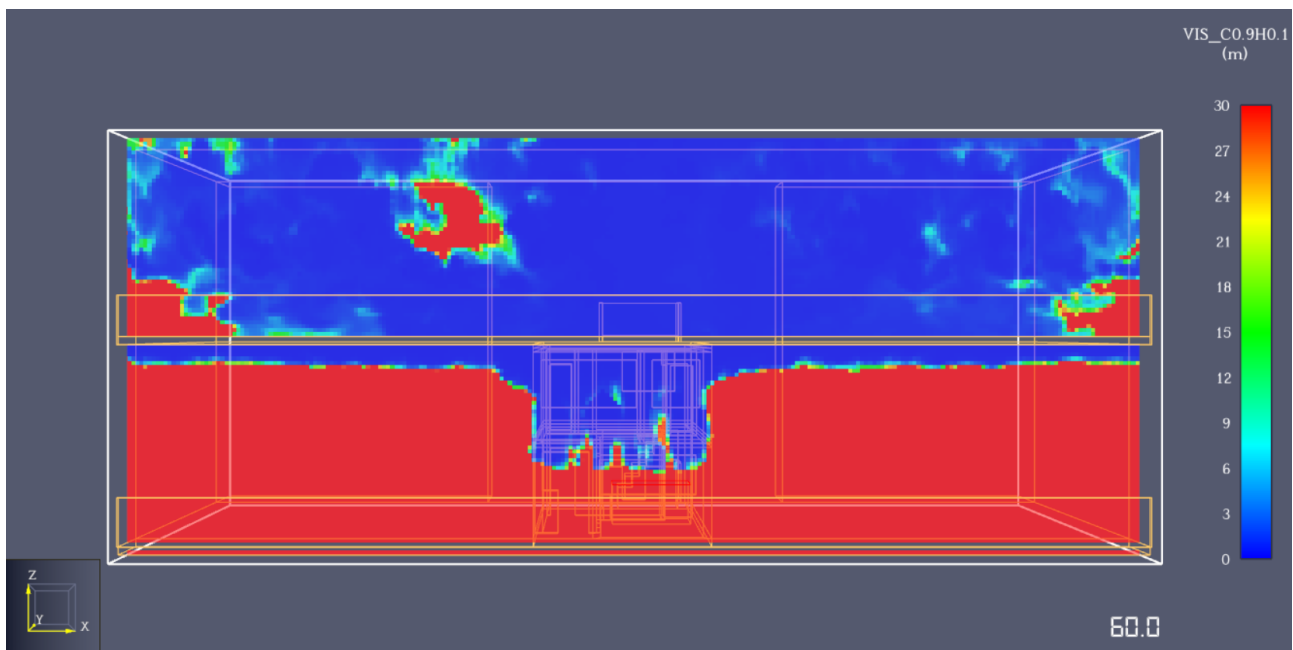
Figure 4 Visibility on walkway deck in case of uncontrolled post-flashover fire in kitchen

As the flats are located off open deck walkways, with unprotected windows, there are possible scenarios in which fire breaks out of the window, or the window or front entrance door are left open, leading to smoke existing the flat. Some simple computational fluid dynamics models indicates that there may be some lateral smoke spread, underneath the overhanging walkway (if the fire is in one of the lower floors), but, principally, such a scenario would be more likely to impact the walkways above, rather than on the same level.

There could be some lateral fire spread via the decorative timber cladding on the front elevation, albeit that the likelihood of vertical fire spread would be likely to be limited by the continuous overhanging walkway, which acts as an inherent fire break.

The walkways themselves could have improved protection through the installation of sprinklers to all flats and channelling screens, both of which in isolation are estimated to have a beneficial effect on visibility conditions on the walkways above a flat with a serious fire.

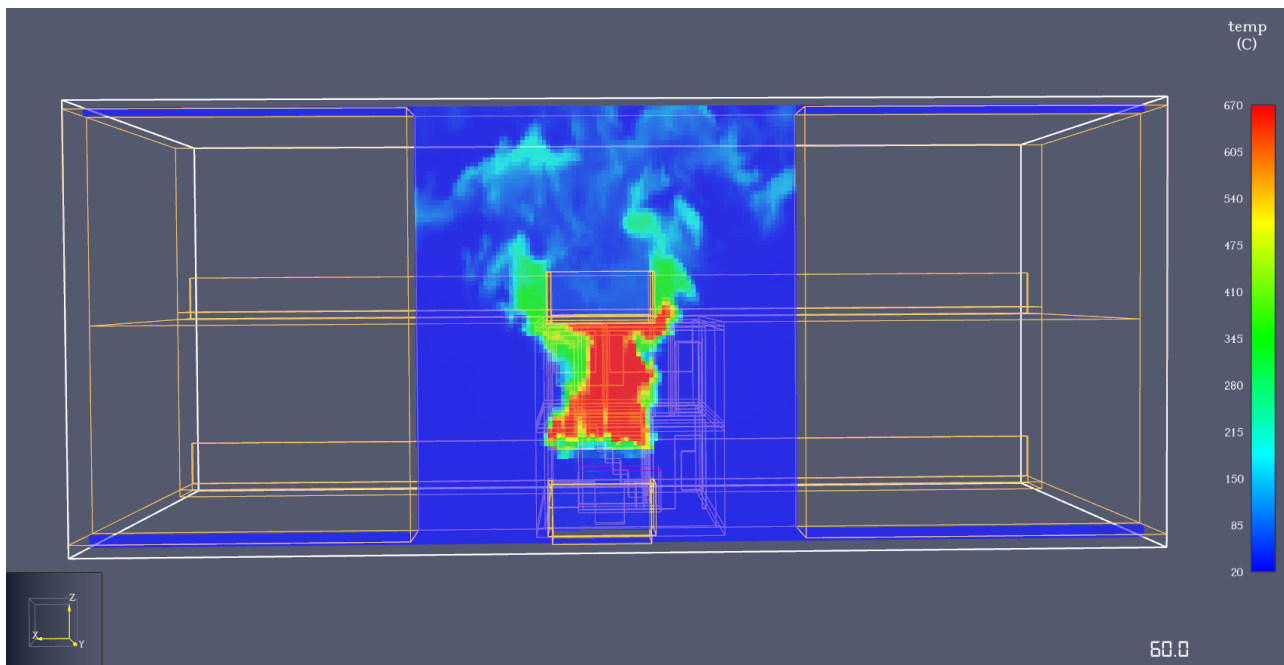
Figure 8 External rear elevation temperatures in case of uncontrolled living room fire

To the rear elevation, the presence of combustible spandrel panels cannot be discounted as a route for vertical fire spread, and this could result in vertical fire spread between individual residential units in certain conditions. The consequences of such a fire could be mitigated through comprehensive domestic alarms within flats, supported by the open deck walkway escape arrangements. Sprinkler protection is likely, in certain scenarios, to achieve significant improvements in terms of risk reduction.

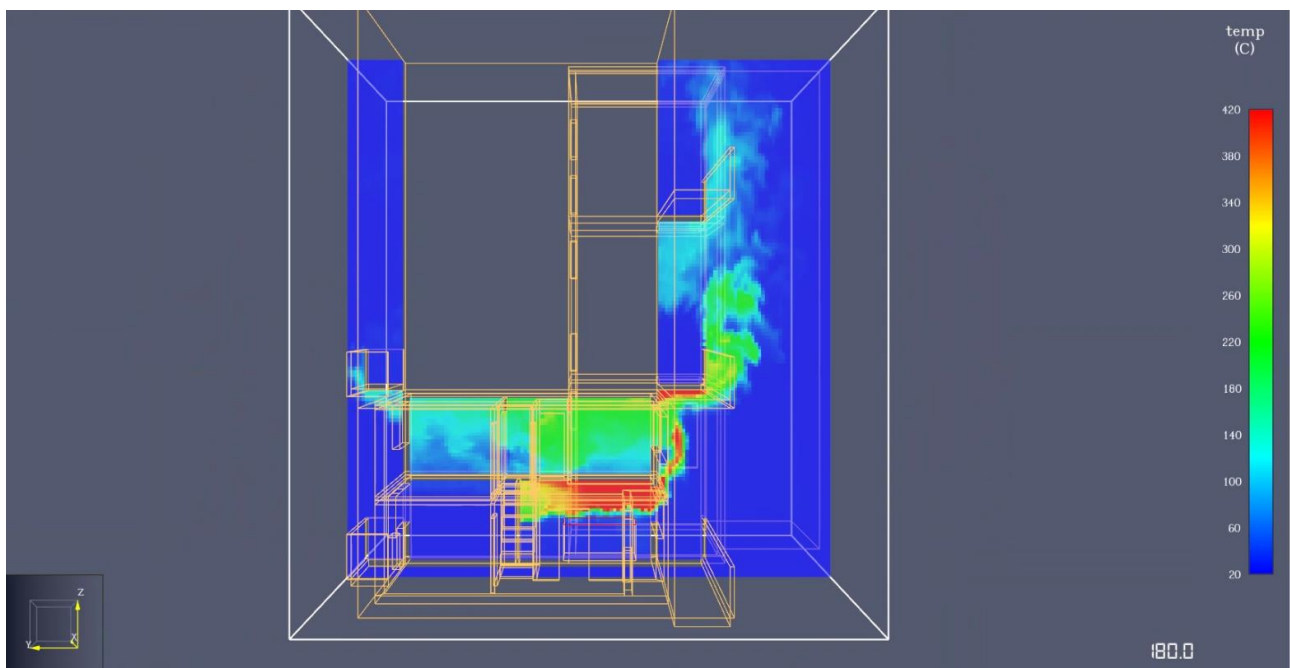
Figure 12 External temperature conditions next to Stair 3 in case of uncontrolled fire in adjacent flat

There are scenarios in which a fire in a flat adjacent to the stair could lead to smoke-logging of the stair, and the likelihood of this is somewhat dependent on the size to which a fire grows in the adjacent flat. The consequences in the case of this occurring next to Stairs 1, 2 and 4 are mitigated by the availability of two-way escape, with the alternative escape routes being remote from one another.

In the case of Stair 3, the consequences could be worse, given the criticality of this route, as the single escape route for occupants of Langton.

Again, the recommendations of the fire strategy to retrospectively install sprinkler protection, and to upgrade the existing windows to the stair, adjacent to the flats, with either fire-resisting glazing or fire-resisting construction, would provide further mitigation.

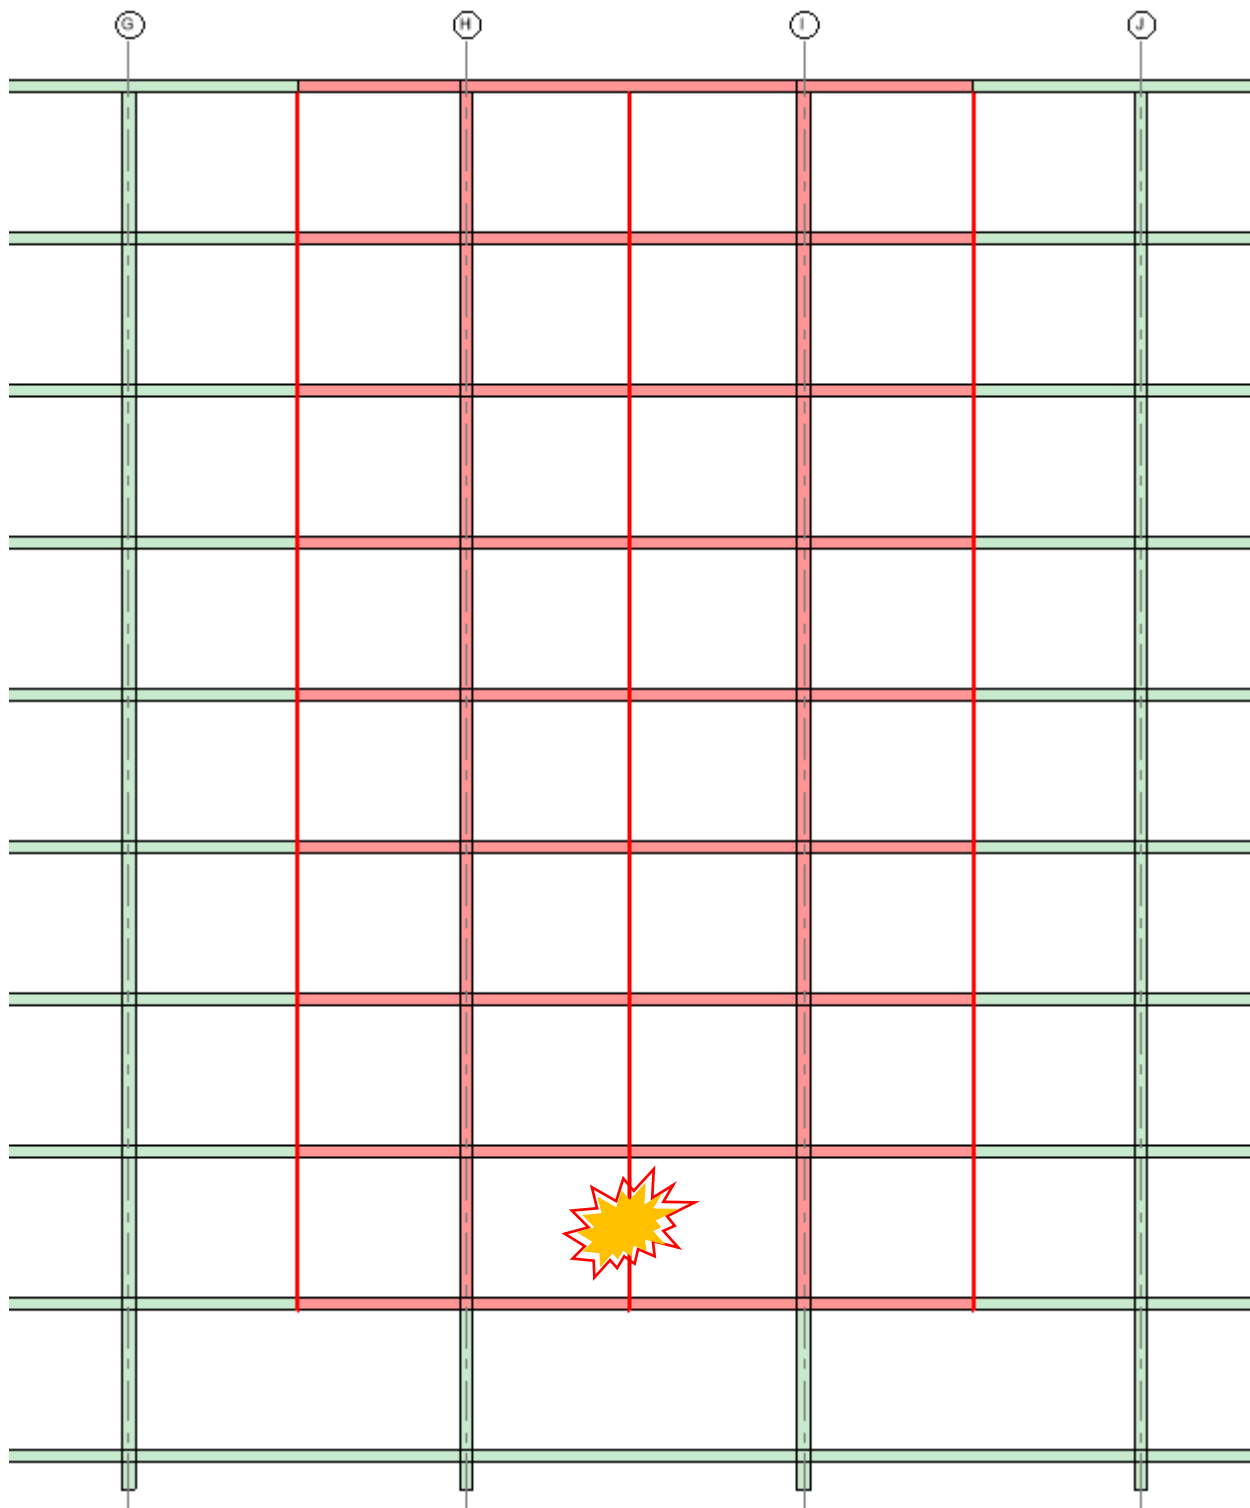
Figure 15 – Collapse mechanism if explosion event occurs within an internal flat, Haviland & John Cozens house (elevation)

An internal gas explosion within any of the blocks at St Judes leads to a failure of the walls and floor slabs above the 2nd floor leading to a disproportionate progressive collapse as shown in Figure 7. The associated number of potential fatalities and the probabilities can be seen below.

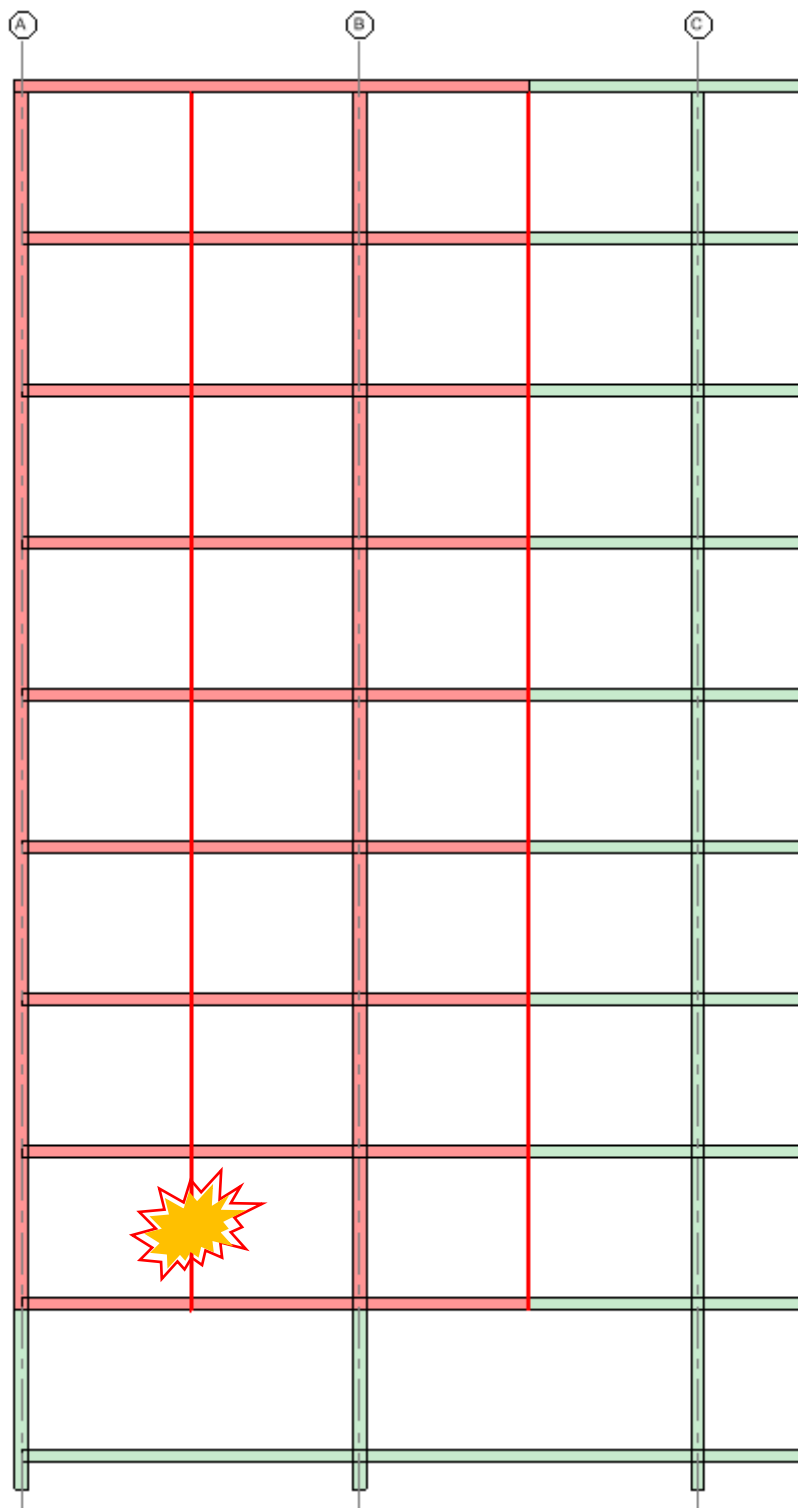
Figure 18 - Collapse mechanism if explosion event occurs within a flank wall flat, Haviland & John Cozens house (elevation)

A gas explosion within any of the flank wall flats of the blocks at St Judes would lead to a failure of the walls and floor slabs above the 2nd floor leading to a disproportionate progressive collapse as shown in Figure 10. The associated number of potential fatalities and the probabilities can be seen below.

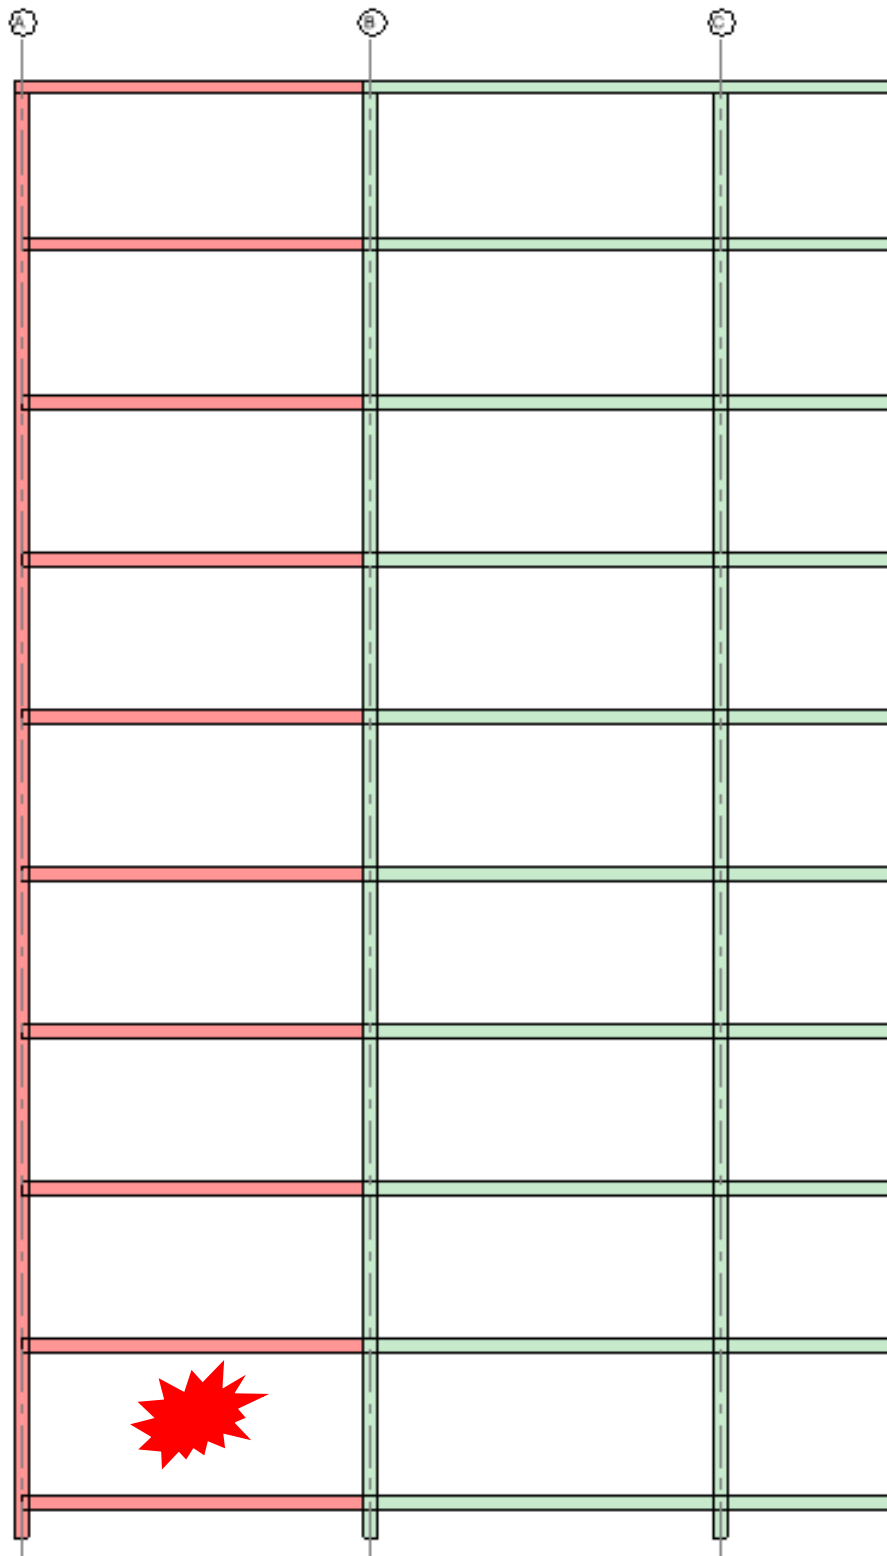
Figure 21 – Collapse mechanism if fire event occurs within a flank wall flat, Haviland & John Cozens house (elevation)

A fire event within any of the flank wall flats of the blocks at St Judes would lead to a failure of the floor slabs due to the low cover to reinforcement, this leaves the flank wall unrestrained and would therefore lead to a

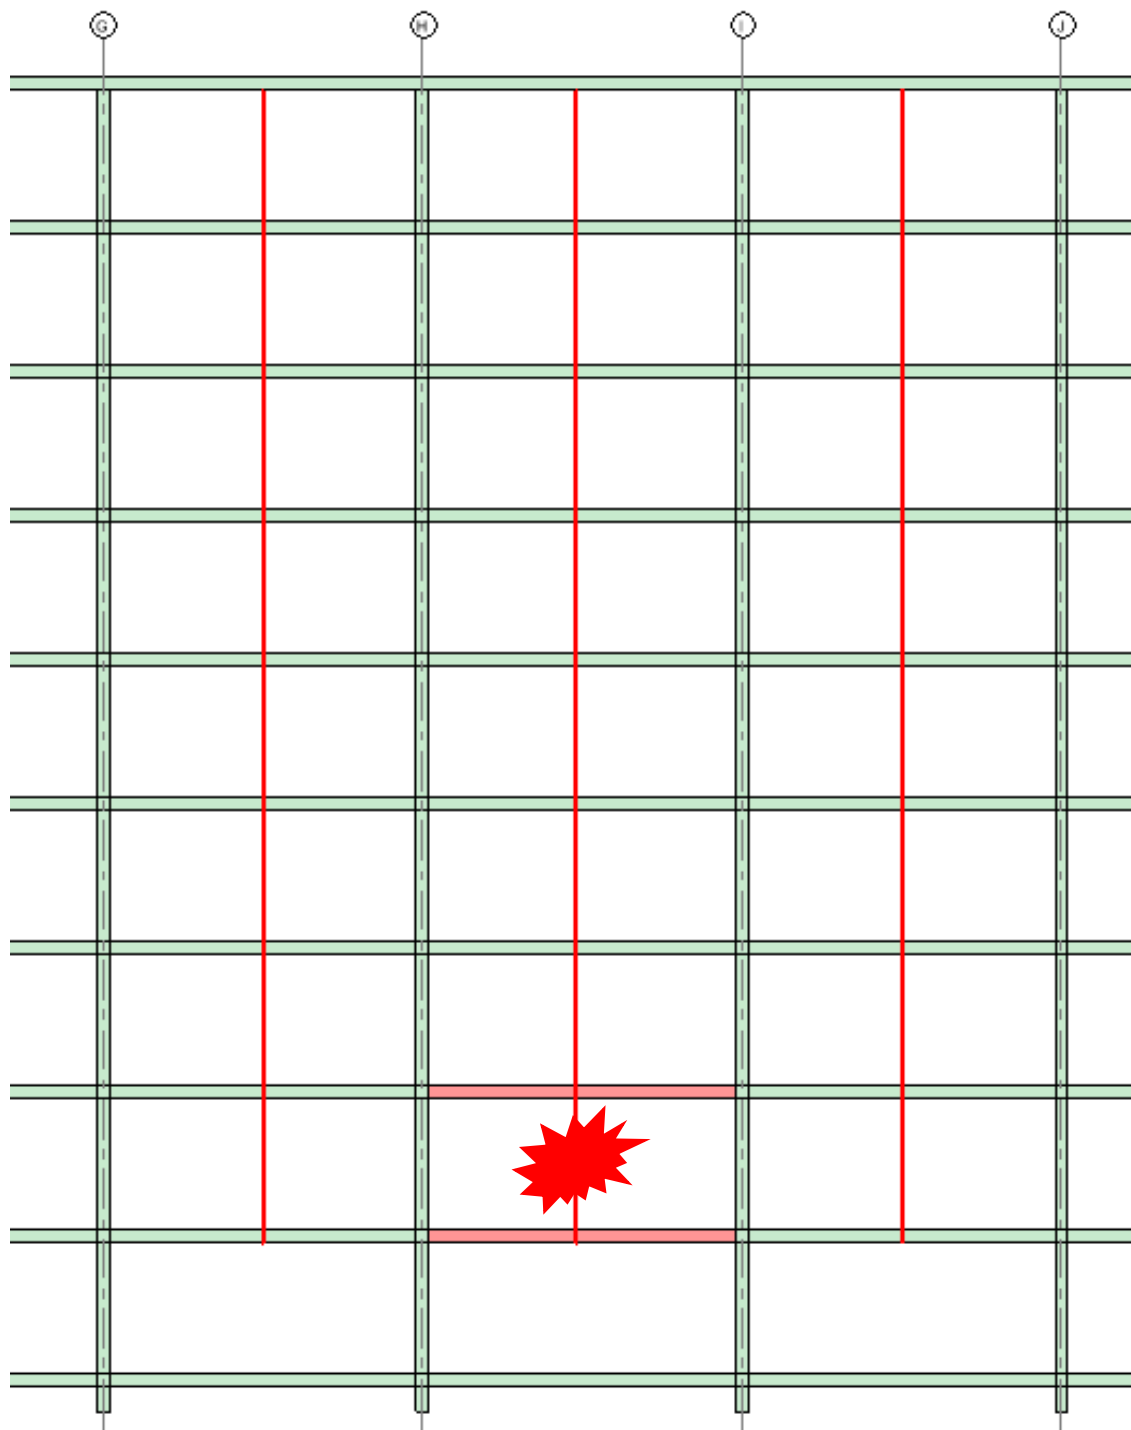
Figure 24 - Collapse mechanism if fire event occurs within an internal flat at level 1, Haviland & John Cozens house (elevation)

A fire event within any of the level 1 flats within Haviland house would lead to a failure of the floor slab above due to the low cover to reinforcement, this would then lead to the collapse of the floor below due to the overloading of the floor and collapse into the nursery below as shown in Figure 16. The associated number of potential fatalities and the probabilities can be seen below.

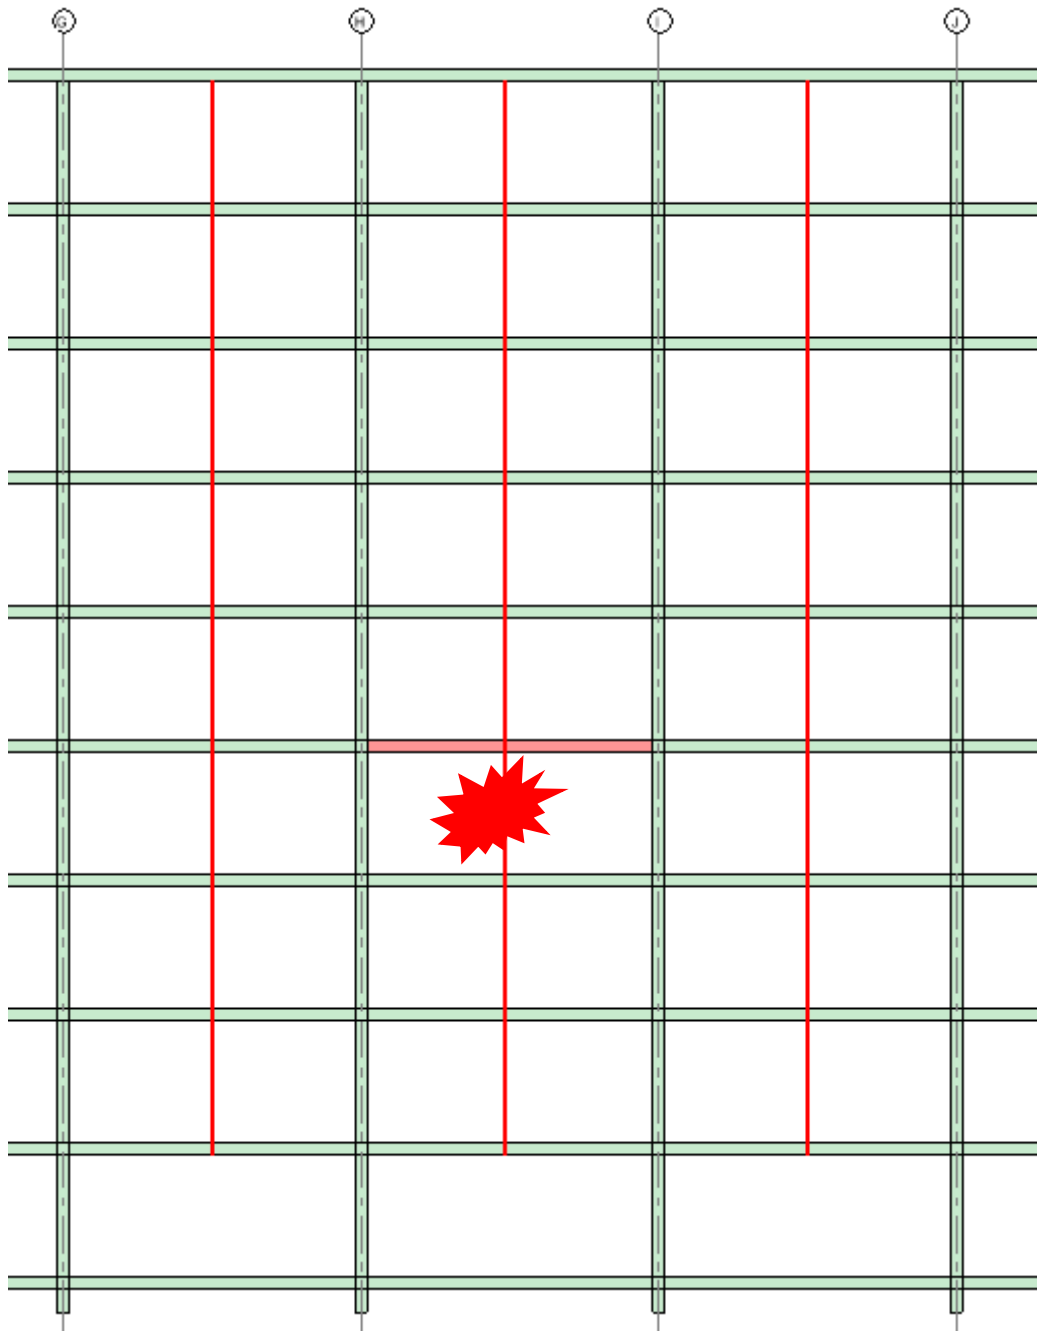
Figure 27 - Collapse mechanism if fire event occurs within an internal flat, Haviland & John Cozens house (elevation)

A fire event within any of the flats of the Haviland & John Cozens blocks at St Judes, above level 1 would lead to a failure of the floor slab above due to the low cover to reinforcement. Due to the existing strengthening frame the collapse in this scenario would be limited to only one floor as shown in Figure 19. The associated number of potential fatalities and the probabilities can be seen below.

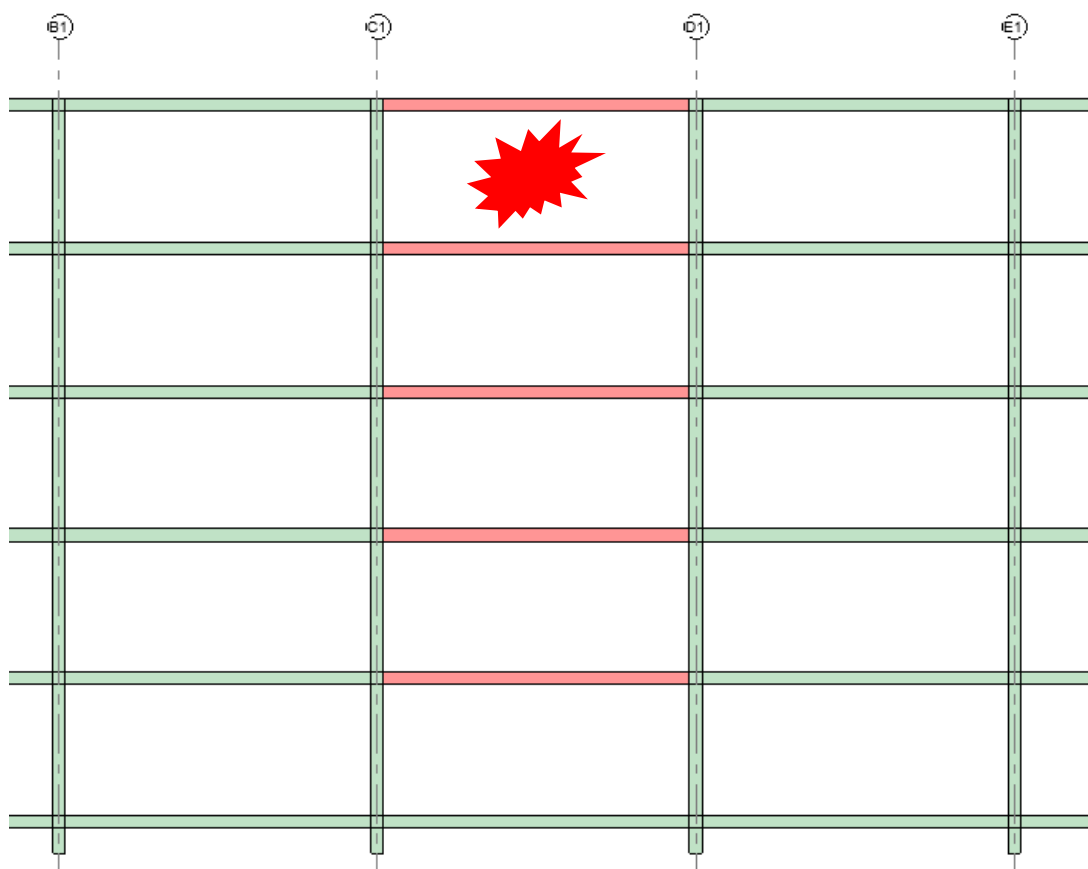
Figure 30 - Collapse mechanism if fire event occurs within top flat, Charleton house (elevation)

A fire event within any of the flats of Charleton House at St Judes, would lead to a failure of the floor slab above due to the low cover to reinforcement. Due to there being no strengthening frame in this block a pancaking effect would occur where the collapse of the slab above leads to the collapse of the slab below due to the weight of collapsed floor as shown in Figure 22. The associated number of potential fatalities and the probabilities can be seen below.

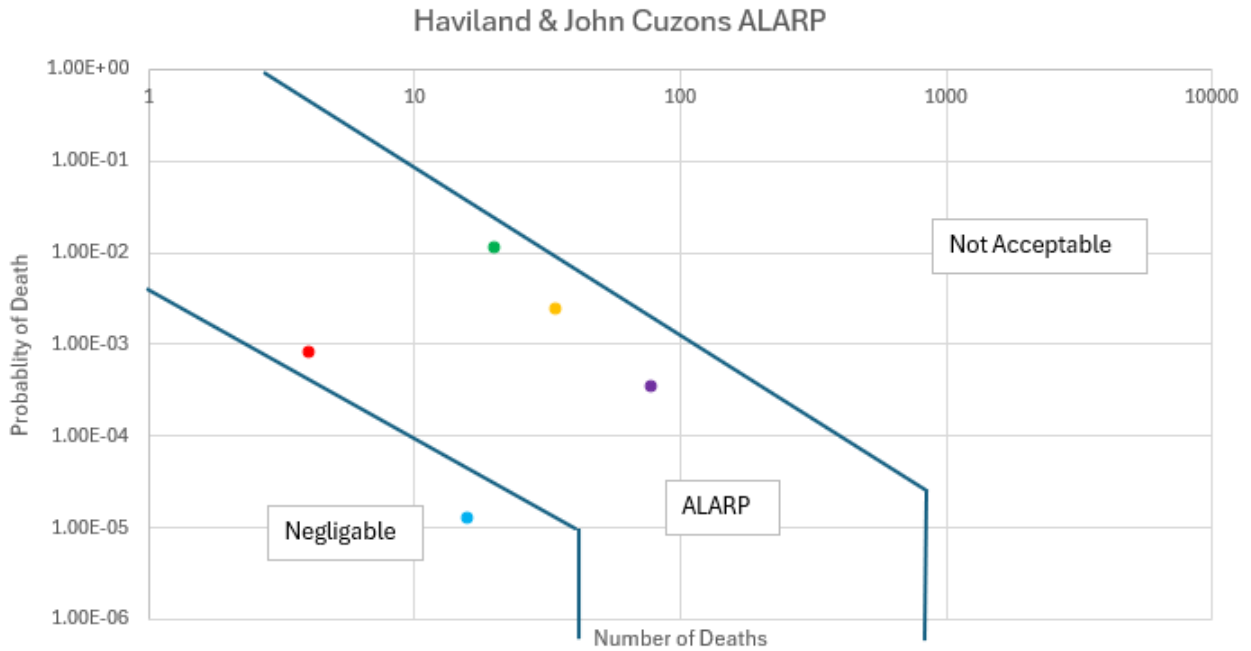
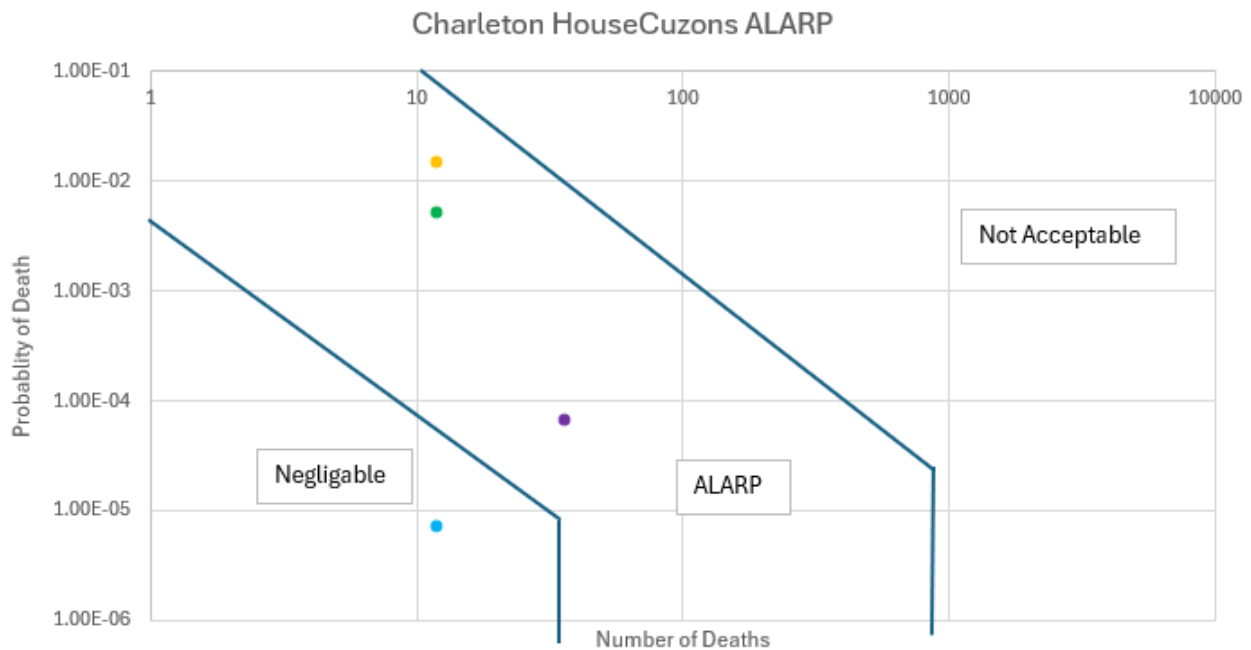
The ALARP analysis using either of the two graphs above shows that the risk of a of a ‘severe’ explosion from a non-piped gas supply (i.e., gas cannister etc) creating the possibility of a progressive collapse event in one
