FIRE RISK ASSESSMENT

Haviland House **St Jude's, Lamb Street, Bristol, BS2 0DT**

CLIENT	Bristol City Council
ASSESSED BY	Bob Birtles
ASSESSED ON	08/08/2024
ASSESSMENT REF.	LS 422854
RECOMMENDED REVIEW DATE	08/08/2025
VERSION	1

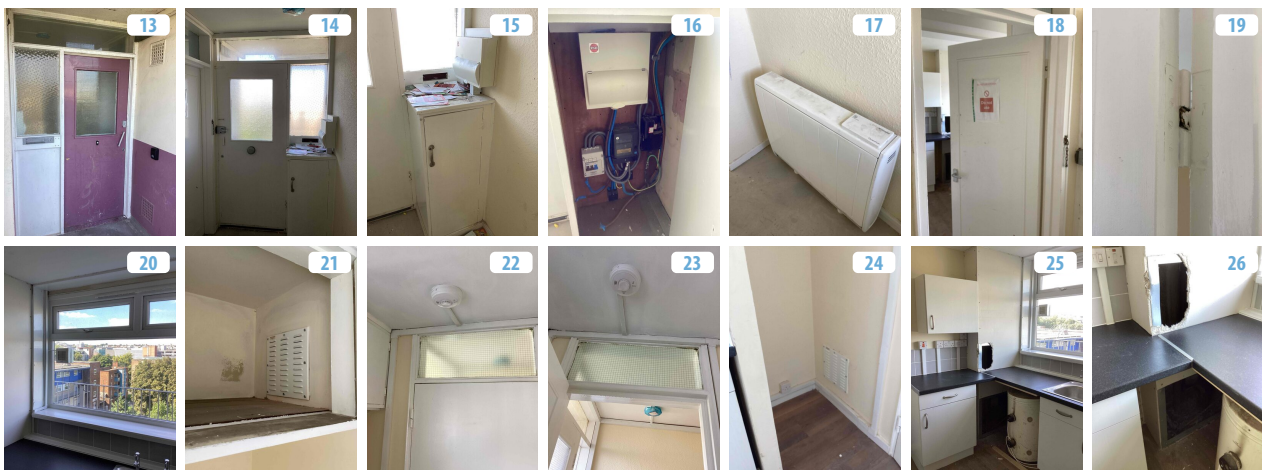
LOCATION Void flat 29, 17/9/2024

A number of intrusive structural assessments have been started.

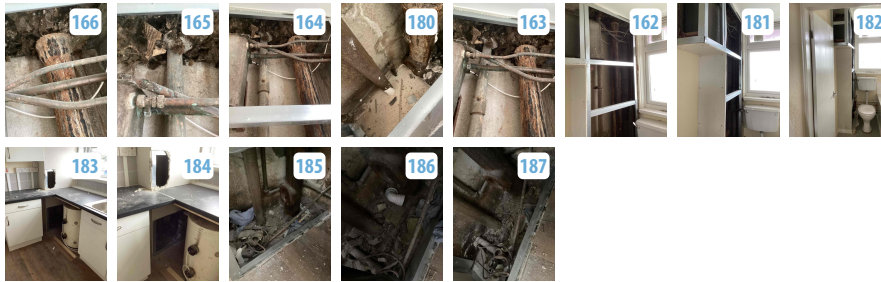
LOCATION Flat 29, additional compartmentation work

Low risk storage, evidence of remedial fire stopping works.

This room accesses the service tunnel area which should be subject to additional control measures if access is required.

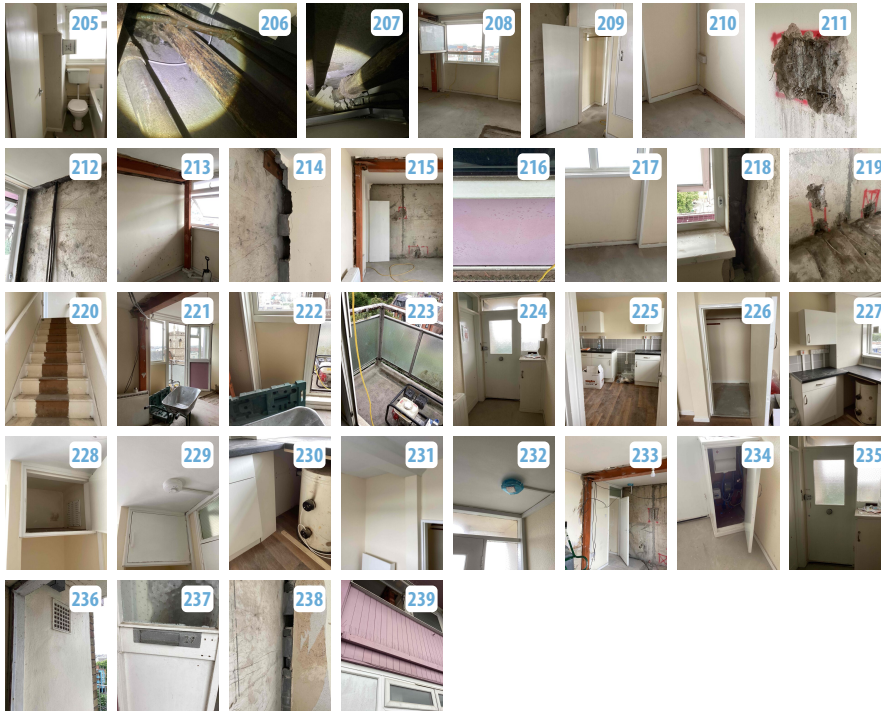
LOCATION Flat 29, intrusive investigation

The accommodation blocks at the site are undergoing a programme of intrusive investigations, followed by remediation work based on the findings.

These include structural surveys, external wall assessments, a review of the passive fire protection measures. Remedial works will include upgrades to the fire detection and alarms within the flats, upgraded flat entrance doors and refurbishments to the external wall make up.

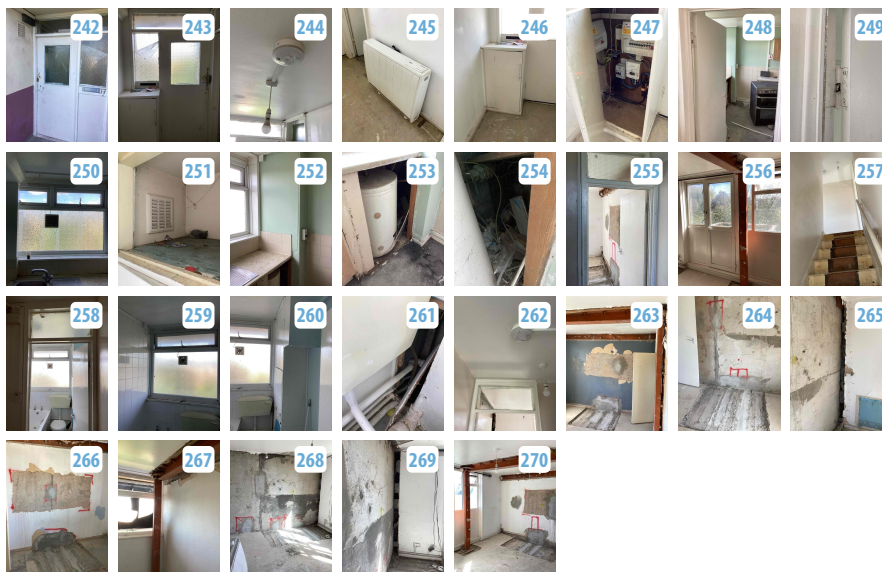
LOCATION Void flat 17, 17/9/2024

Some evidence of smoke damage and subsequent cleaning after a small kitchen fire.

Duplex hallway protected layout (questionable timber panelling and glazing), hallway, kitchen, lounge leading to balcony, stairs. Kitchen door no self closer, but includes rising butt hinges.

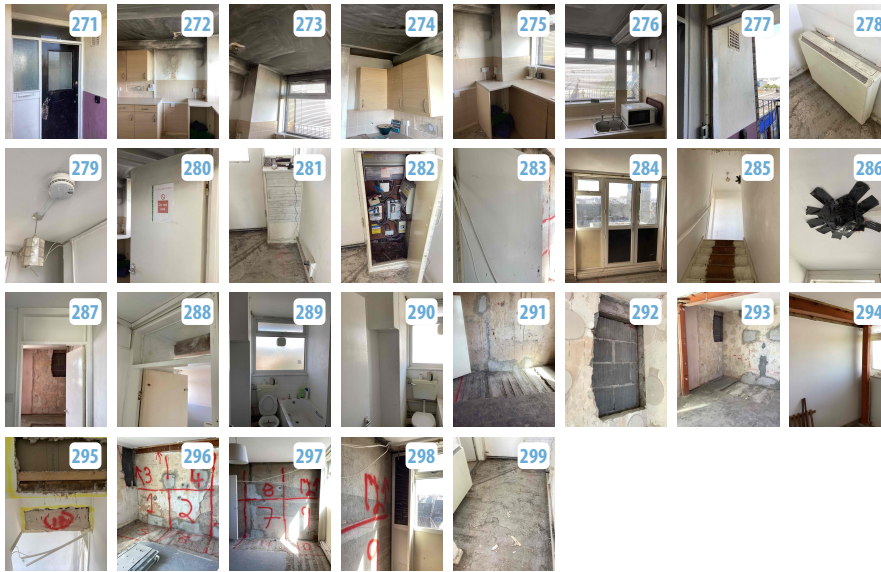
LOCATION Void flat 33, 17/9/2024

Intrusive works completed, preparing for reoccupation.
