# FIRE RISK ASSESSMENT

## **Charleton House** **St Jude's, Great Ann Street, Bristol, BS2 0DS**

CLIENT	Bristol City Council
ASSESSED BY	Bob Birtles Keith Todd
ASSESSED ON	24/07/2024
ASSESSMENT REF.	LS 422354
RECOMMENDED REVIEW DATE	24/07/2025
VERSION	1

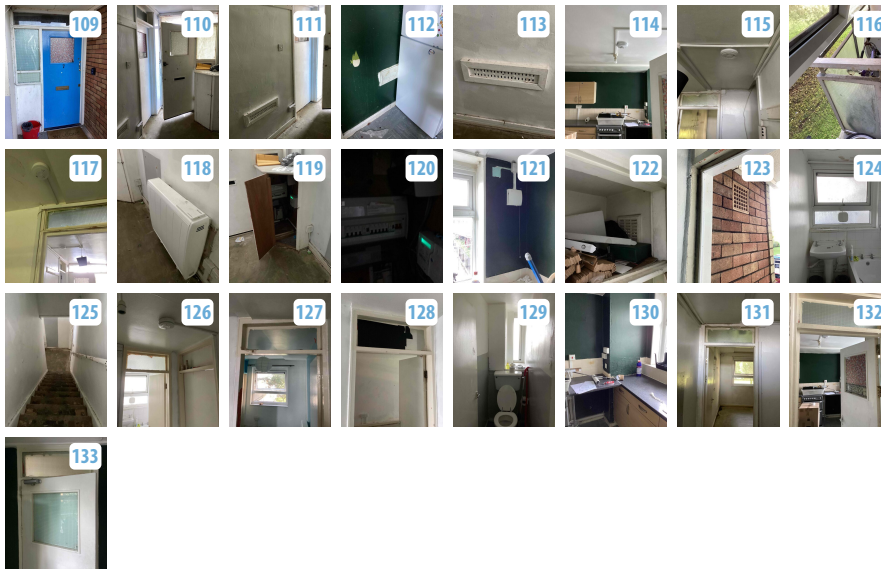
LOCATION Void Flat 7 17/9/24

- Duplex hallway protected layout (unknown fire performance of glazing): hallway, kitchen, lounge leading to balcony, stairs. Stairs up to landing, 3 bedrooms, toilet and bathroom.

Fire detection: smoke alarm in hallway, lounge and landing, heat alarm in kitchen. Legacy heat alarm on landing and in kitchen. Legacy smoke alarm on landing.

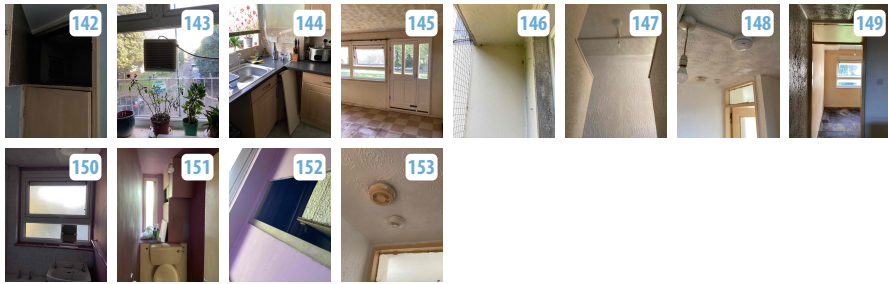
LOCATION Void flat 12 17/9/2024

Single level, one bedroom, hallway protected layout (unknown fire performance of glazing): hallway, lounge leading to kitchen, bedroom, bathroom.  
 Main entrance is a fire door, due to proximity to staircase. Working self closer, combined intumescent strip and cold smoke seal, metal letterbox with intumescent sleeve, Georgian wired glazed side panels, spyglass, 3 hinges, openable from escape side without a key.  
 Fire detection: smoke alarm in hallway and lounge and heat alarm in kitchen.  
 Electrical heating.  
 Ventilation from kitchen is via an extract fan and an air brick.  
 Ventilation from bathroom is via an extract fan.  
 Pipework hidden behind boxing construction in bathroom, some access to floor below.  
 Various markings for structural intrusive assessment, red spray paint.

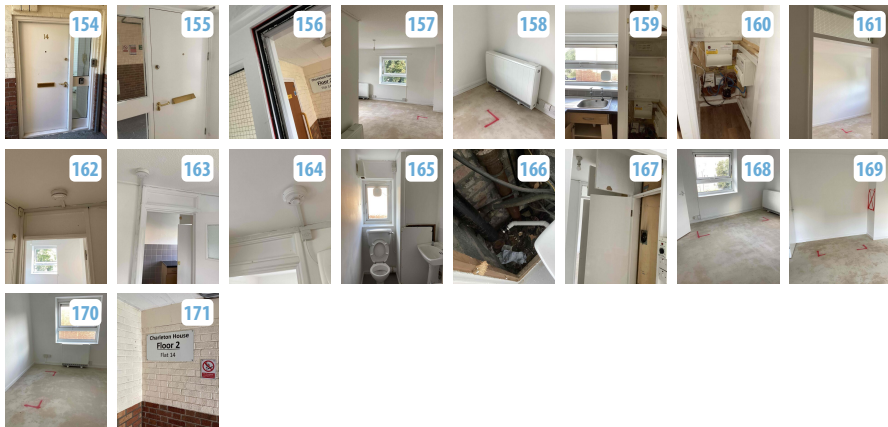
LOCATION Void flat 14, 17/9/2024

Flat survey escorted by Synergise staff.  
 Intrusive survey works have been carried out, with additional support to the lounge (6x props and timber planks).  
 Access to the ductwork leading through the flat.  
 Structural elements have been exposed.  
 Walls are of brick, shafts are blockwork, floors are reinforced concrete.
