FIRE RISK ASSESSMENT

Langton House St Jude's, Lamb Street, Bristol, BS2 0DR

CLIENT	Bristol City Council
ASSESSED BY	Bob Birtles Keith Todd
ASSESSED ON	24/07/2024
ASSESSMENT REF.	LS 422355
RECOMMENDED REVIEW DATE	24/07/2025
VERSION	1

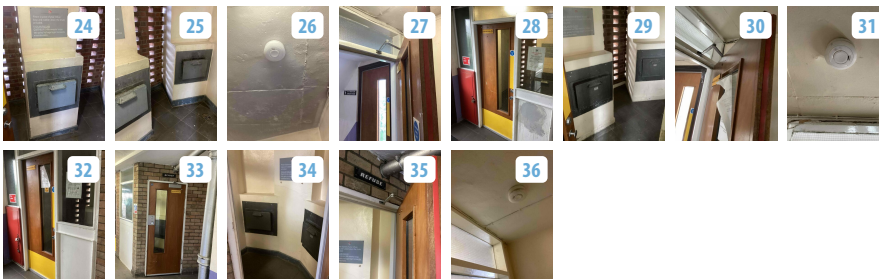
This block does rely on the staircase which incorporates the refuse chute hatches at the ground, 1st and 3rd floors.

These hatches are of solid construction, in a room protected by a self closing fire door, including intumescent strips and cold smoke seals with a local smoke detector device.

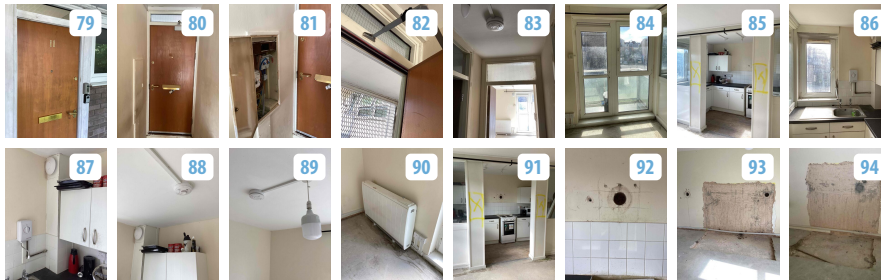
LOCATION Void flat 11, 17/9/2024

Various structural intrusive assessment areas and yellow markings on the secondary columns in the kitchen.

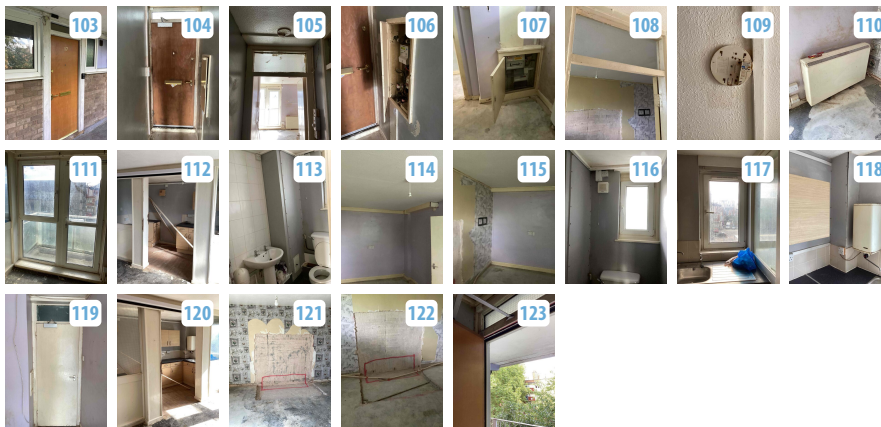
LOCATION Void flat 17, 17/9/2024

- Single level, one bedroom, hallway protected layout: hallway, lounge leading to kitchen area and balcony, bedroom, bathroom. No door in kitchen area, however the lounge has a fire door (with a self closer). Questionable glazing over bedroom door to hallway. Main entrance is a fire door. Working self closer, combined intumescent strip and cold smoke seal, metal letterbox with intumescent sleeve, Georgian wired glazed top panel, spyglass, 3 hinges, openable from escape side without a key. Fire alarm, legacy smoke alarm in hallway has been removed. No other provisions, although this is a void flat so the risk is minimal. Electrical heating. Main circuit breakers and distribution board are in the bedroom, protected by timber construction with nominal fire resistance. Ventilation from bathroom is via an extract fan and window. Ventilation from kitchen is via an openable window. Pipework hidden behind boxing construction in bathroom and kitchen. Ductwork running through the bedroom. Two structural intrusive assessment areas.

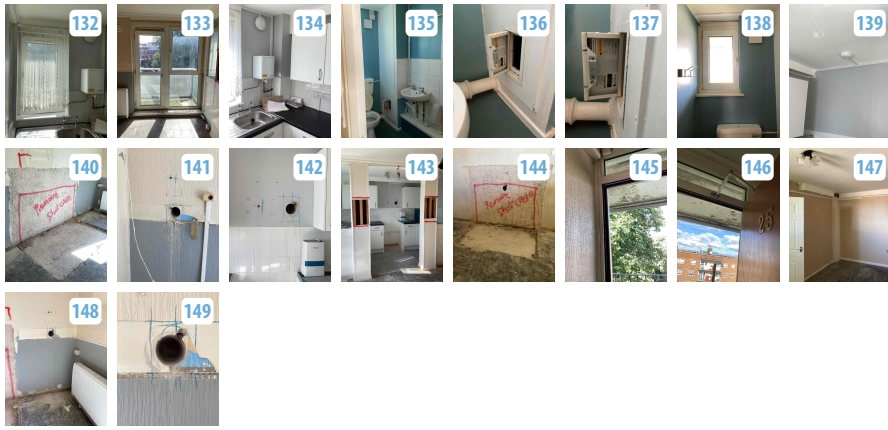
LOCATION Void flat 25, 17/9/2024

- Single level, one bedroom, hallway protected layout: hallway, lounge leading to kitchen area and balcony, bedroom, bathroom. No door in kitchen area, also the lounge only has a lightweight, hollow door (no self closer). Questionable glazing over bedroom door to hallway. Main entrance is a fire door. Working self closer, combined intumescent strip and cold smoke seal, metal letterbox with intumescent sleeve, Georgian wired glazed top panel, spyglass, 3 hinges, openable from escape side without a key. Detection, new smoke alarm system in hallway, lounge; and heat alarm in kitchen; legacy smoke alarm in hallway has been removed. Electrical heating. Some circuit breakers and distribution board are in the bedroom, second system in hallway. Ventilation from bathroom is via an extract fan and openable window. Ventilation from kitchen is via an extract fan and openable window. Pipework hidden behind boxing construction in bathroom and kitchen. Ductwork running through the bedroom. Two main structural intrusive assessment areas and access to the secondary columns and some core drill holes.

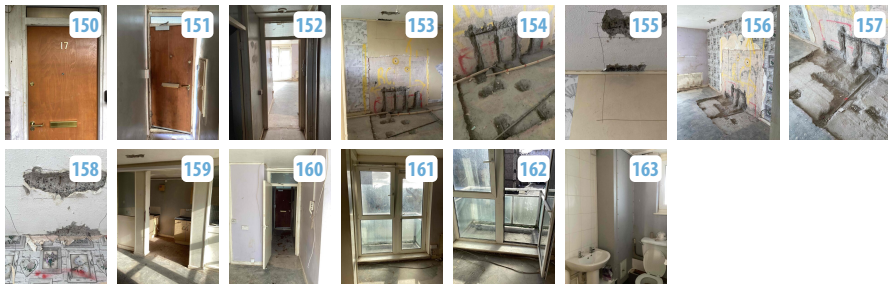
LOCATION Flat 17, intrusive works have been carried out, visual assessment on 17/10/2024

Concrete floors with steel reinforcement.
 Blockwork walls.
 Fire door (single direction of escape on the open air deck access).

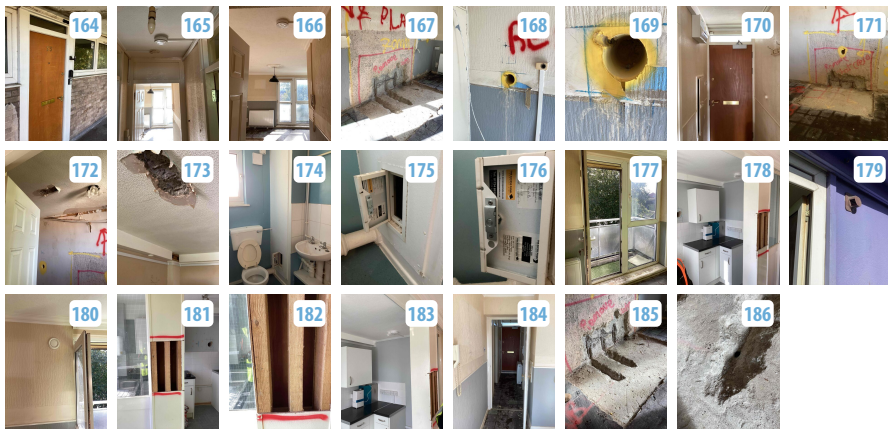
LOCATION Flat 25, intrusive works have been carried out, visual assessment on 17/10/2024

Concrete floors with steel reinforcement.
 Blockwork walls.
 Fire door (single direction of escape on the open air deck access).
 Spalading to floor below.
