Conservation Area 5

Clifton & Hotwells

Character Appraisal & Management Proposals

June 2010

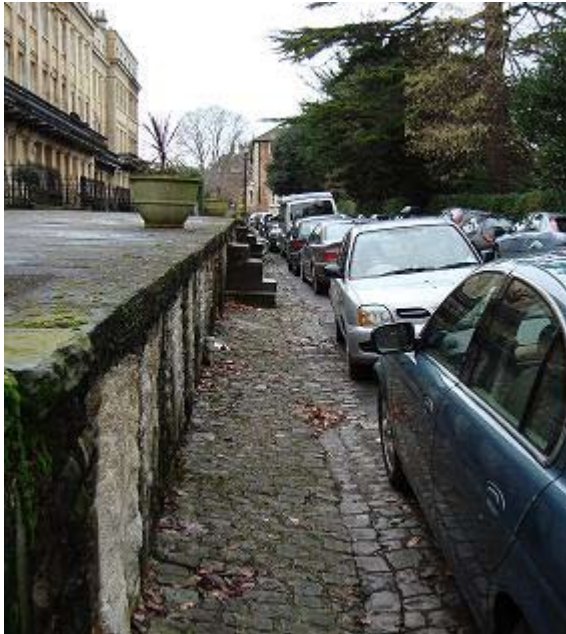
Figure 35: Worcester Terrace raised pavement

- 7.1.4m Historic street surfaces include the raised pavements to Vyvyan Terrace and Worcester Terrace and the original setted Cobblestone Mews. Vyvyan Terrace also has fine wrought iron and stone balconies, and stone Juliet balconies at nos. 3 & 19.

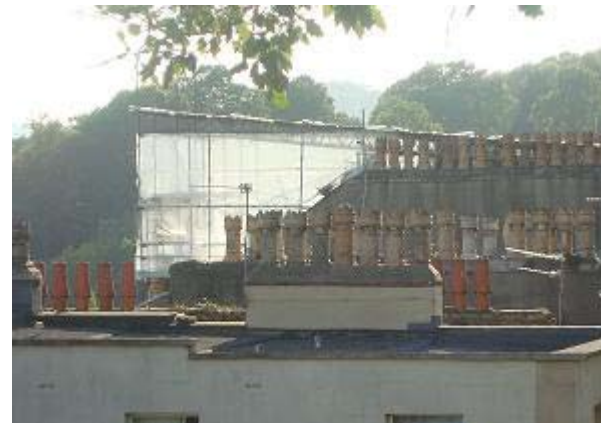
Figure 61: Chimney stacks and pots along the skyline

- 7.2.3 Bristol's hilly topography with corresponding long views and vistas means that roof profiles form an important factor in local interest. In Clifton and Hotwells, roof profiles contribute greatly to the character of the area and are fundamental to the architectural integrity of a building or group. Alterations at roof level can consequently have a significant impact on an individual building and the wider context.
- 7.2.4 Chimney stacks and pots form striking features when seen against the skyline. Replacement or removal of chimney pots and stacks is discouraged, even when redundant.

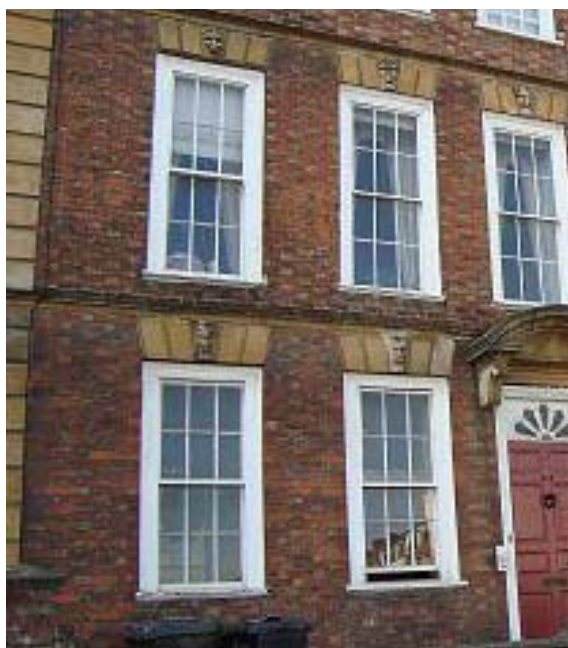
Figure 63: Early 6-over-6 timber sashes, Dowry Parade, flush with the brick facade

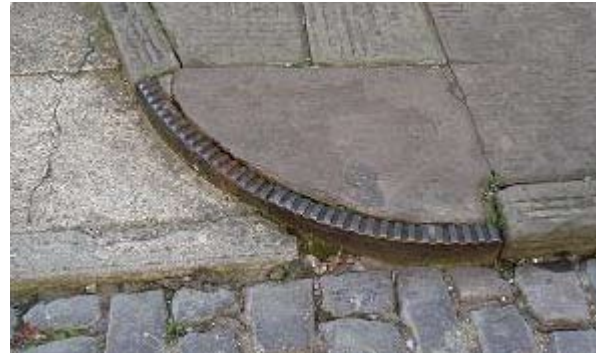
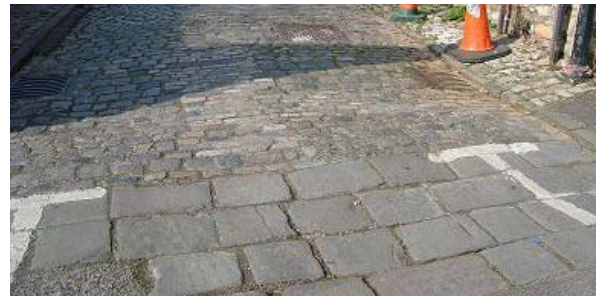
Figure 89 & 90: Traditional iron kerb edge; Pennant flag cross over to setted mews

- 7.3.4 A particular townscape feature of Bristol is iron kerb edging, used to prevent damage to vulnerable Pennant corner stones. Only four streets in the Conservation Area retain their iron edges (3 Clifton Spa streets, and 1 in Hotwells). 80% -100% of the remaining pavements in the conservation area have Pennant kerbs, except in Hotwells where the number reduces to 50%. This is a feature and should be kept.

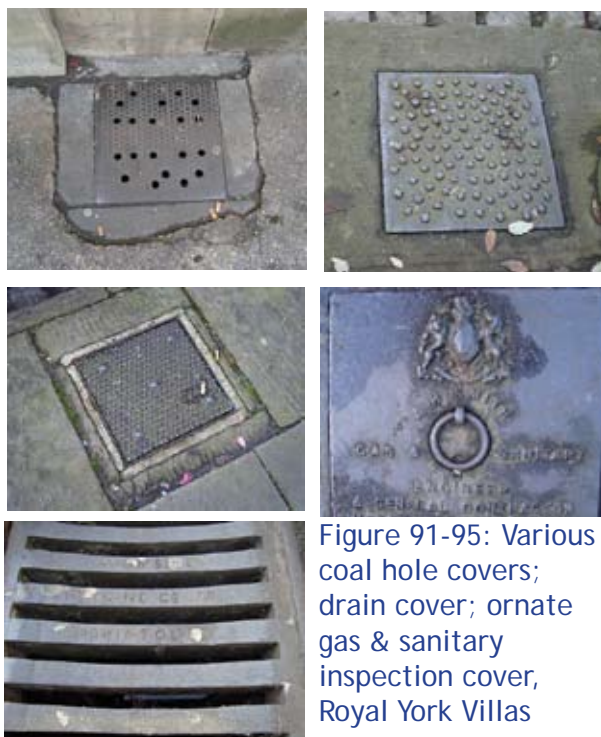
Figure 91-95: Various coal hole covers; drain cover; ornate gas & sanitary inspection cover, Royal York Villas

- 7.3.7 Many styles of coal hole, predominantly in the earlier streets. If re-paving occurs these should be kept, preferably with pennant stone frame around. They are a feature of the area.
- 7.3.8 Although most drains are Bristol Water, some have Bristol founders marks such as this one by Avonside Engineers who made steam locomotives.
- 7.3.9 Schemes to restore the traditional street surface would greatly enhance the character of the area and promote its historic context. Continued maintenance of street surface, particularly setts, is vital as these easily become dislodged and can present difficulties to pedestrians and non-ambulant users.

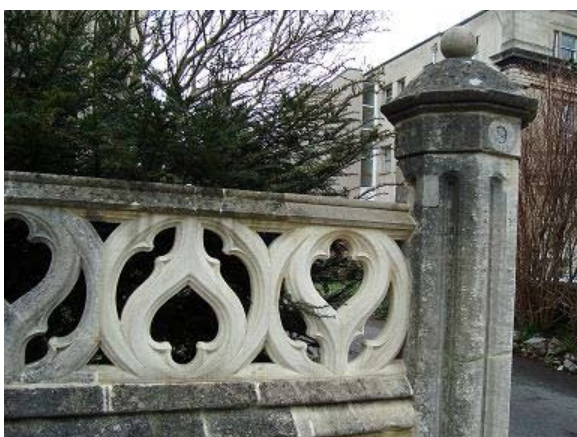
Figure 102: This stone balustrade on Clifton Park has been expertly repaired

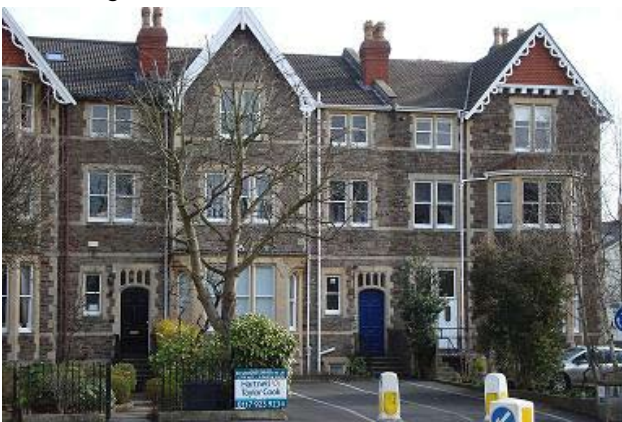
Figure 121: The garden on the right has lost the whole of its boundary wall and been surfaced for car parking. This impacts on the street and terrace as well as individual property and causes run-off during heavy rainfall leading to blocked drains and flooded roads

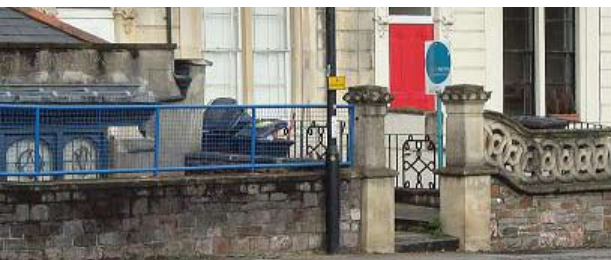
Figure 122: unsympathetic replacements railings detract from the stone balustrade opposite

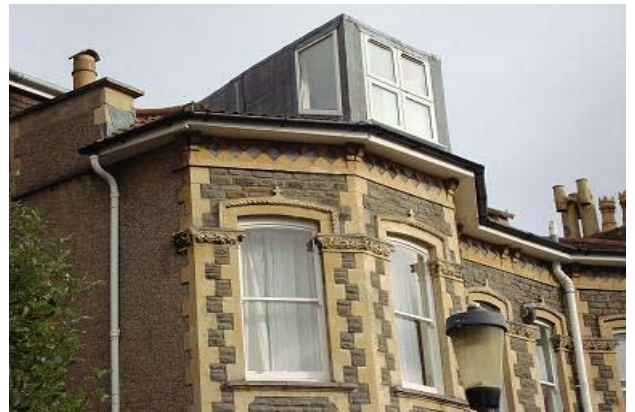
Figure 123: This style of dormer is out of scale and poorly detailed. It detracts from the building and the wider street

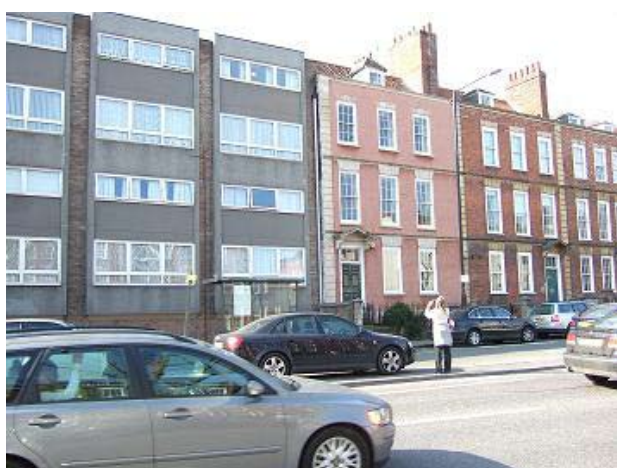
Figure 125: Dowry Parade, the material and fenestration pattern fails to respect that of the Grade II listed properties it adjoins and detracts from the quality of the group and the wider area

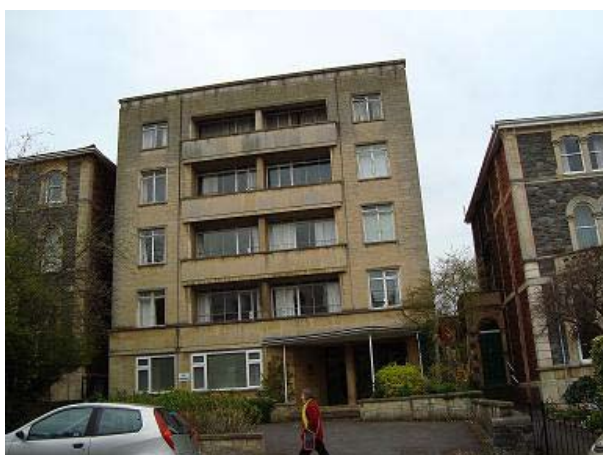
Figure 126: Pembroke Road flat block that is out of scale with the otherwise consistent building height and roof line of the street

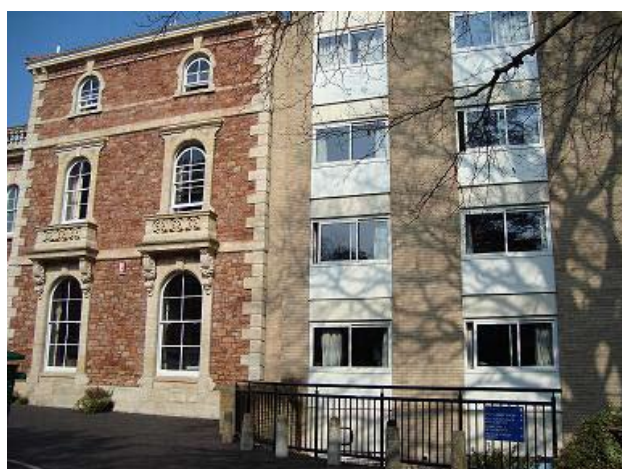
Figure 127: Wisemans, Worcester Road, is poorly detailed and the horizontal windows detract from the beautiful examples next door

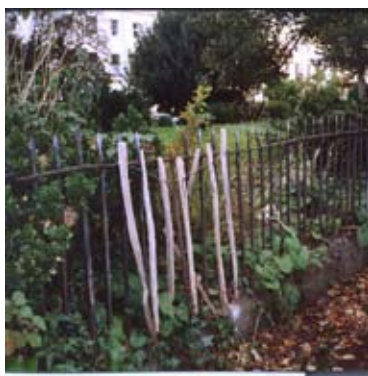
Figure 129:
Wooden fence
used to plug
gap in the rail-
ings to a com-
munity garden

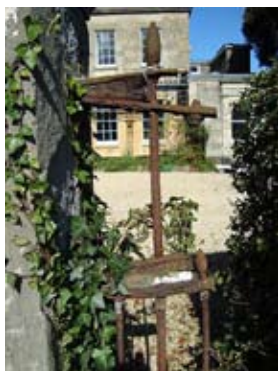
Figure 130-31: Examples of boundary rail-
ings that have fallen into a severe state of
disrepair and are at risk of being lost through
irreparable damage

7.3.13 When railings are repaired, the posts should be lead soldered and individually let into the stone coping, to prevent corrosion of the foot and the original quality of workmanship. Stone should be left unpainted or rendered.

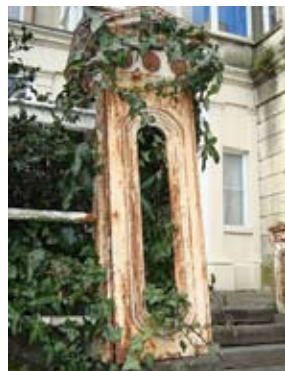
Figure 132:
Steel gate,
inappropriate
for Grade II
house and
attracts
graffiti

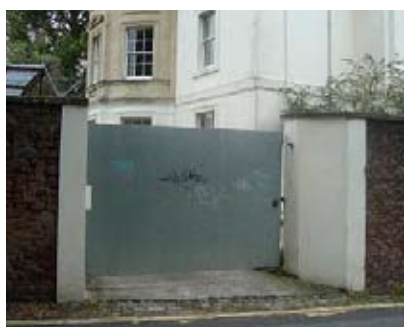
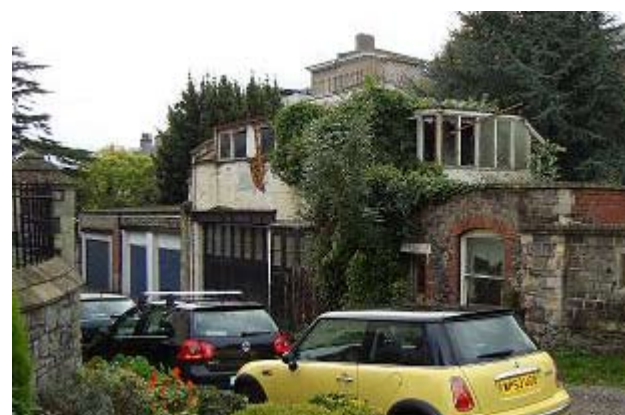
Figure 133: Traditional garage has been left
to rot and overgrow with vines. The negative
impact is on the character of this mews street
which feels neglected and on the traditional
garages that are worthy of retention and sym-
pathetic restoration

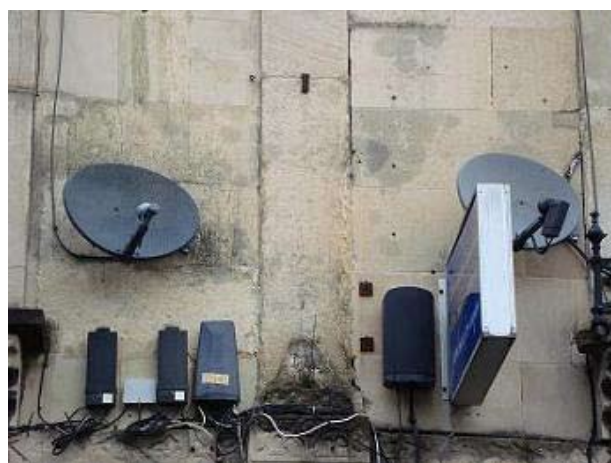
Figure 134: Satellite dishes on the sides
of listed buildings are not acceptable.
Unauthorised dishes can be enforced against
and the owners required to remove them

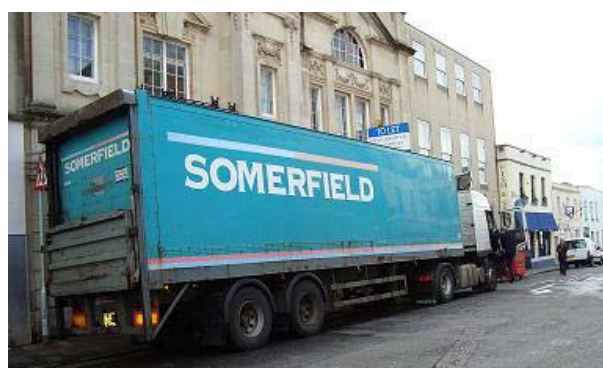
Figure 135: Large lorries down narrow
streets cause damage to pavements

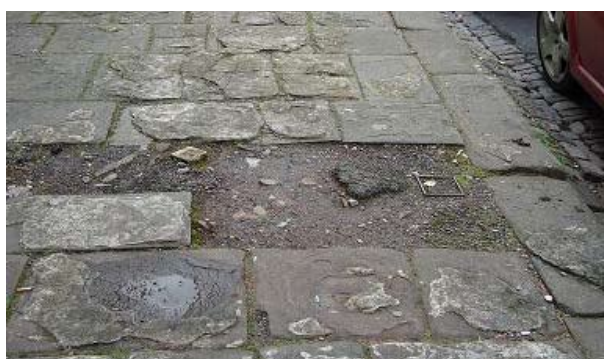
Figure 136: This pennant paving on a Grade II terrace is sorely neglected

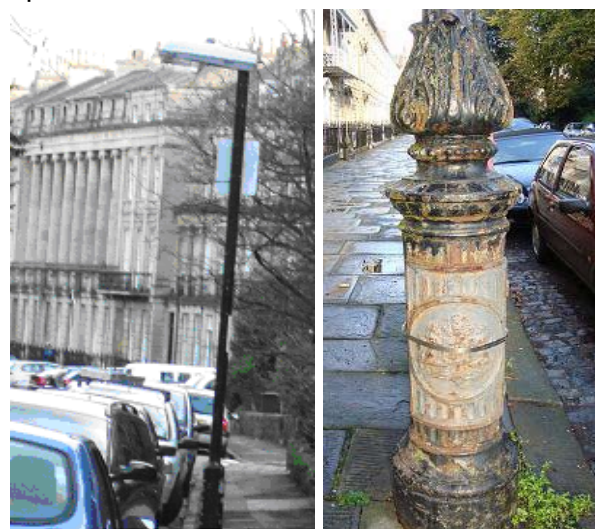
Figure 138-39: An unsympathetic modern replacement lamp standard adjacent to Grade II* Vyvyan Terrace and Christchurch; Grade II lamp standard in poor state of repair

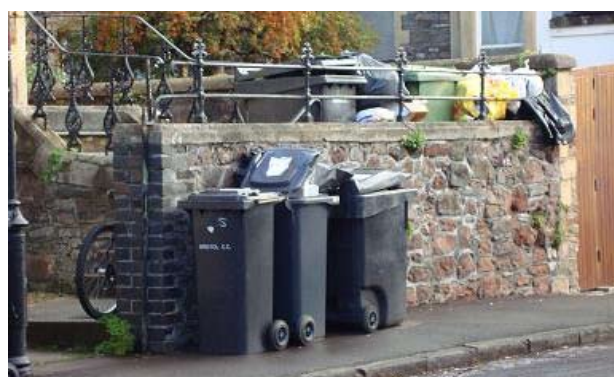
Figure 140: Wheelie bins cause an obstruction on the narrow pavement
