The River Avon

1.1 The New Cut

1.2 Purpose and scope of the assessment

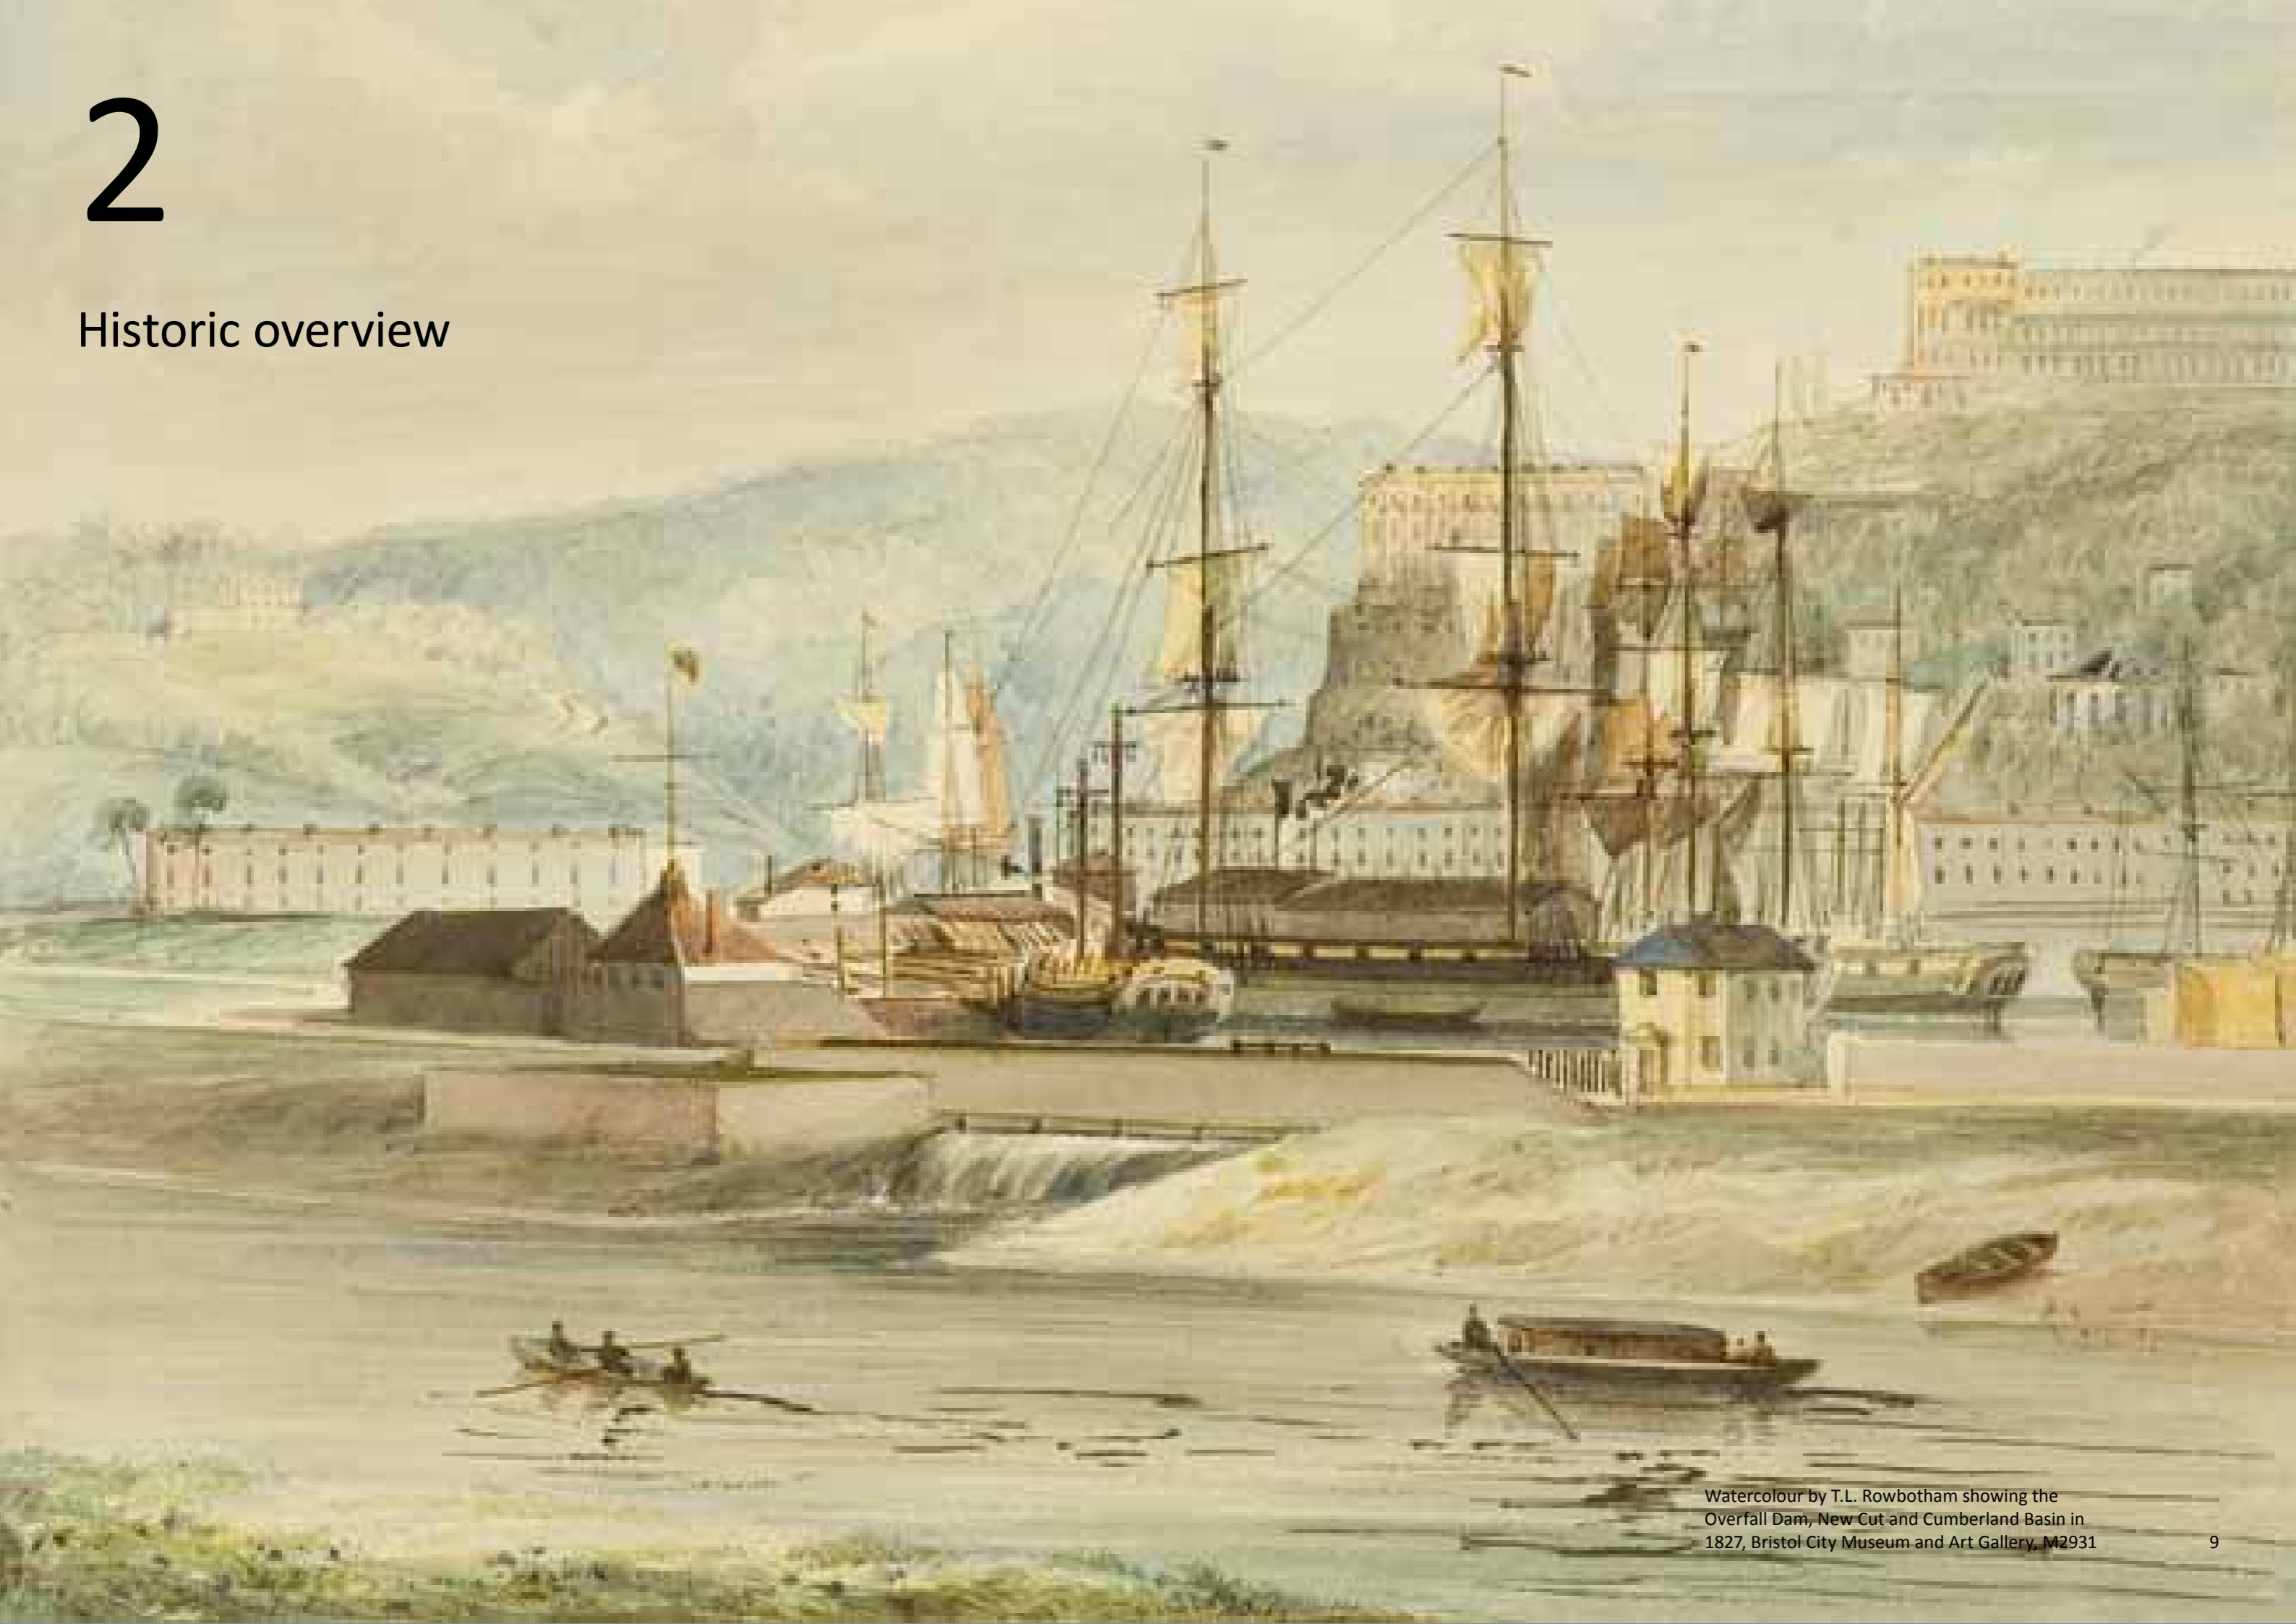
Watercolour by T.L. Rowbotham showing the Overfall Dam, New Cut and Cumberland Basin in 1827, Bristol City Museum and Art Gallery, M2931

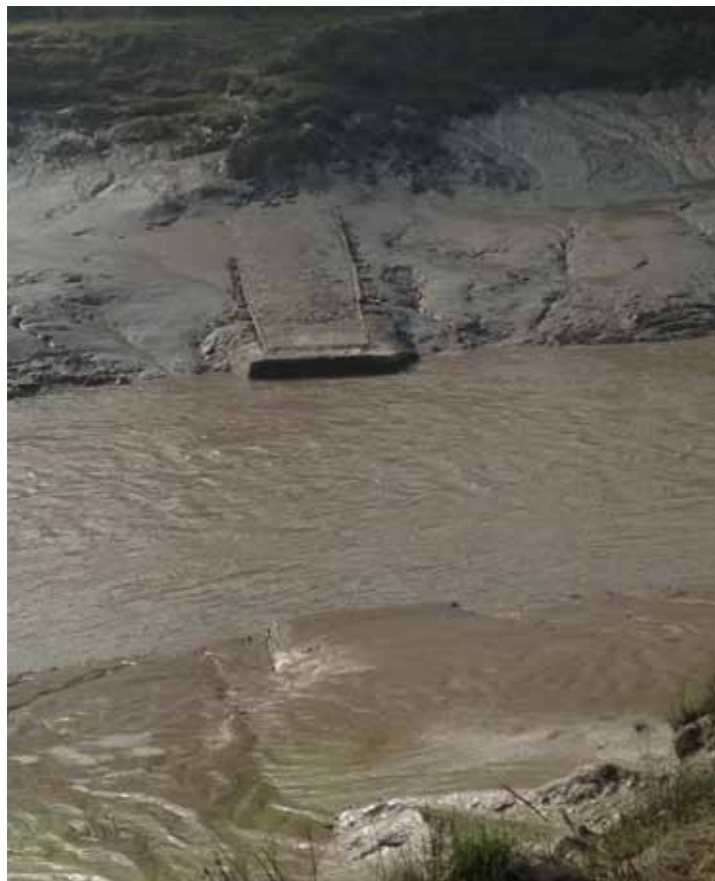
**Fig 7
Rownham Ferry**

Rownham Ferry

Before the completion of the Clifton Suspension Bridge in 1864, the Rownham Ferry was the main crossing for people moving between Clifton and Hotwells to the Somerset side of the river. The original crossing shown in the image right was moved in 1867 when the North Entrance Lock was created. The remains of this later crossing are visible at low tide on both river banks (below).

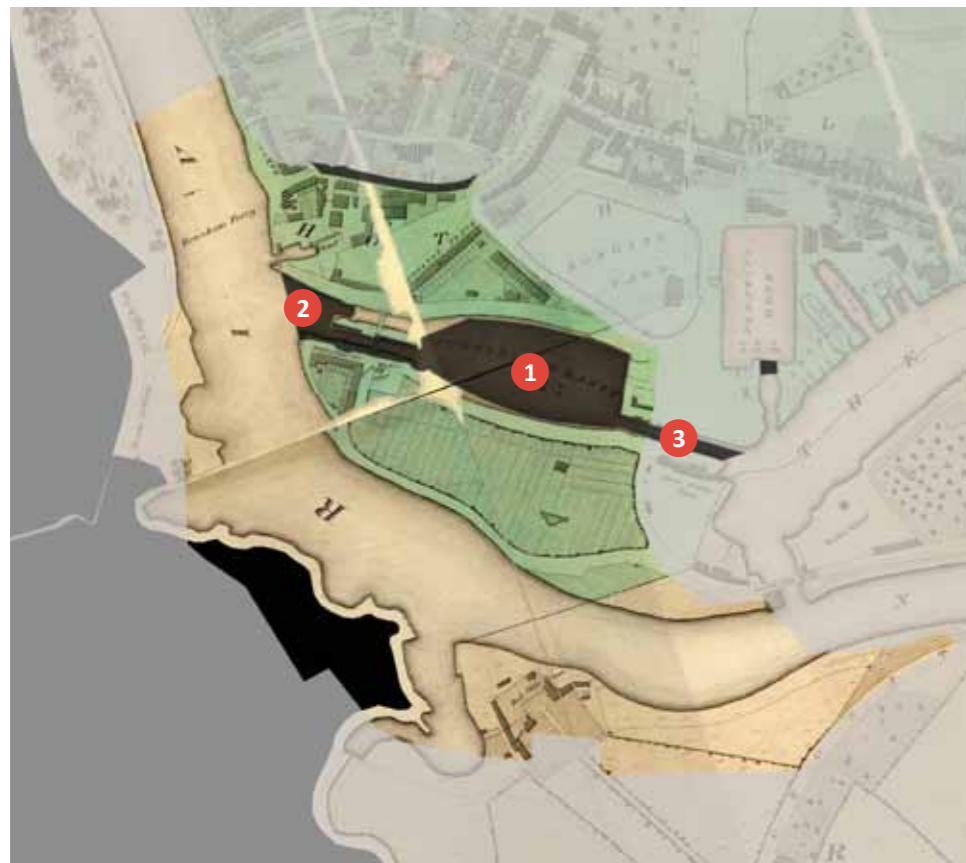
1828 main features:

- By 1828 the main landscape feature that had been created and that survives today was the Cumberland Basin itself **1** together with the original Entrance Lock (South Entrance Lock) **2** and Junction Lock (South Junction Lock) **3** now both dammed.
- The entrance lock originally consisted of two lock gates until the engineering amendments in the later 19th century. The northern of these two locks survives as a small dock set within the 'Knuckle'.
- The South Entrance Lock was widened by Brunel in 1849 while the South Junction Lock is the original Jessop 1809 design.

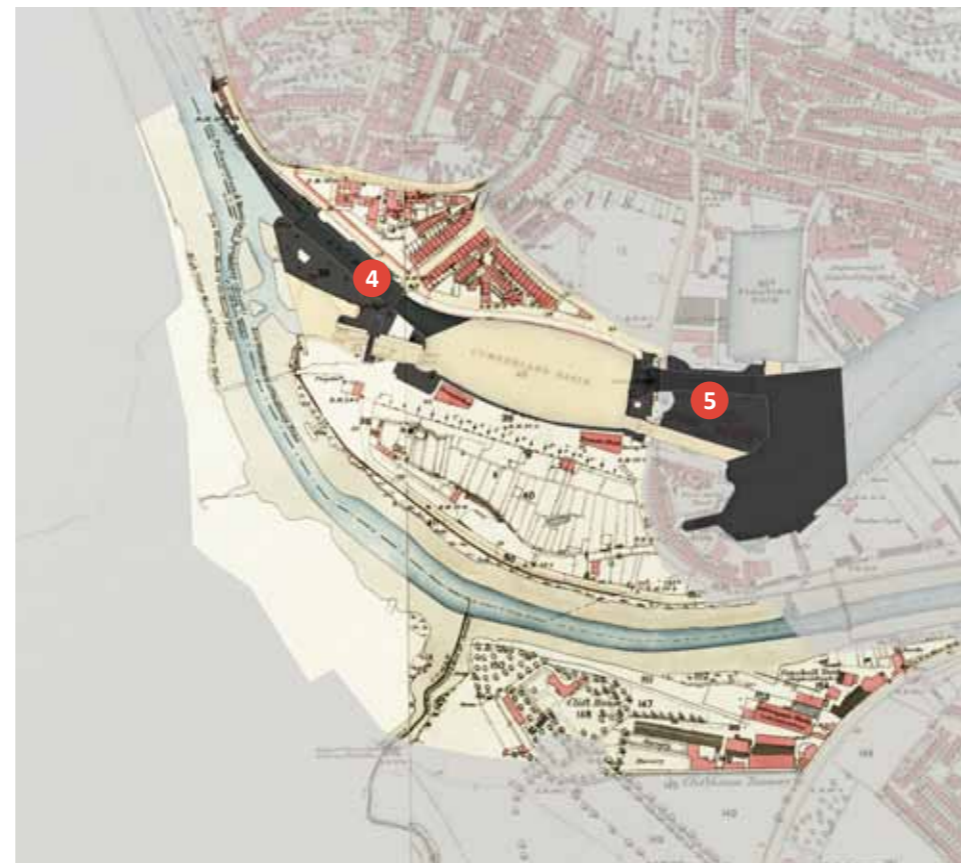
1880:

- Brunel's 1849 alterations to the Entrance Lock included the introduction of the swing bridge over what is now the South Entrance Lock. This was later moved to the North Entrance Lock that it now sits alongside. **4** The bridge over the South Entrance Lock was created in 1875 as a replica of Brunel's bridge.
- In 1867-73 the locks were altered again by Docks Engineer Thomas Howard resulting in the creation of the current configuration including the North Junction Lock **5**

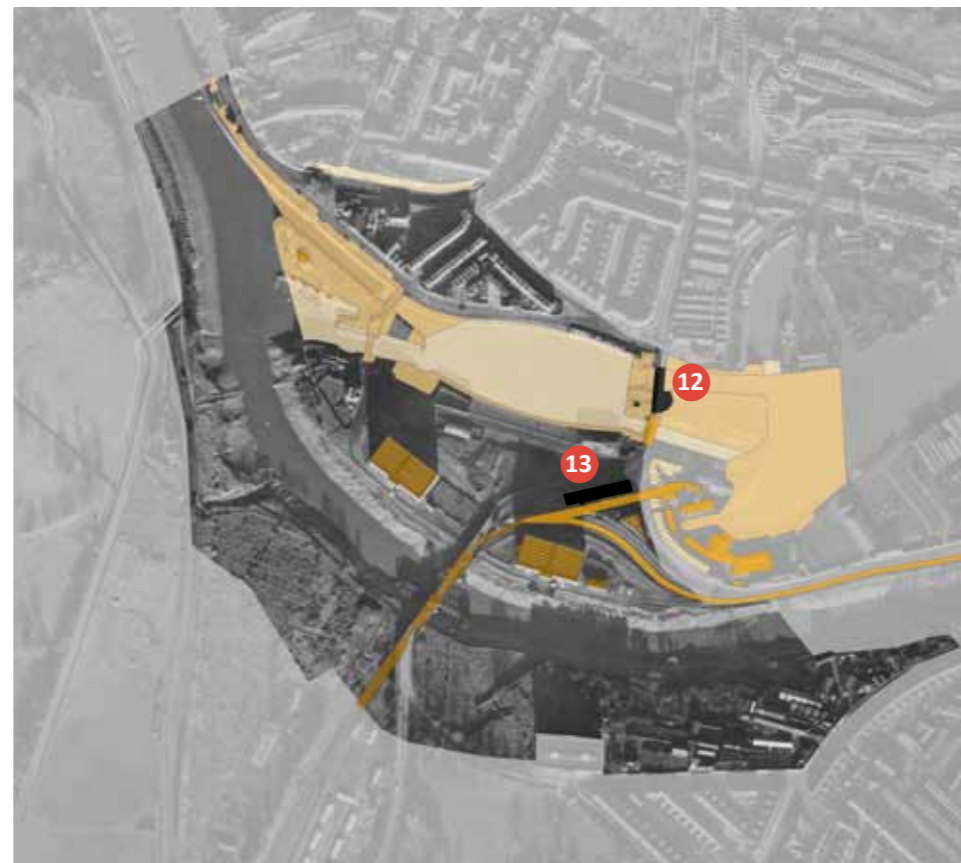
1930s-1946:

- The swing bridge over the North Junction Lock **12** was completed in 1925 as part of road improvement works in the area.
- Terrace of municipal houses added c.1930 **13**
- There was limited bomb damage within the character area during the war

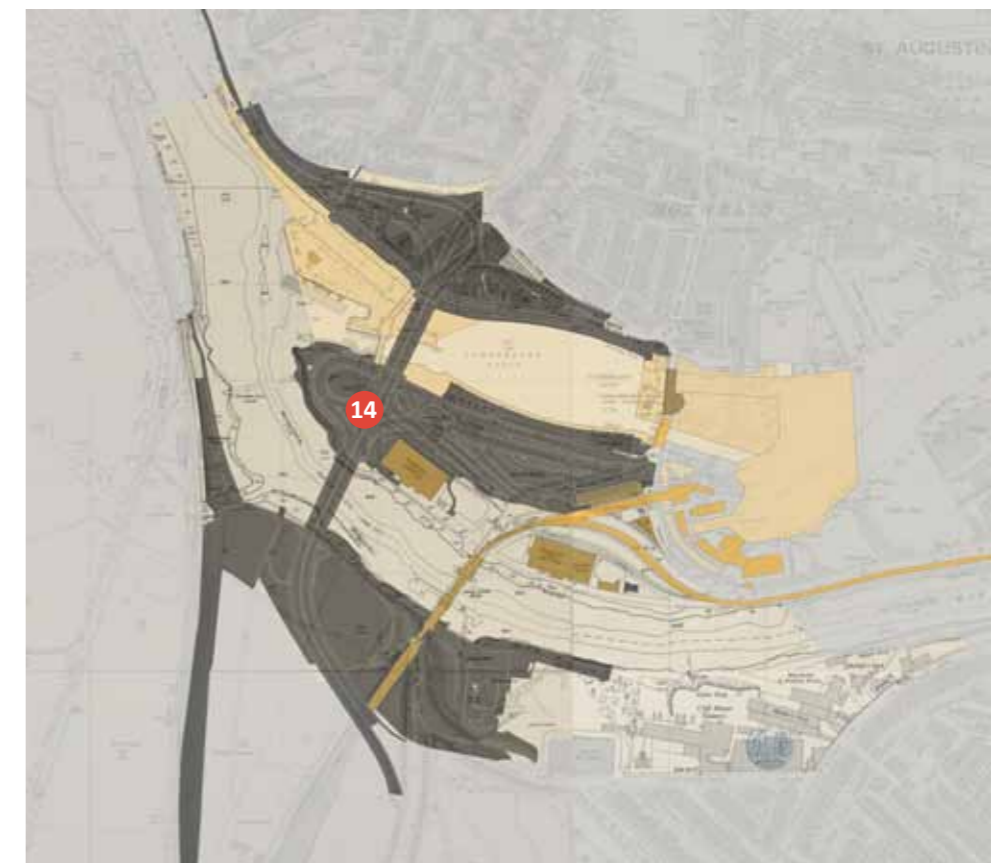
1950-1965:

- Introduction of the current road infrastructure in 1963-5 and associated landscape designed by Sylvia Crowe **14**

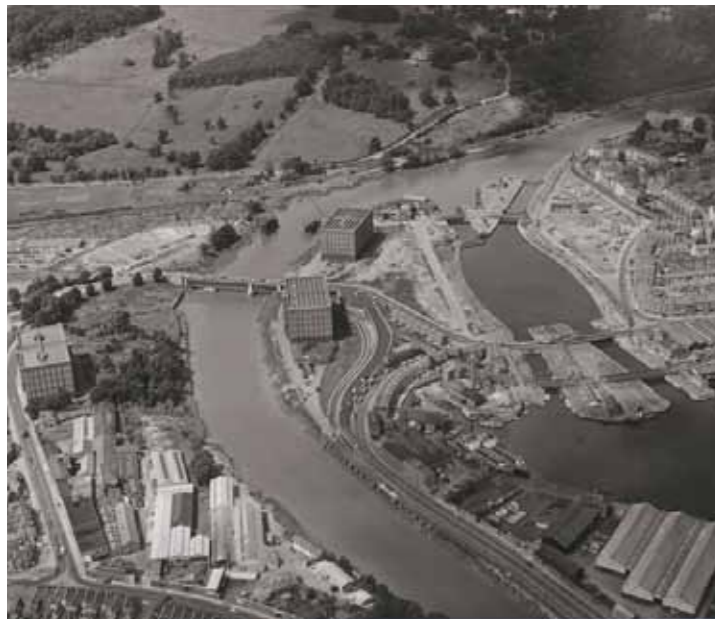
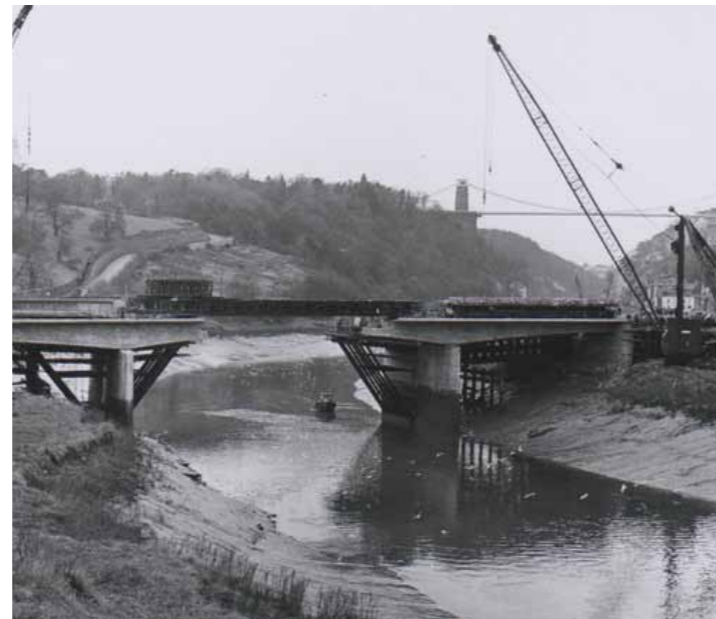
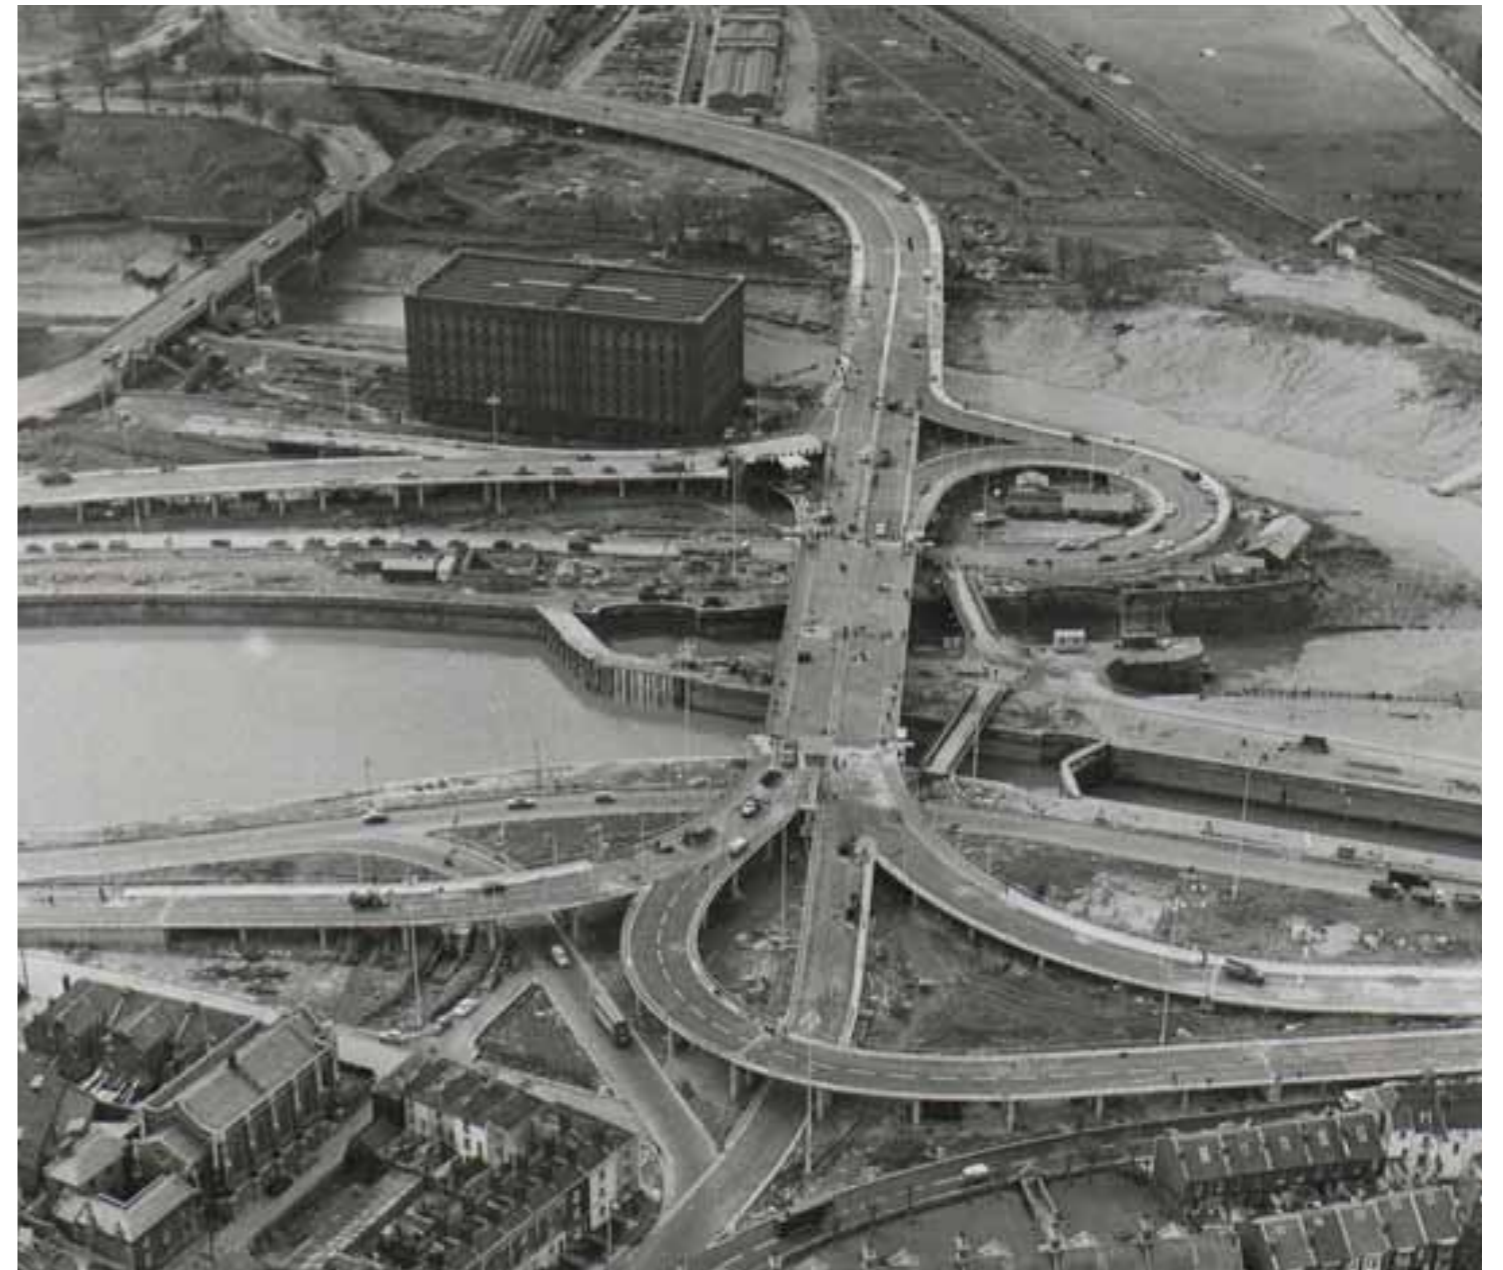
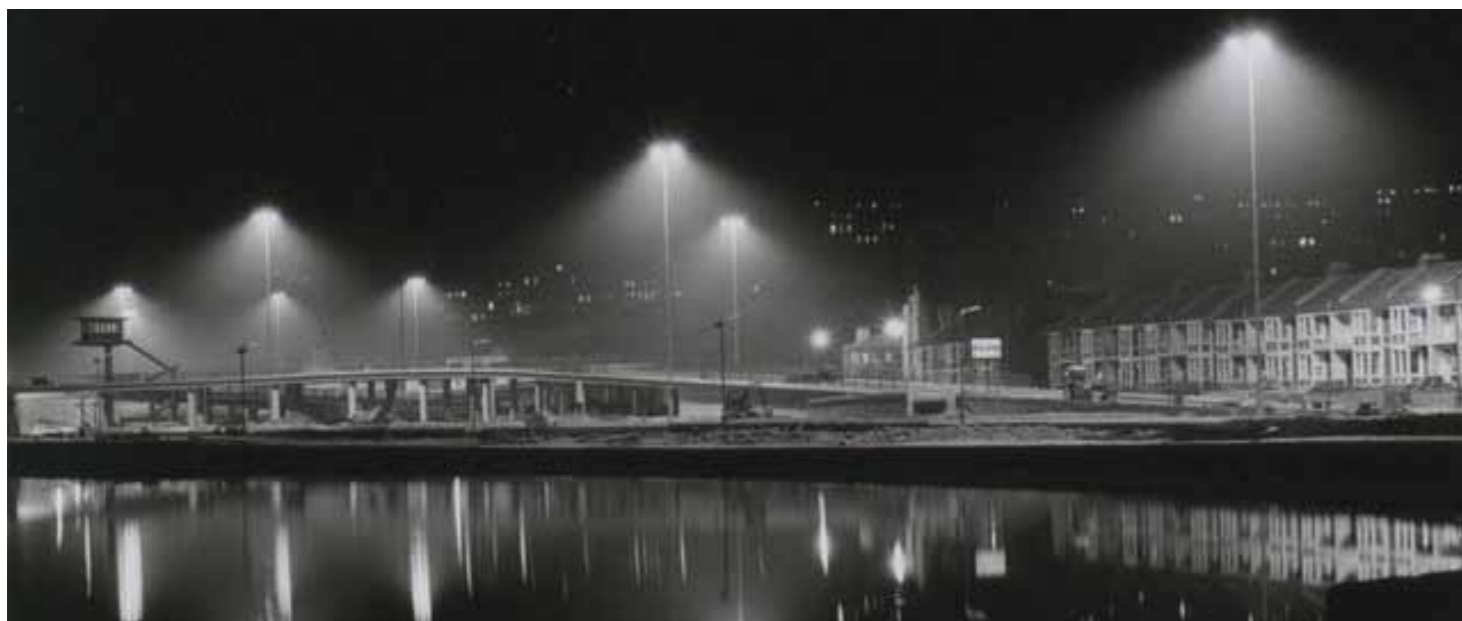
- 1** Initial stages of the Cumberland Basin road scheme with houses and other buildings having been cleared, Bristol Archives, 40826/DOC/28
- 2** Avon Bridge over the New Cut under construction in 1964, Bristol Archives, 40826/CUM/18
- 3** Near completed road scheme, 1965, Bristol Archives, 40826/CUM/20
- 4** Construction works mid scheme, c.1964, Bristol Archives, 40826/FLO/14

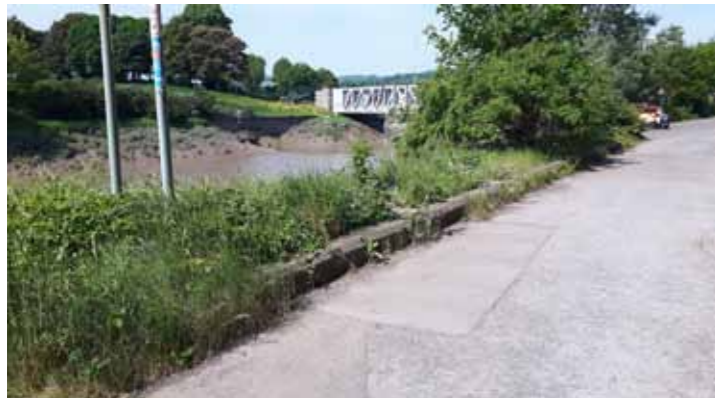
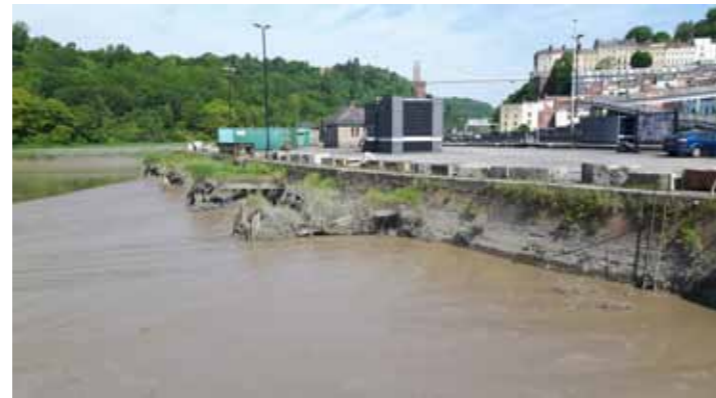
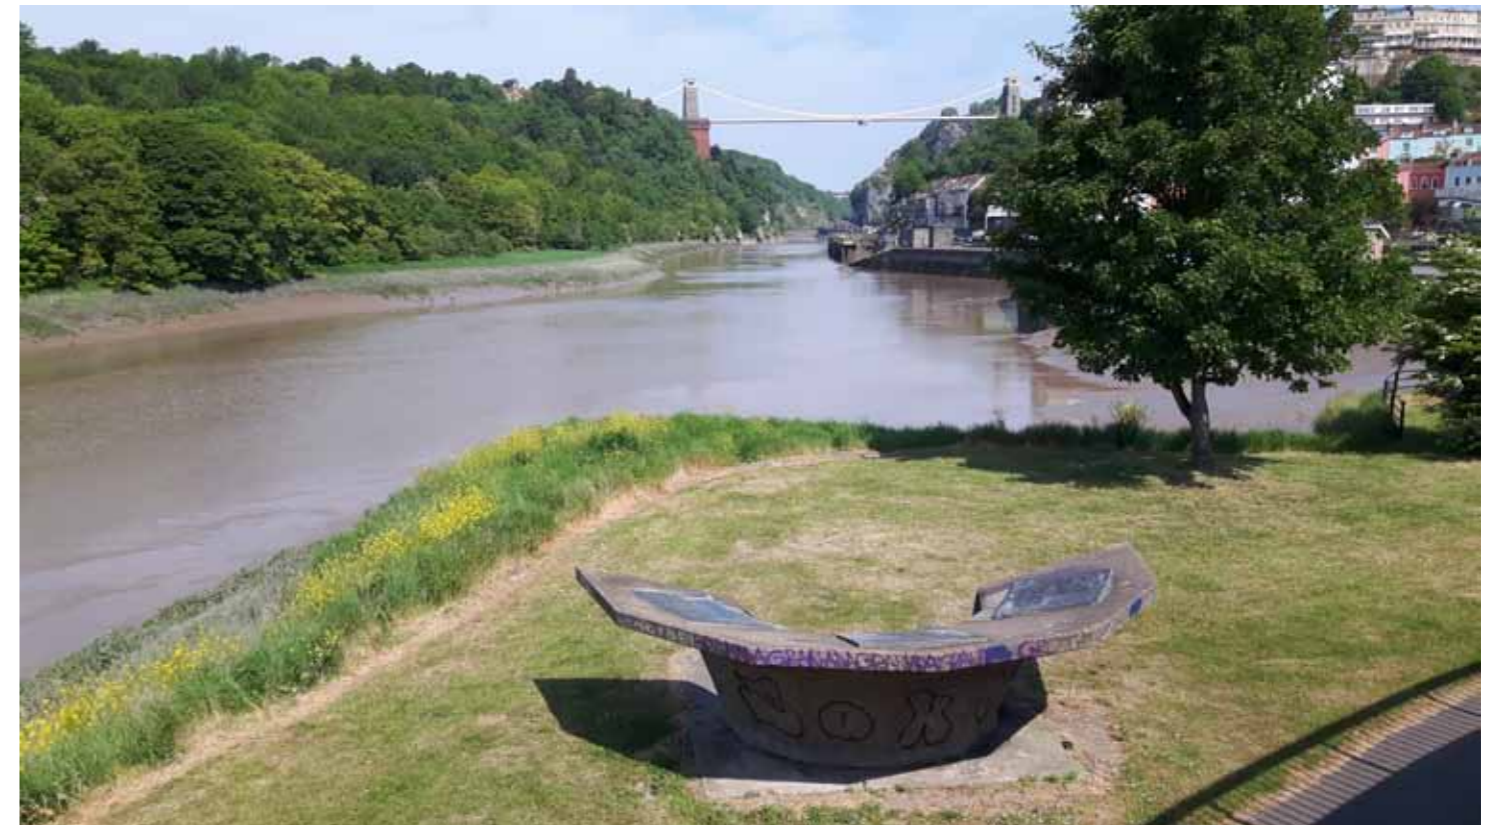
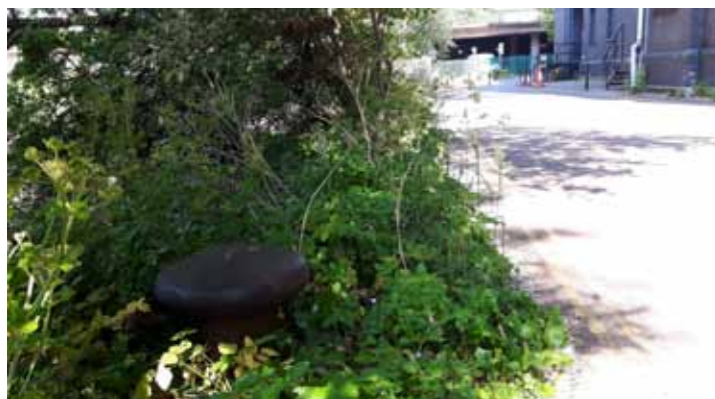
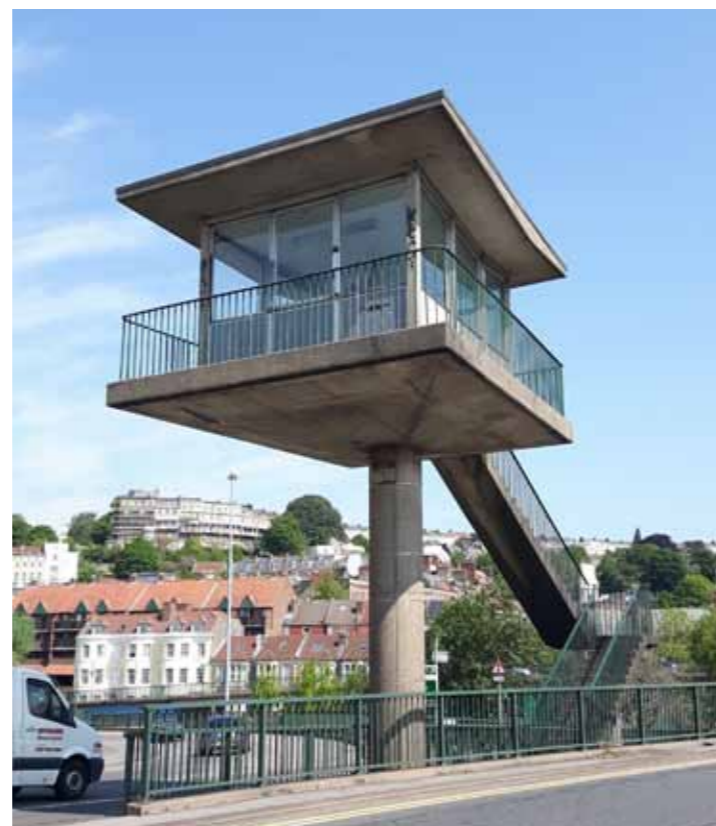
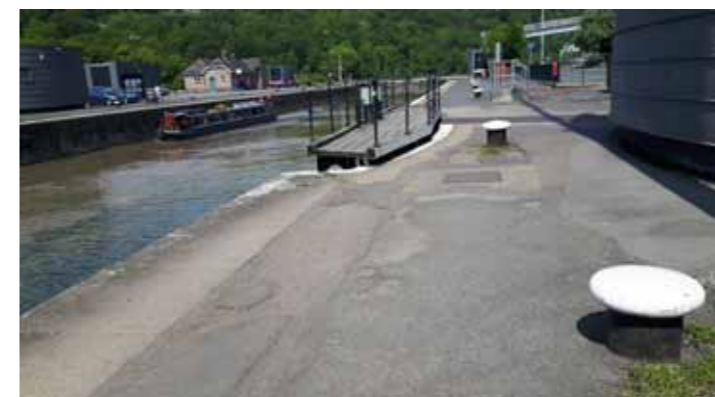
Fig 15
Character and setting

- 1 Remains of wharf alongside A Bond
- 2 Mooring post near B Bond
- 3 Mooring posts around 1960s landscaping
- 4 Remains of 1880s timber piers for ship repairs on the south side of the Knuckle

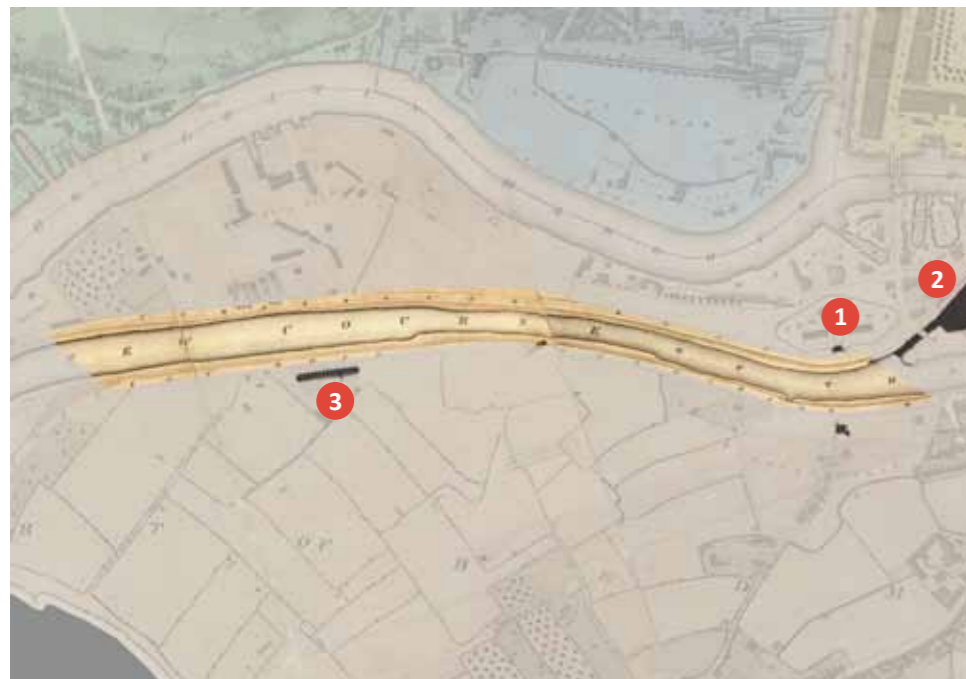
- By 1828 the banks of the New Cut will have appeared relatively bear. The newly constructed New Gaol **1** will have been the significant landmark.
- Bathurst Basin immediately to the east **2** was created at the same time as the New Cut and Floating Harbour.
- The first housing along the south bank had been built by 1828 such as the existing nos.156-170 Coronation Road **3** that would have appeared quite isolated at the time.

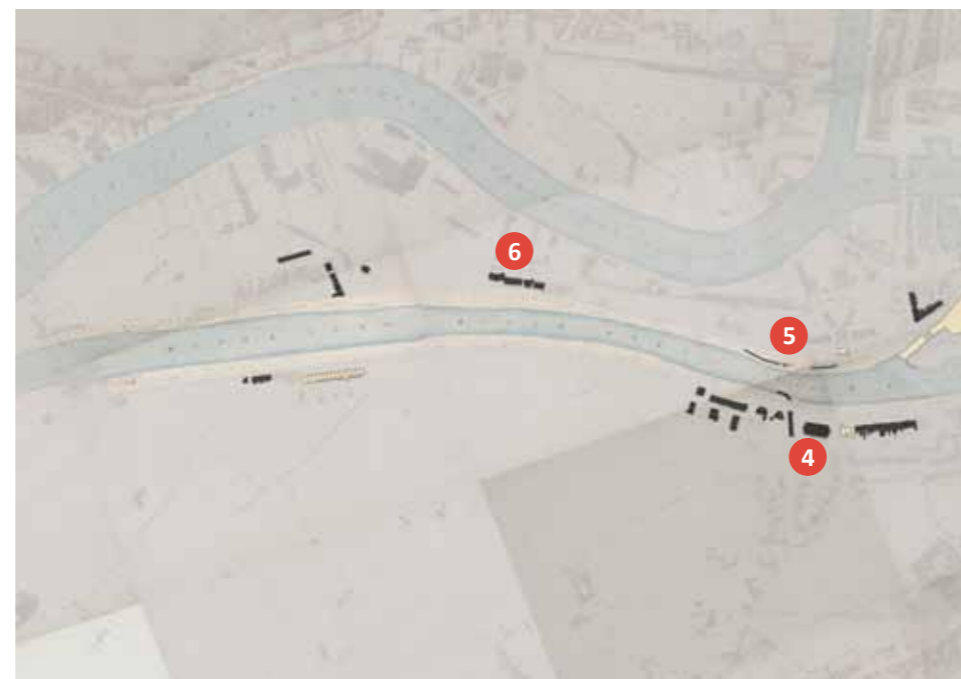
- By the middle of the 19th century additional housing had appeared along the south bank and St Pauls Church **4** had been built for this new community.
- At the same time the Gaol Ferry and slipways **5** were introduced.
- The first housing on the north bank had also been built **6**

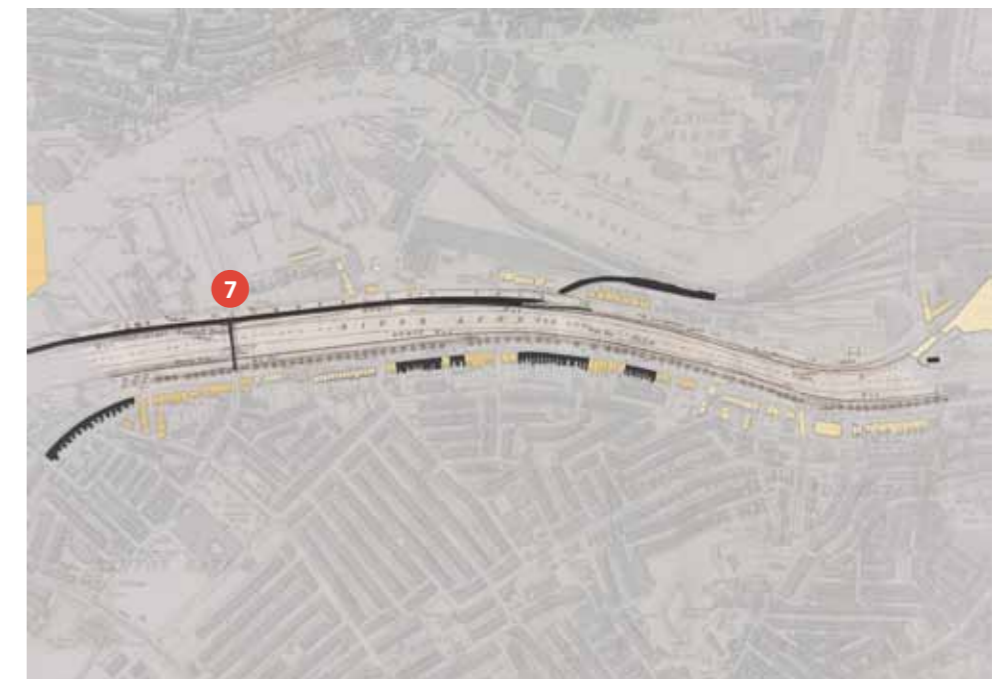
- By the early 20th century almost all the housing along Coronation Road had been completed.
- The significant elements introduced by this date were the harbour railway, Chocolate Path and Vauxhall Bridge **7**

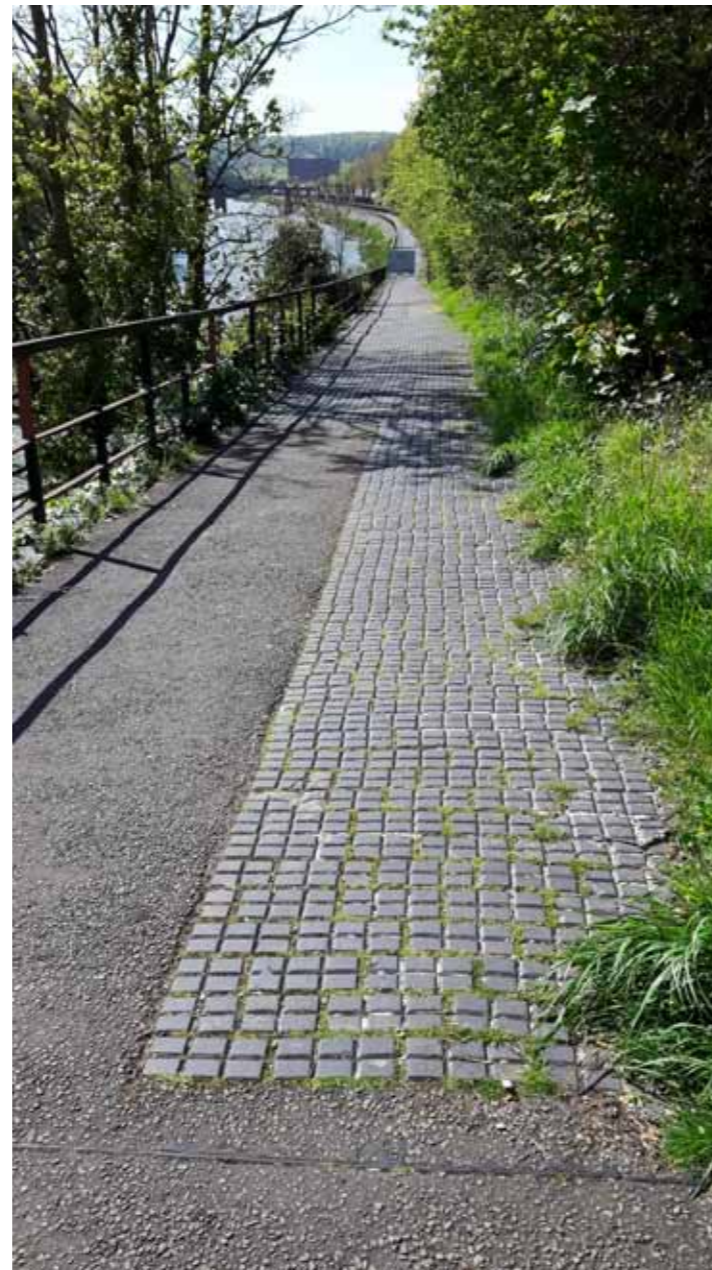
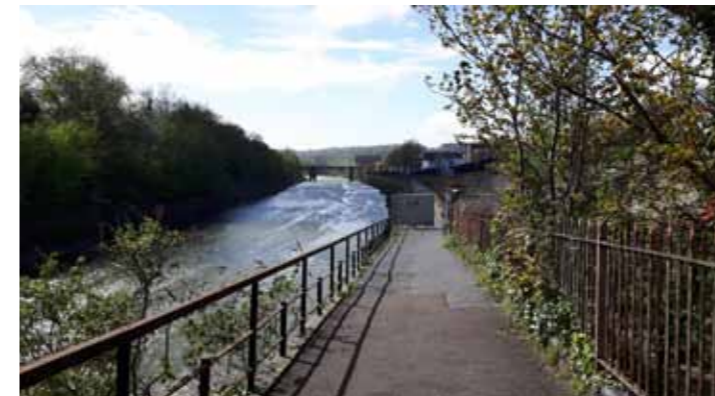
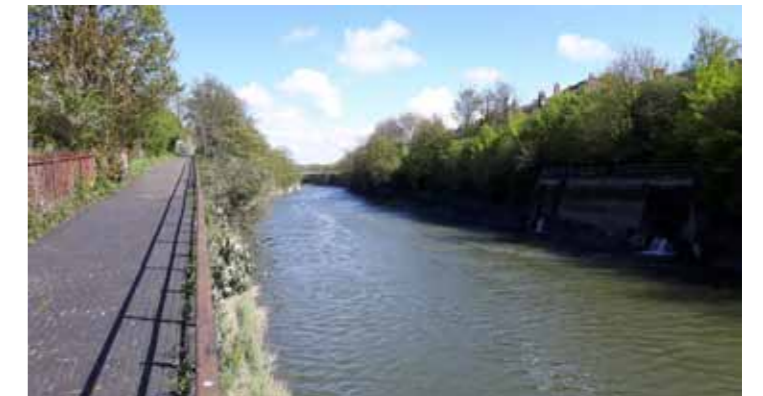
Fig 26
The Chocolate Path

- 1** The east end of the Chocolate Path
- 2** View west along the path, original railings on the right
- 3** View east from the path towards Gaol Ferry Bridge
- 4** 1914 view of Vauxhall swing bridge open for shipping on the New Cut, notice revealing arches on north bank constructed c.1900 for Chocolate Path and Harbour Railway, Know Your Place, HC3802

The path and railway structure are currently in poor condition and are closed to use due to areas of subsidence.

The path is fenced either side by iron railings that are also in a poor condition. There are areas of surface repairs to the distinctive 'chocolate bar' blocks that have been less than sympathetic.

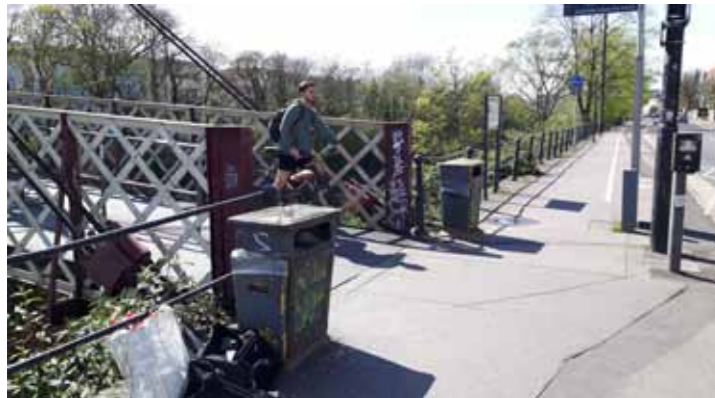
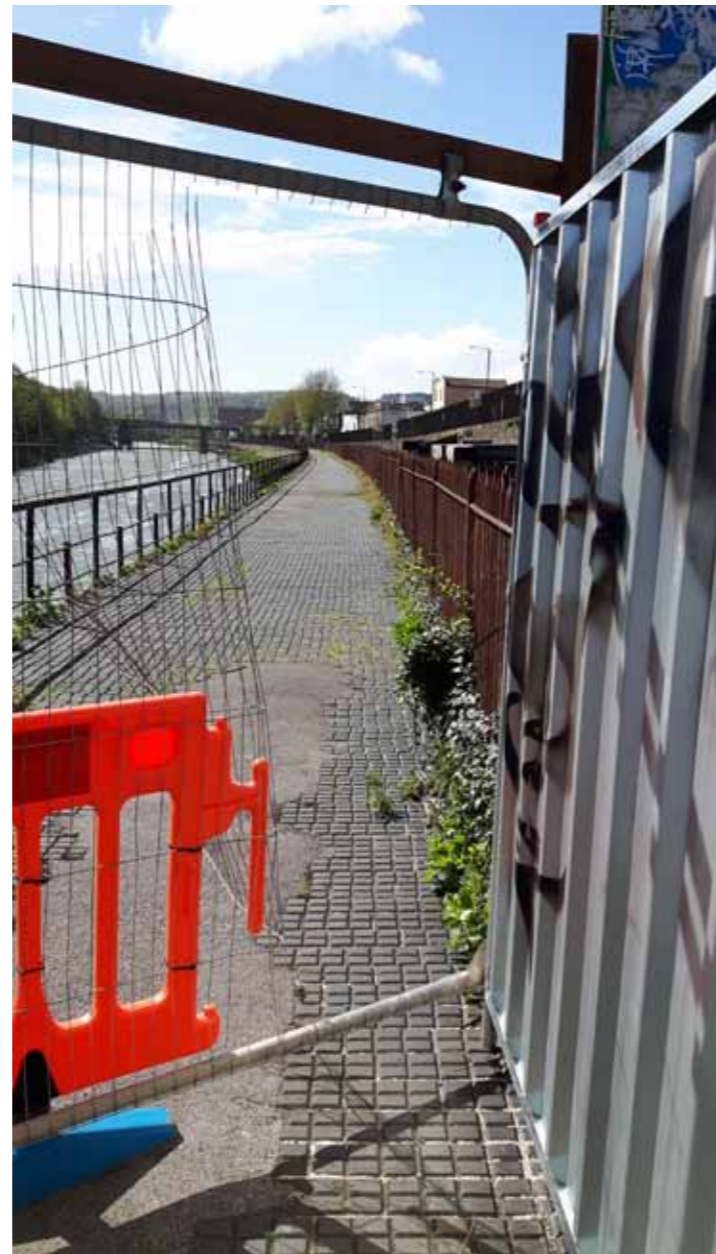
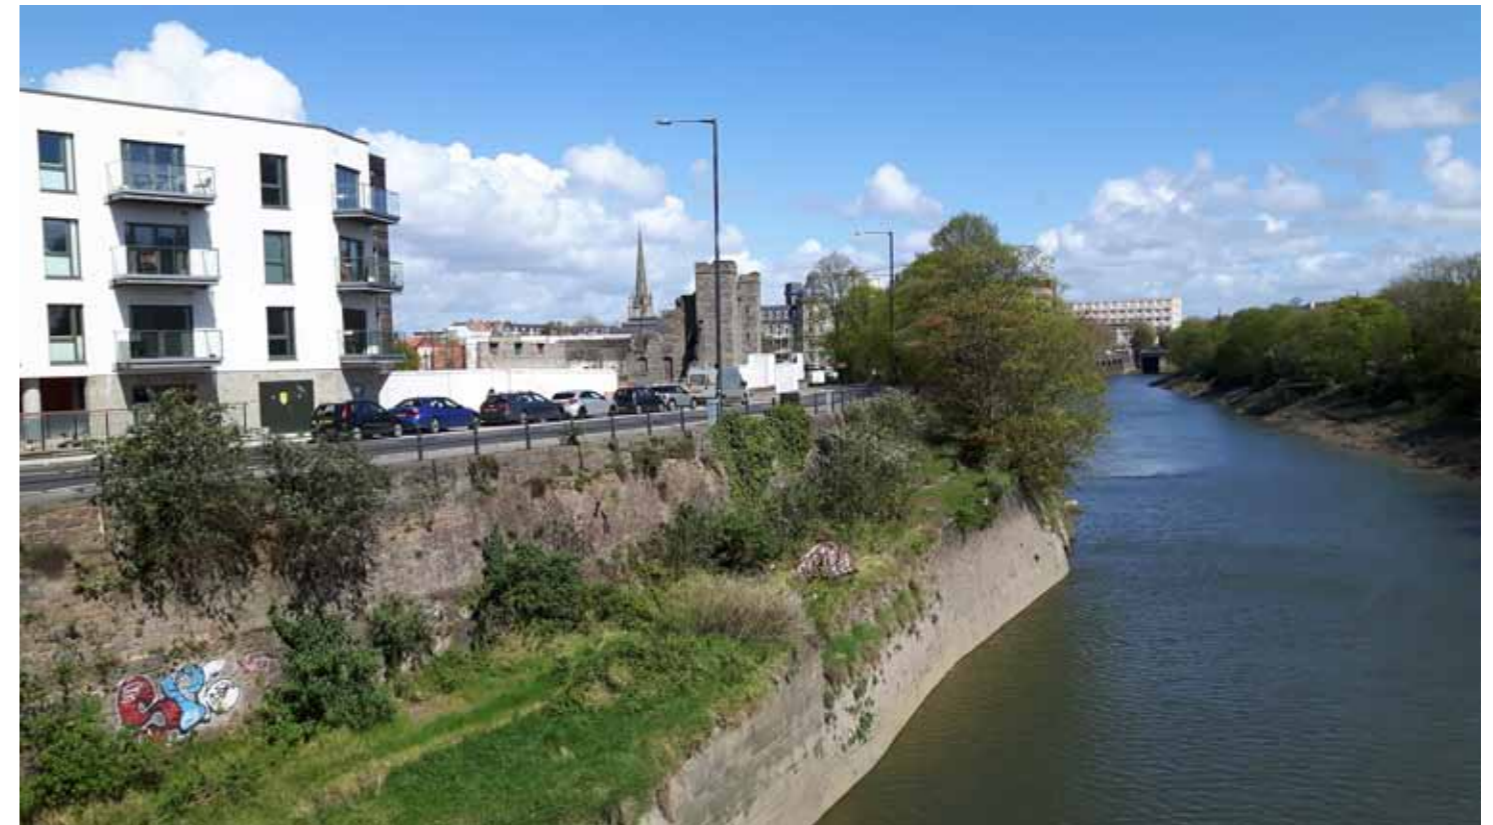
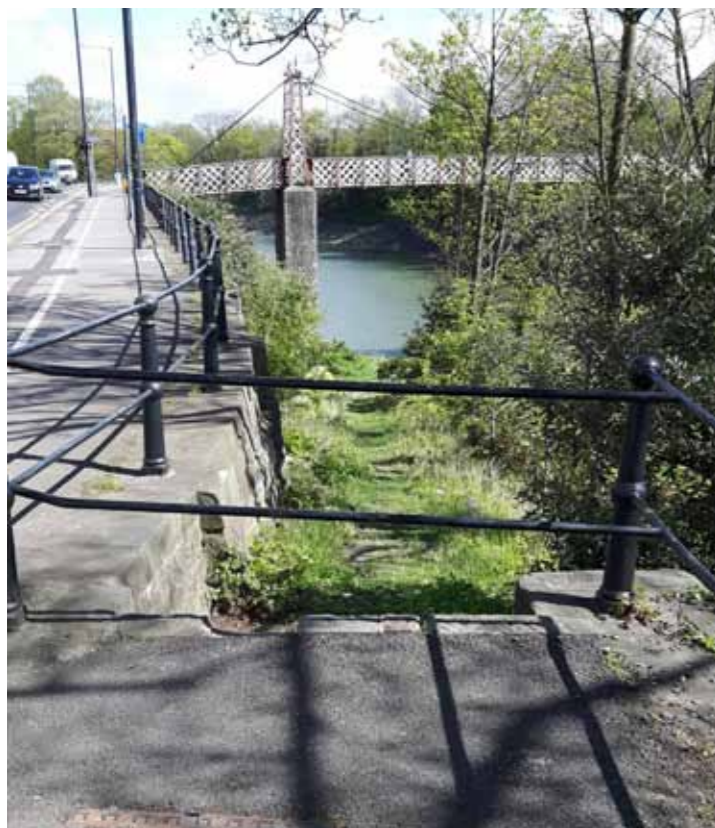
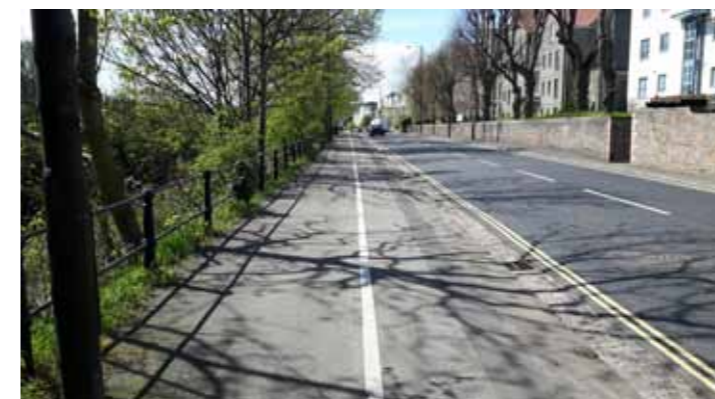
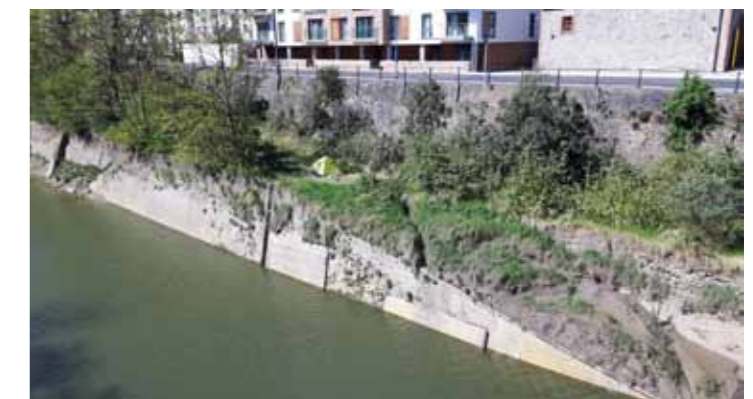
Fig 28
Character and setting

- 1** Gaol Ferry Bridge where it lands at Cumberland Road
- 2** One of the original Gaol Ferry slipways, Cumberland Road
- 3** The currently closed Chocolate Path, original railings on the right
- 4** View towards the Gaol Gate and St Mary Redcliffe from Gaol Ferry Bridge
- 5** Cycle route, Cumberland Road
- 6** Gaol Ferry slip way
