The River Avon

1.1 The New Cut

1.2 Purpose and scope of the assessment

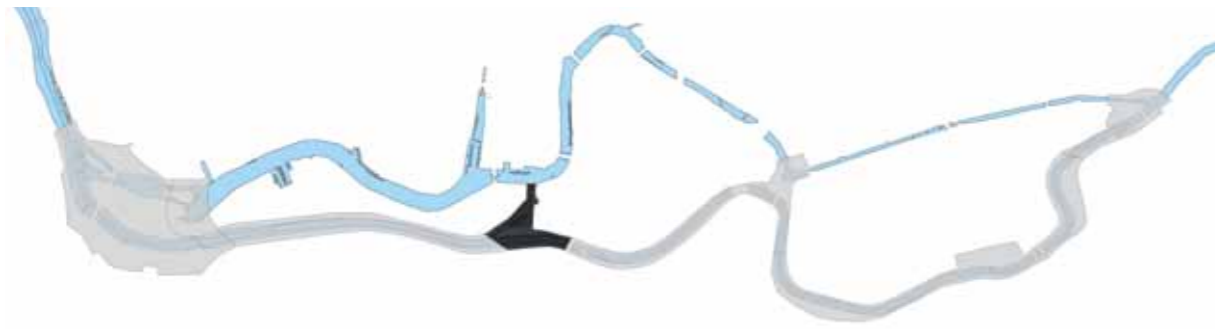
Fig 32
Bathurst Basin entrance lock

- 1 Original stone carved water level markings close to original lock gate fixings
- 2 Lockside bollard relocated as part of works for new Metrobus bridge on the right
- 3 Iron fixings for the original outer lock gate
- 4 Entrance to the lock now in filled
- 5 Original ramped path alongside lock
- 6 Second World War concrete dam

The entrance lock to Bathurst Basin has not operated since the Second World War. It was deliberately dammed in 1939-40 to prevent the potential catastrophic flooding that would be caused by bombing of the basin. Similar efforts were made at Totterdown Lock.

The route of an original early 19th century path runs down from the swing bridge footpath. This ramped path once led to a stepped access to the New Cut depicted on the 1828 Ashmead plan and may date to the construction of the New Cut itself.

The concrete dam from the Second World War also has a degree of historic significance despite being a later alteration that permanently ceased the original function of the lock.

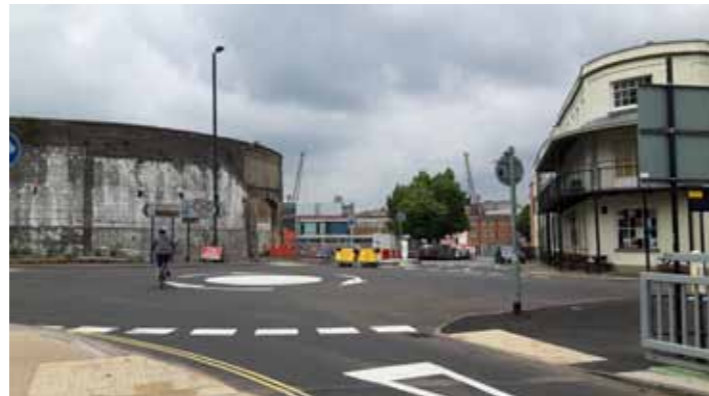
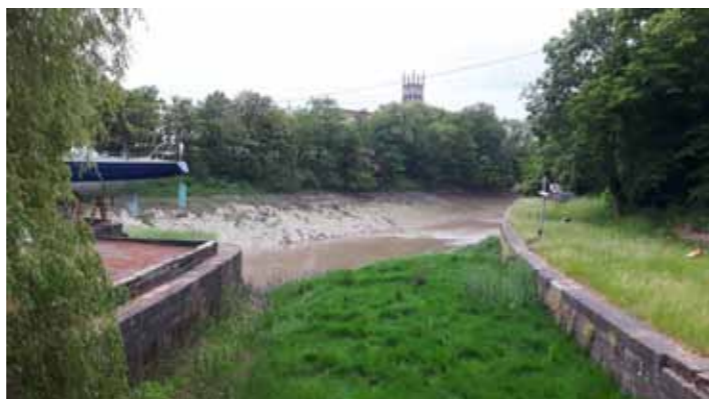
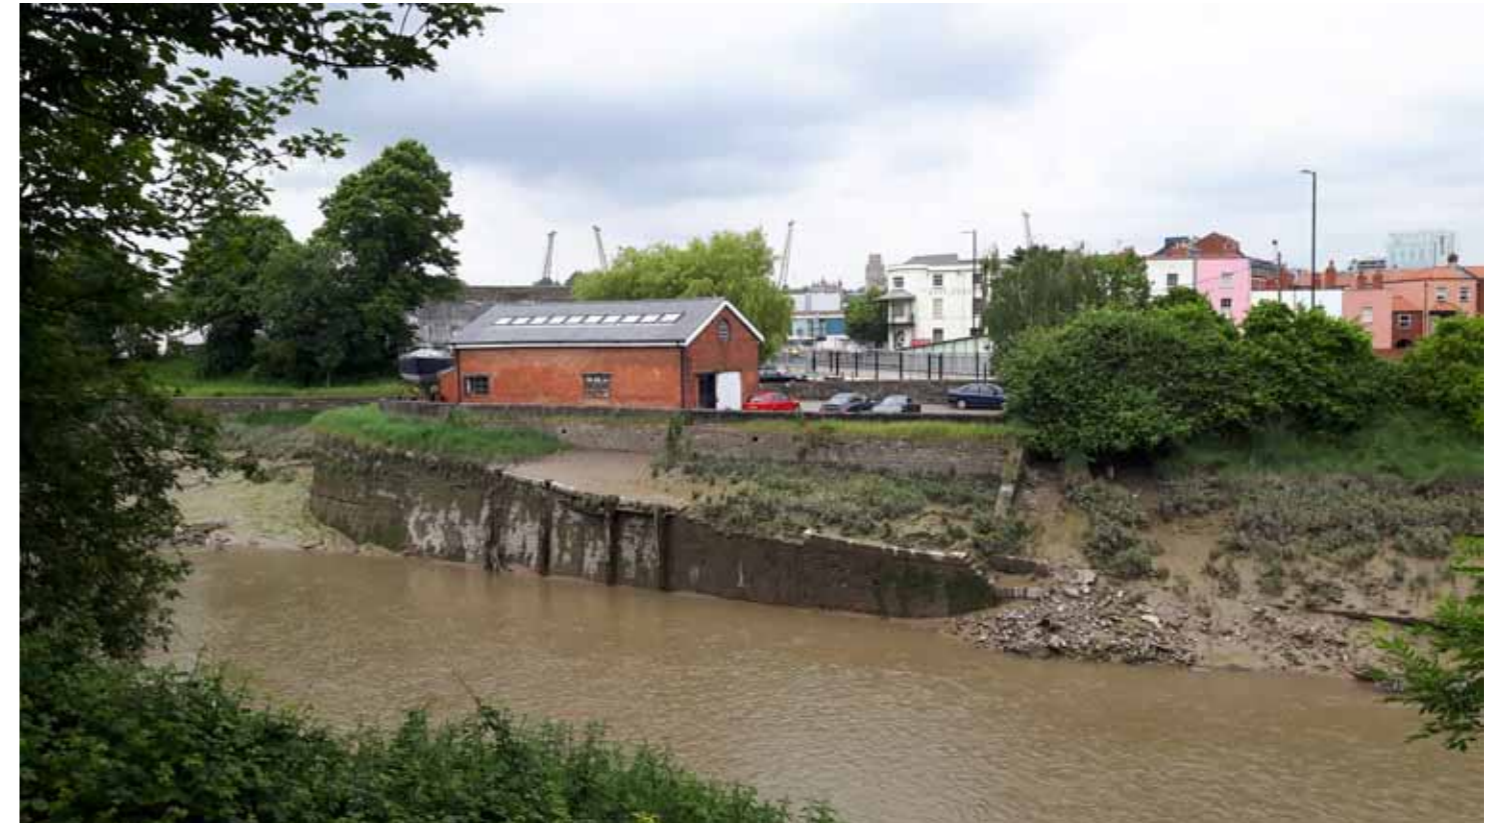
Fig 33
Character and setting

- 1** Glimpsed view from the Wapping Road end of the swing bridge into the city
- 2** View from the swing bridge across the lock entrance towards St Pauls Church
- 3** Glimpsed view of the character area from Coronation Road

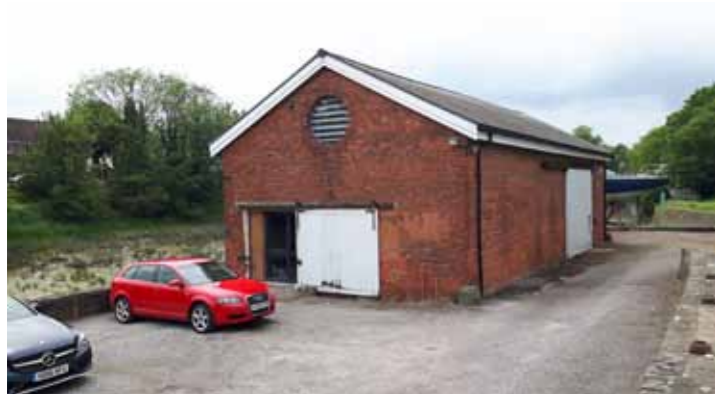
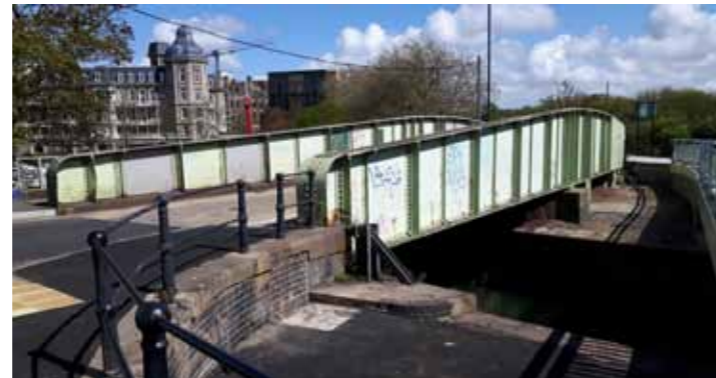
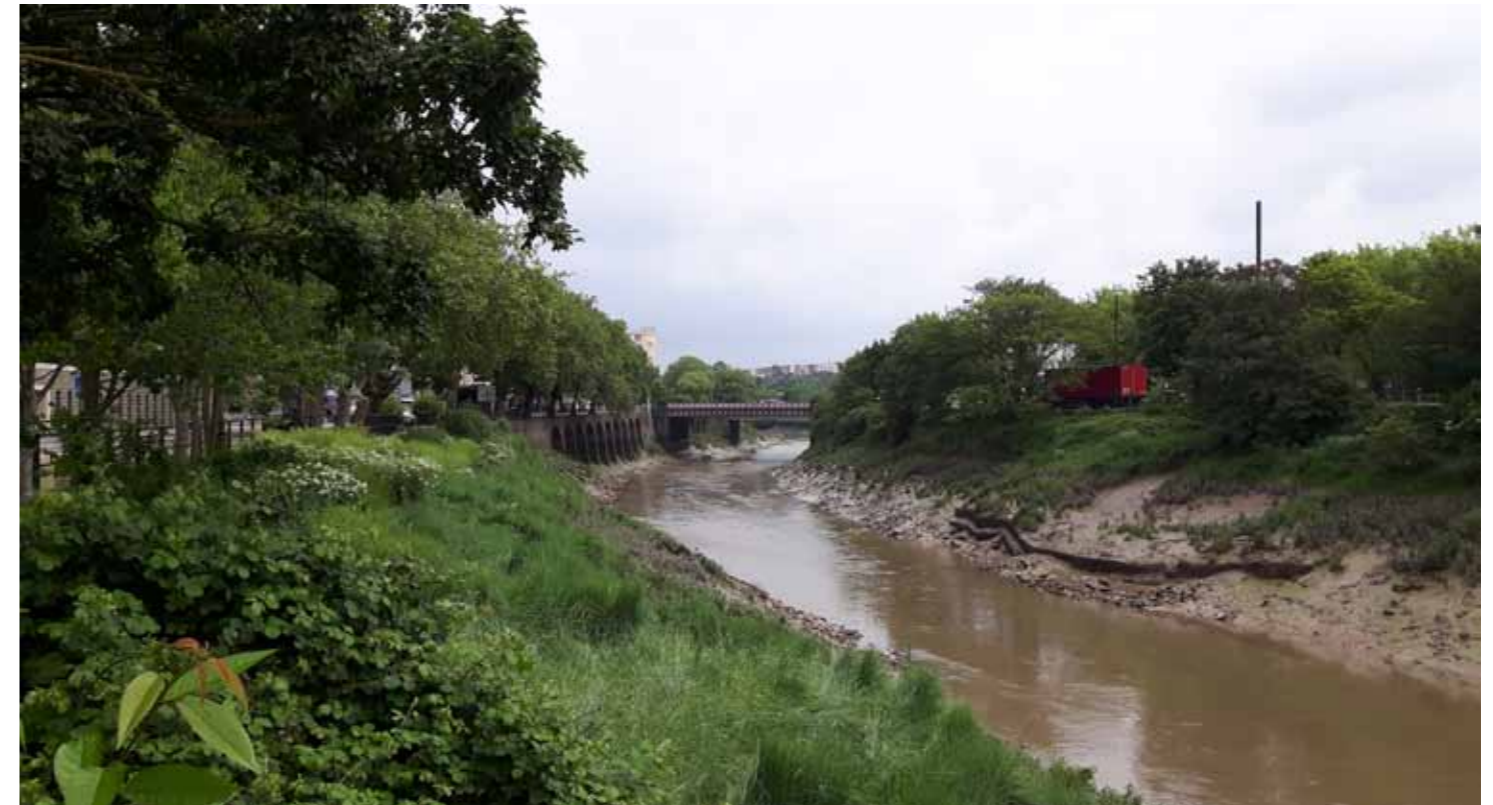
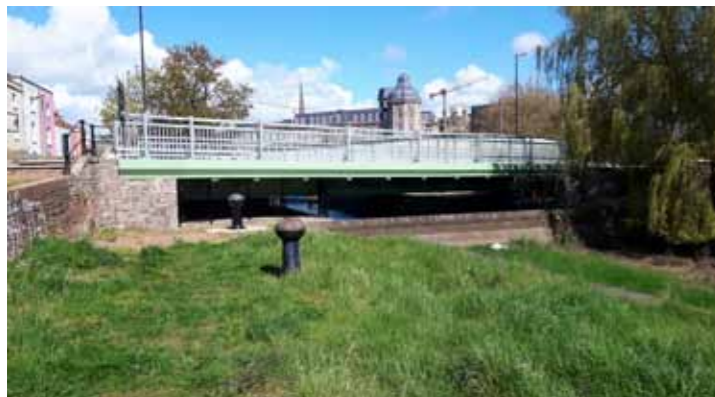
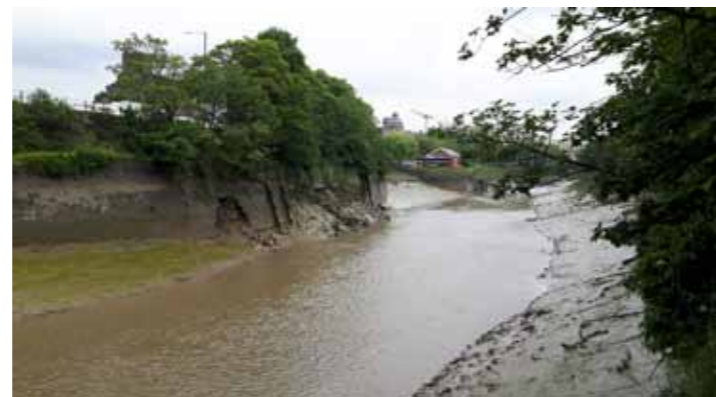
Fig 34
Character and setting

- 1** Cardiff and Channel Steamship Co shed built in 1883
- 2** New Metro bus bridge built alongside 1906 swing bridge
- 3** Swing bridge over the lock built in 1906
- 4** View towards the entrance to Bathurst Basin from Coronation Road Gaol Ferry slipway
- 5** View towards Bedminster Bridge and Totterdown beyond from close to the steamship co shed

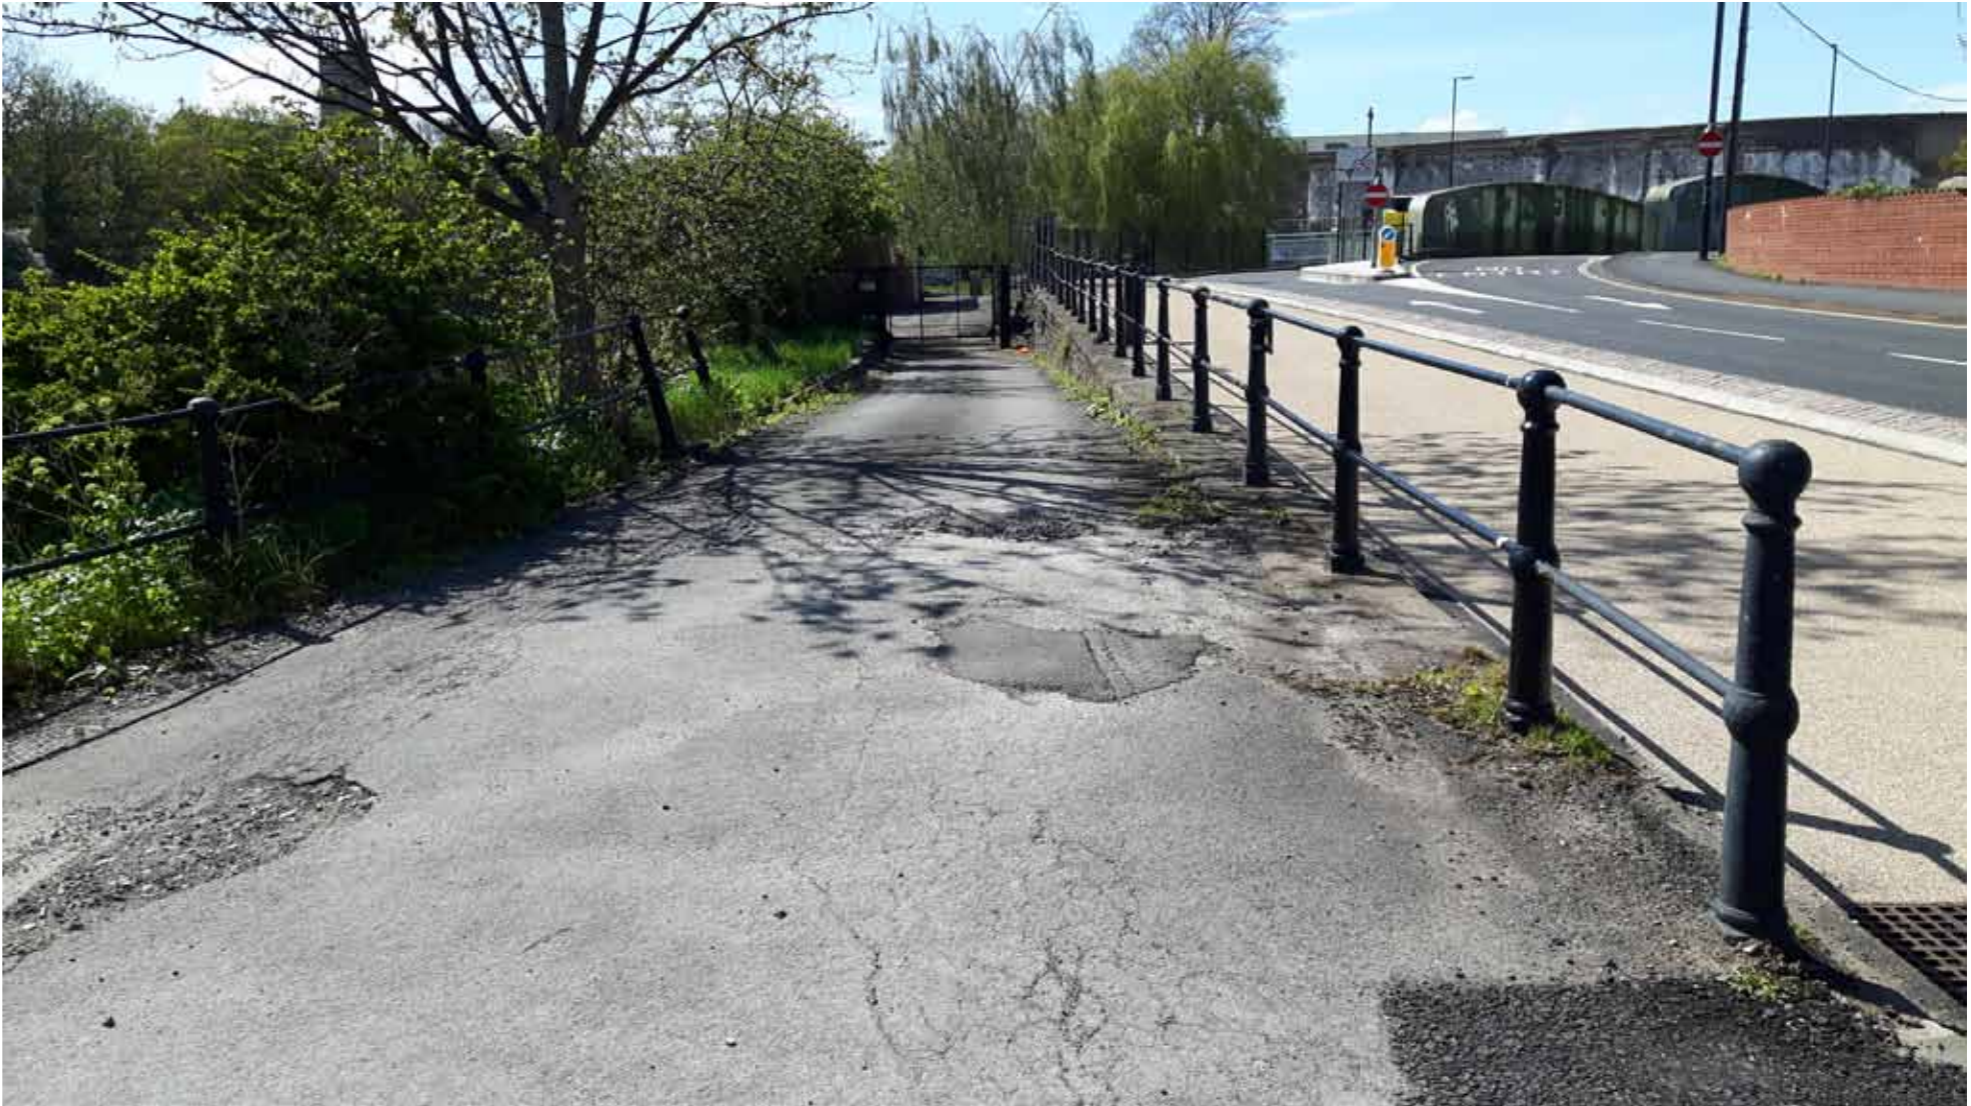
Fig 35
Current access to the former Cardiff and Channel Steamship Co shed

| Asset | Strengths | Weakness | Vulnerability to change | Opportunities | Policy requirements |
|---|--|--|--|--|--|
| Cardiff and Channel Steamship Co shed Undesignated | A character building within the City Docks Conservation Area with a degree of historic significance resulting from its former use | Currently in private use its setting is compromised by poor boundary treatments on the Commercial Road side | Tidal defence works should have no physical impact on this structure, although access will be a consideration to ensure there is no impact to the viable use of the building | Landscaping works could provide better boundary treatments for the site on Commercial Road | As above |

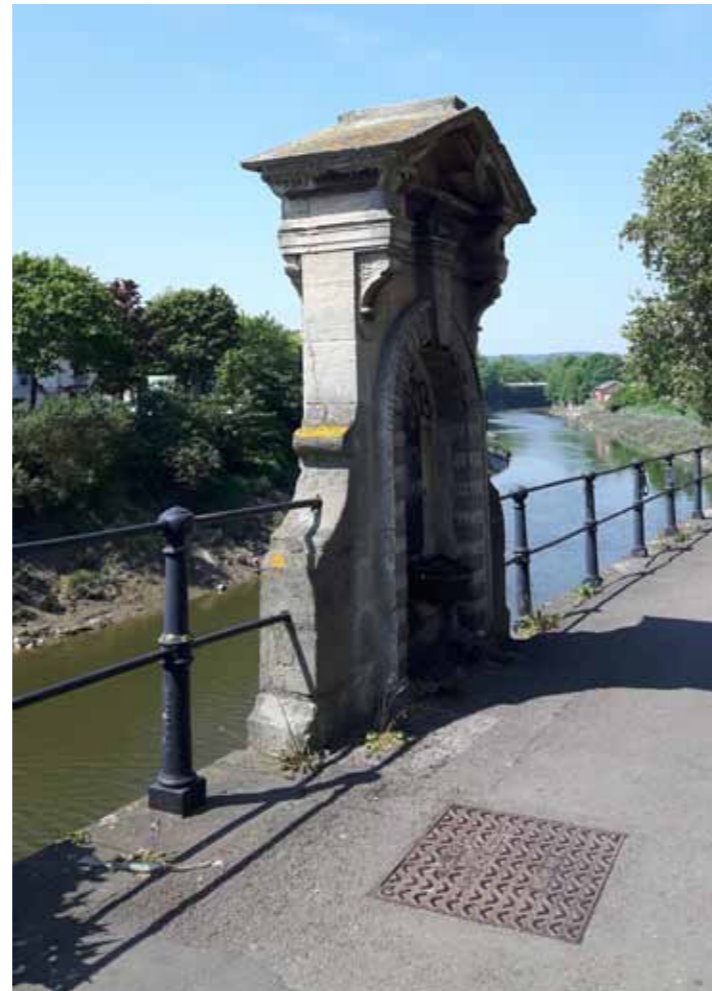
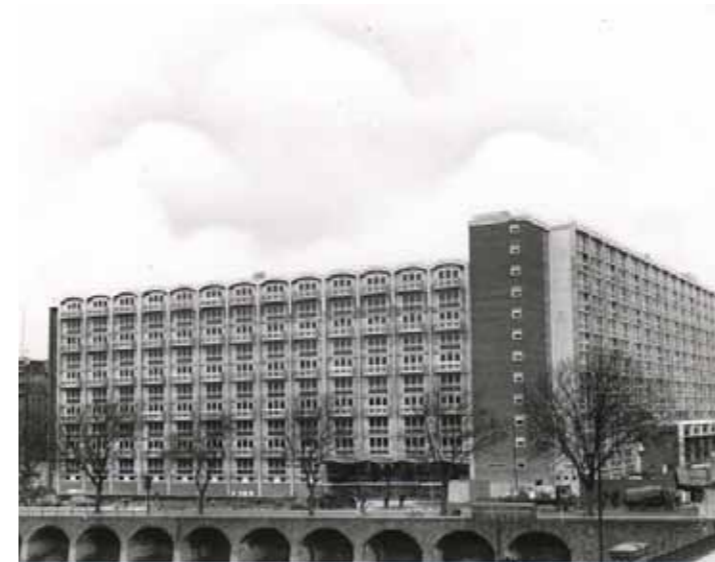
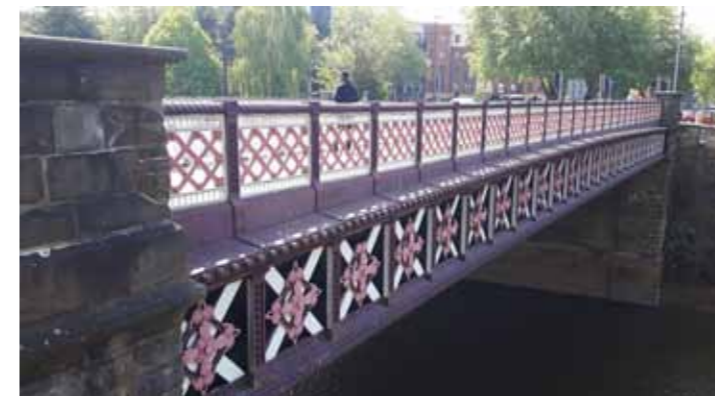
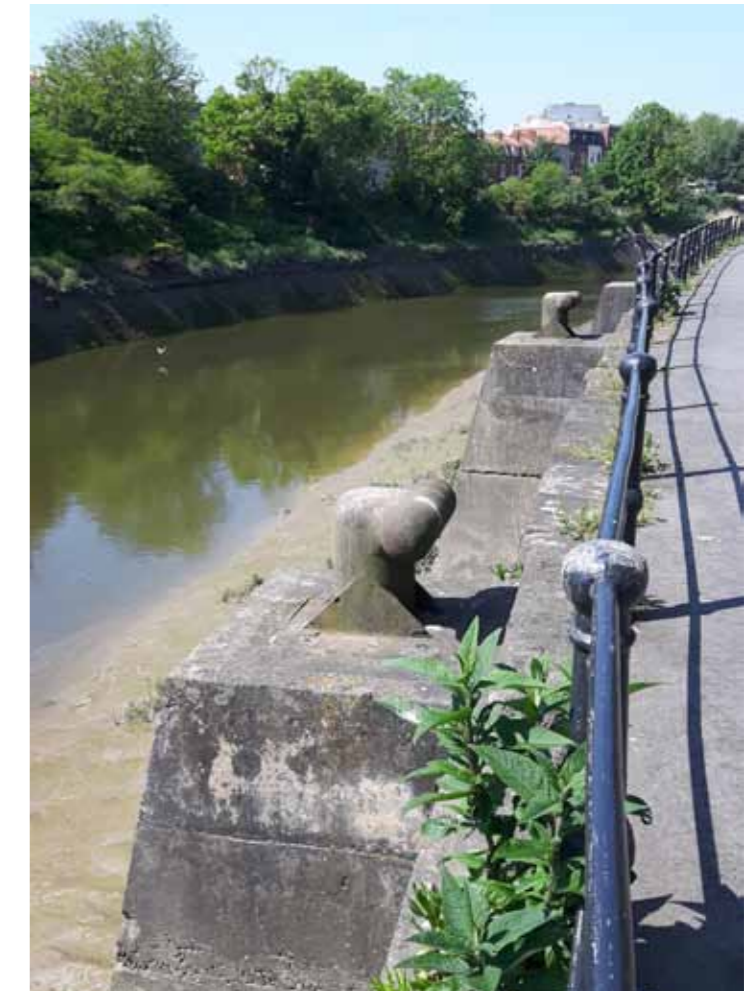
Fig 39
Heritage assets

- 2 The relieving arches supporting the Commercial Road approach to Bedminster Bridge. These undesignated assets contribute to the character of the conservation area particularly with the architectural reference of the roof form in the residential block above.

- 3 At Bedminster Bridge the impact is likely to be minimal given the height of the structure above the flood risk area.
- 4 Along Clarence Road are a set of steel mooring posts set within concrete buttresses. These are set between surviving 19th century stone buttresses and are likely to date to the 1960s relating to a later phase of the Redcliffe Estate development or associated demolition works. Although outside of any conservation area they contribute to the historic character of the area and the setting of the Bedminster Conservation Area to the south.

- 1 Drinking fountain near Bedminster Bridge
- 2 1960s view of Francombe House with 19th century relieving arches below Clarence Road in foreground
- 3 Bedminster Bridge
- 4 Steel mooring posts on Clarence Road

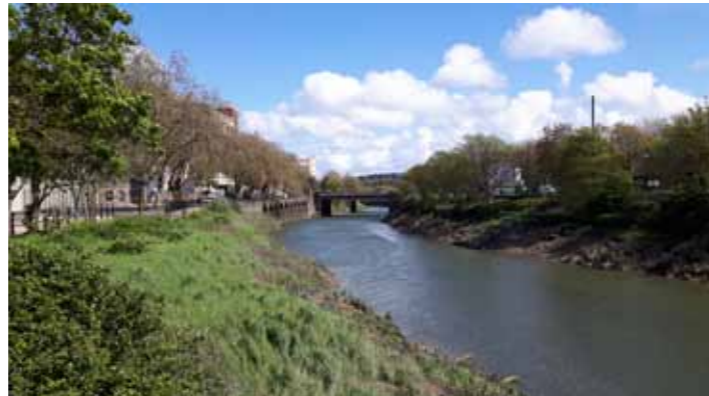
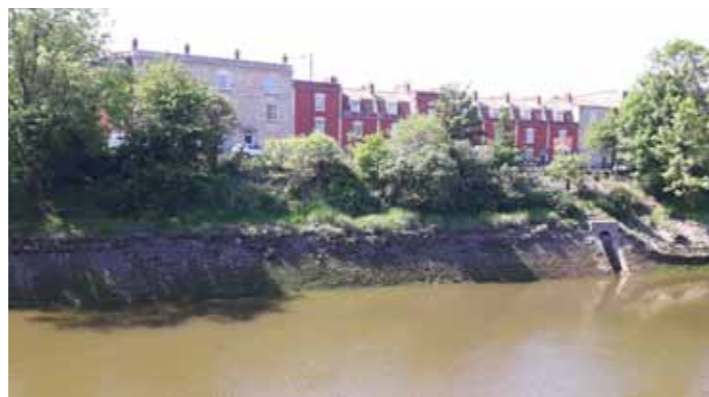
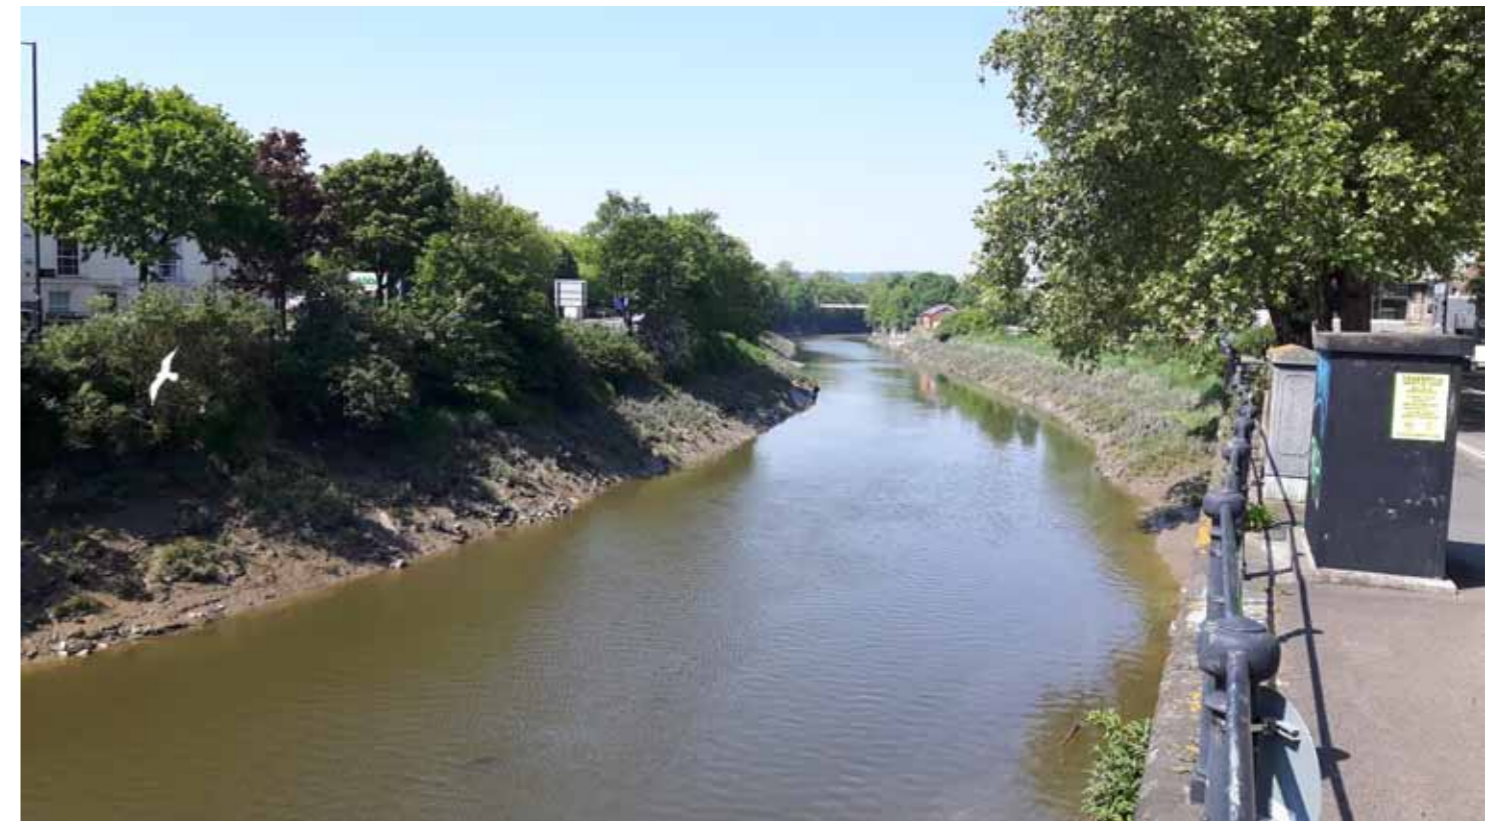
Fig 40
Character and setting

- 1** View towards Bedminster Bridge from the Bathurst Basin character area
- 2** Looking into the Bedminster Conservation Area from Clarence Road
- 3** View towards Gaol Ferry Bridge from near to Bedminster Bridge

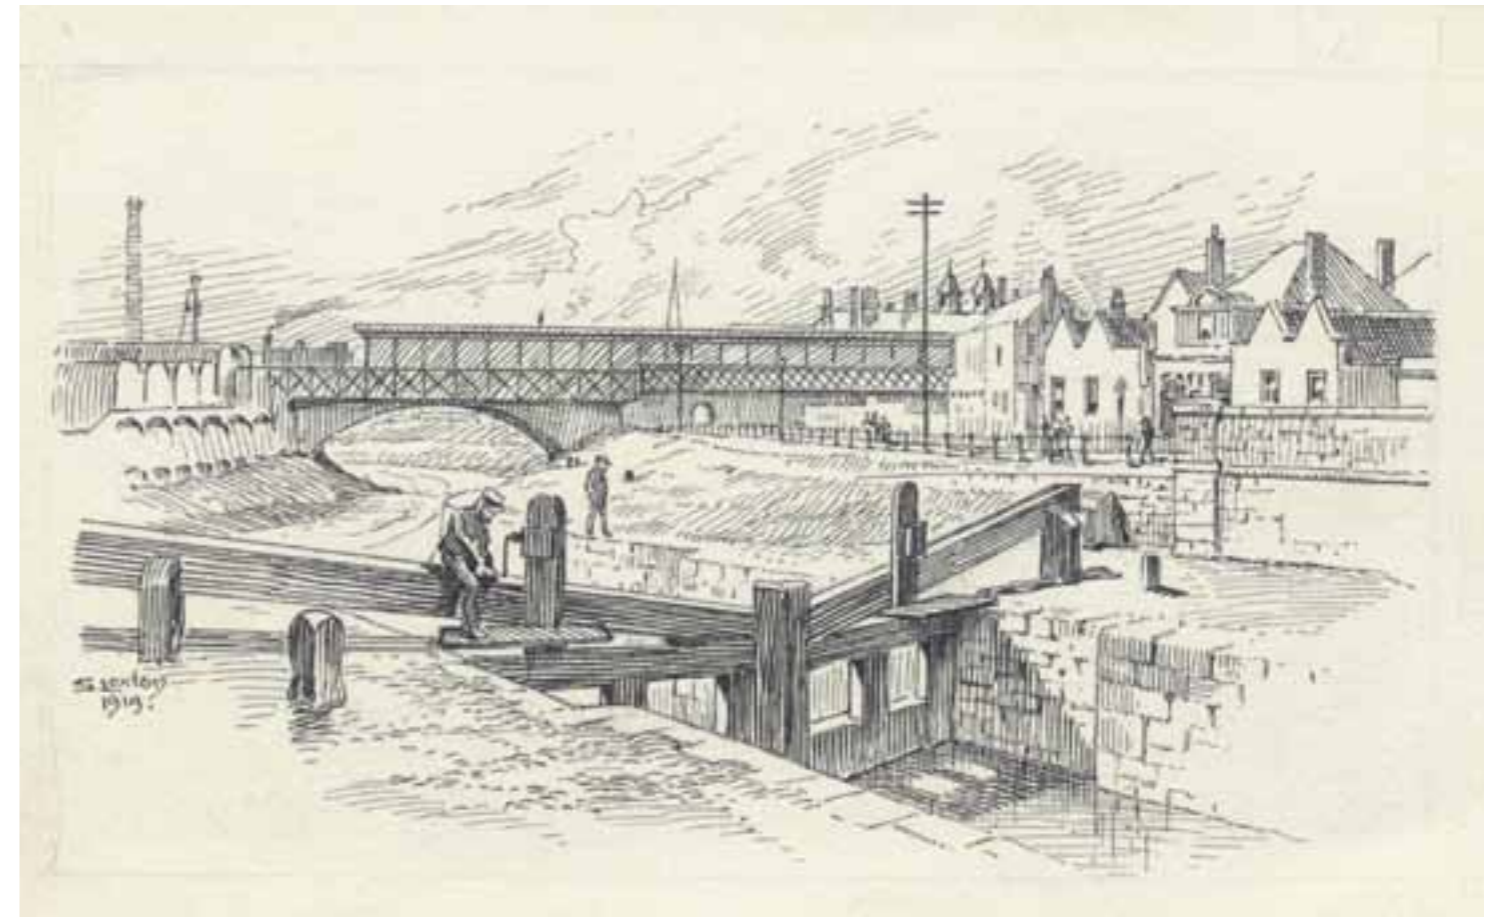
Fig 41 Early 20th century drawing by Samuel Loxton of Totterdown Lock, Bristol Archives, U1146

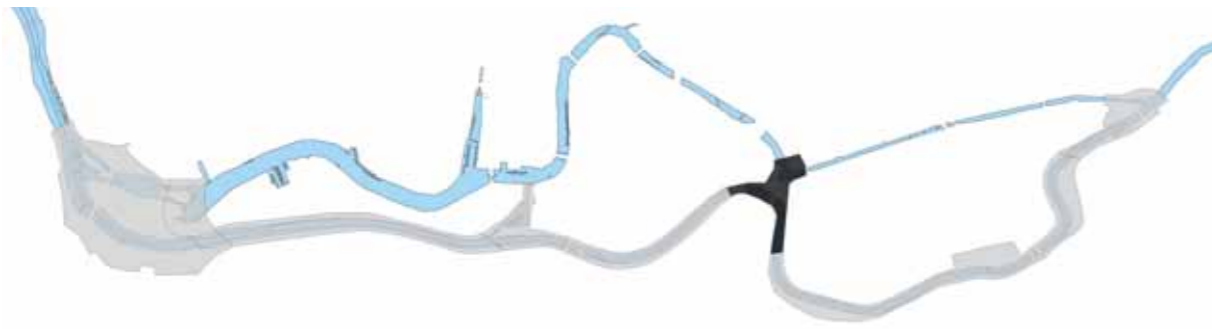
1828 main features:

- Plumley and Ashmead's 1828 map of Bristol depicts the post Floating Harbour/New Cut landscape with Totterdown Lock 1 and the Feeder Canal 2 either side of Totterdown Basin 3

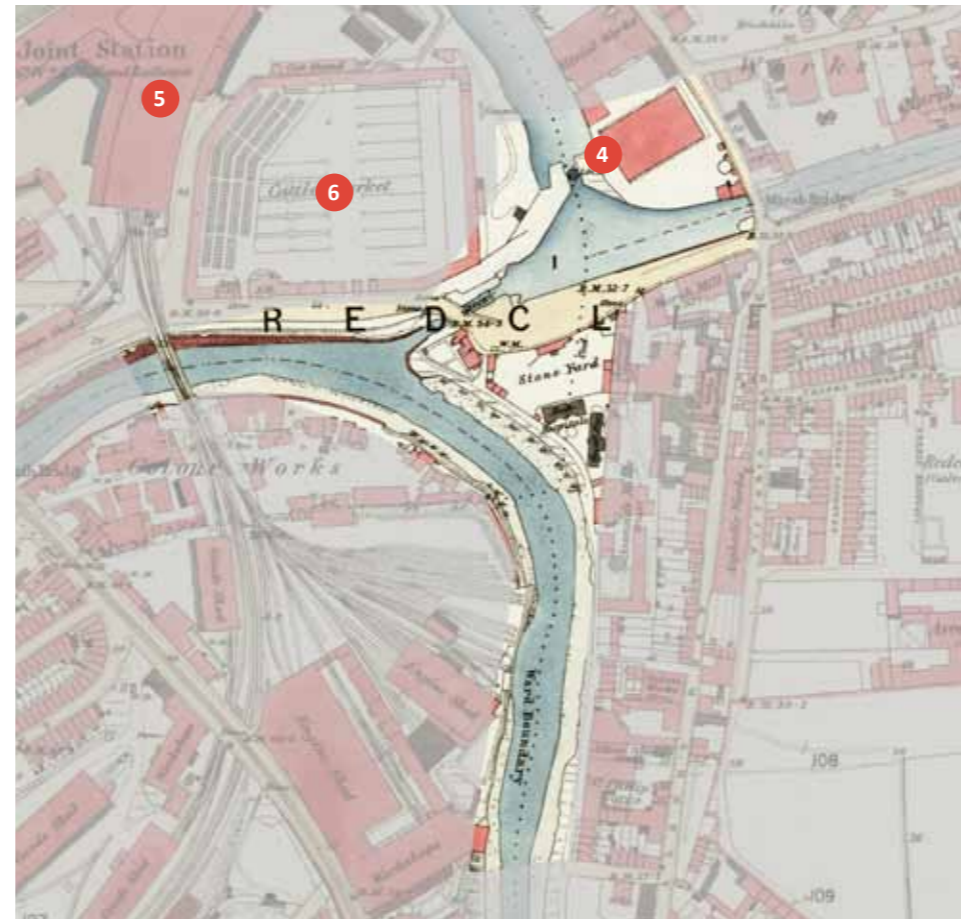
1880:

- By 1880 an additional lock had been added to the northern entrance to the Totterdown Basin 4
- Temple Mead station had opened originally in the 1840s and then expanded in the 1870s 5
- As a result of the improved transport links by rail and water the cattle market had opened adjacent to Totterdown Basin 6

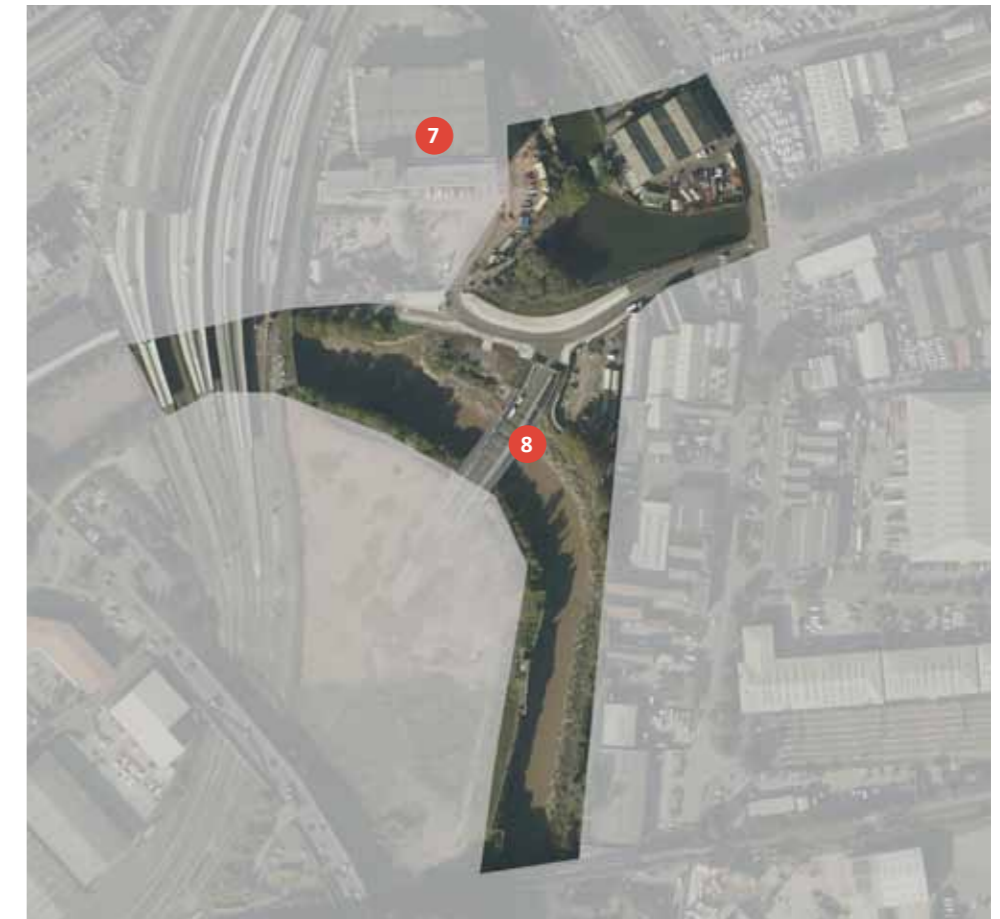
2016:

- In landscape terms the area remained relatively unchanged during the 20th century. The most significant change being the further expansion of Temple Meads station in the 1930s and the closure of the cattle market to be replaced by the Post Office Sorting Office 7
- More recently a new bridge, Brock's Bridge has been constructed over the river 8

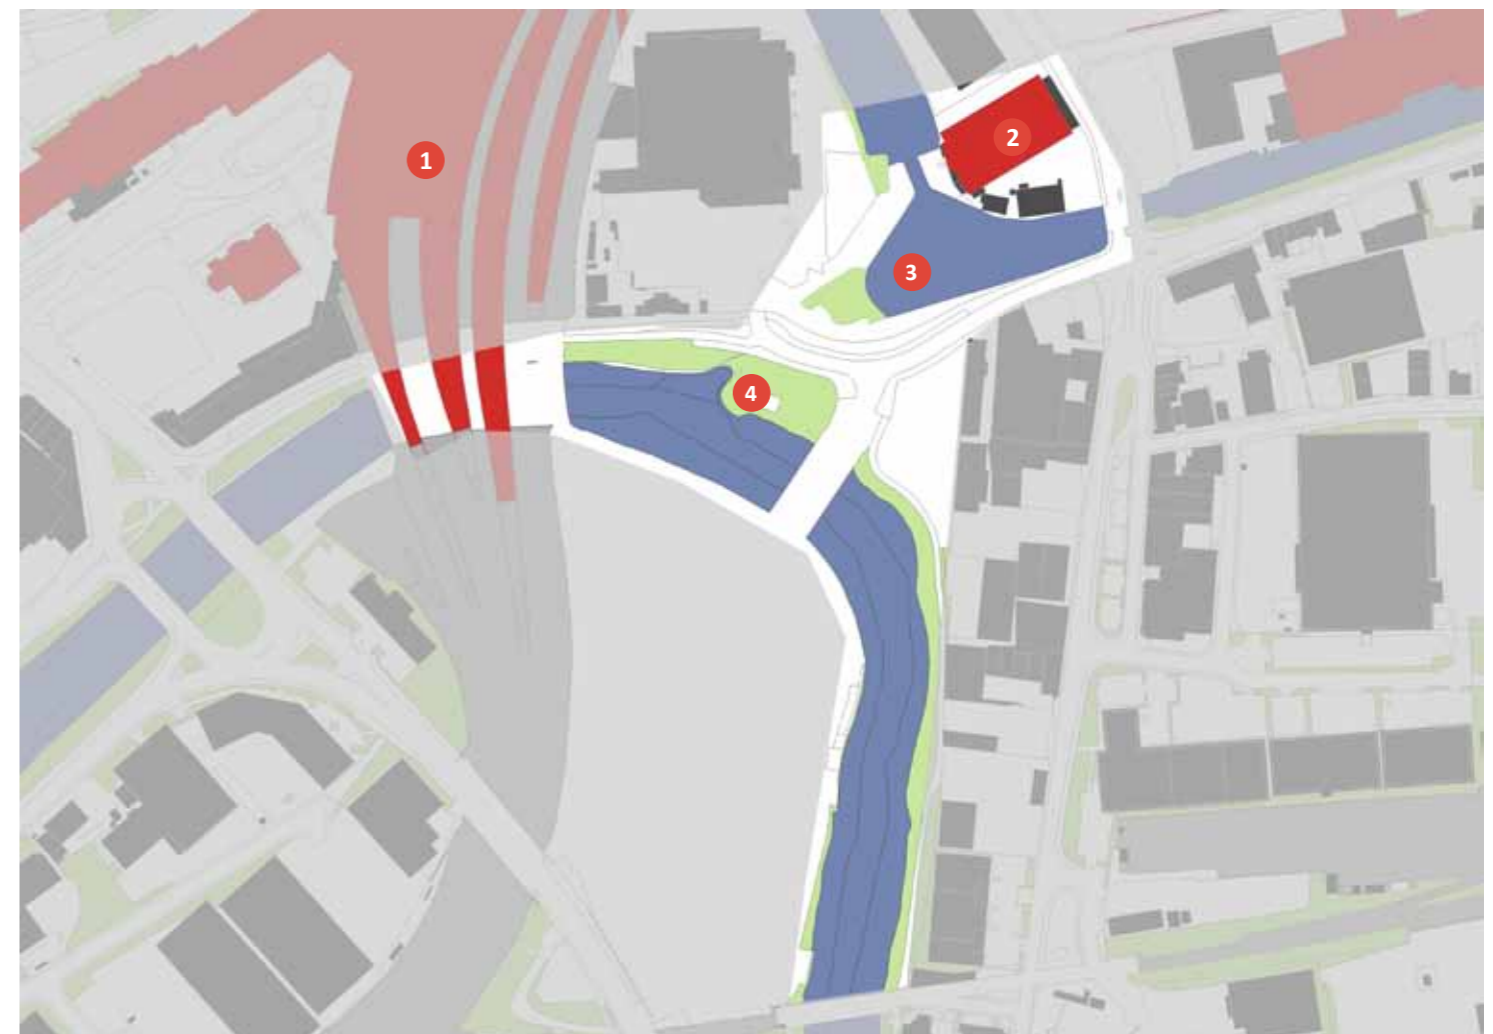
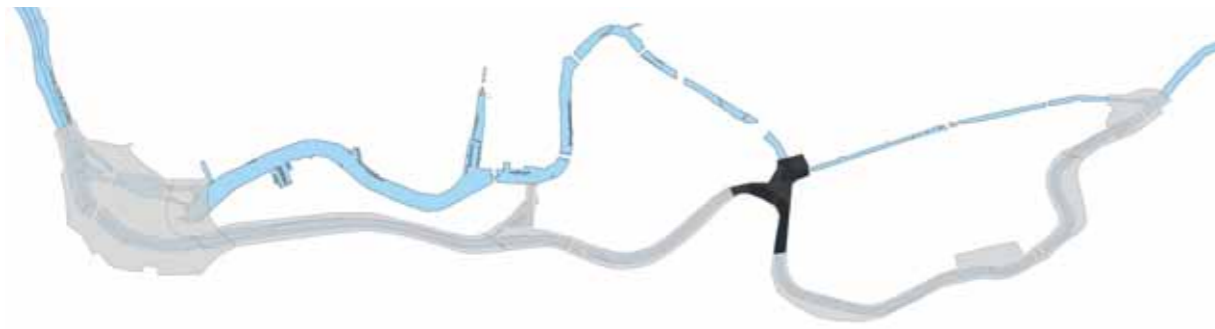
Fig 42
Totterdown Lock and Basin

- 1 Aerial view of Totterdown Lock
- 2 Dockside fabric alongside Totterdown Basin
- 3 Totterdown Basin
- 4 Surviving cast iron lamp post

In terms of undesignated assets the basin as a whole (3) including the remains of its entrance lock and mooring posts and other dockside fabric are of historic significance dating to similar periods as the listed fabric elsewhere in the Floating Harbour.

The remains of Totterdown Lock (4), although greatly altered through recent highway works and the Second World War infilling is an undesignated heritage asset with historic significance relating to the creation of the Floating Harbour.

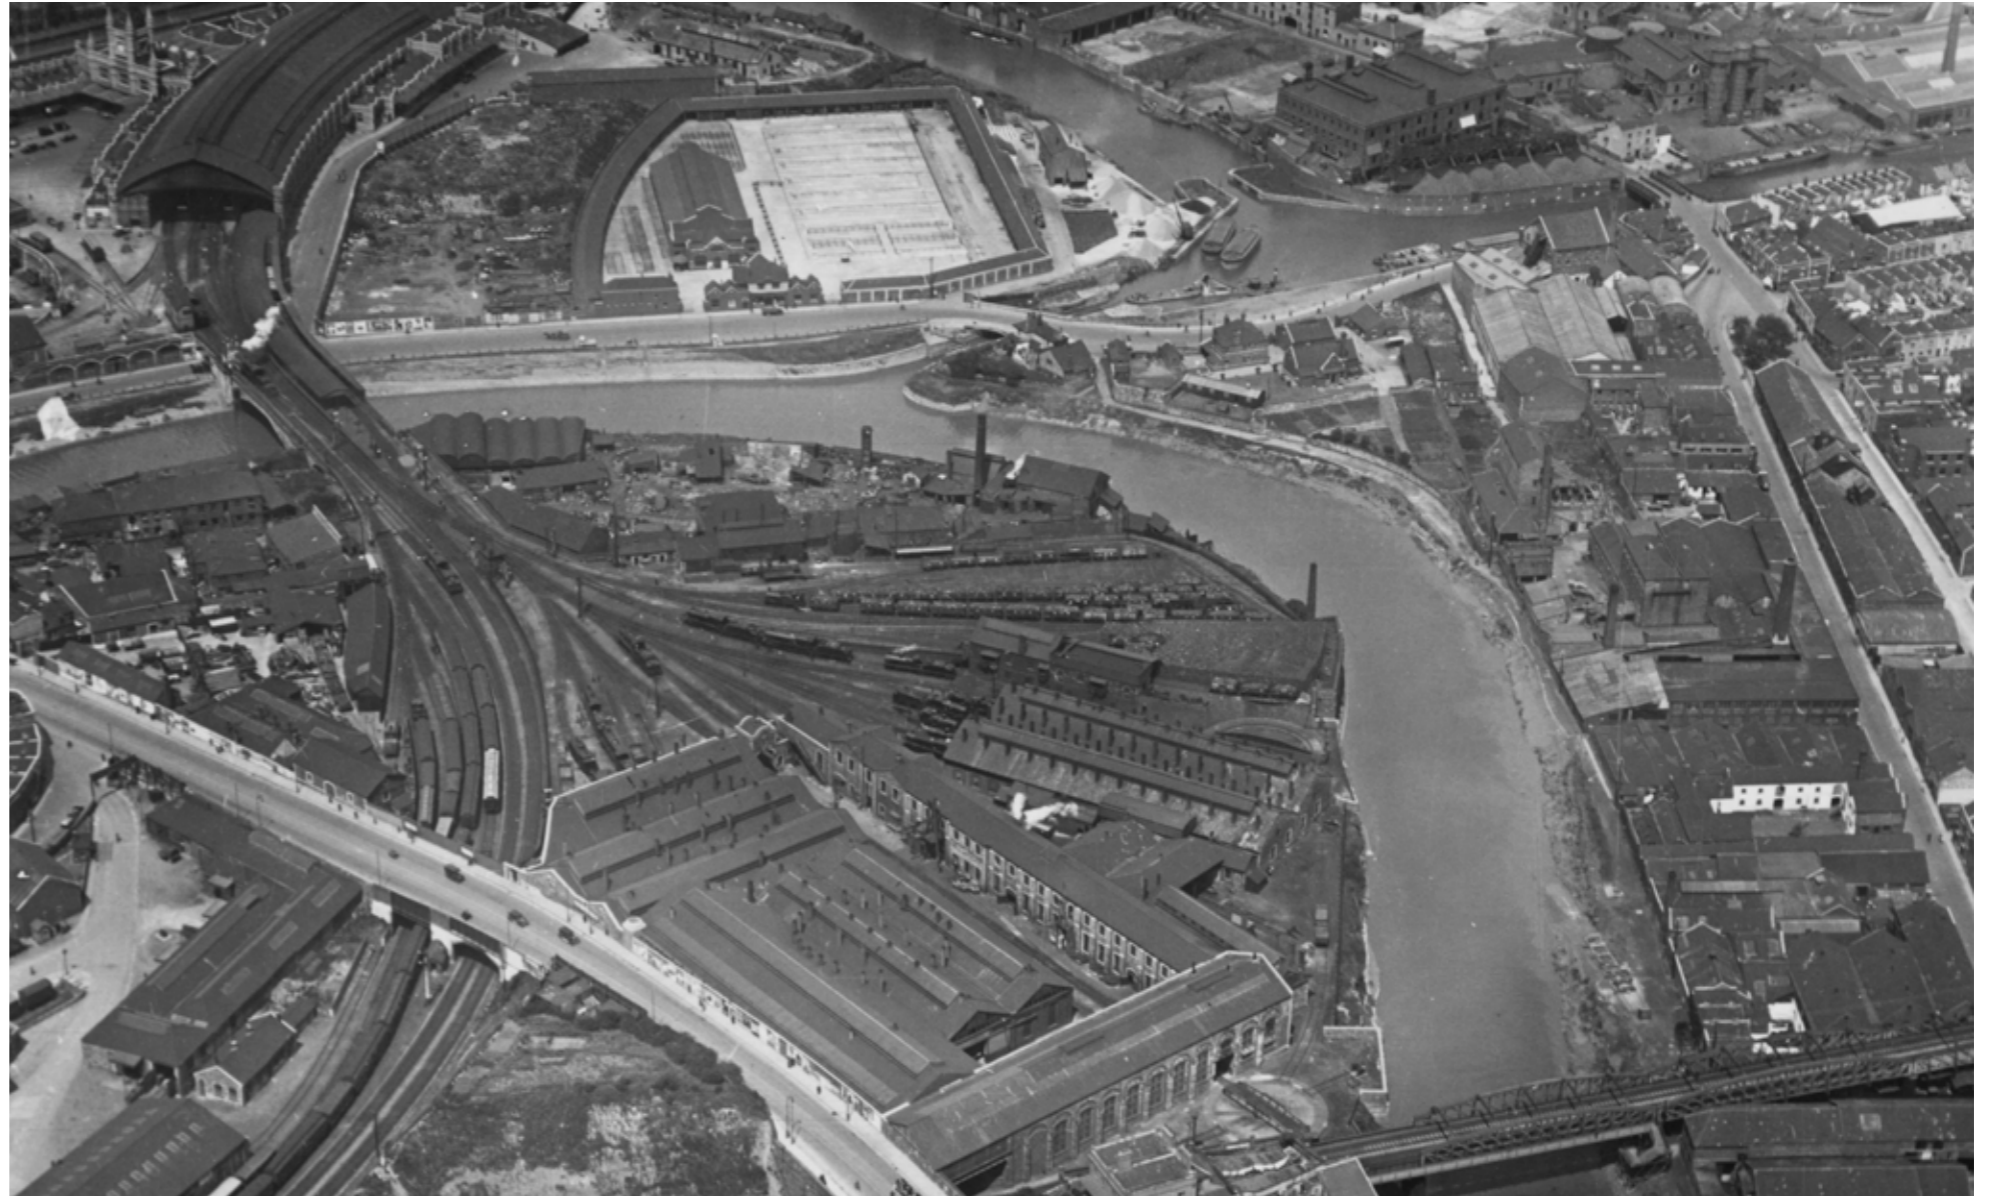
Fig 43
Totterdown Lock and Basin with the railway yards in the foreground, Albert Clarke
Collection, Bristol Archives, 44819/3/26

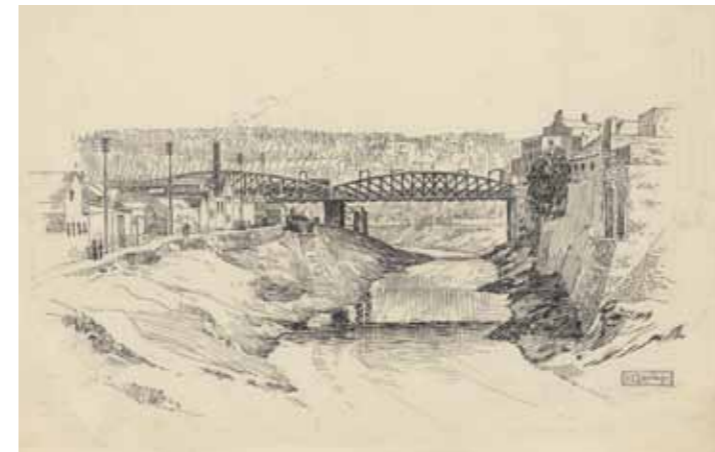
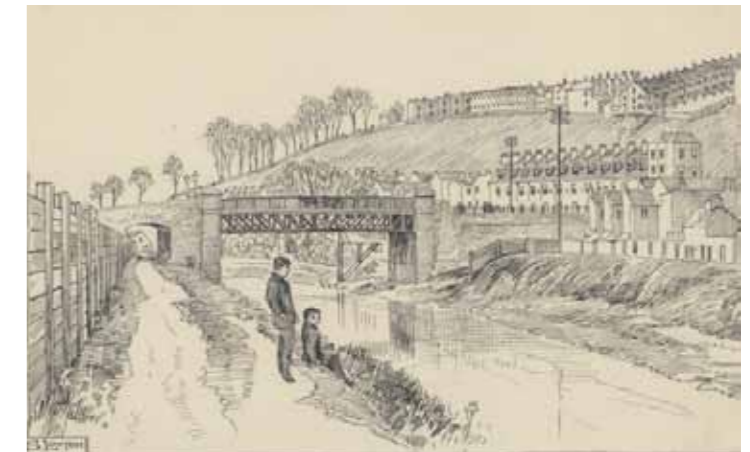
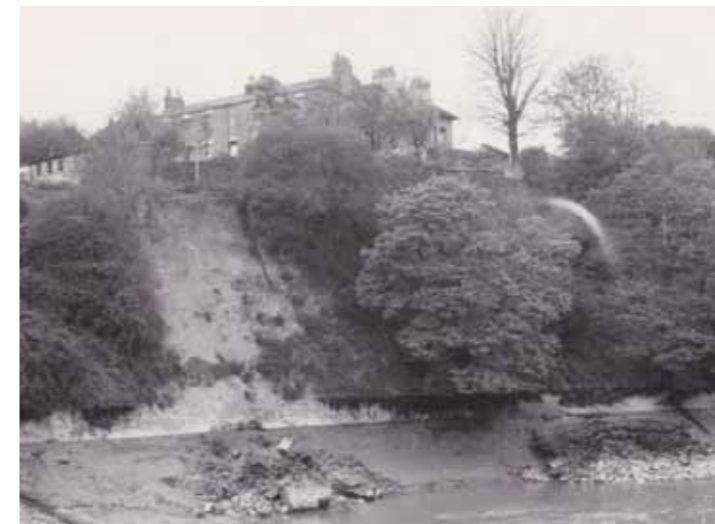
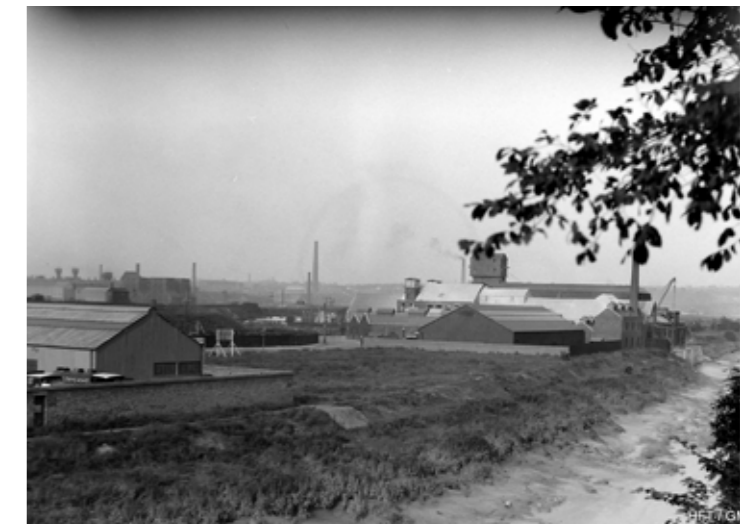
- 1 Ink drawing by Samuel Loxton of the railway bridge over the Avon viewed from Totterdown Lock, Bristol Libraries, C118
- 2 Ink drawing by Samuel Loxton of Totterdown Bridge Bristol Libraries, C137
- 3 A view of the western bank of the River Avon, April 1972, image courtesy of Know Your Place
- 4 St Philip's Marsh, c.1930, Geoffrey Tarring Collection

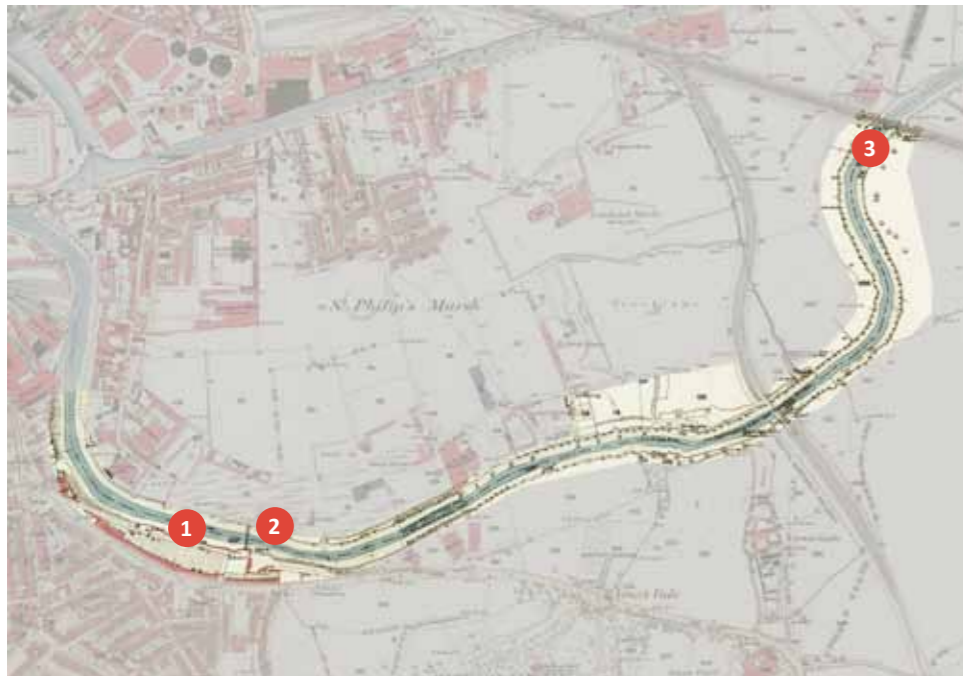
1880 main features:

- As a natural river course, the most significant features within this area tend to relate to the historic bridges or bankside land uses and their interfaces with the river. However, the earliest significant landscape feature is the former route of the Bath Road **1**. This was realigned to its current location by the mid 19th century as a result of persistent flooding and landslips, although its former course was retained to provide rear access to properties fronting the new Bath Road.
- Totterdown Bridge was constructed in the 1880s to provide highway access to St Philip's Marsh **2**
- The earliest bridge along this stretch of river is the Avon railway bridge constructed in 1839 by Brunel **3**

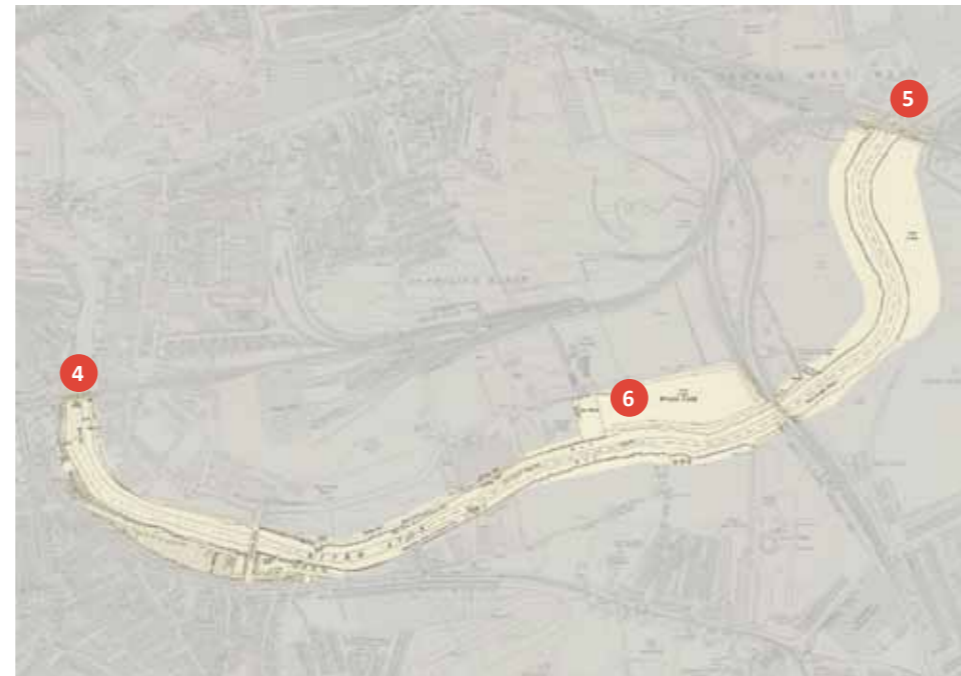
1910:

- In the late 19th century an additional railway bridge was constructed as part of the growing railway infrastructure across St Philip's **4**. This bridge defines the western end of this character area
- Additional railway lines were added either side of Brunel's Avon bridge in the late 19th century as railway use increased **5**
- Sparke Evans Park opened in 1902 **6**
