The River Avon

1.1 The New Cut

1.2 Purpose and scope of the assessment

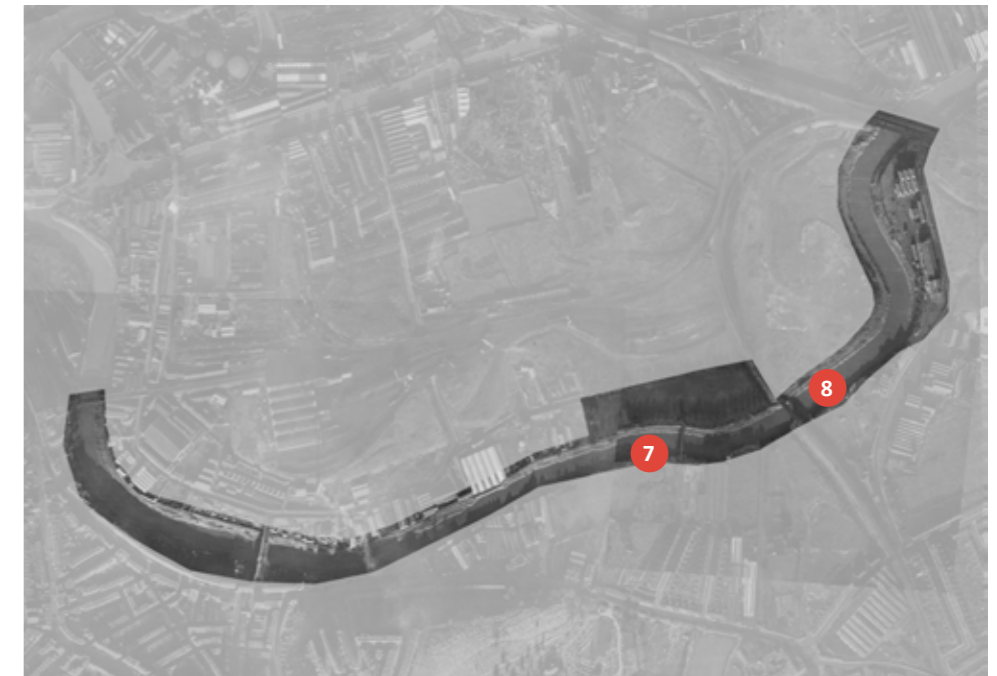
1946:

- The suspension bridge over the Avon connecting to Spark Evans Park was constructed in 1933 by John Lysaght Ltd of St Philip's **7**
- The introduction of the St Philip's Causeway structure and associated elevated highway infrastructure in the 1990s resulted in the removal of a Victorian railway bridge and general erosion of the historic character towards the eastern end of the character area **8**

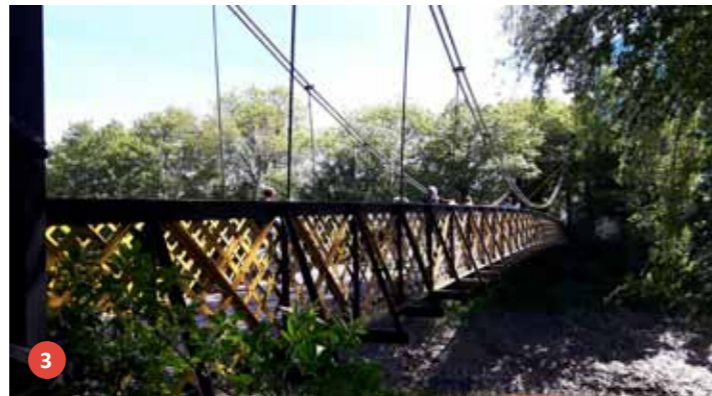
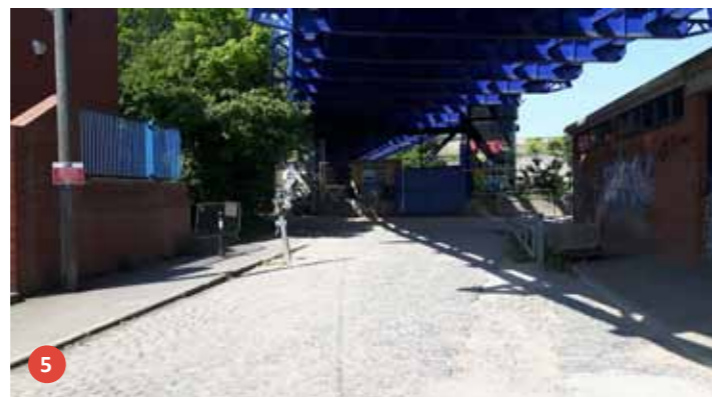
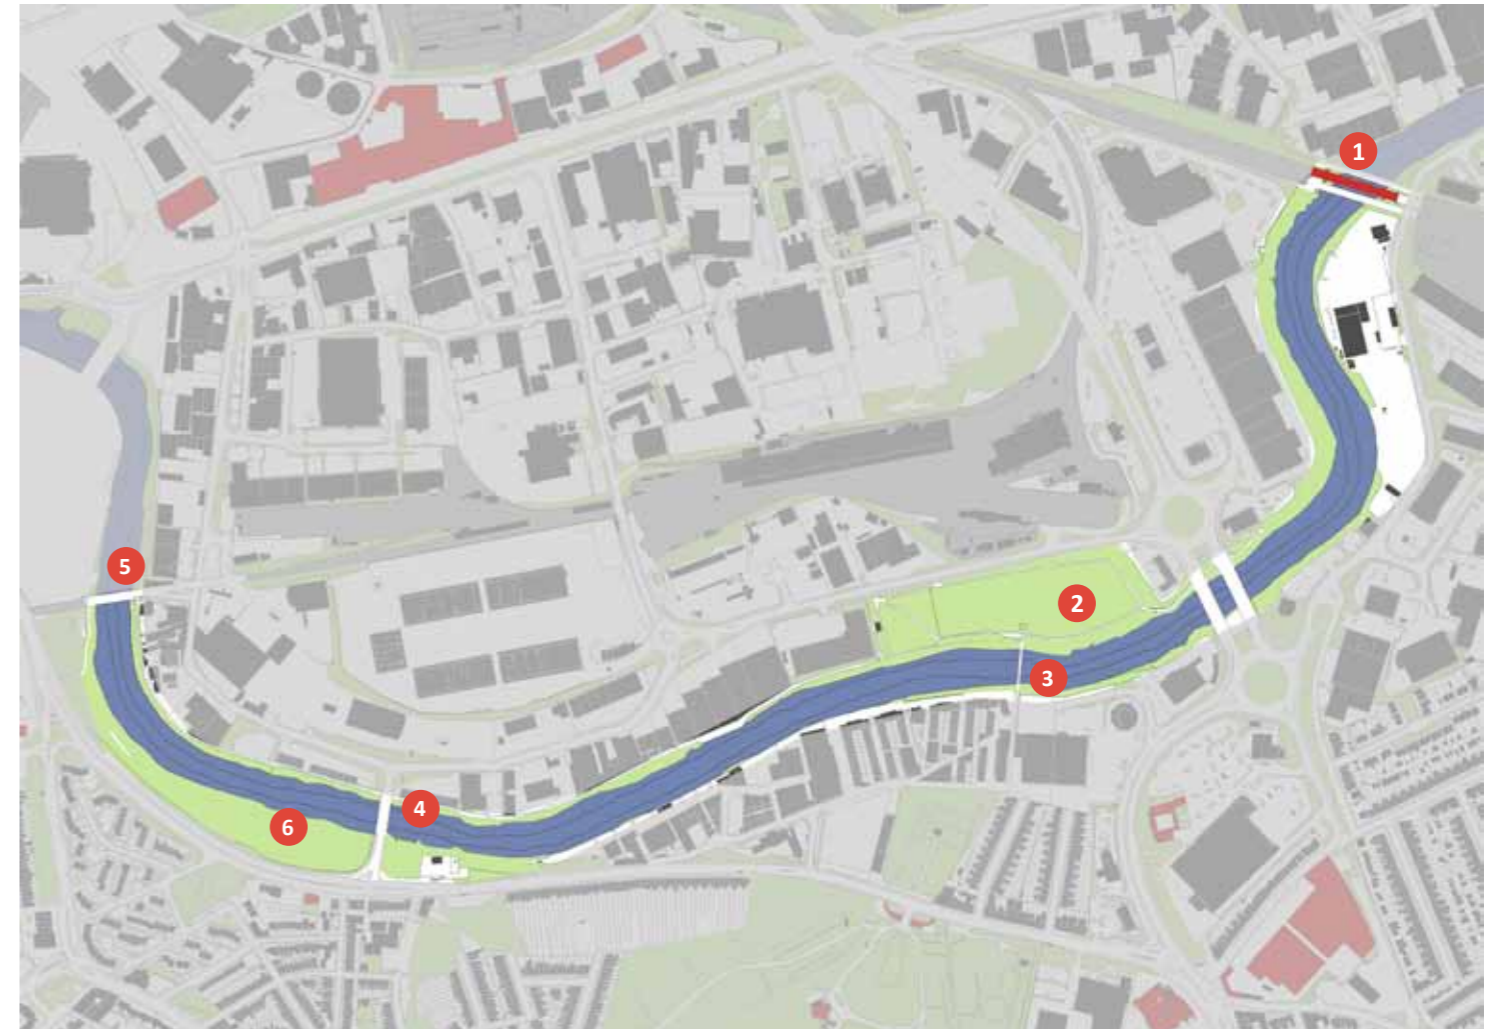
- 3 The Sparke Evans Park bridge
- 4 Totterdown Bridge
- 5 Victorian railway bridge
- 6 The remains of the former Bath Road now overgrown along the southern bank

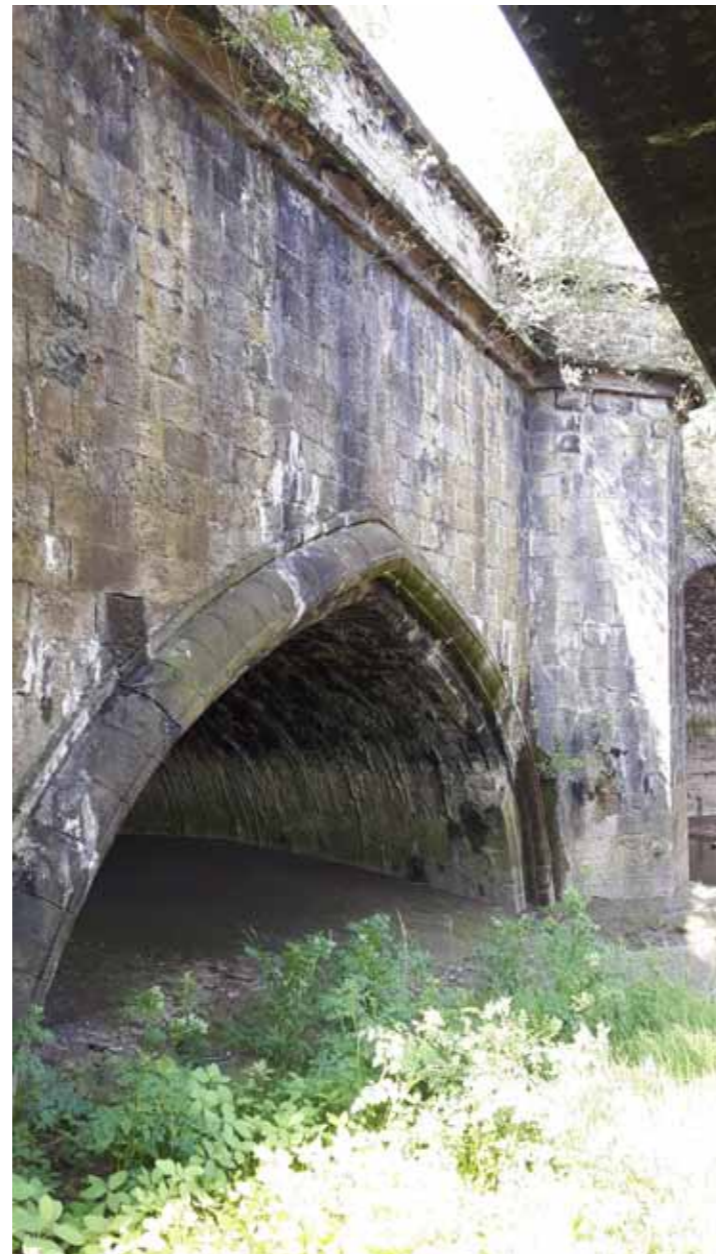
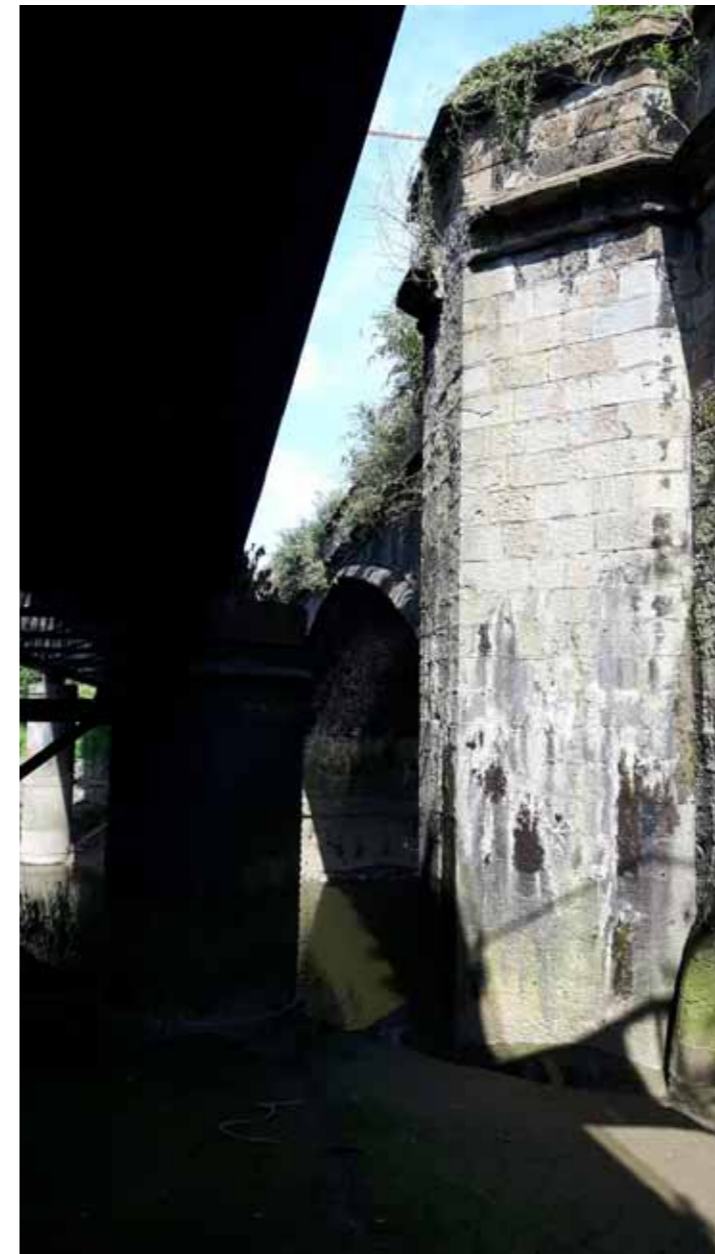
This railway bridge was constructed in 1839 to the design of I K Brunel as part of the Bristol and Exeter railway line. The bridge is Grade I listed despite being almost entirely obscured by the two later iron railway bridges that now stand alongside Brunel's stone structure.

The Grade I listed bridge incorporates the Tudor architectural style that Brunel used in many of his railway structures along the Great Western and Bristol and Exeter Railways. Of particular interest are the moulded stone arches and the semi-octagonal buttresses that form refuges for railway workers above.

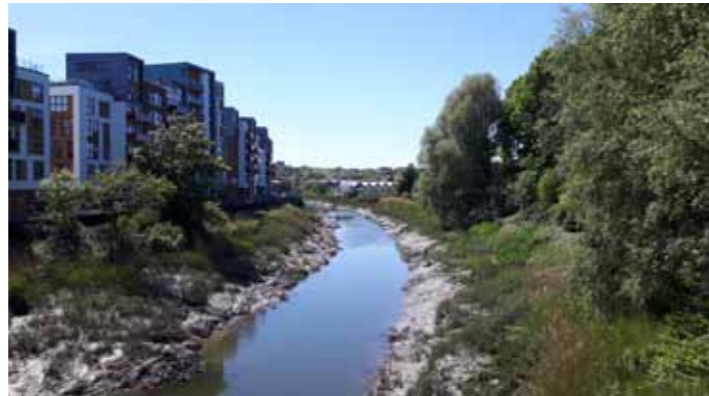
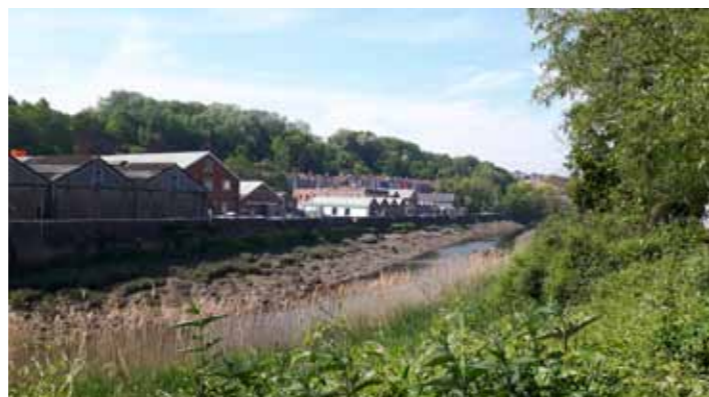
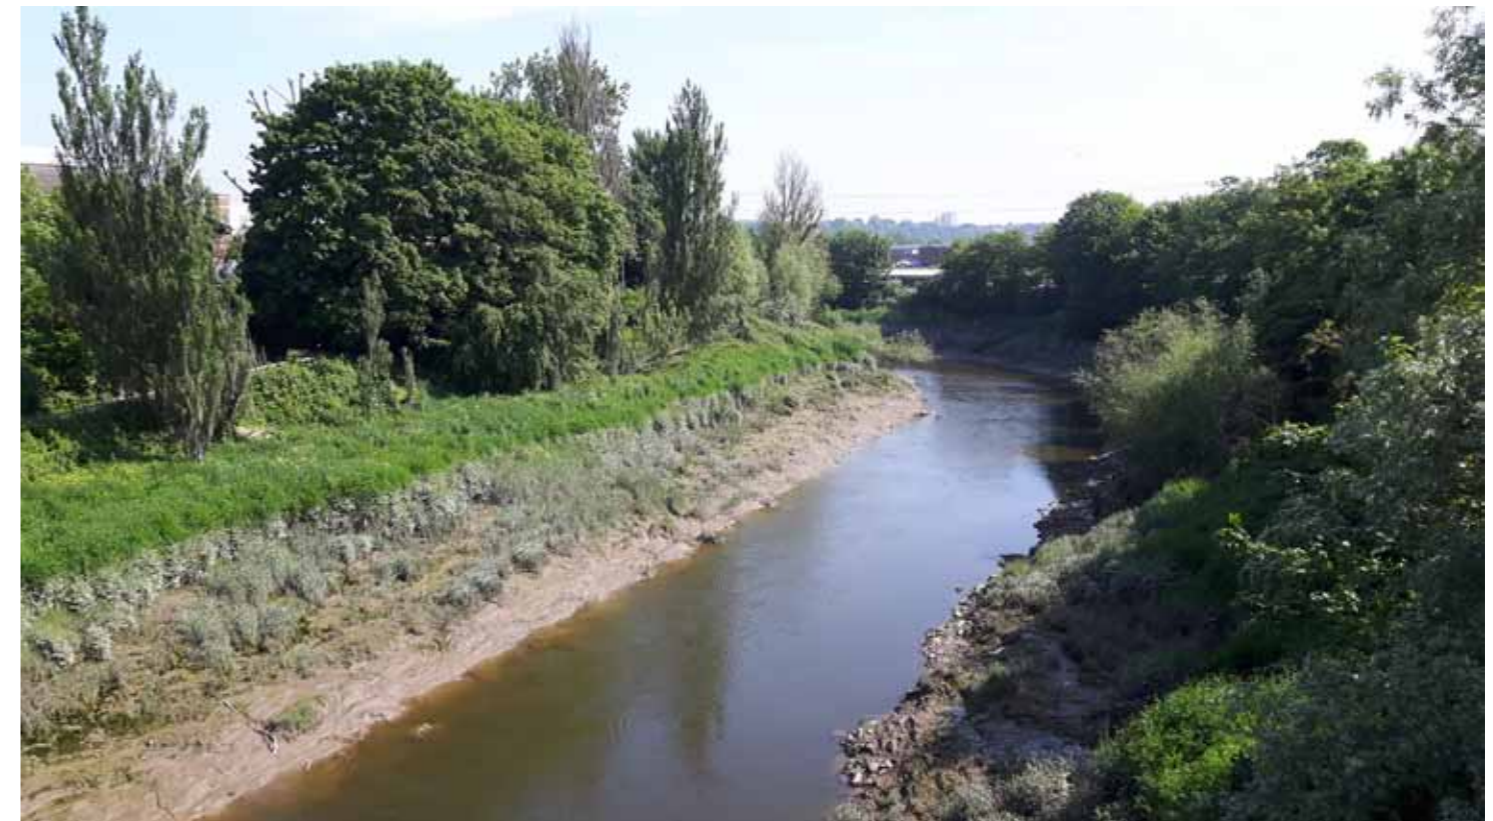
Fig 48
Character and setting

- 1** View west from Sparke Evans Park Bridge
- 2** Paintworks from the Avon riverpath
- 3** View east from St Philip's Causeway junction bridge

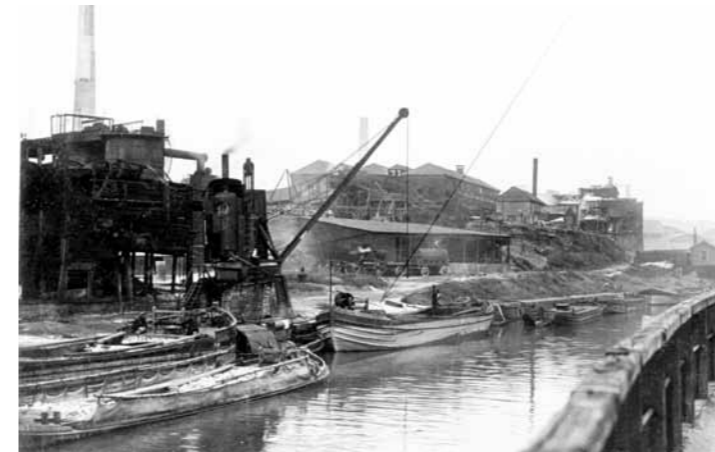
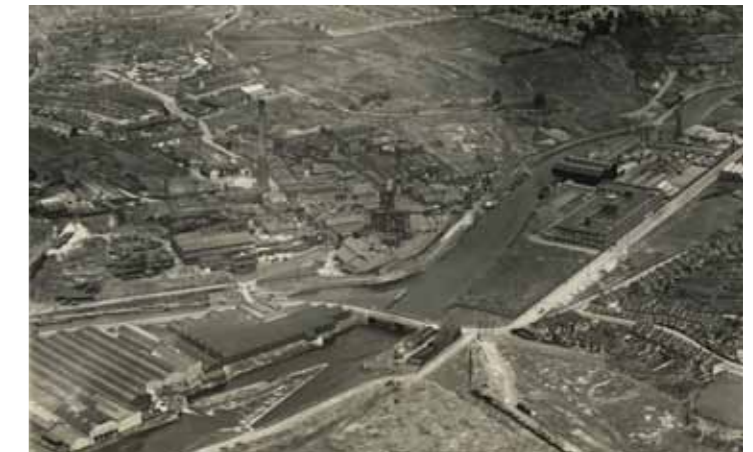
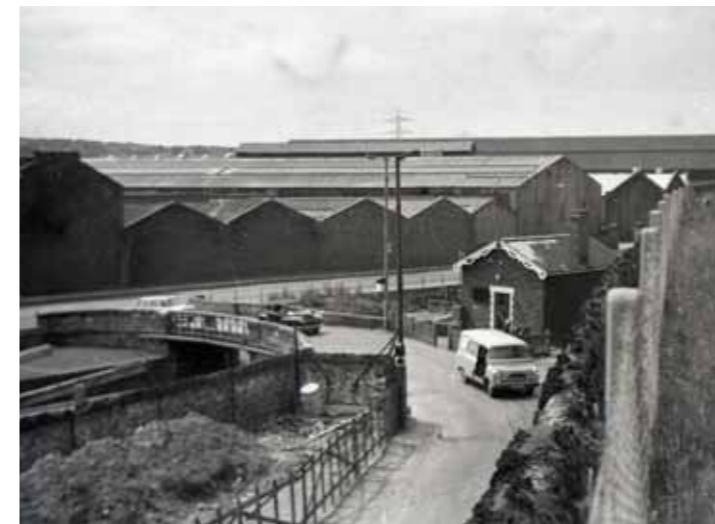
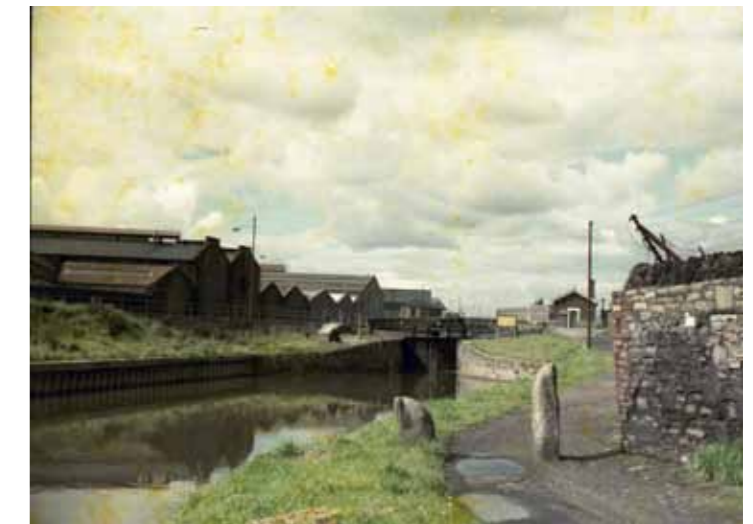
3 Netham Lock in the early 1960s, image from Know Your Place

4 Netham Lock, mid 1960s, image from Know Your Place

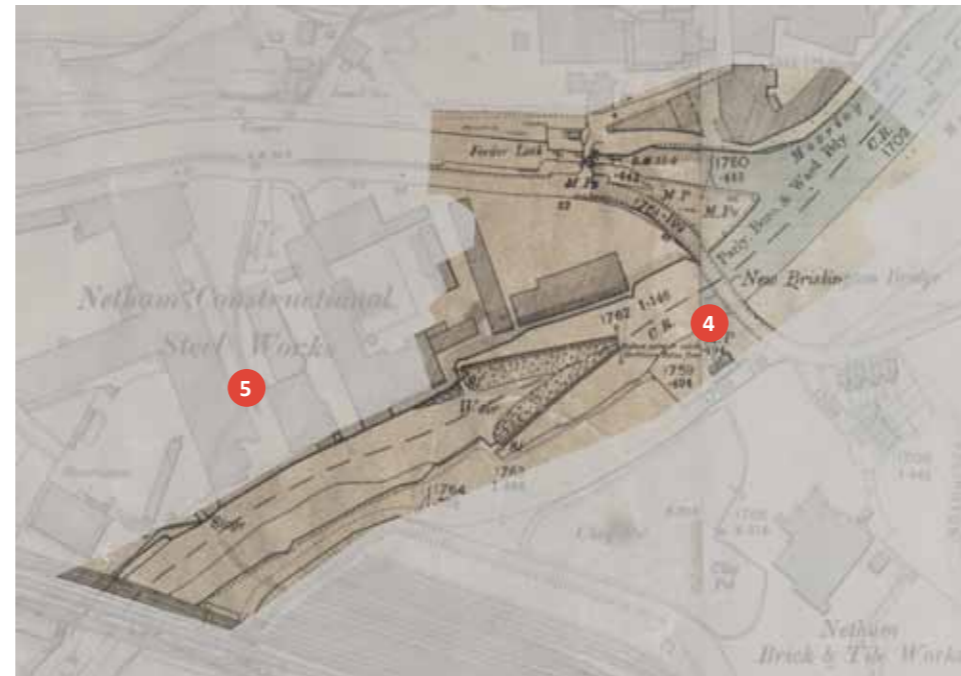
1880 main features:

- Netham Lock was created as part of William Jessop's design for the Floating Harbour, Feeder Canal and New Cut. **1** A bridge over the lock connected Feeder Road with Netham Road to the north, although until about 1900 there was no bridge over the river to the south
- The lock-keeper's cottage was built at the same time as the lock **2**
- Netham Dam or Weir was also constructed in 1809 to divert water into the Feeder. **3** It was later raised in height at the suggestion of Brunel and has subsequently been modified

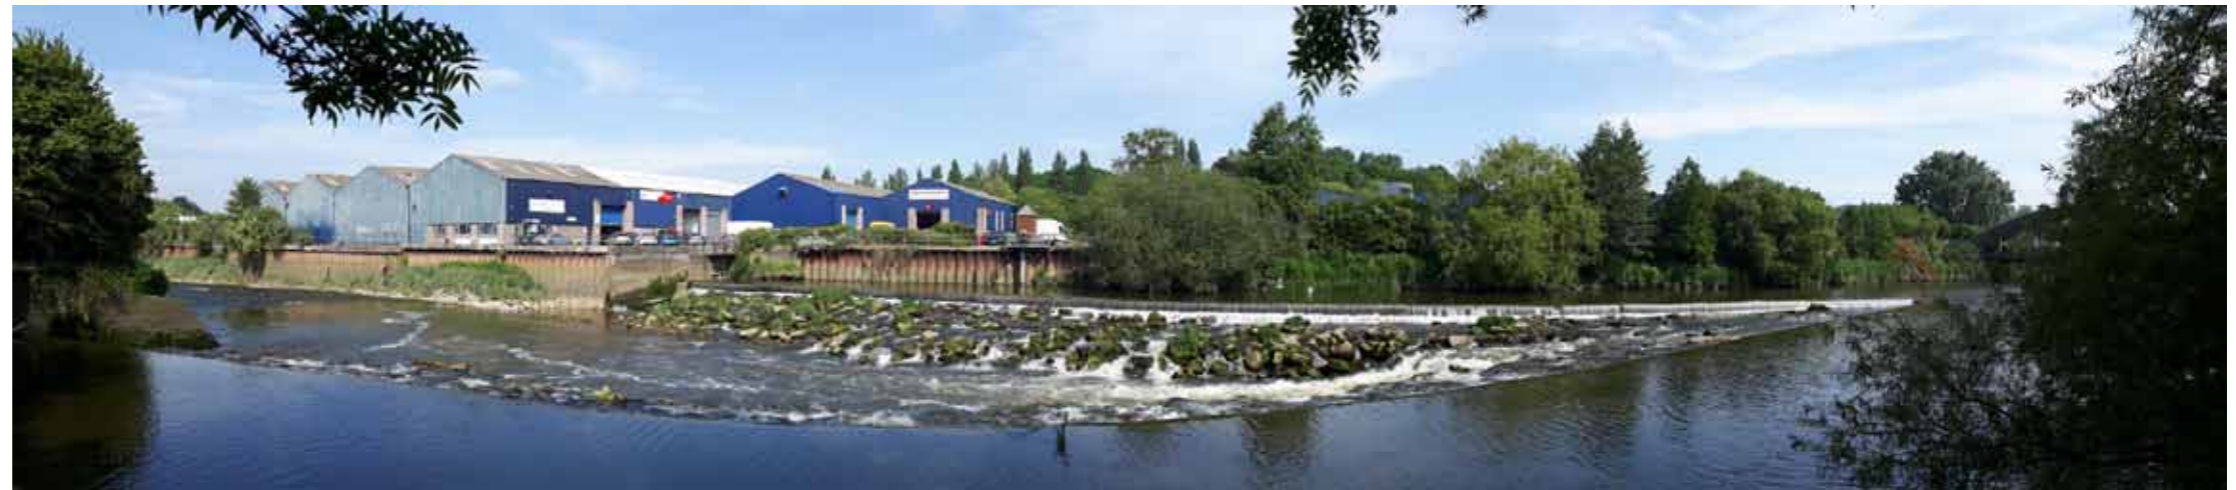
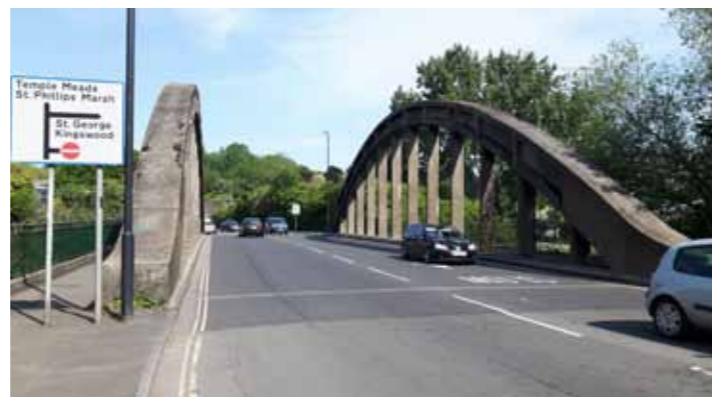
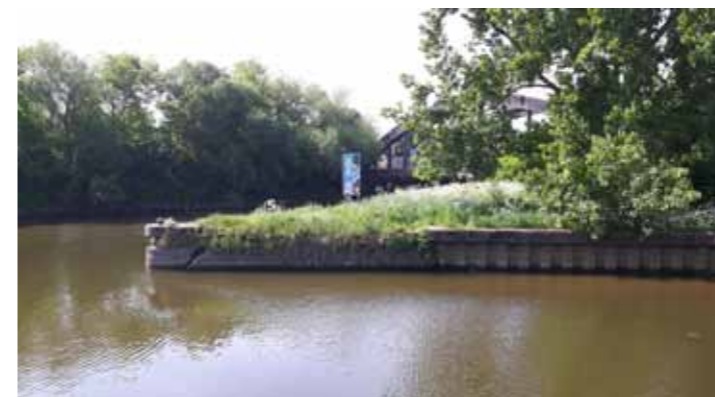
Fig 52
Heritage assets

The eastern stone abutment that forms the junction of the Feeder and tidal river is likely to date to 1809 along with the lock fabric. At least one mooring post as marked ('M.P.') on the historic plans is visible on the end of this abutment. Concrete retaining structures have been added to the western end of this abutment and there are severe structural cracks visible in the stonework.

- 1 Netham Weir viewed from the southern bank
- 2 New Brislington Bridge
- 3 Stone abutment at the junction of canal and river showing clear signs of structural movement

| Asset | Strengths | Weakness | Vulnerability to change | Opportunities | Policy requirements |
|---|--|--|--|--|---|
| Feeder canal/river abutment Undesignated | Likely to date to the earliest phase of harbour/canal construction this stonework together with its associated mooring posts contribute to the character of the Avon Valley Conservation Area | Suffering from structural movement it is likely that parts of this feature are in danger of collapsing into the river | Almost certainly if tidal defence works are required here it will necessitate the loss of this feature that may be failing in any case | Creating a robust abutment that contributes to the verdant setting of the conservation area and includes reused materials such as the stoneworks and mooring posts | Works to this area will be required to preserve or enhance the character of the conservation area |

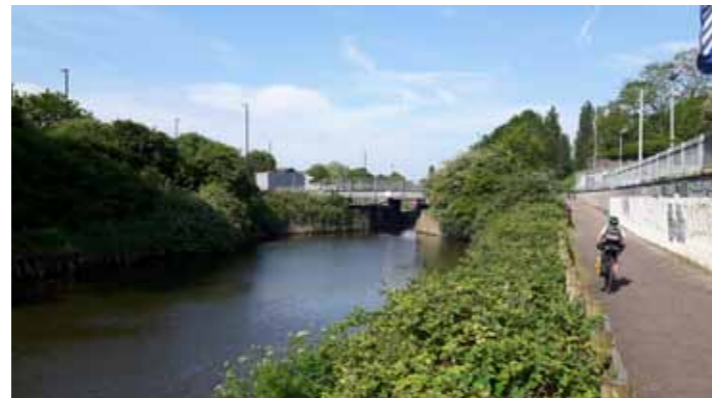
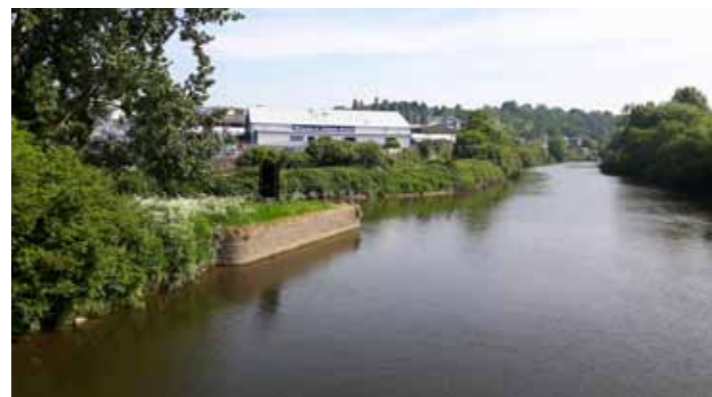
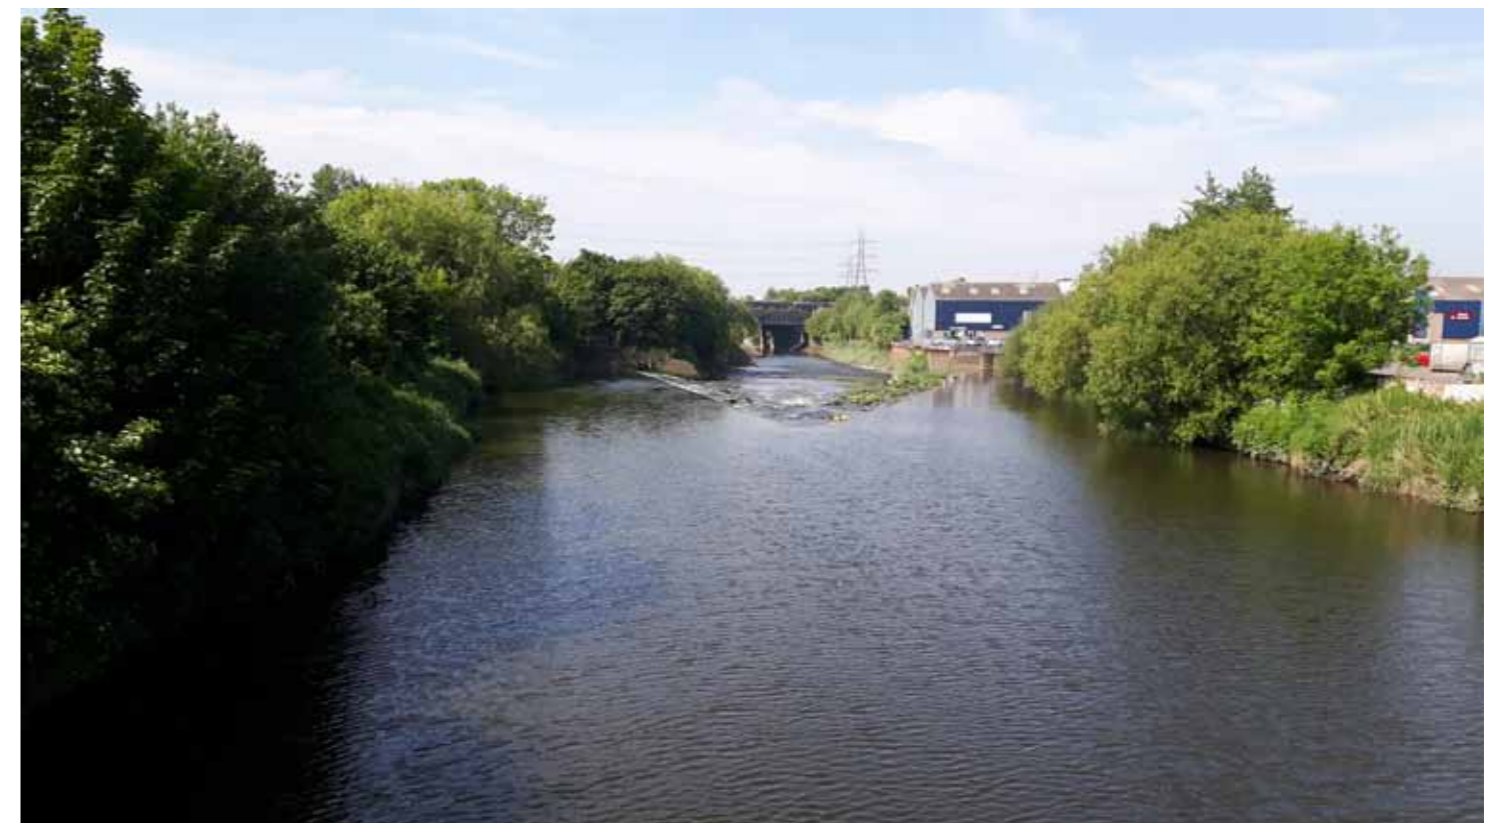
Fig 53
Character and setting

- 1** View towards Netham Lock from the cycle path approach within the Avon Valley Conservation Area
- 2** View along the river from New Brislington Bridge into the conservation area
- 3** View towards Netham Weir from New Brislington Bridge

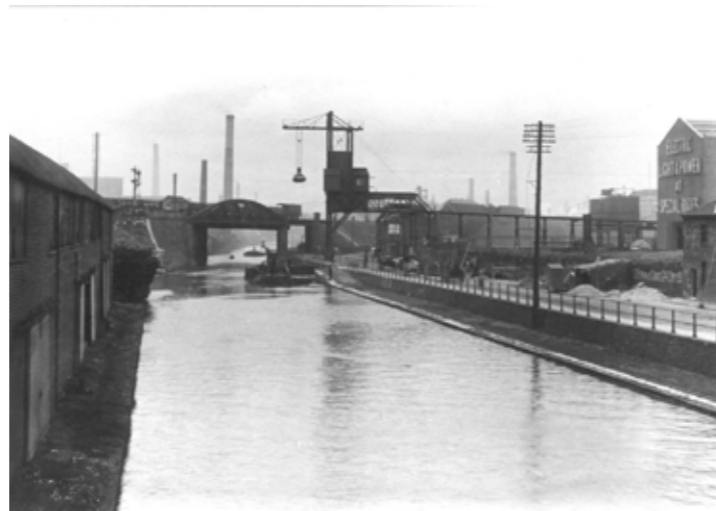
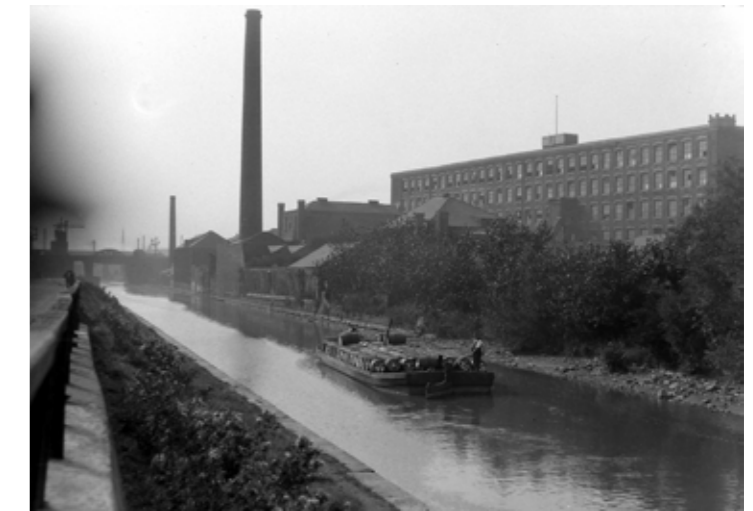
Fig 54
The Feeder

- 1** The Feeder in 1920 looking east towards the St Philip's railway bridge. The modern St Philip's Causeway now cuts across this view. Notice the ramped access to the tow path in the distance, Port of Bristol Privileges Collection, M Shed, P13759
- 2** Closer view of St Philip's railway bridge beyond the access to the tow path in the 1930s, Tarring Collection, 067-067-P4280134
- 3** Great Western Cotton Works on the north side of the Feeder in the 1930s, Tarring Collection, 069-069-P4280138

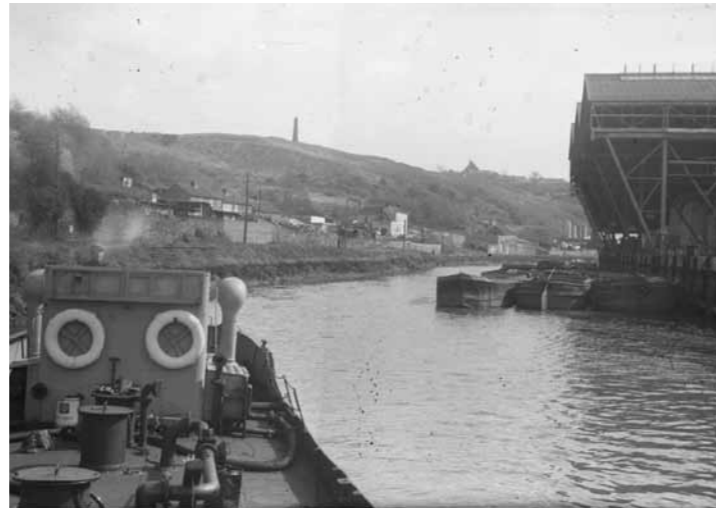
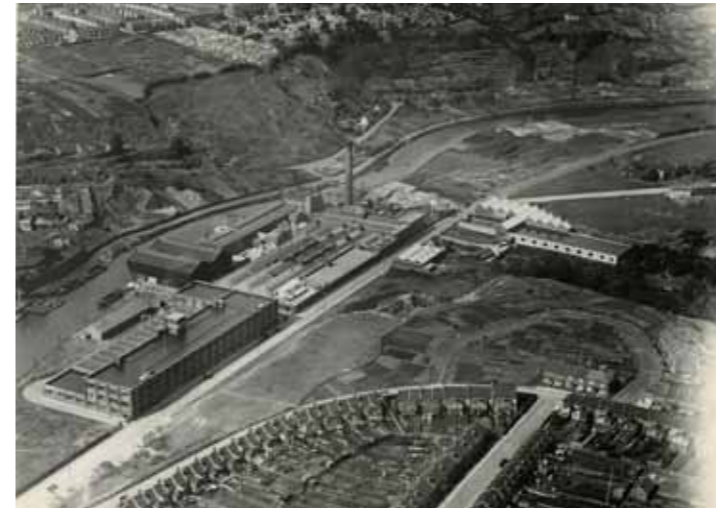
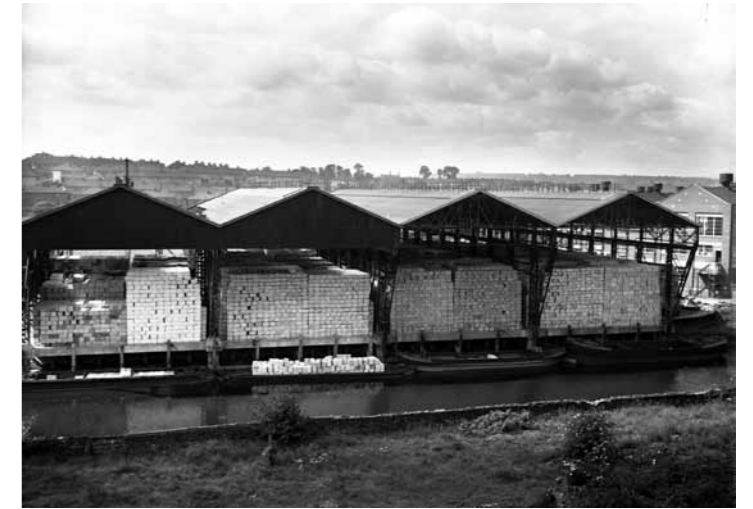
Fig 55
St Anne's Board Mills

- 1** View east along the river toward Trooper's Hill in the 1960s. St Anne's Board Mills on the right, Know Your Place, SGMRG/BIAS photograph
- 2** 1920s aerial view of St Anne's Board Mills, Albert Clarke Collection, Bristol Archives, 44819/3/142
- 3** Scandanavian wood pulp in storage at the Board Mills. The concrete dockside in front of these sheds now forms the riverside for the Burgess Green Close 1980s BDC development, Hartley Collection, M Shed, 265095

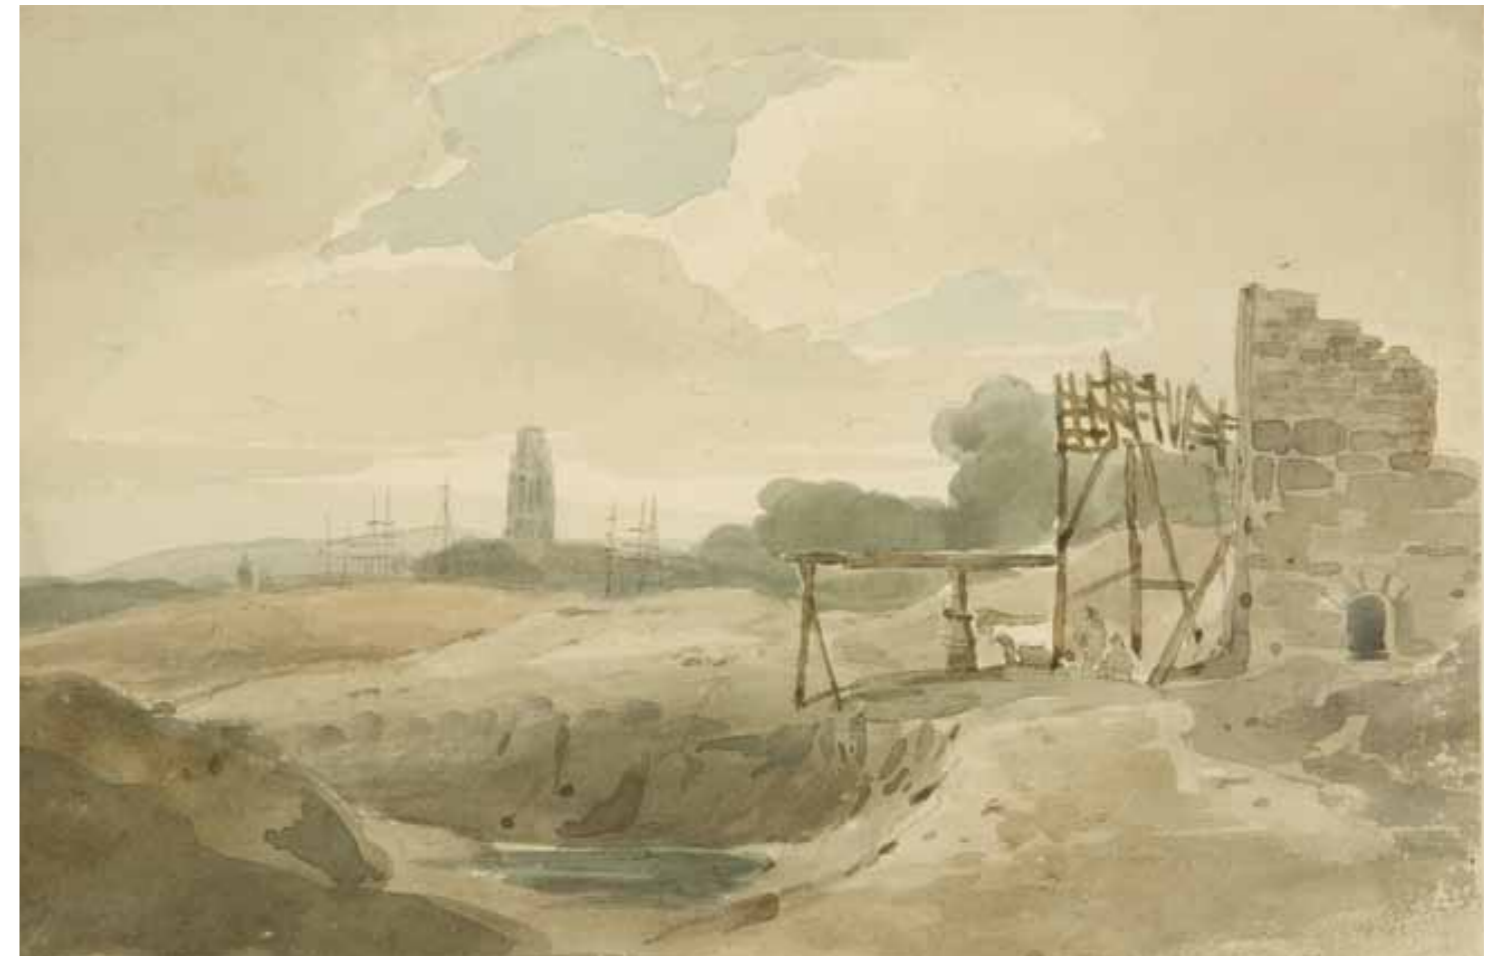
Fig 57 The only known image of part of the New Cut construction infrastructure. This painting by Rev. John Eagles produced in the early 1820s shows the derelict remains of an engine house for a fire [steam] engine, used between the Ropewalk at Wapping and Clift House during the excavation of the New Cut 1804 to 1809, Bristol City Museum and Art Gallery, M2958
