Bristol Avon Flood Strategy - Cumberland Road Defences

Geotechnical Feasibility Study

Reference: 285982-ARP-ZZ-RP-GEO-003 Cumberland Road Feasibility Study

Issue | 26 January 2024

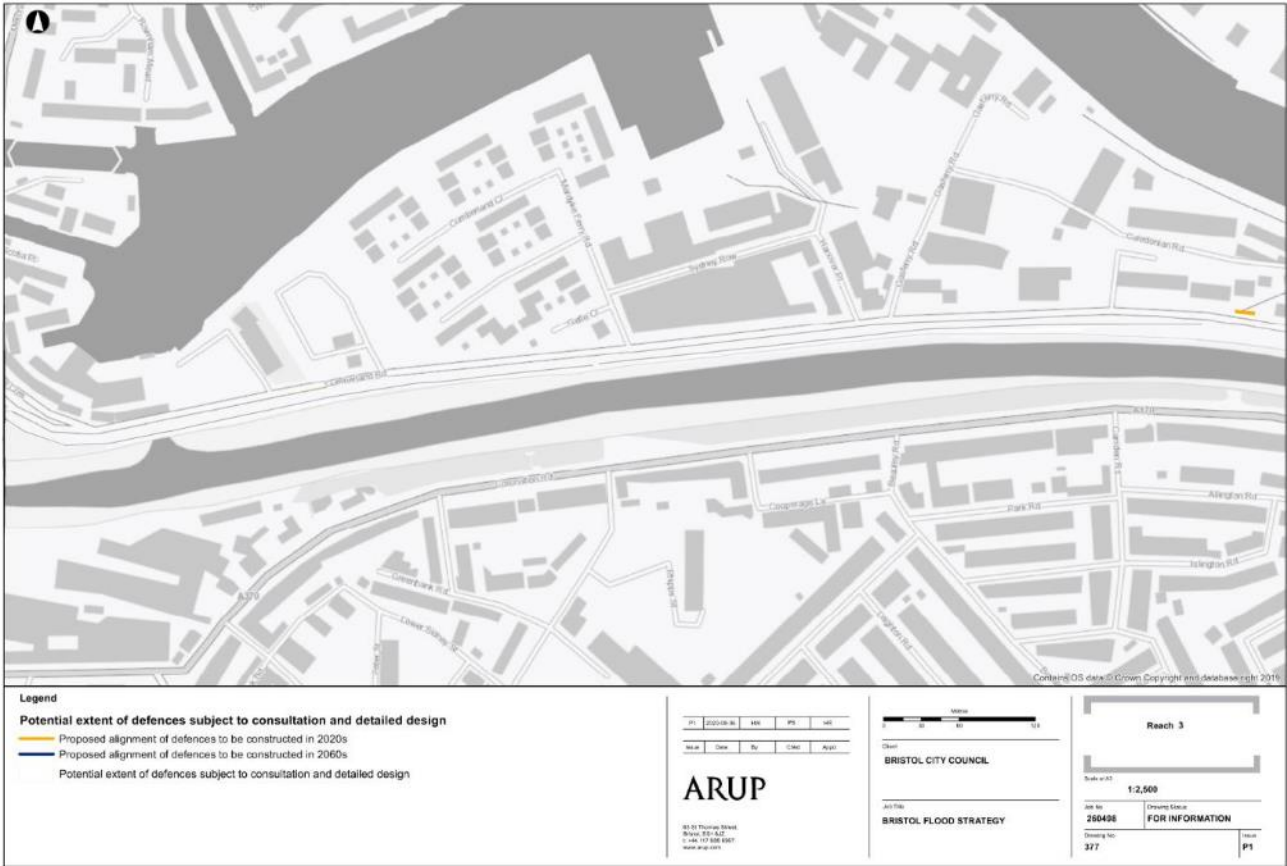
Figure 5 - Extent of flood defences in Reach 3

For Reach 3 a flood gate is proposed across the railway underneath Cumberland Road bridge, this will have a flood wall of 2m in height on the downstream end and ramps on the upstream end. The flood gate will tie directly into the Reach 2 defences. The location of the flood gate is shown on Figure 5.

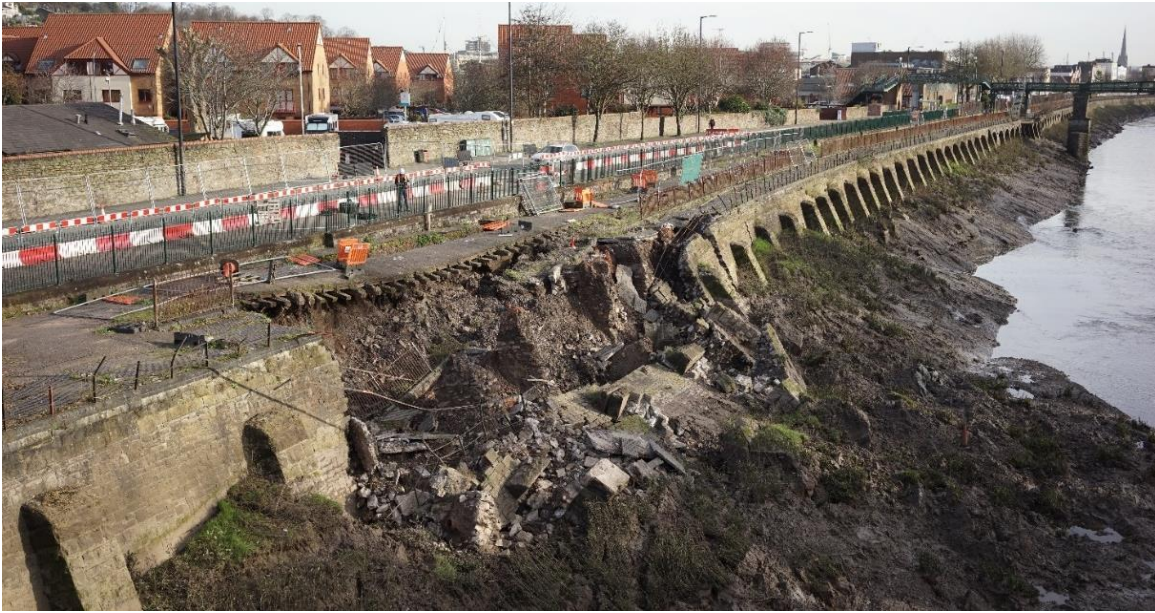
Given that the failure of drainage was a contributing factor to the failure of the preexisting structure, any proposed design should also include enhanced/repaid drainage solutions. It should be noted that the slip failure followed several years of movement and subsequent monitoring by the council. A picture of the 2019 slip is shown in Figure 7, and from a historic slip in 1981 in Figure 8.

Figure 7: Showing the historic 2019 slip on Cumberland Road

In 2019, the Chocolate Path stabilisation works were carried out following the ground failure of the road due to excessive deformation. This slip failure occurred following several years of of movement and monitoring of the ground underlying the Chocolate Path.

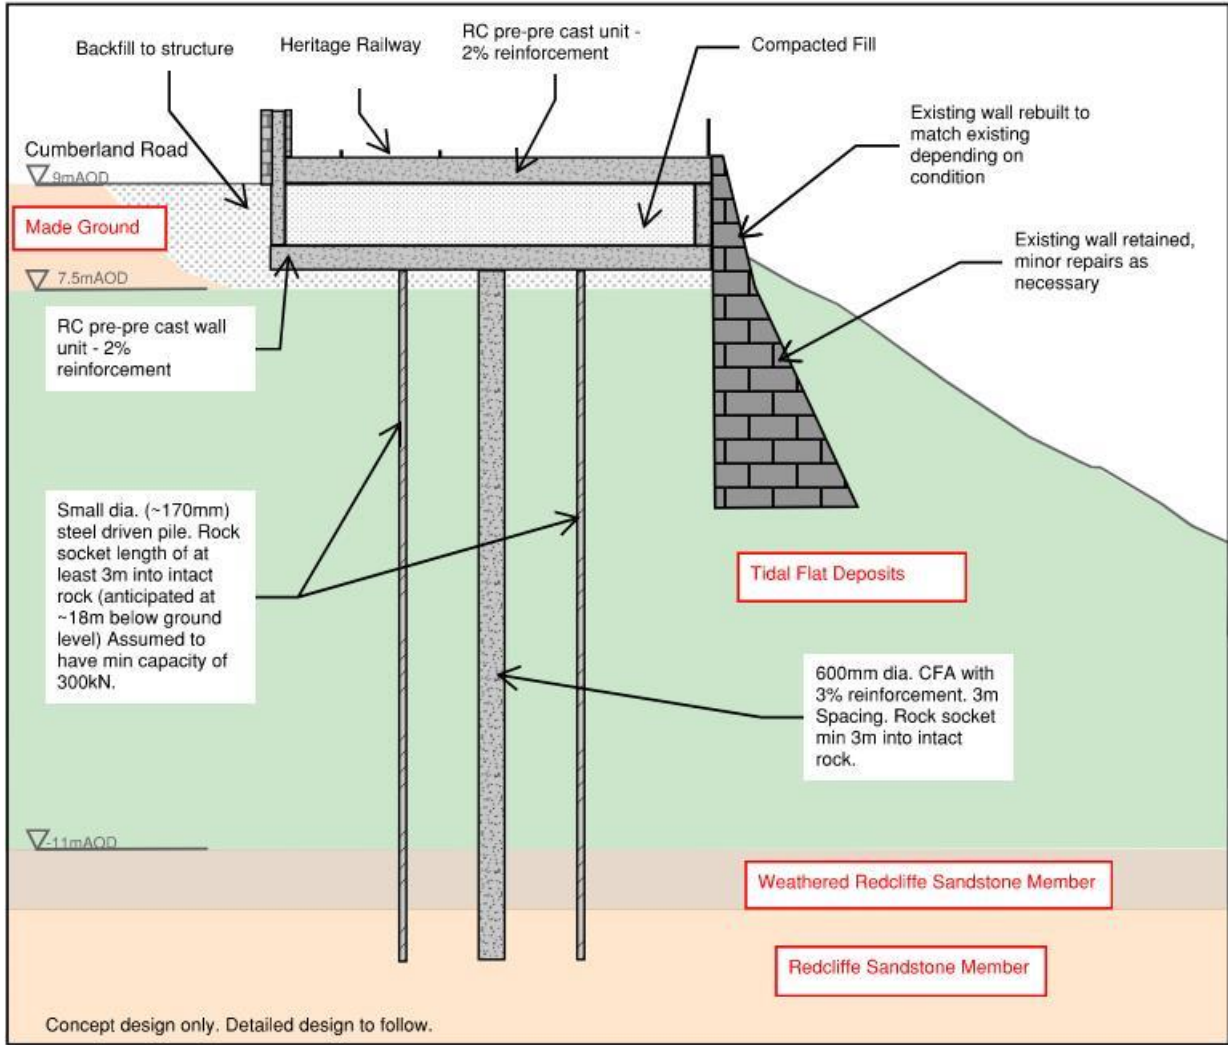
Figure 9 - Western Reach 2 Cross Section

Figure 9 and Figure 10 present geological cross sections for the current proposals along Reach 2, divided into the western end where the Tidal Flat deposits are anticipated to be present and then towards the eastern end where they are anticipated to be absent. It is noted that both sections present the concept design only and that further detailed design will be required to confirm the approach.

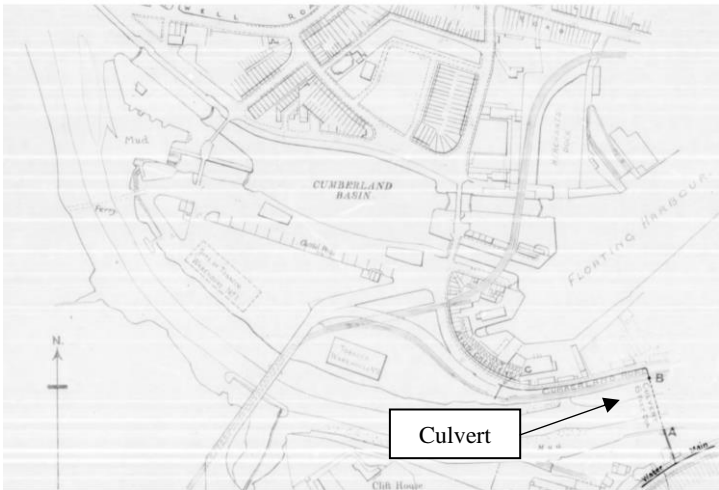
<p data-bbox="165 1509 887 1568">Archive reference: CD-03881_38402-000384_Proposed Work on Culvert Water Main around Cumberland Basin_14-12-1983</p>	<p data-bbox="919 1003 1388 1196">As shown on the historic drawing on “Proposed Work on Culvert Water Main Around Cumberland Basin_14-12-1983”, there is a culvert water main recorded on the east of Avon crescent between Cumberland Road and Coronation Road. The culvert is of 6ft (circa 1.8m) dia. as indicated in the drawing.</p>

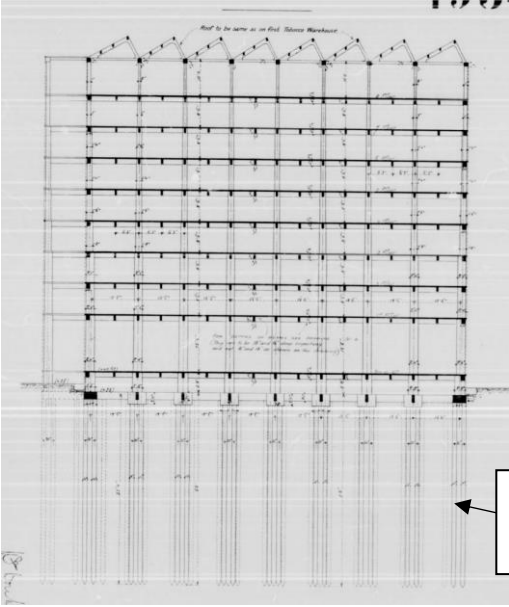
<p>Possibly the driven timber piles</p> <p>Archive reference: CD-02097_4790_Transfer Section Drg No 2_24-08-1905</p>	<p>To the west of Reach 2, there were Tobacco warehouse buildings located on Cumberland Basin on either side of the Ashton Ave bridge. From the historic drawing, the buildings were supported by piles, which appears to be driven timber pile, of 15in (circa 0.4m) dia. and 51ft 4in (circa 13m) long. The impact of this foundation to the proposed works is considered negligible due to its distance from Reach 2. The foundation depth is indicative of bedrock depth to at least 13m depth in the area near the west of Reach 2.</p>

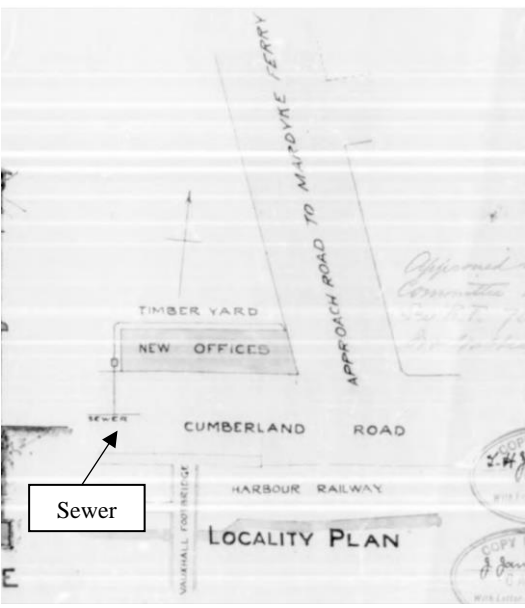
<p>Sewer</p> <p>Archive reference: CD-03892_38402-000397_Offices Cumberland Road_14-12-1983</p>	<p>There was a sewer drain beneath the Cumberland Road opposite to Vauxhall bridge and adjacent to Mardyke Ferry Road, as indicated on the drawing dated c.1983. This implies potential underground utilities near the proposed works.</p>

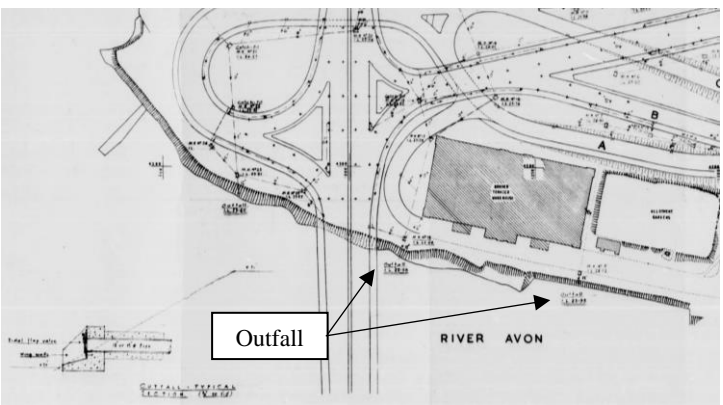
<p>Outfall</p> <p>RIVER AVON</p>	<p>There are two no. of outfalls on the west of Reach 2 on the front of Tobacco Warehouse Building along with the existing watermain and manhole, as indicated on the drawing date c.1984</p>

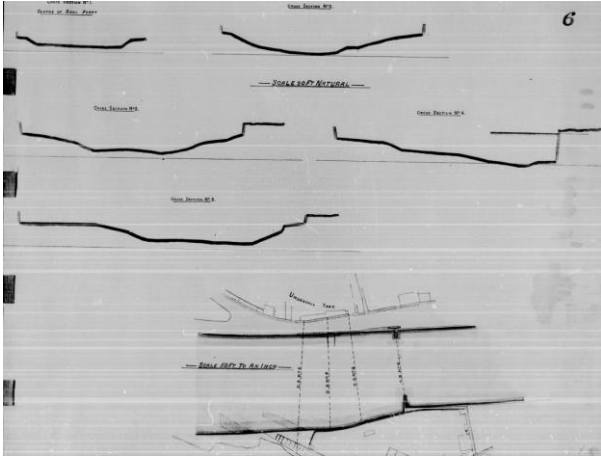
<p>Archive reference: CD-06002_38402-002394_Sections Across New Cut_06-10-1989</p>	<p>There are sections across the New Cut besides the outfall sluice, showing the river profiles, as indicated in the drawing date c.1989.</p>

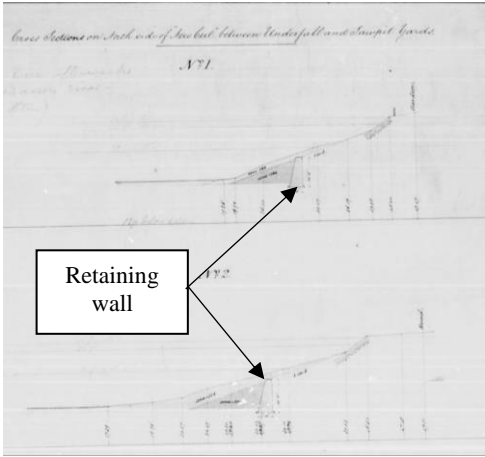
<p>Archive reference: CD-06199_38402-001431_Cross Sections on South Side of New Cut Between Underfall and Sawpit Yards</p>	<p>There are records on retaining walls of circa. 10ft 6in – 16ft (3.2 – 4.9m) in height on the north side of Avon New Cut between Underfall and Sawpit yards. Above the retaining wall were the 1 in 3 slope till the brick-facing slope beneath the road.</p>

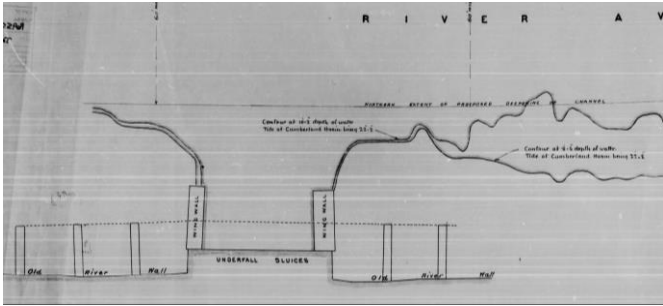
<p>Archive reference: CD-06135_38402-002497_Underfall Sluices_12-10-1989</p>	<p>Plan view of the Underfall sluice showing the arrangement of wing wall for the Underfall sluice and the old river wall.</p>

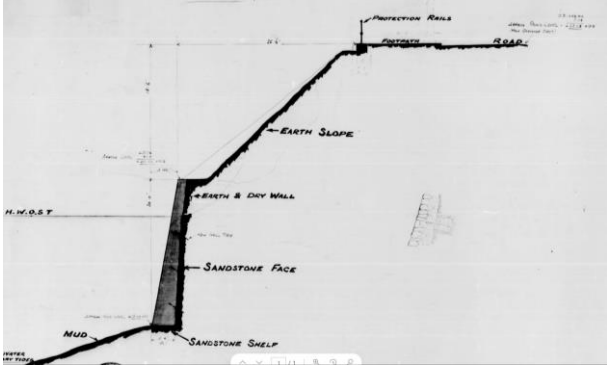
<p>Archive reference: CD-07700_38401-000001_Slip of Wall in New Cut Gaol Ferry_24-11-1982</p>	<p>As shown on the drawing, titled “Slip of wall in New Cut Gaol Ferry” dated 24/11/1982, there was a 20ft (6.1m) high retaining wall recorded at the river bank, probably as part of the stabilization works. The retaining wall is shown sitting on mud at 15ft (4.6m) AOD with sandstone wall facing.</p>

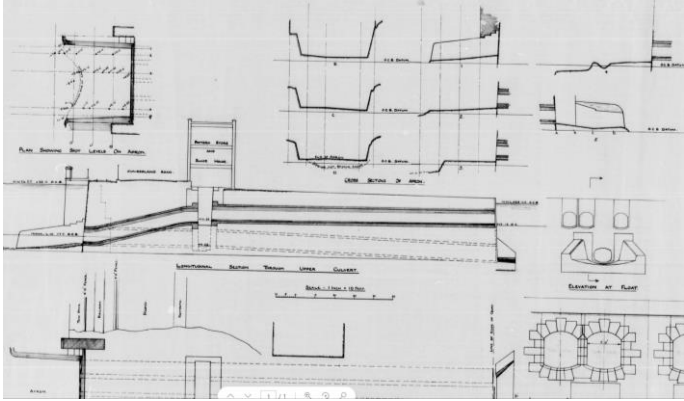
<p>Archive reference: CD-07773_38401-000010_Underfall Sluices_08-11-1989</p>	<p>Plan view of the Underfall Sluice, elevation and the longitudinal section of its culvert, as shown on the drawing dated 22/9/1944.</p>

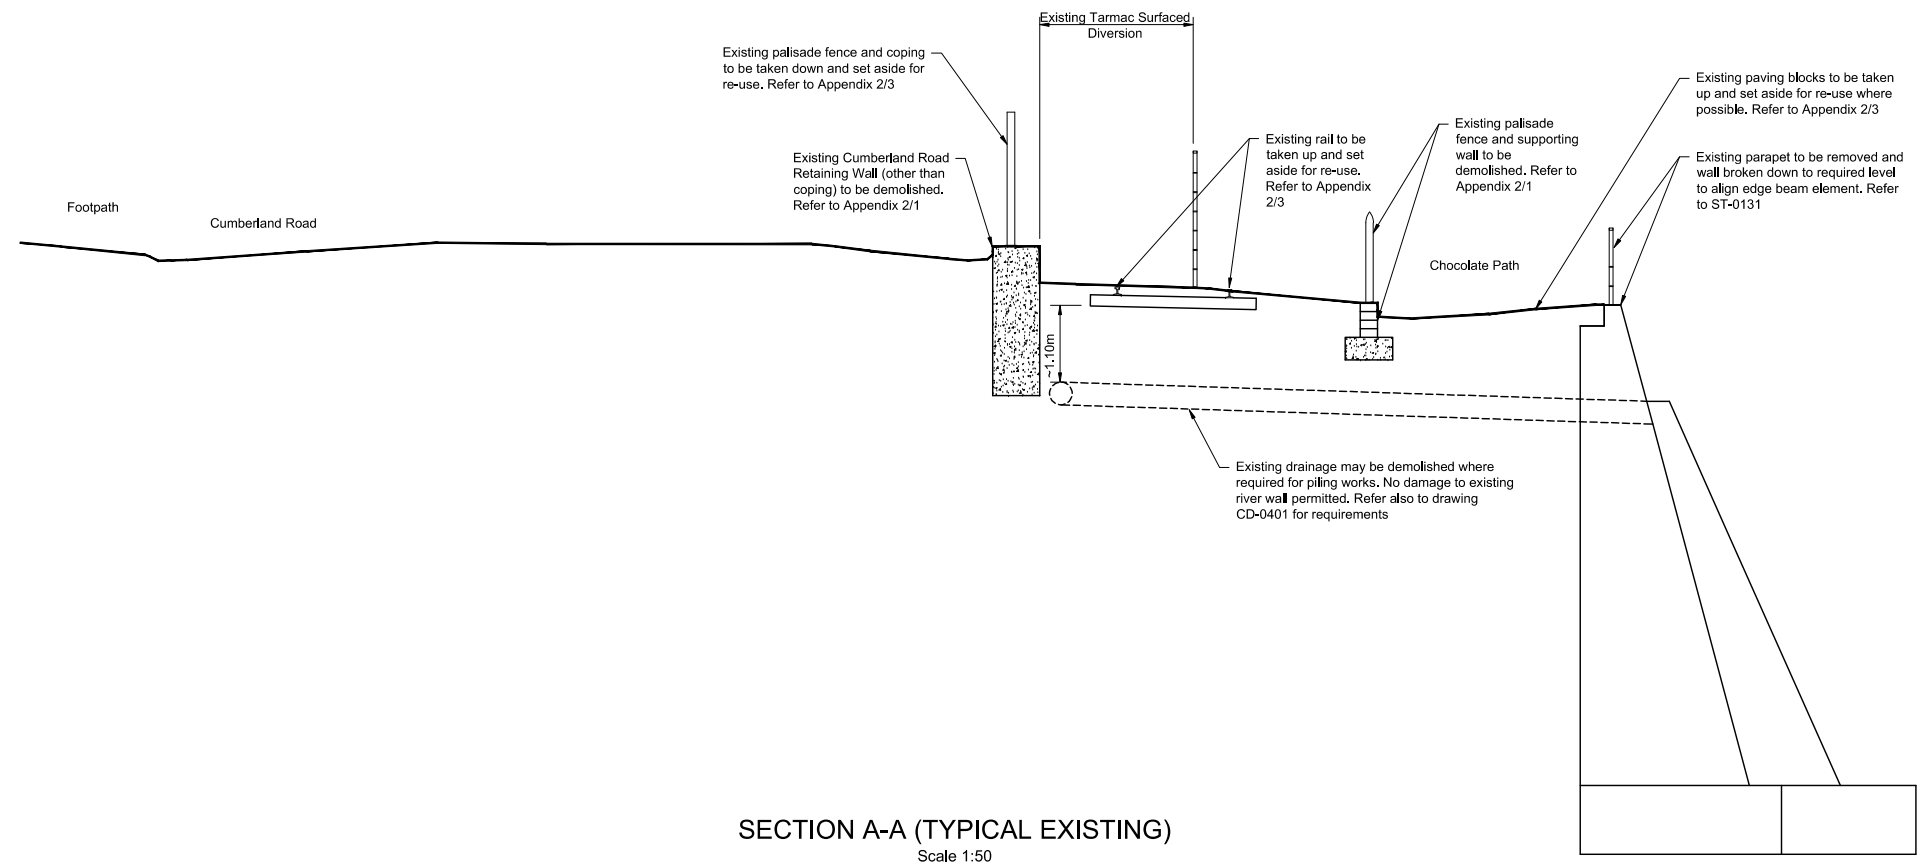
SECTION A-A (TYPICAL EXISTING)
Scale 1:50

Cumberland Road Stabilisation Works Typical Cross Section

The 2019 proposed Cumberland Road stabilisation works typical cross section drawing in Appendix D shows proposed drainage locations.

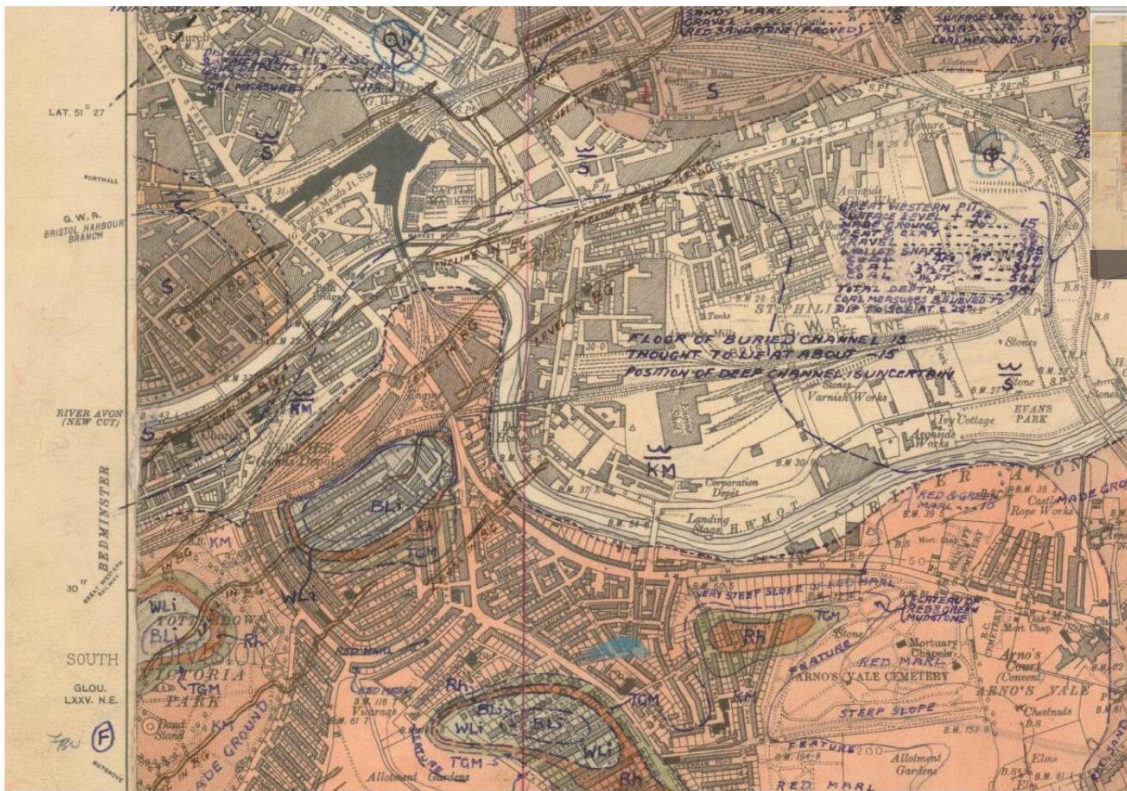
Figure 6: BGS Gloucestershire Map (1949) with Buried Chanel Annotation

In light of the information given above, the risk of encountering a buried channel underlying the site is considered minimal.

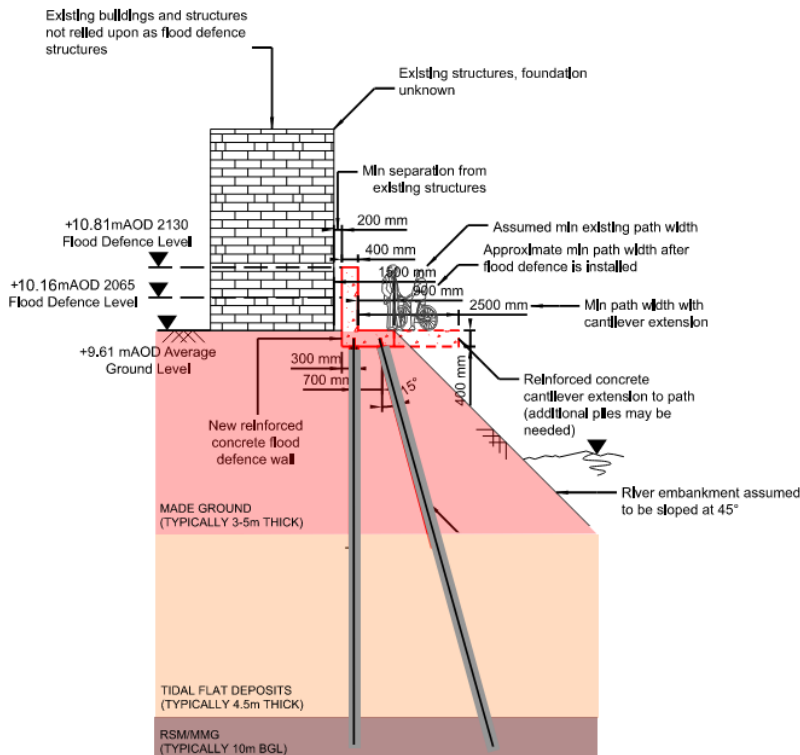
Figure 8: Reach 7 proposals (extract from Baseline Report)

Figure 8, extracted from the baseline report [2], shows the proposed concrete retaining wall on mini piles alongside the interpreted geology. The design of the mini piles will need to consider the risk of extending into the underlying bedrock. This could create piles which are in the order of 12m in length.
