**EVIDENCE FROM AERIAL PHOTOGRAPHS AND SATELLITE IMAGERY  
STOKE LODGE PLAYING FIELDS, WEST DENE, STOKE BISHOP, BRISTOL, BS9 2BH**

**STATEMENT OF CHRISTINE DIANE COX BA MA MCIFA FSA**

**DATE** : 07 SEPTEMBER 2026

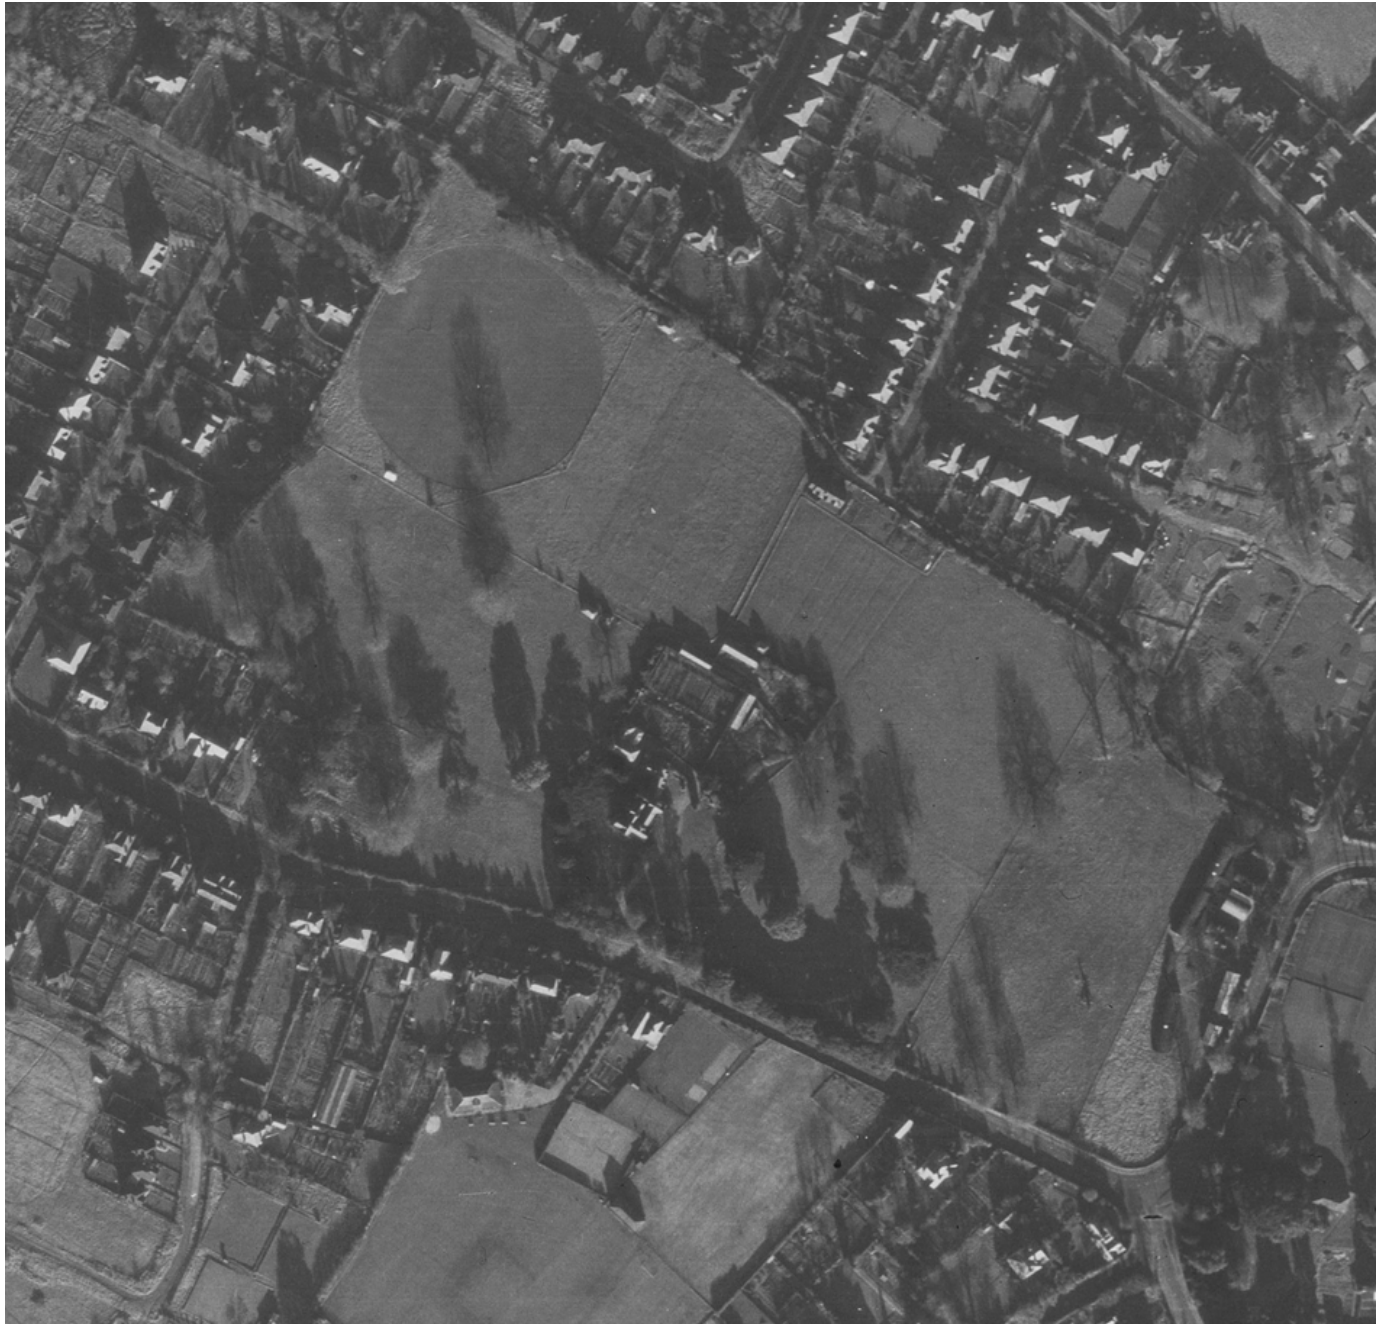
**FIGURE 2: 04 DECEMBER 1946**

32. The cricket field was clearly defined by a circular boundary, consistent with its use for organised matches. There were some light-toned areas on the ground at the NE corner of the field within the cricket pitch circle area. These do not appear to be external access tracking or paths or connect in a linear fashion to the adjacent housing area.

33. A fence enclosing the cricket pitch is visible and corresponds closely with the extent shown on the 1928 cricket lease plan, Figure 3.

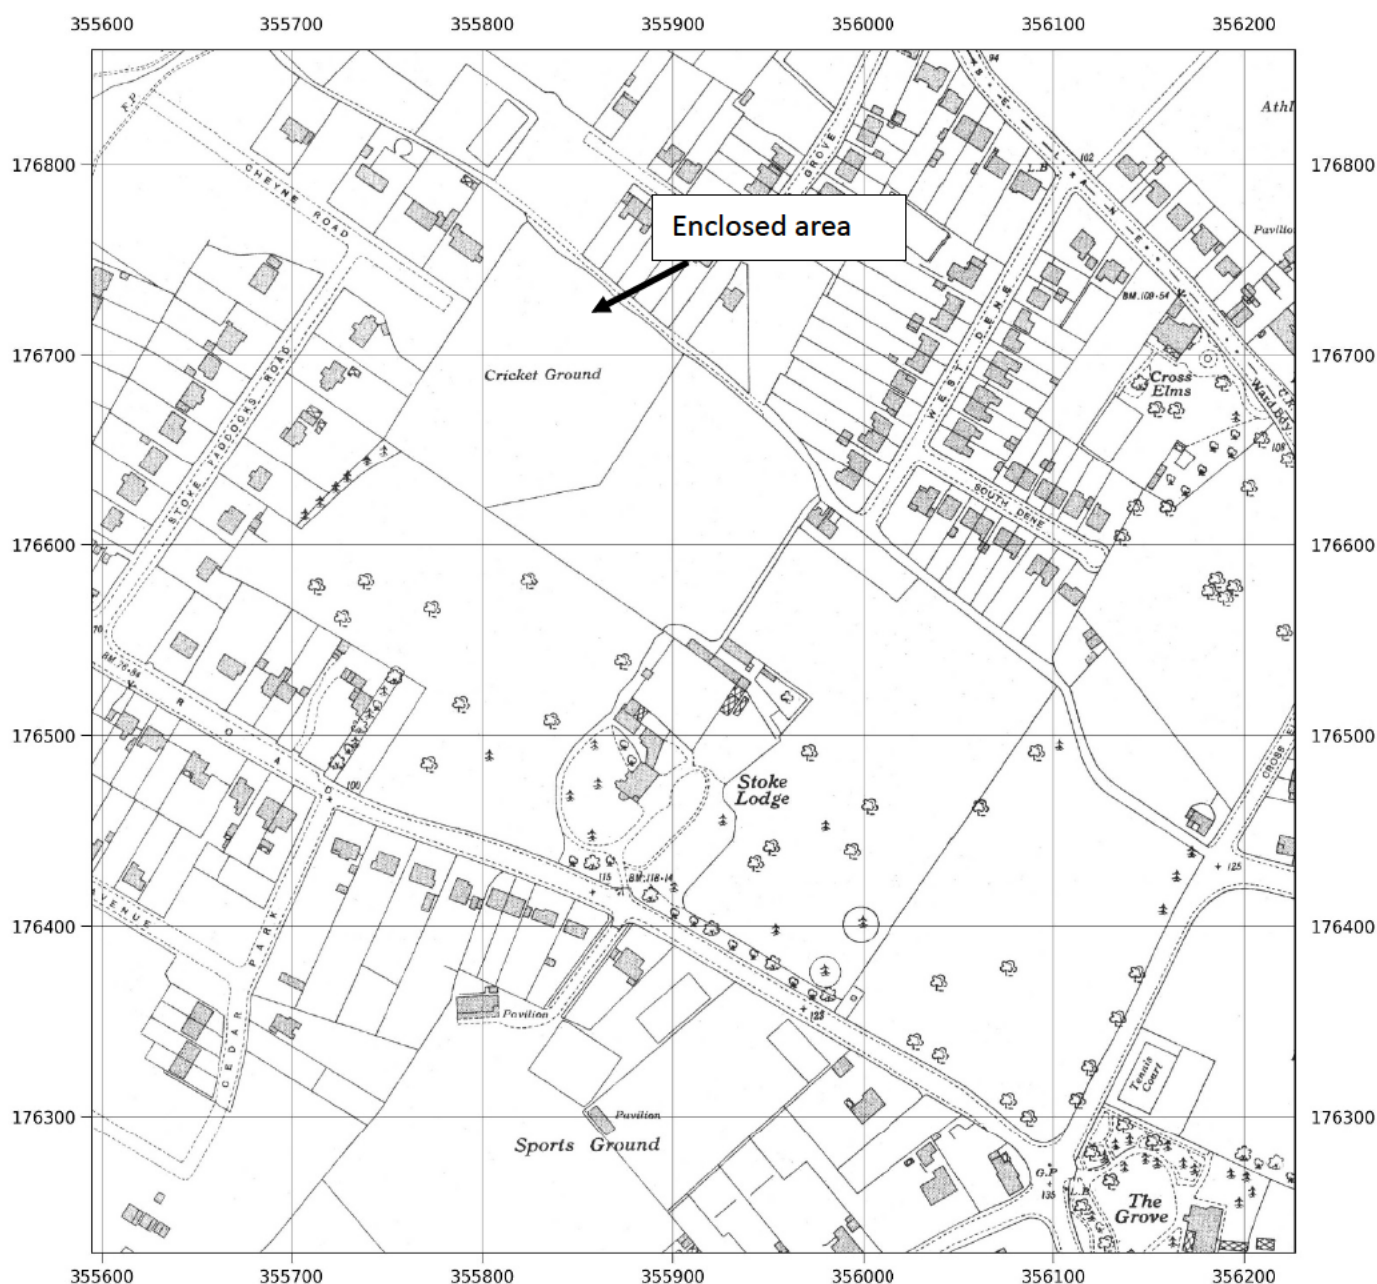
FIGURE 4: OS 25 INCH TO ONE MILE MAP REVISED IN 1936 AND PUBLISHED IN 1938

34. The 1936 OS map was georeferenced<sup>5</sup> to the modern map and 1946 aerial photograph in QGIS to show the position of the fenced area.

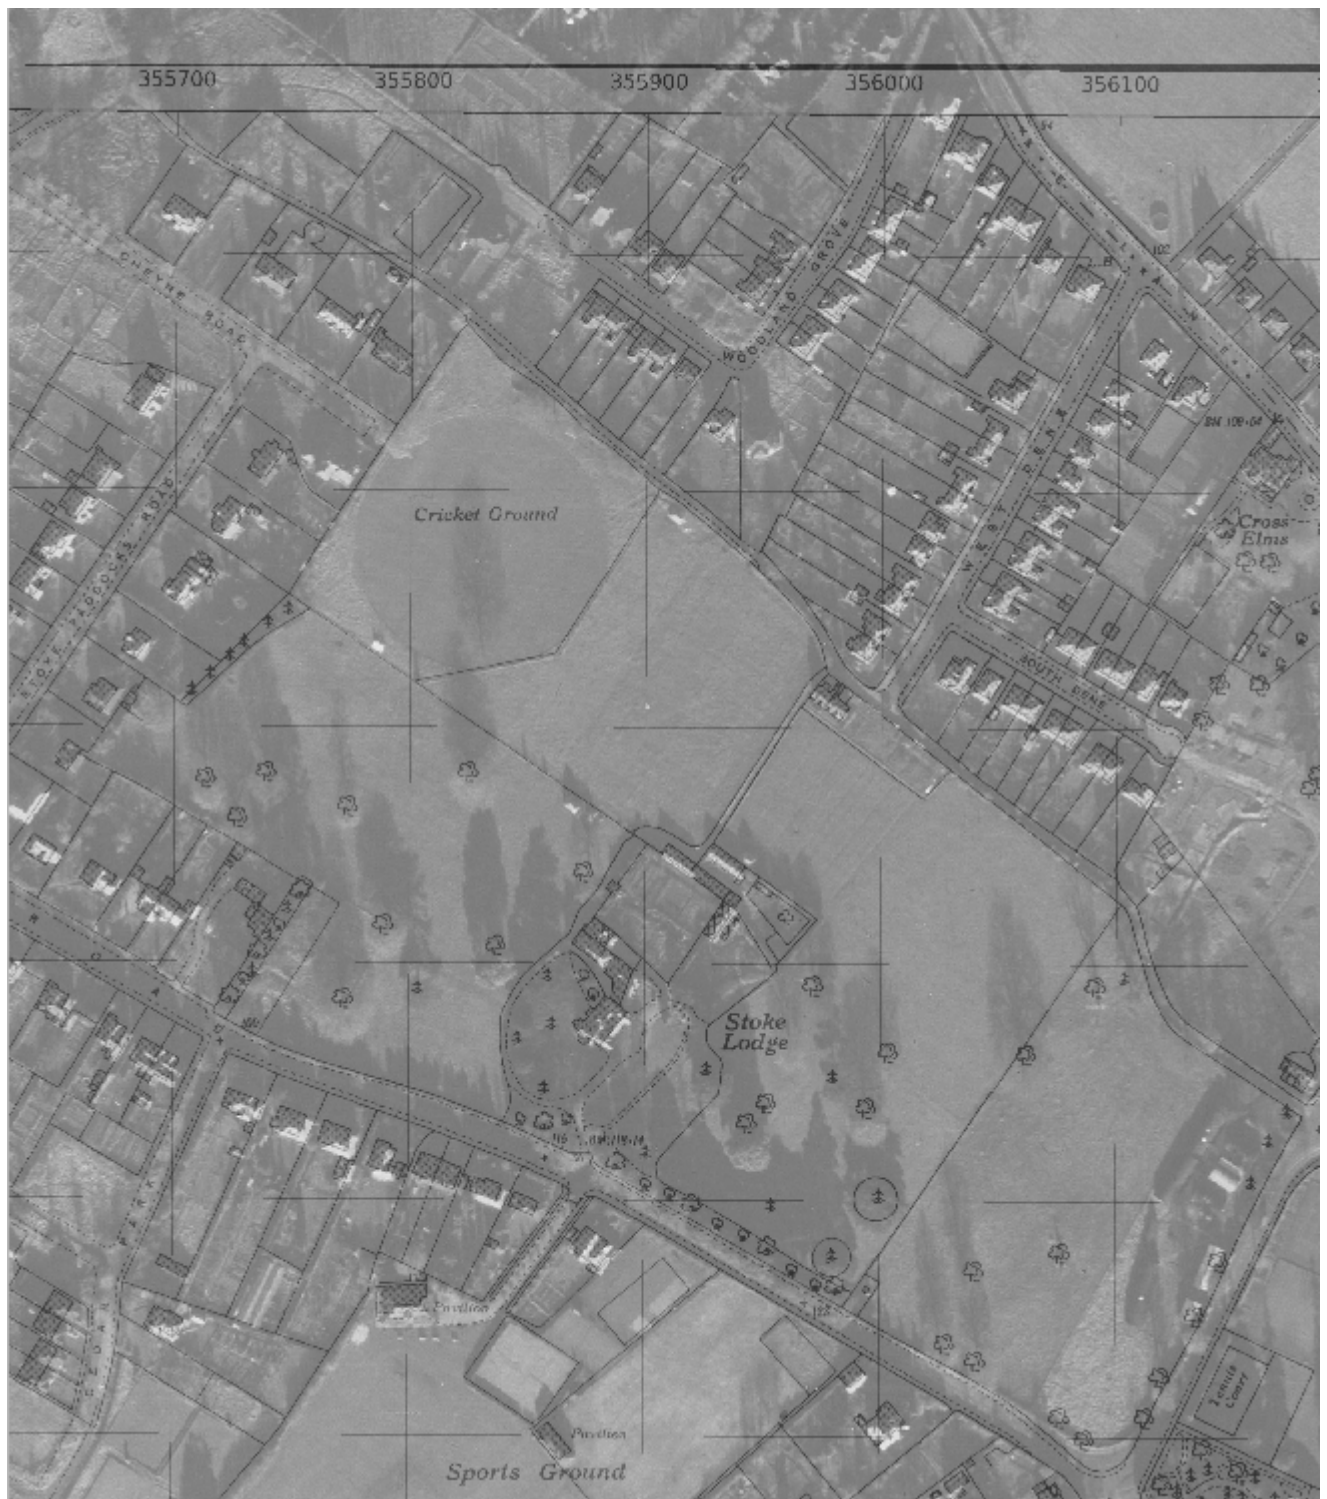
**FIGURE 6: 1936 MAP OVER 1946 AERIAL PHOTO**

37. **Figure 6** shows the site in 1946, overlain with the 1936 OS map at 68% transparency. This indicates the concordance of the boundary around the ground in 1936 and 1946.

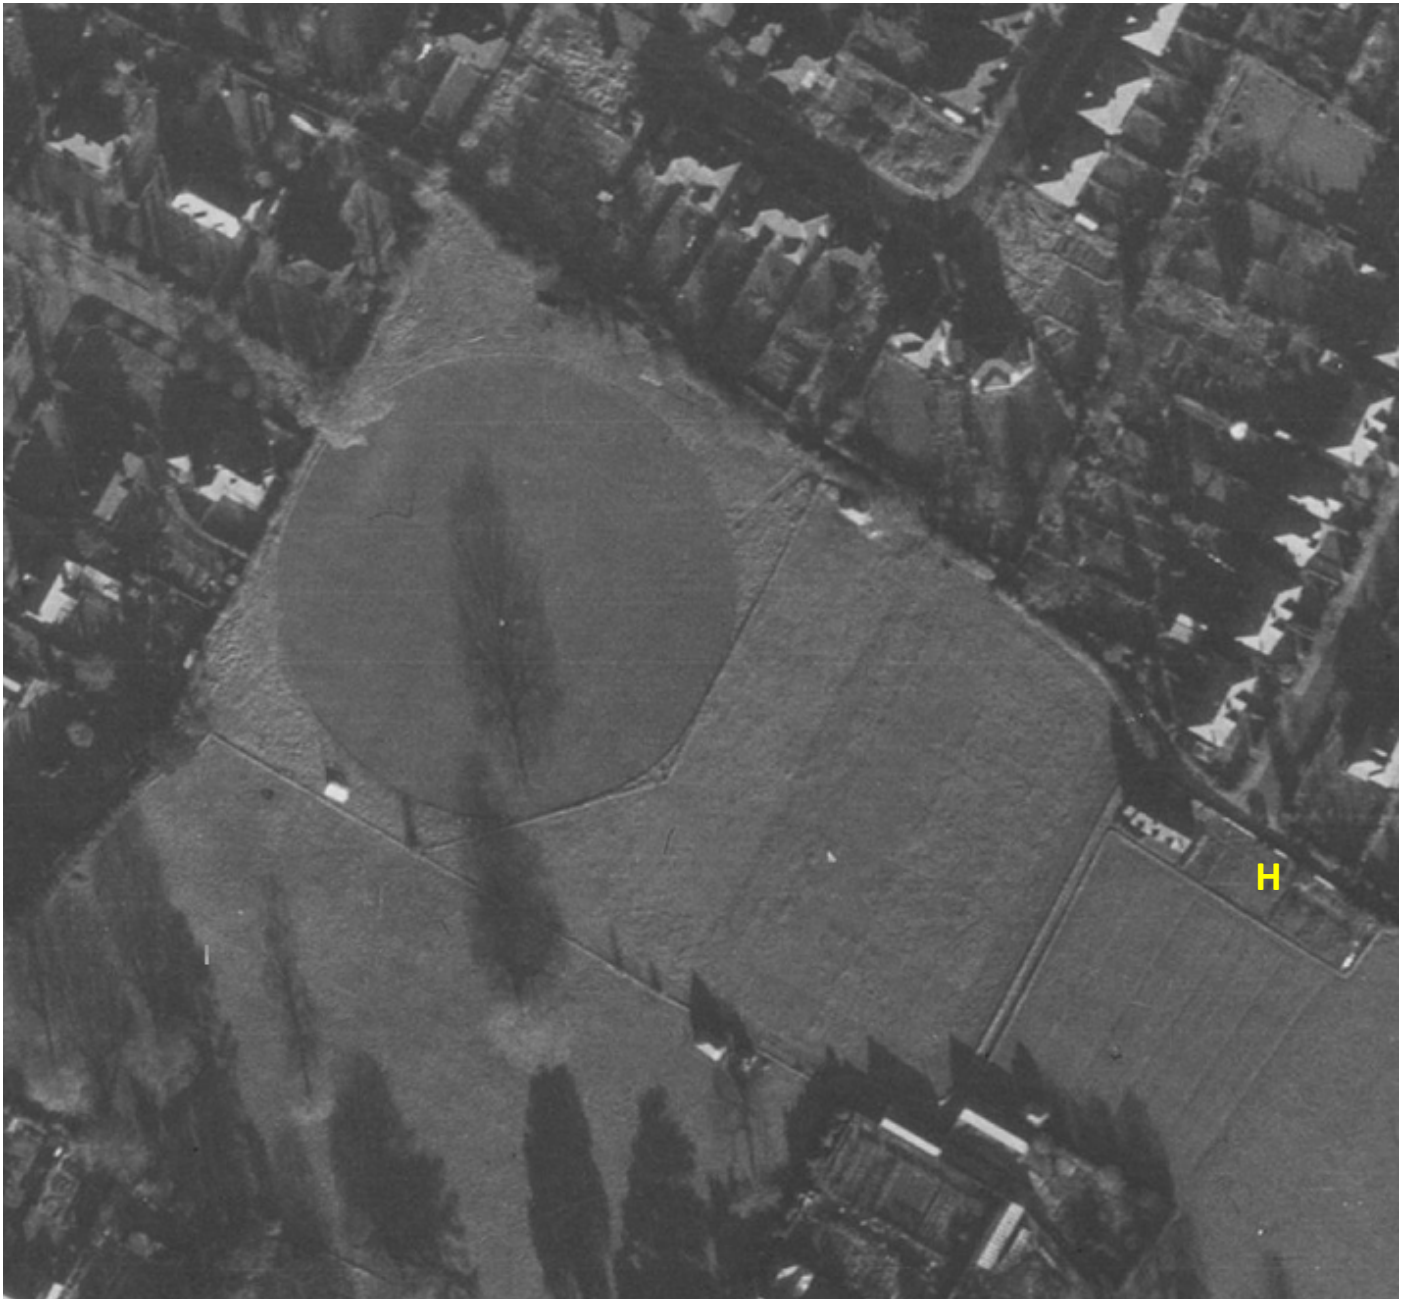
**FIGURE 7: CLOSE UP SHOWING THE CRICKET GROUND AND ENVIRONS IN 1946**

38. **Figure 7** shows a close-in part of 1946 aerial photo at the area marked as a 'cricket ground' in the 1936 OS map. This is the first visible sports facility recorded on the aerial photos.

39. The grassed playing field appears well maintained and free from significant surface disturbance. Some vegetation growth is visible at the interface of the field and Cheyne Road.

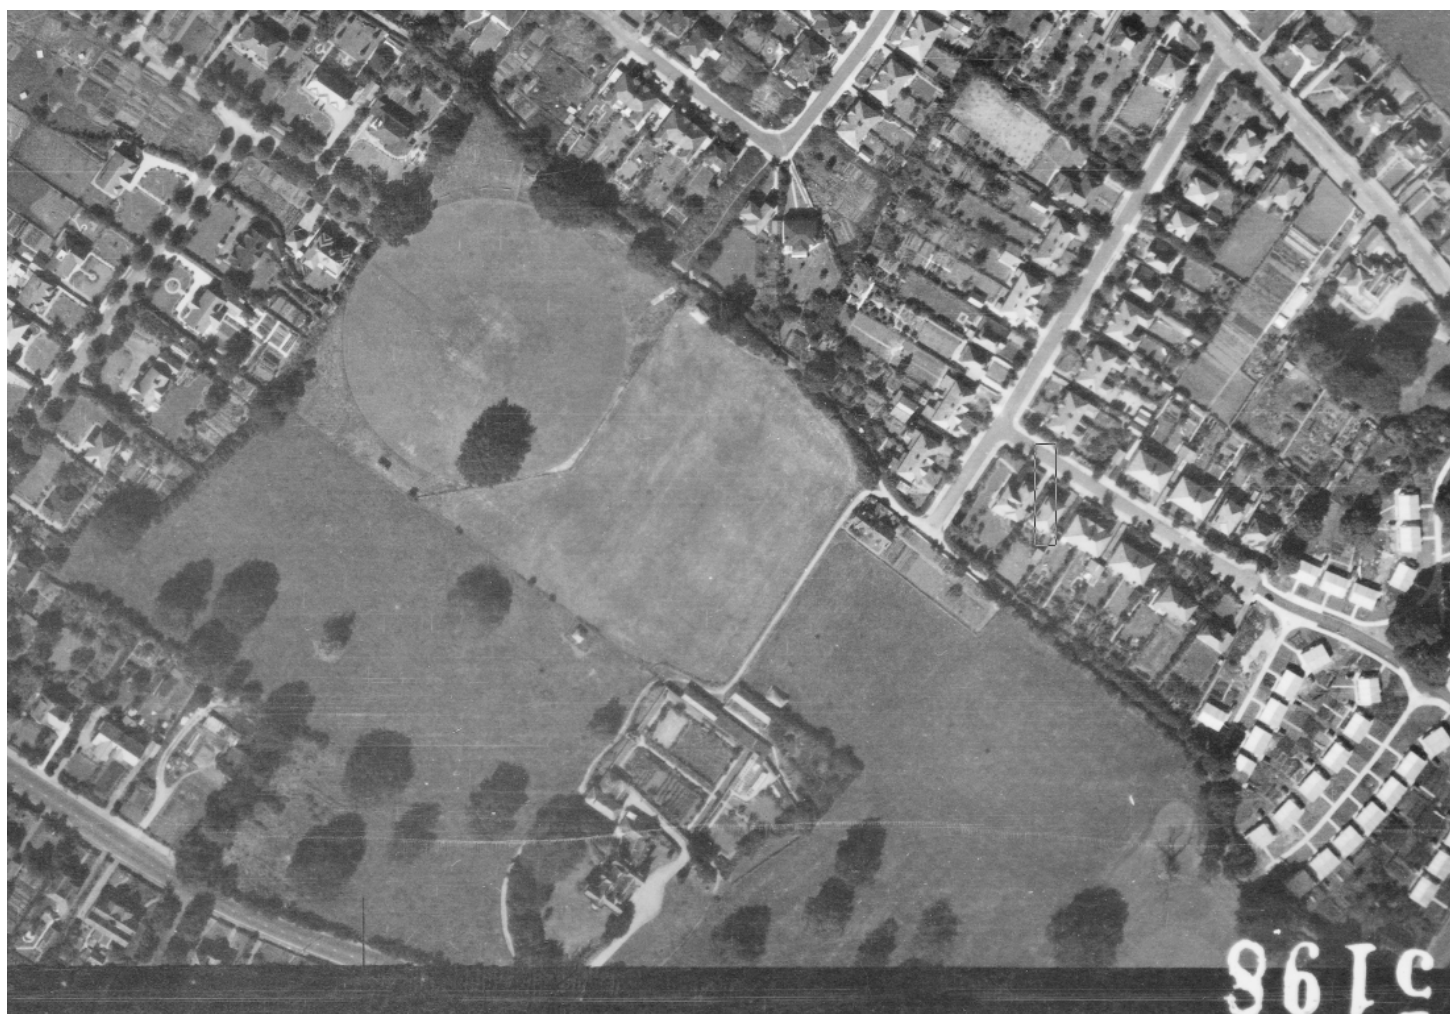
**FIGURE 8: 14 AUGUST 1947**

47. The aerial photograph, **Figure 8**, was captured during the summer season, with deciduous trees in full foliage, but not impeding visibility across the site. The conditions are similar to those recorded in December of the previous year.
48. The cricket pitch is clearly defined by a circular boundary, consistent with its use for organised cricket.
49. A fenceline enclosing the cricket pitch is visible and corresponds closely with the extent shown on the 1928 cricket lease plan.

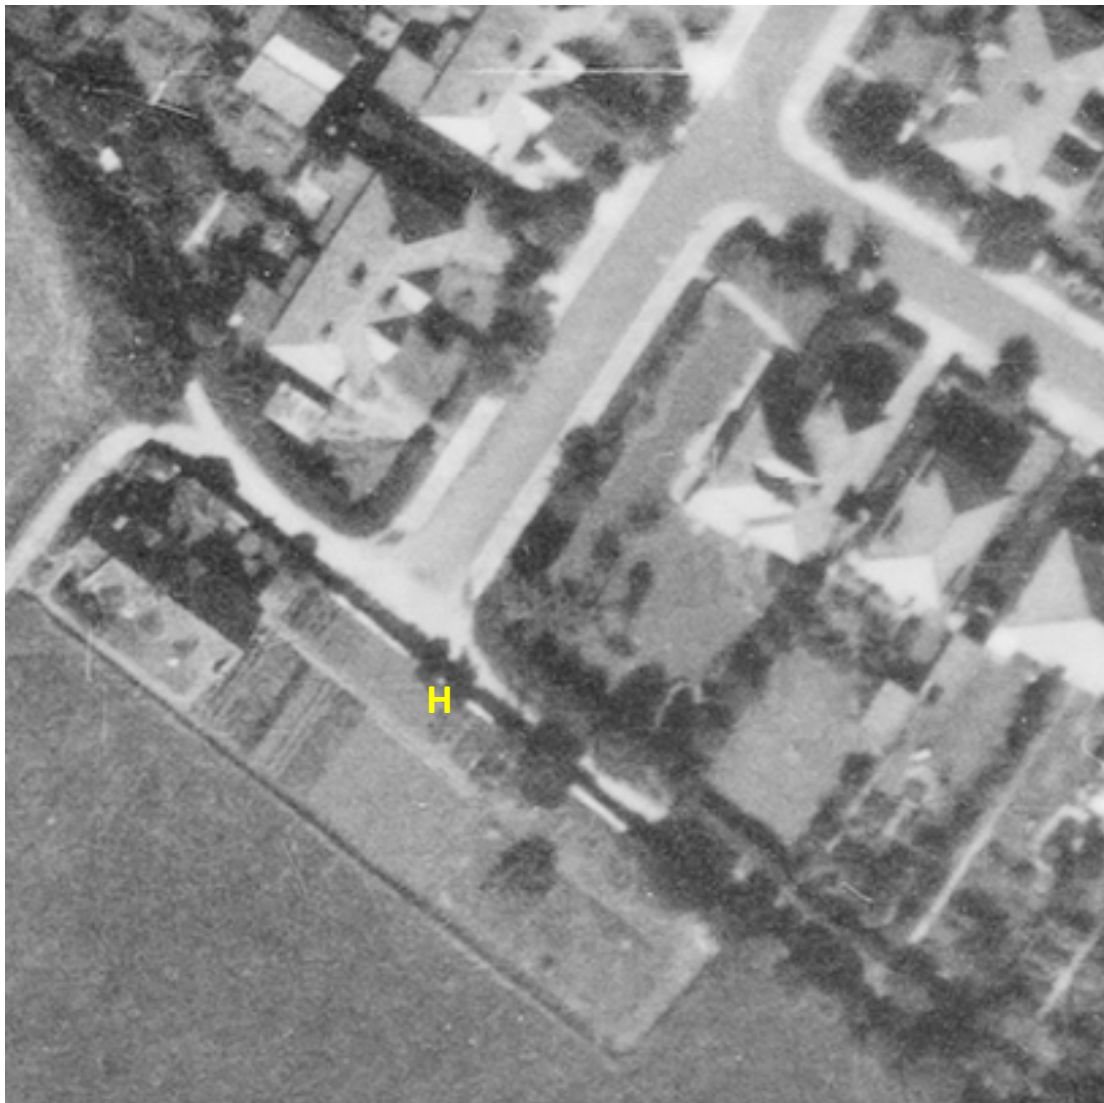
**FIGURE 9: NO ACCESS AT POINT H, 1947**

50. The grassed playing field appears well maintained and free from significant surface disturbance. Lines on this image are the result of scratches on the negative roll which have occurred during the automated development and/or printing process of the large format film.
51. No evidence of pedestrian tracks is visible around the perimeter of the playing fields.
52. No informal footpaths or desire lines are visible crossing the playing fields. A formal path is visible connecting the lodge and the buildings on the northern perimeter of the site.
53. There is a visible dark toned linear feature across the boundary of the site at Point H with no visible access from West Dene into what was then a private garden area. This is shown on **Figure 9**.

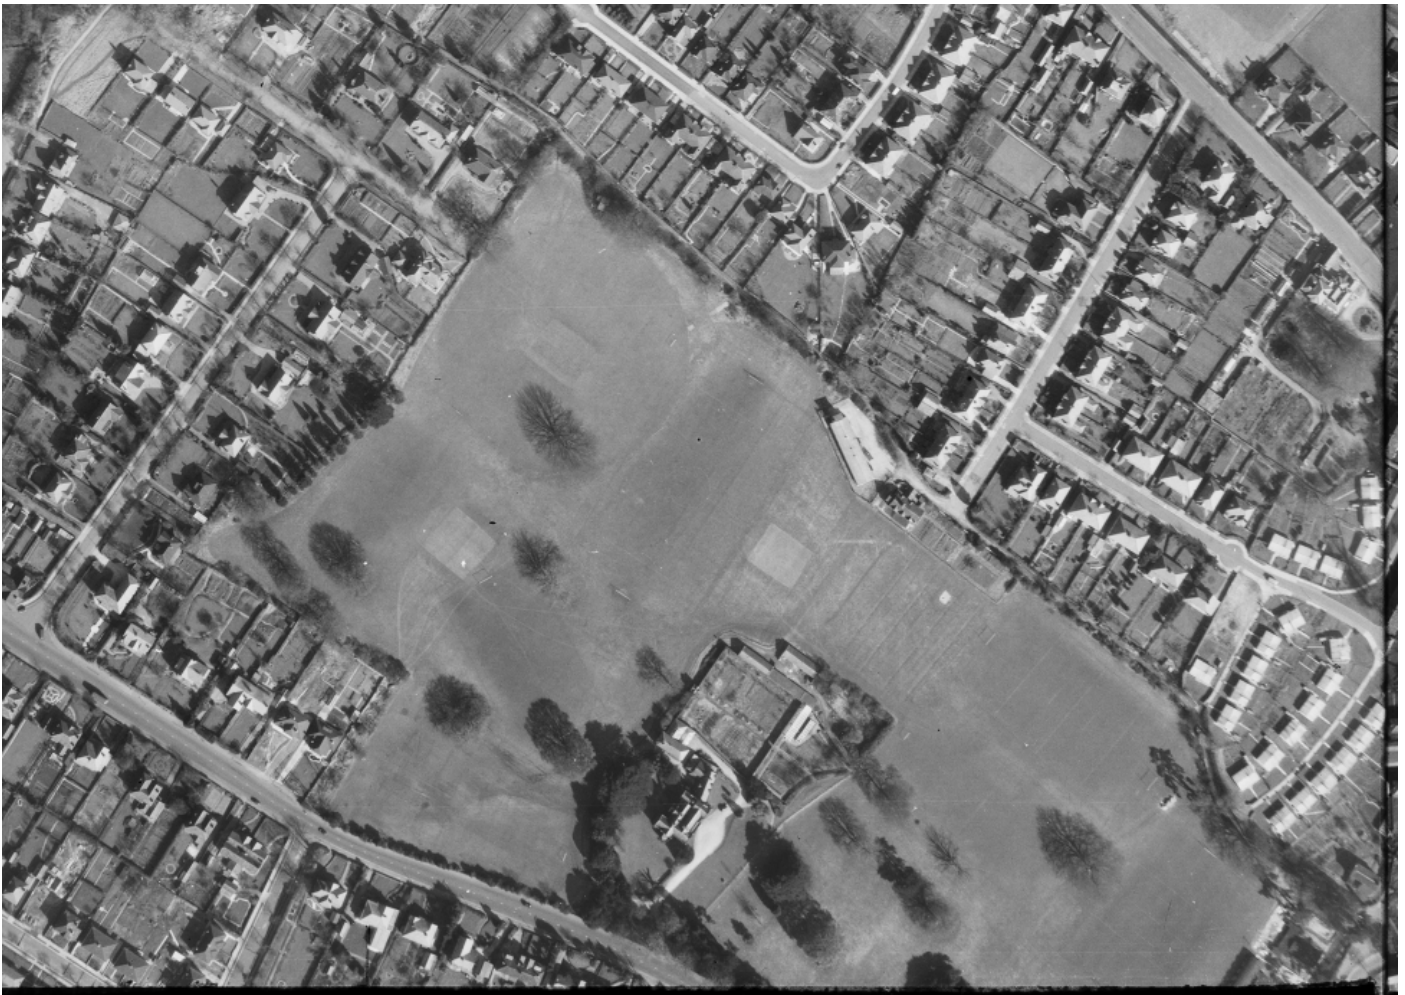
FIGURE 10: 31 MARCH 1955

62. A series of small narrow tracks are visible in the grass within the site, which do not traverse the site but indicate access to and from the sporting areas. Again, these tracks show that the surface is susceptible to wear as it occurs.

64. No visible pedestrian tracks or informal routes cross the playing fields along the later claimed routes. The small tracks associated with access to the sporting areas demonstrate that the grassed surface was capable of recording wear, indicating that pedestrian use along the claimed routes was not occurring at a level sufficient to produce detectable ground disturbance at the time of photography.

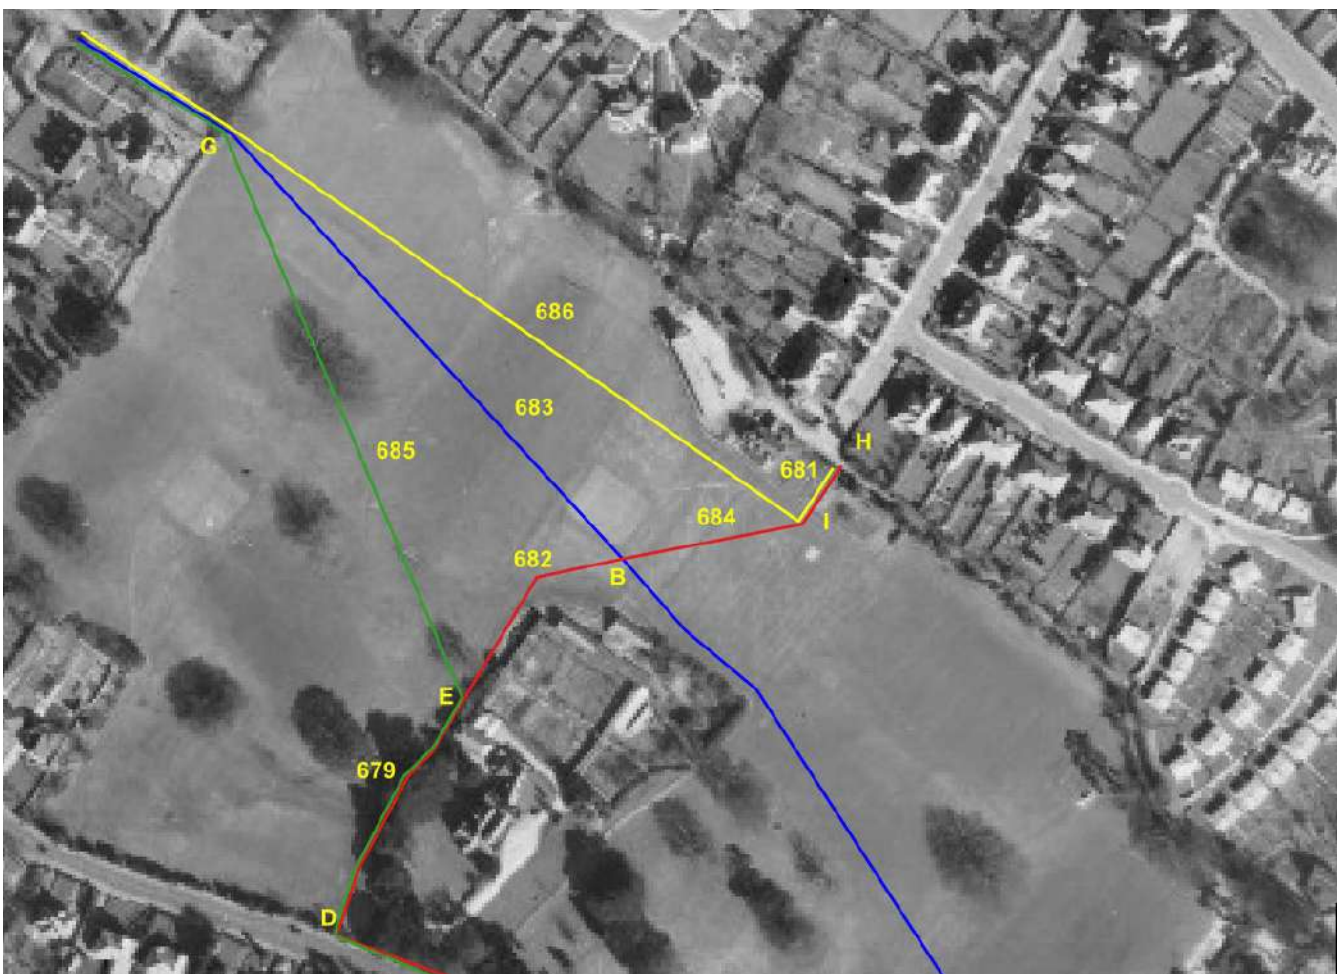
FIGURE 12: 1955, WITH THE CLAIMED ROUTES WHICH WOULD HAVE TRAVERSED PITCHES IF PRESENT

65. **Figure 12** shows that the claimed routes would have had to cross active sports pitches and access an area over a private garden if used at this date. The full resolution photograph included in the annexe should be consulted to see the details of the pitches and goals visible in 1955.

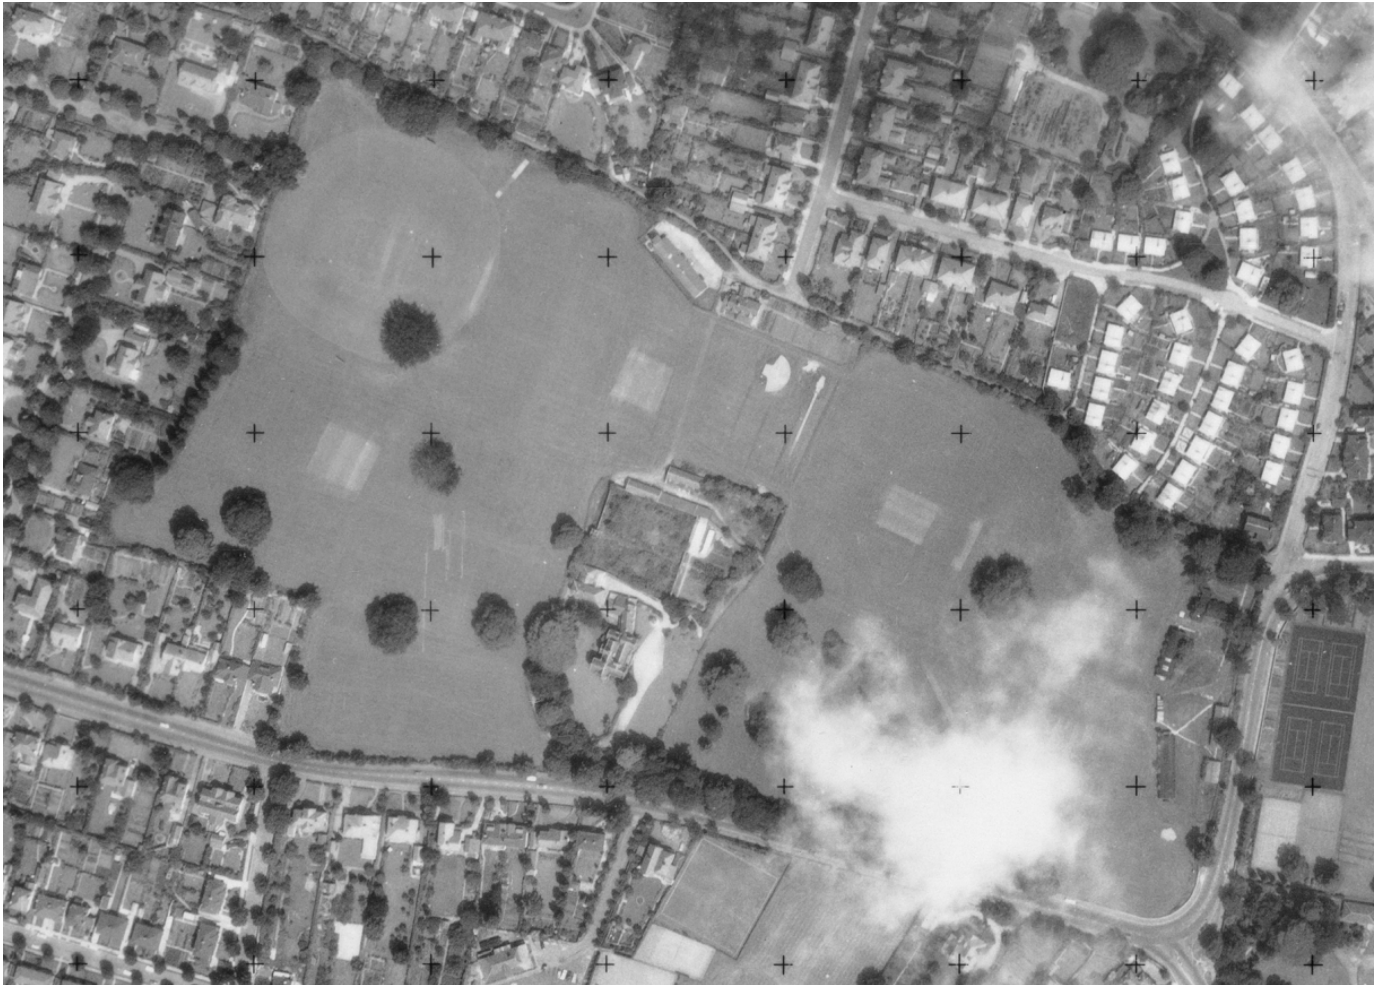
**FIGURE 13: 26 JUNE 1960**

69. No evidence of pedestrian tracking is visible around the perimeter of the playing fields and no evidence can be seen of access at point H.
70. No informal footpaths or desire lines are visible crossing the playing fields. As in previous years, the claimed routes would have had to cross active sports playing areas if present and would have been visible as worn lines in the receptive ground surface, which they are not.

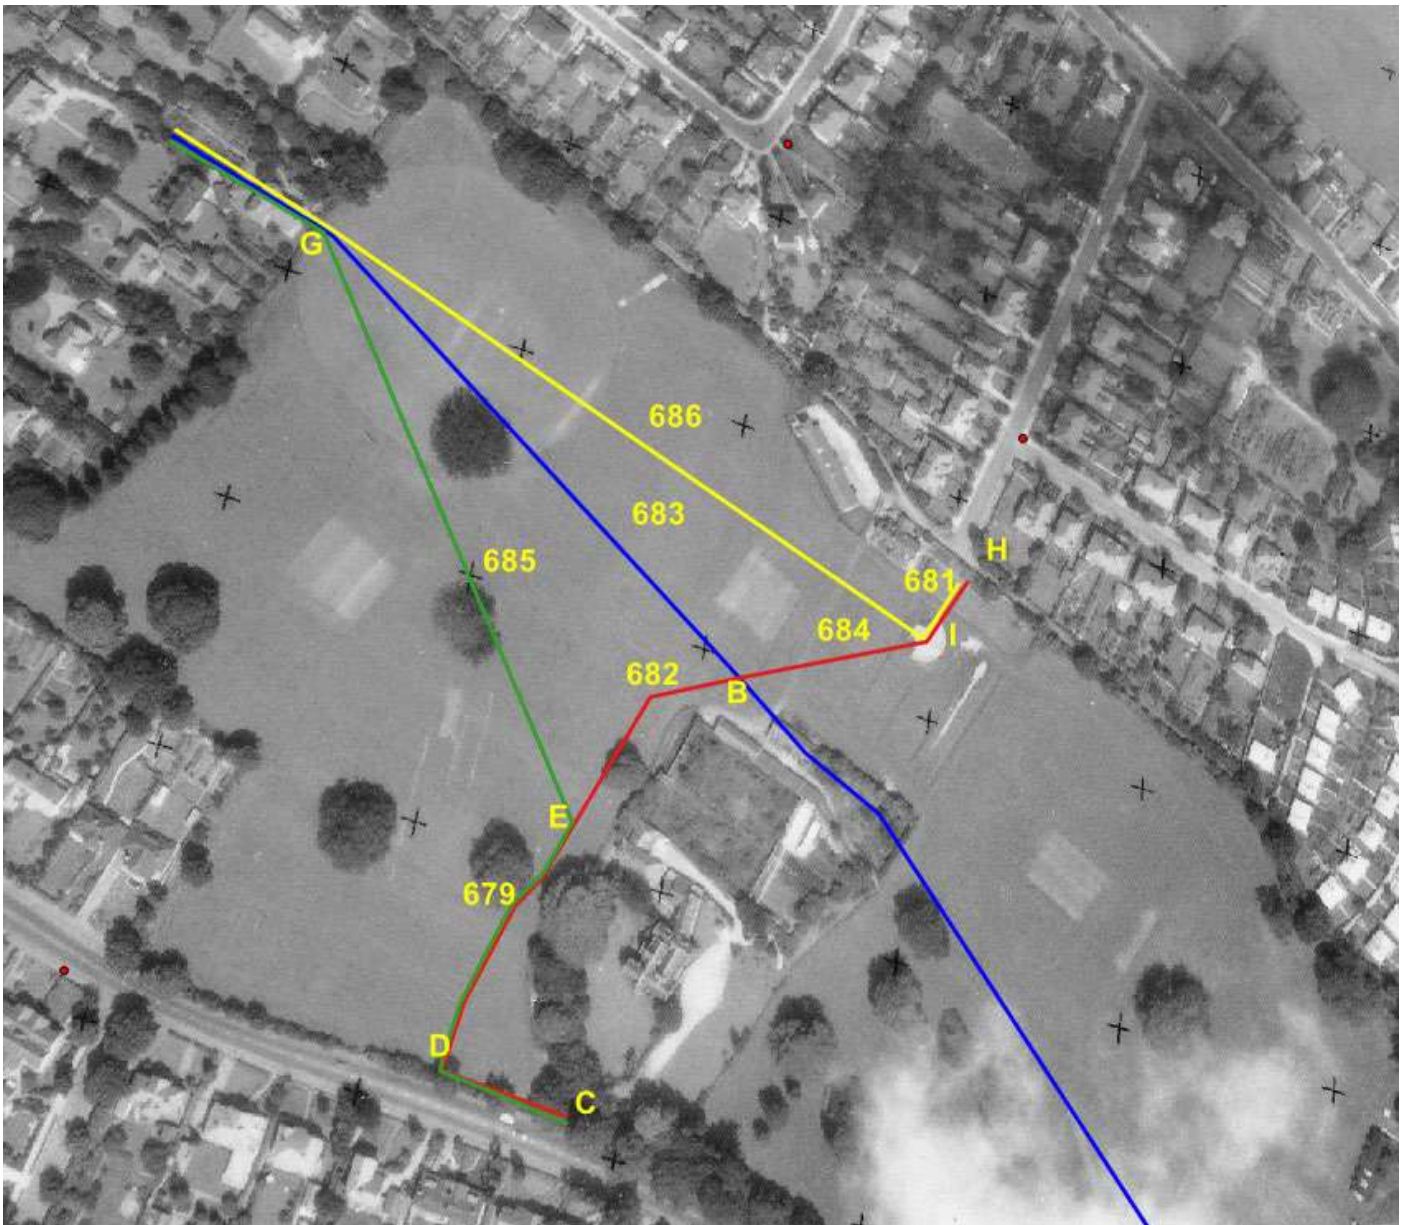
FIGURE 14: 1960 AERIAL PHOTOGRAPH WITH OVERLAIN CLAIMED DMMO ROUTES

71. The 26 June 1960 aerial photograph demonstrates that the site was established and managed as organised cricket and athletic areas in the summer field sports season.
72. The absence of visible pedestrian tracks or informal routes across the playing fields indicates that pedestrian use was not occurring at a level sufficient to produce detectable ground disturbance at the time of photography.
73. **Figure 14** shows that the claimed routes would, if present in 1960, have had to traverse an active cricket pitch and a permanent throwing sports area at point I, when in fact they were not at all visible either as active or residual tracks in what is proven to be a susceptible surface.

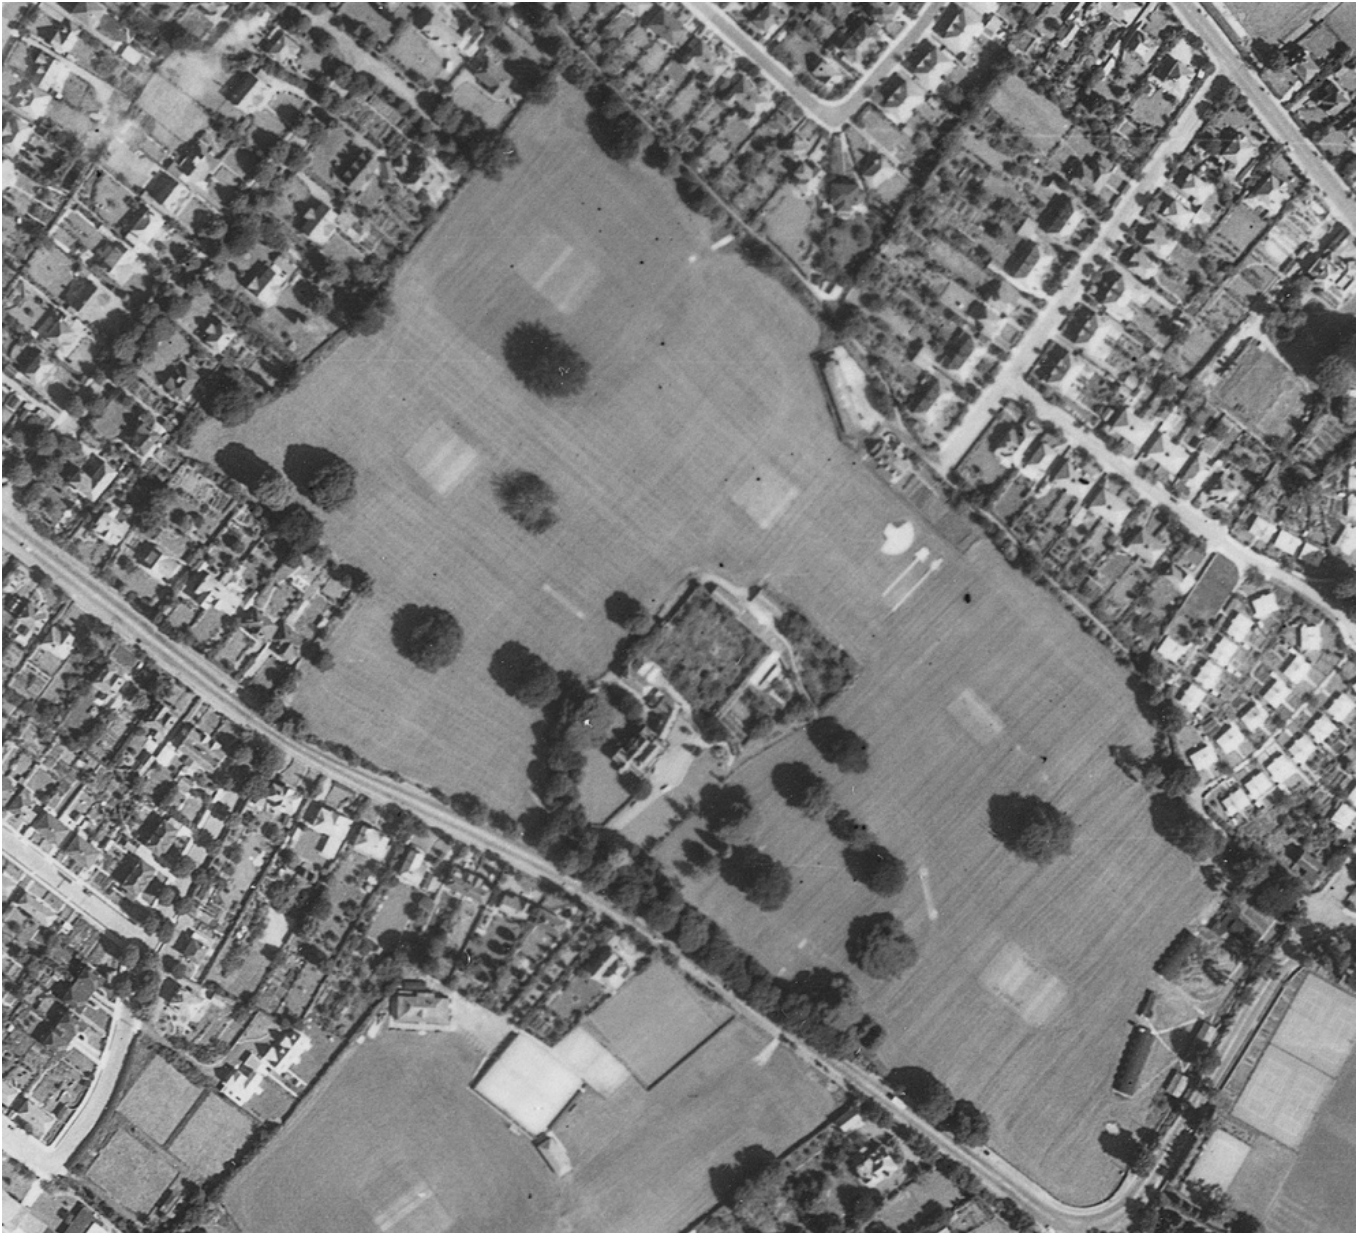
**FIGURE 15: 26 JULY 1963**

78. No evidence is visible of worn pedestrian tracks around the perimeter of the playing fields. A formal path visible in 1946 connecting the lodge and the buildings on the northern perimeter of the site is now not prominent although its former line can be discerned in the grass.

82. The absence of visible perimeter or internal pedestrian wear suggests that informal access across the playing fields was not occurring at a level sufficient to produce detectable ground disturbance at the time of photography, on a susceptible surface as proven in 1955.

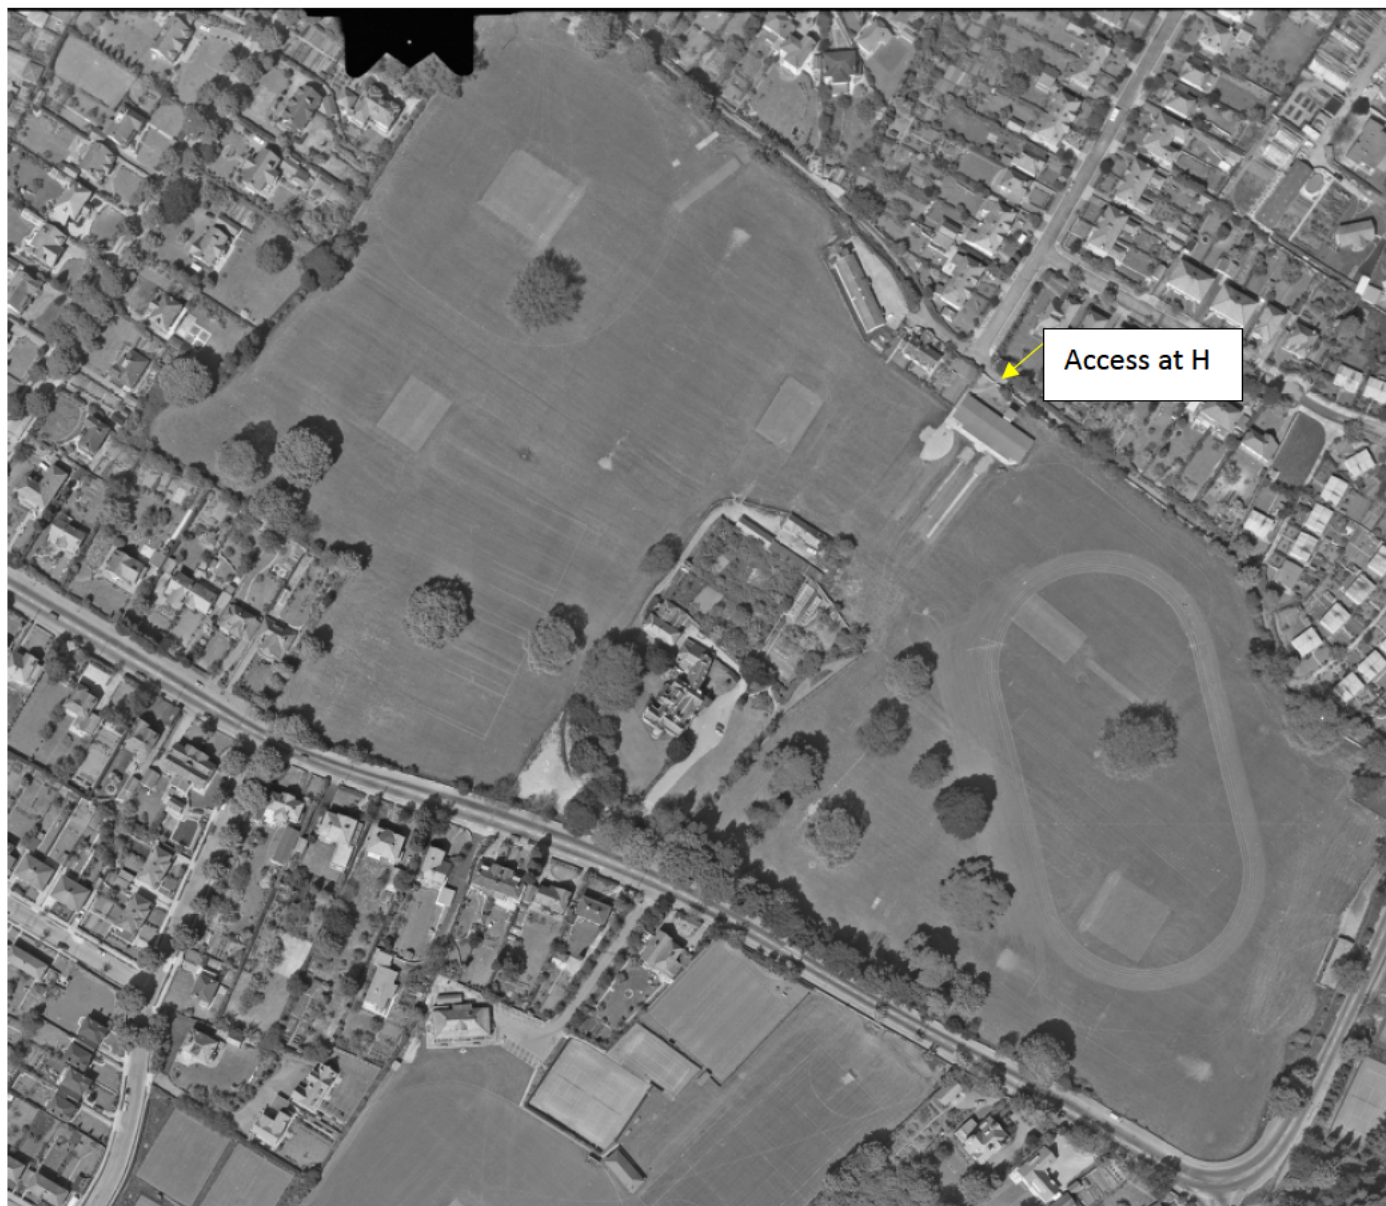
**FIGURE 16: 18 MAY 1970**

86. The grass is uniformly close-cut throughout the sporting areas.
87. No evidence of informal perimeter paths is visible.
88. No pedestrian routes are visible across the playing fields, and if they were present would have had to traverse cricket areas, jump sport areas near I, and the oval marked out athletics track enroute to point A. As in 1963 a small square object is visible in the field near point A, and access here is not well defined, with no line or wear leading into or across the field to or from A.

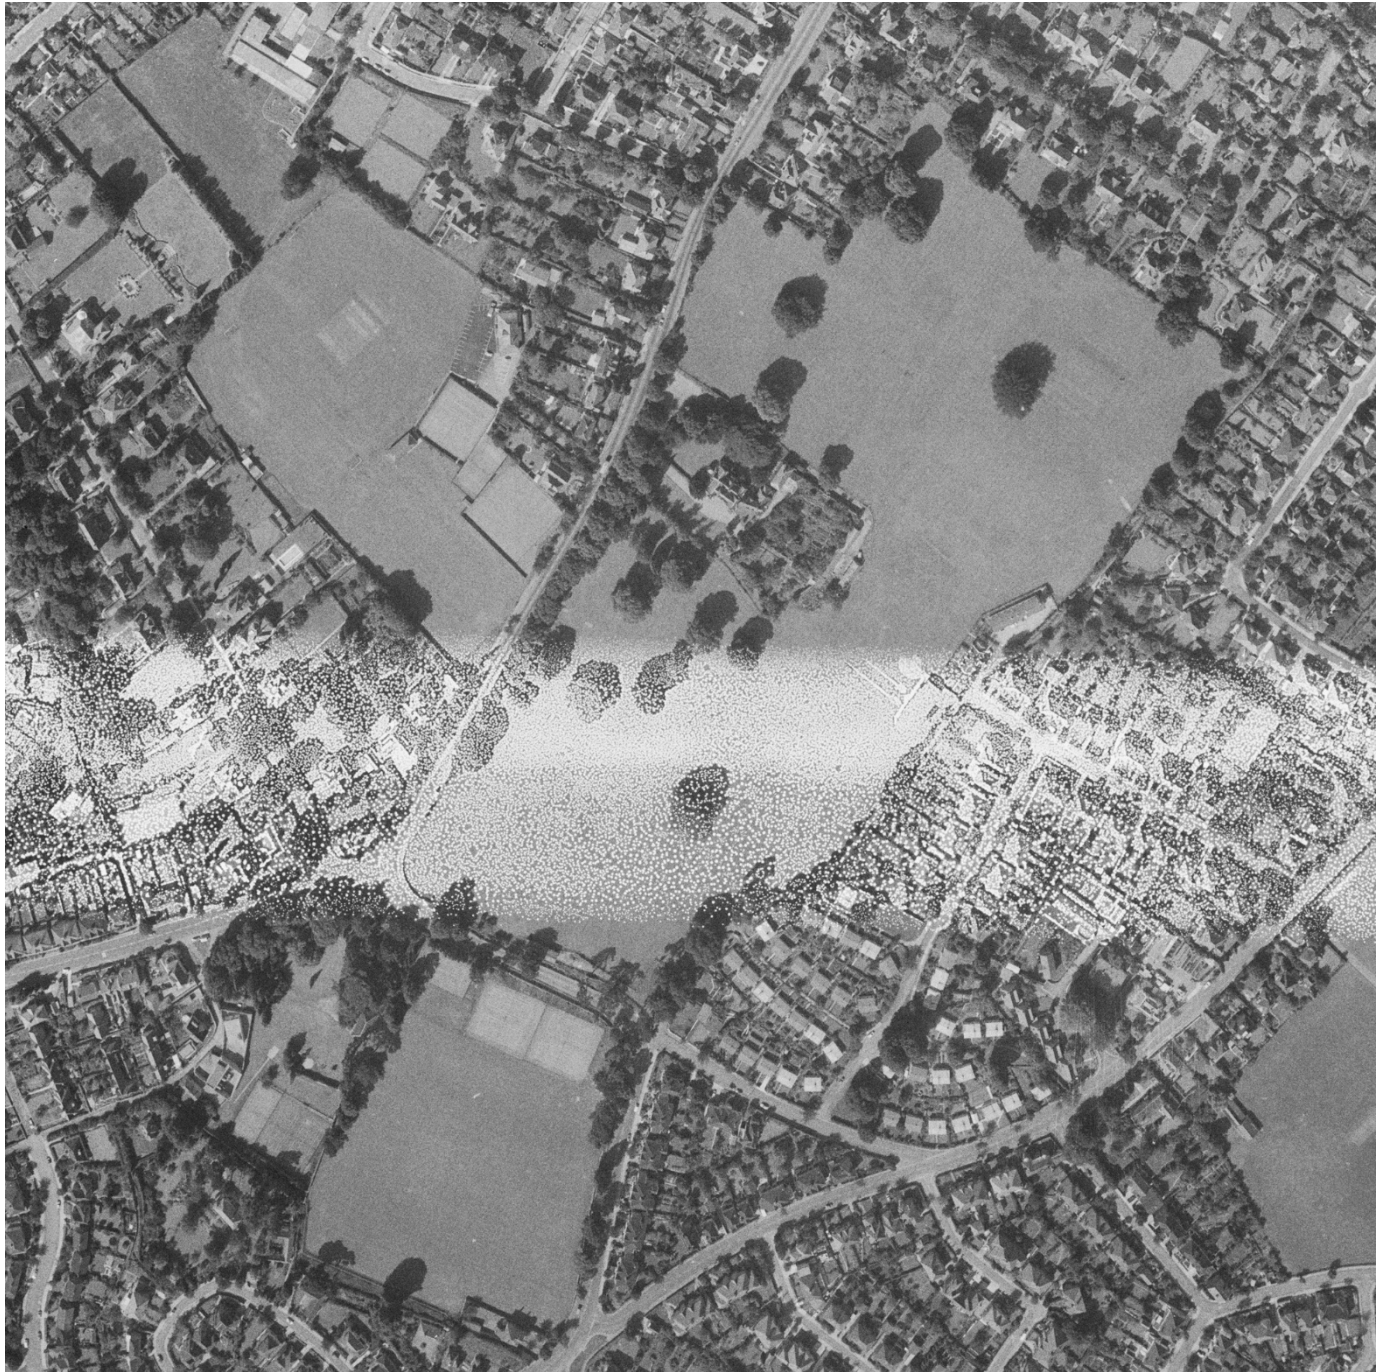
**FIGURE 18: 16 AUGUST 1971**

Source: National Collection of Aerial Photography, HSL/UK/71/0163/102. © NCAP. Image cropped to site. Note damage to negative, not reversible.

- 106. The 16 August 1971 aerial photograph is consistent with the 1963, 1970 and July 1971 imagery, demonstrating the continued management of the site for organised sport.
- 107. Apart from the localised area of image disturbance, which is a fault on the original negative (cause was checked with the supplying archive) no evidence of informal pedestrian access or the claimed routes are visible at all around or across the site.
