**EVIDENCE FROM AERIAL PHOTOGRAPHS AND SATELLITE IMAGERY  
STOKE LODGE PLAYING FIELDS, WEST DENE, STOKE BISHOP, BRISTOL, BS9 2BH**

**STATEMENT OF CHRISTINE DIANE COX BA MA MCIFA FSA**

**DATE** : 07 SEPTEMBER 2026

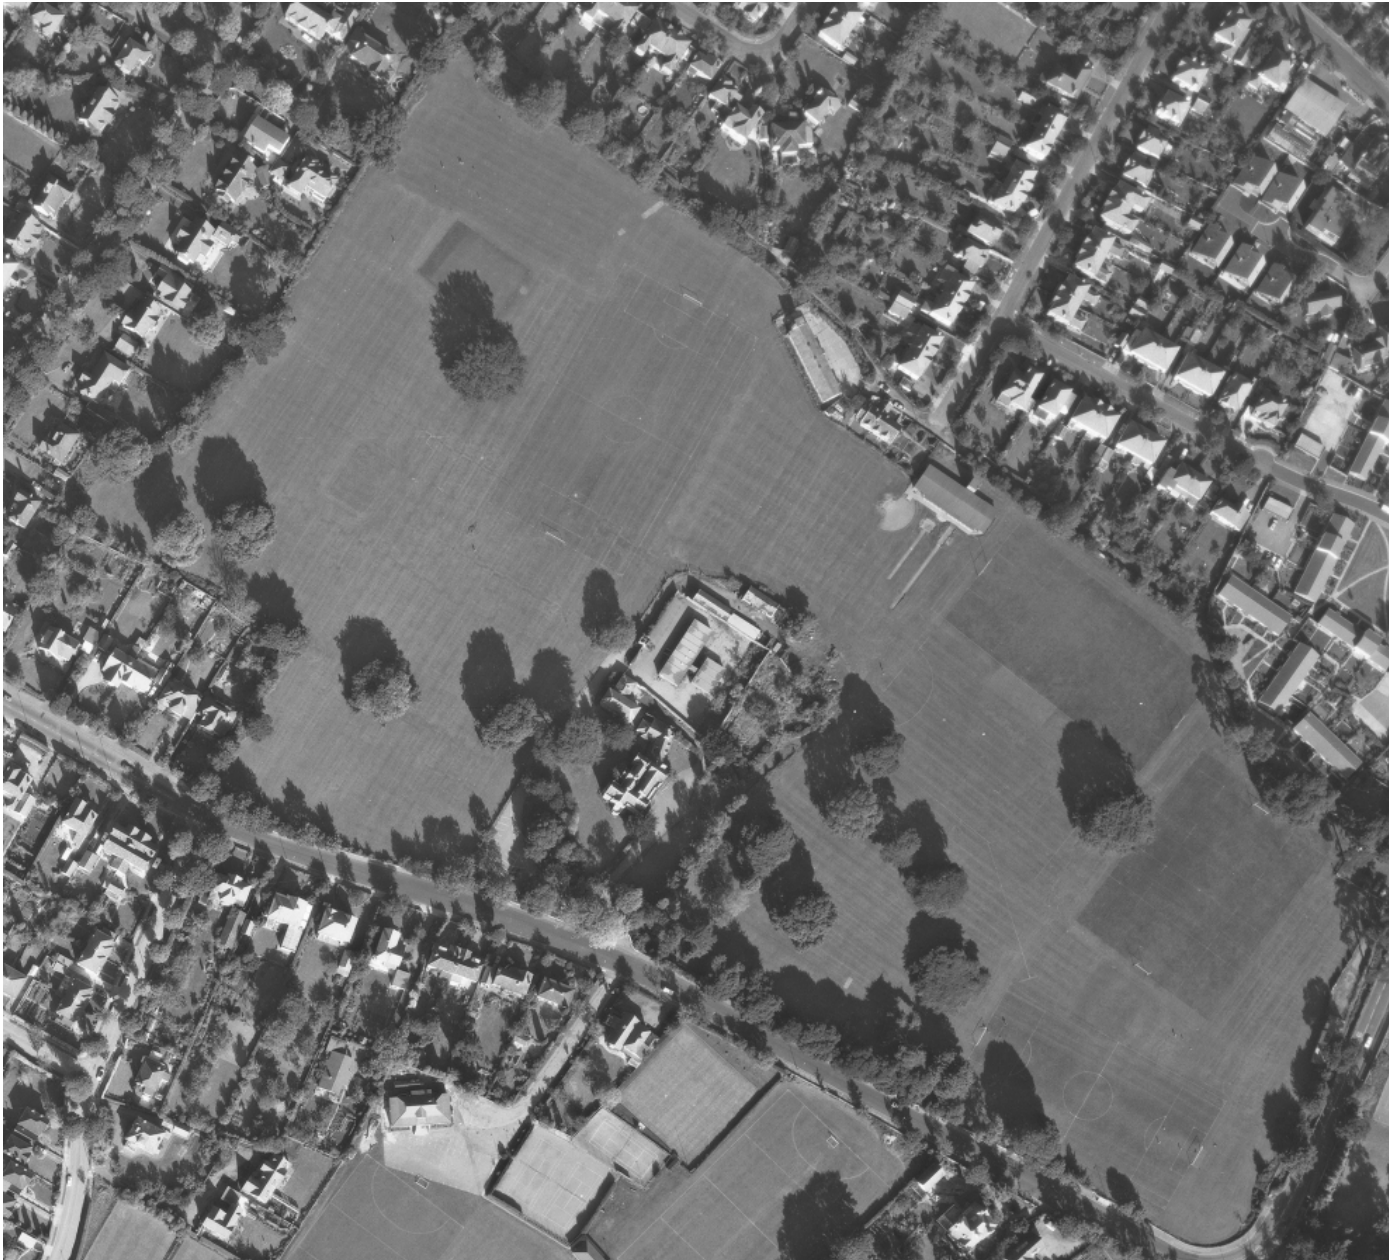
**FIGURE 19: 12 OCTOBER 1980**

118. The photograph captures the transition between the winter football season and the summer athletics and cricket season. Sports use was intense and over the whole field area.

119. Football and rugby markings and goals are visible.
120. The long jump facility continues to be maintained.
121. The grass is uniformly managed throughout the site.
122. No perimeter pedestrian tracking is visible.
123. No informal pedestrian routes are visible across the sports ground, which presents intensive evidence for multi-sport use. Again, as in all previous years, the claimed routes would have had to cross active sporting areas but no corresponding pedestrian wear is visible along their lines. This spatial overlap is demonstrated in **Figure 21** and **Figure 22**, which show particularly that claimed route 683 (blue) would have passed through a cricket square, football pitches and a football goal area. 686 (yellow) would have crossed a cricket pitch and edge of a square, and 685 (green) traversed marked visible cricket and football pitches during both seasons.

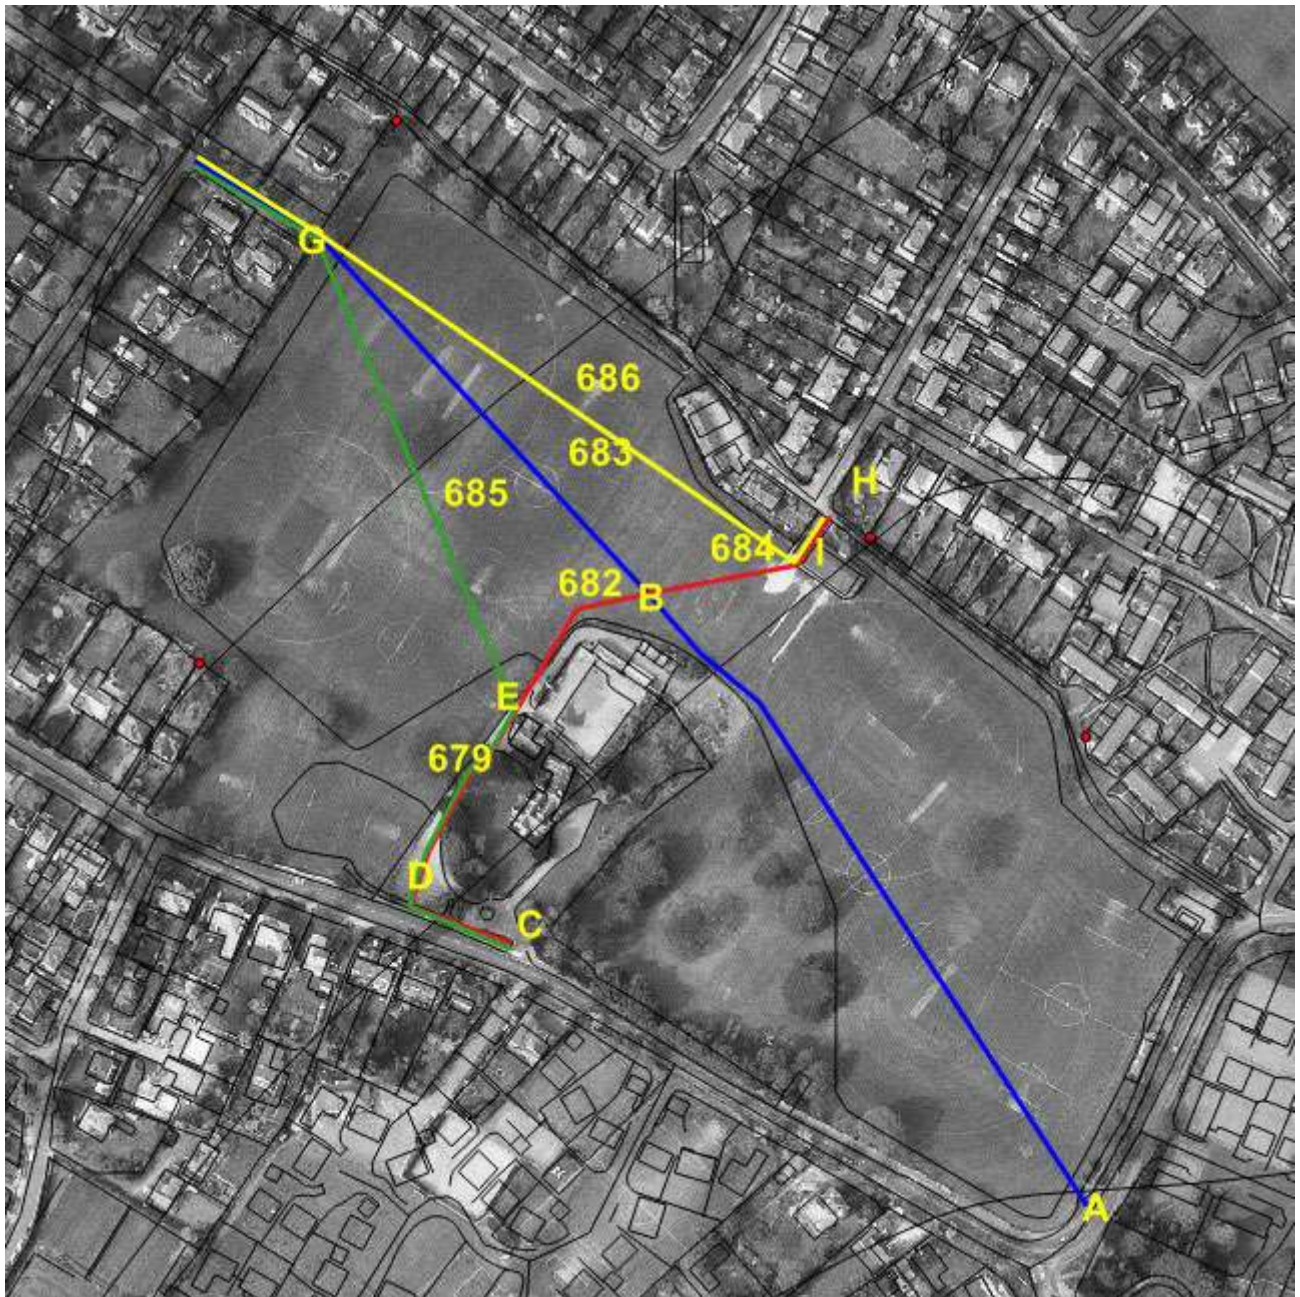
**FIGURE 22: 1982 PHOTO SHOWING THE CLAIMED ROUTES AND THE CONFLICTING SPORTS USE**

124. Boundary vegetation and limited fencing around the buildings remain consistent with earlier photography. There was a gap at Point G in the boundary, but no substantial tracking around this point in 1982. Point G directly abutted the marked outer circle of a cricket pitch and the claimed routes also traverse marked football pitches, and a throwing sport area. Notably the 'Blue route' 683 traversed the marked goal area of a football pitch to the northwest of point A as noted above and shown in **Figure 22**.

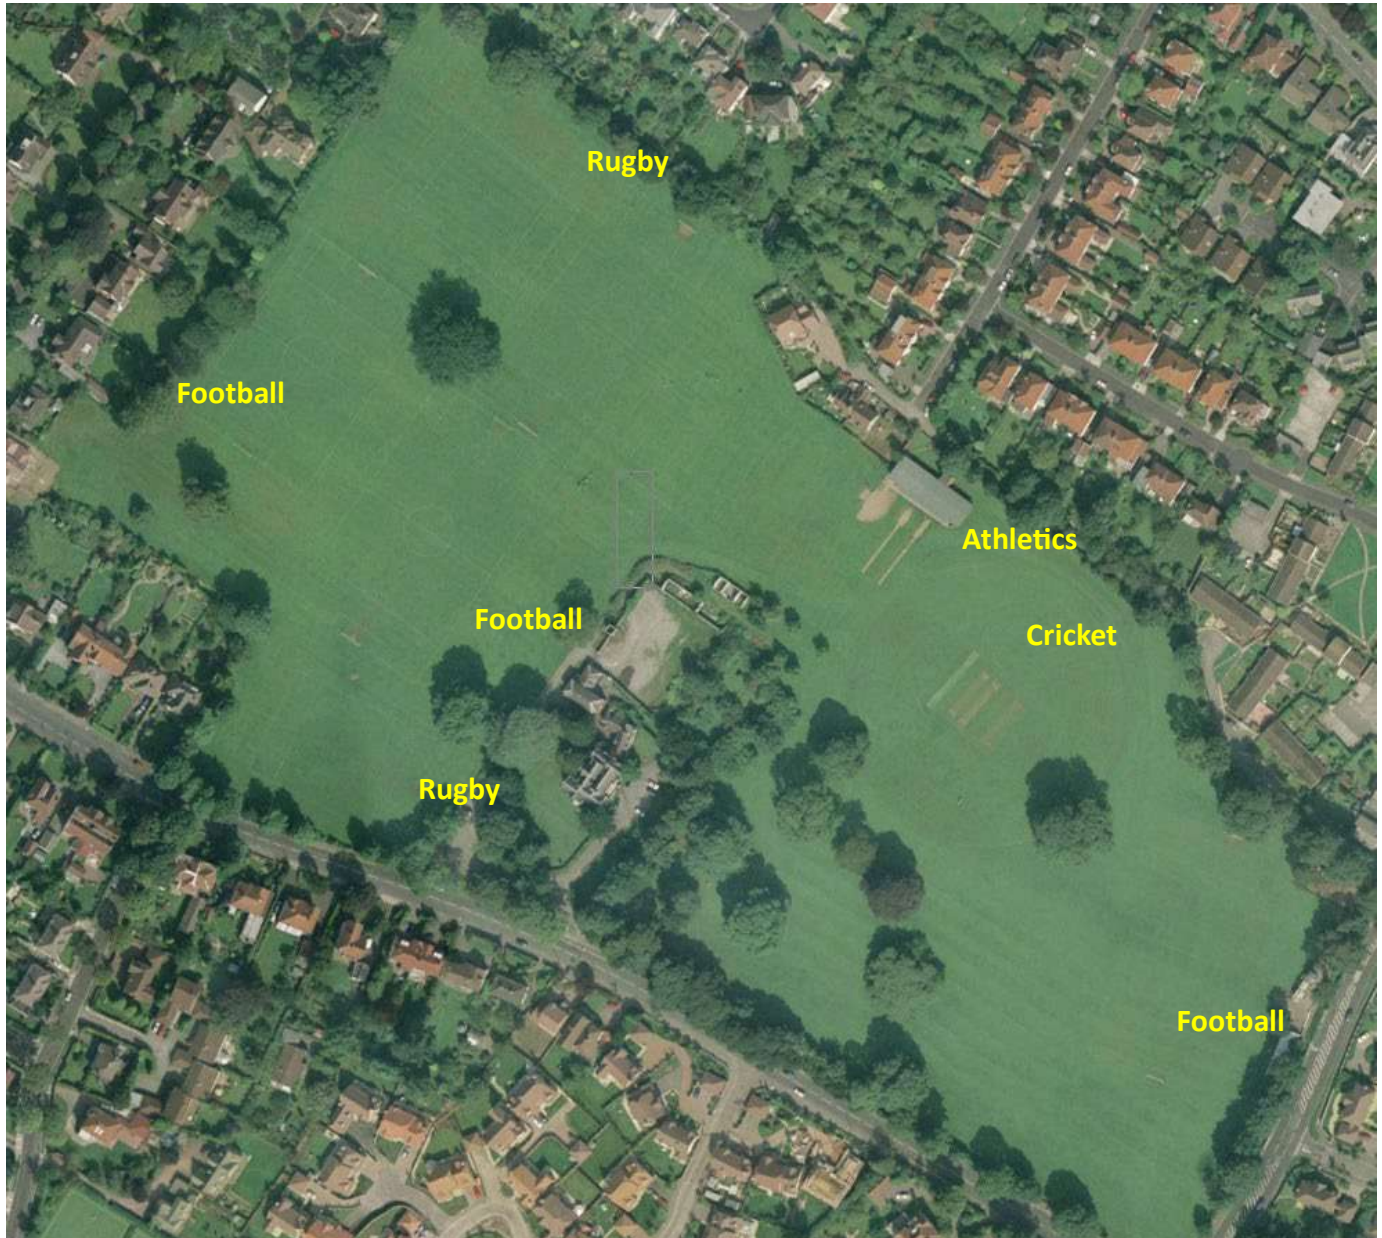
**FIGURE 23: 1999**

site, and would have been traversed by the claimed routes, as in 1982 (**Figure 22** compared to **Figure 23**, both showing sports use).

129. No tracking was visible across the site in this 1999 aerial photograph, and even at this 25cm resolution, would have been visible if present, which it was not.
130. The absence of visible tracking and the positive visible evidence for sports use continued in subsequent years in this period.
131. A further 1999 aerial photograph, securely dated by the provider to 24<sup>th</sup> July of that year confirms the sports use in 1999 alongside an internal or potentially sports maintenance track across the site from external sources as shown in **Figure 24**.

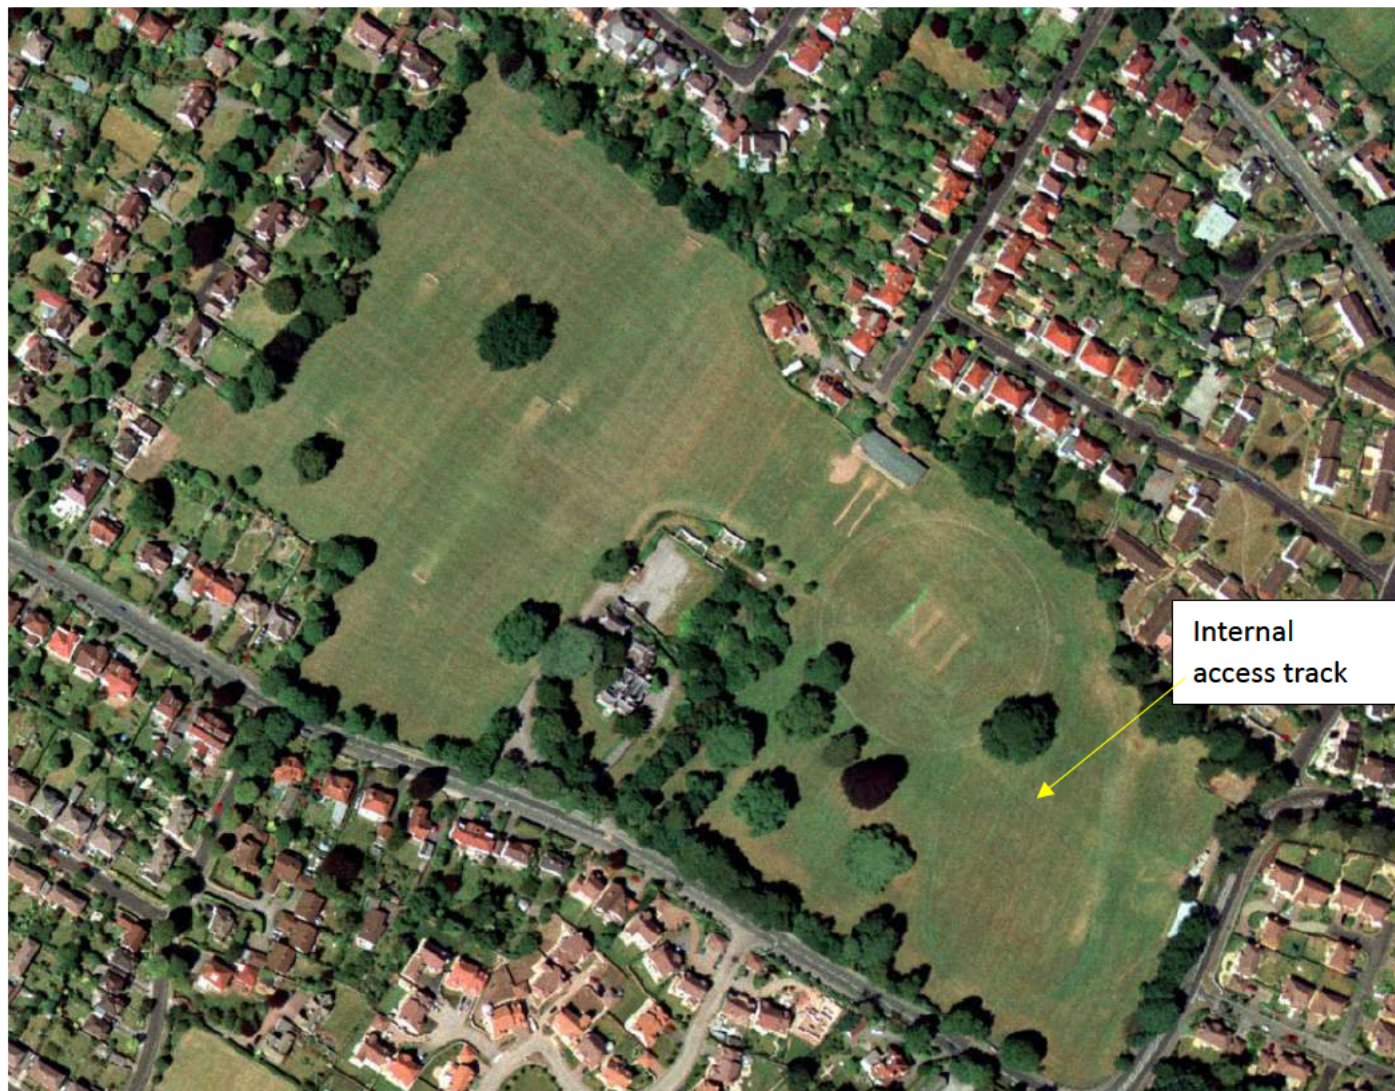
**FIGURE 24: 24 JULY 1999**

132. In July 1999, ball sport goals were visible in the northwest of the site, athletics pits were present.
133. A marked and maintained cricket pitch overlaid part of the area formerly marked as a running track in the southeast sector, where lane markings were still visible.
134. There was a slightly indented track, marked on **Figure 24**, which led to or from the cricket pitch outer circle marking and towards a light toned structure abutting the southeastern boundary.

135. Mowing and maintenance of the grass had taken place, which was evidenced by wide machine track marks on the mown grass surface.
136. No tracking was evident at all along or in the vicinity of the claimed DMMO routes. As in previous years any routes would have had to cross active sports areas including ball sport pitches and a well-maintained cricket pitch which coincided in its eastern part with the markings of a full-sized running track.

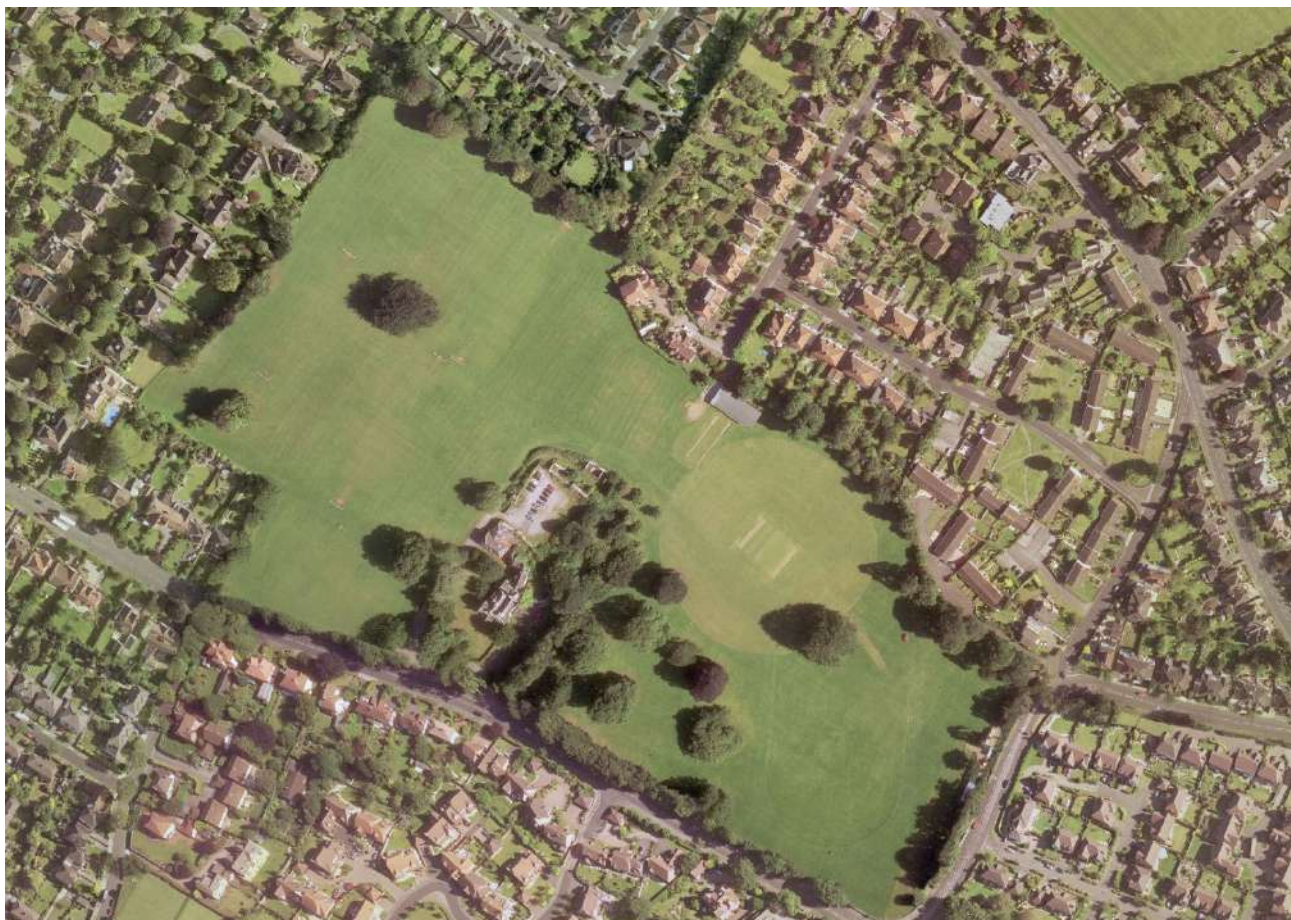
**FIGURE 25: 15 JULY 2002**

137. In July 2002, site wide sports use was again visible, as shown in **Figure 25**.
138. Ball sports goals, cricket and an overlapping running track were marked.
139. The grass was well maintained with tracking internally likely for this purpose and a red vehicle evident in the site.
140. Some items, likely people, were visible on the southern part of the marked track and in the southeast sector.
141. Point A was in tree shadow. Access from H is visible again with no continuation tracks into the main grassed area of the site. None of the claimed DMMO routes were visible, although other tracking was visible on this date within the site, which is in accordance with the closely maintained condition of the site at these and other dates of observation from aerial and satellite-based sources.

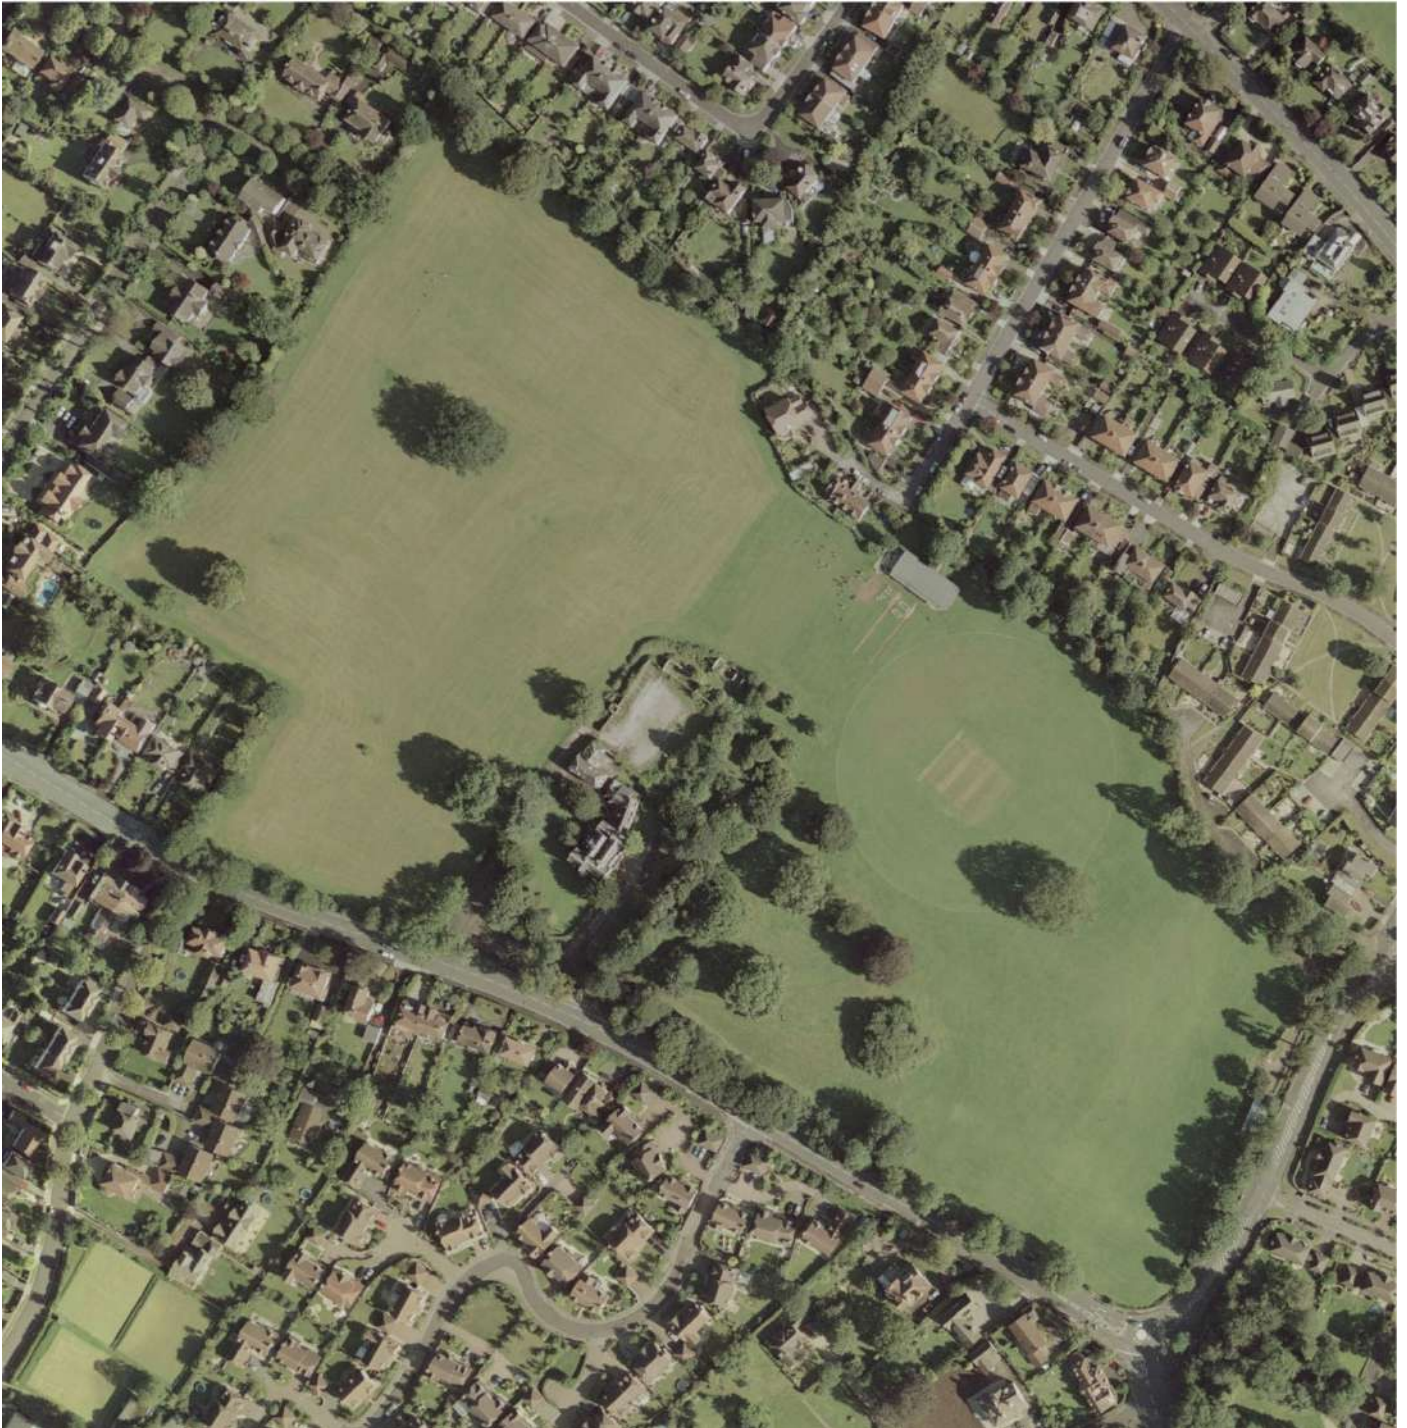
**FIGURE 26: SURVEY CAPTURED AUGUST 2004 – MAY 2005**

142. This 25cm resolution aerial photograph, **Figure 26**, was taken as part of a digital aerial survey captured between 21 August 2004 and 27 May 2005.
143. It clearly shows the site was mown closely recent to the time of photography and machine lines are visible in the grass surface. There were no football or rugby markings visible at the date of capture, and a cricket pitch was present.
144. Two groups of items which are likely people were visible in the site. One group is visible adjacent to the well-maintained athletics jumping area, where some new rectangular markings indicated ongoing use as shown in **Figure 27**. Another group of likely people was visible on the area of the previously marked northwestern cricket pitch, as shown in **Figure 28**.

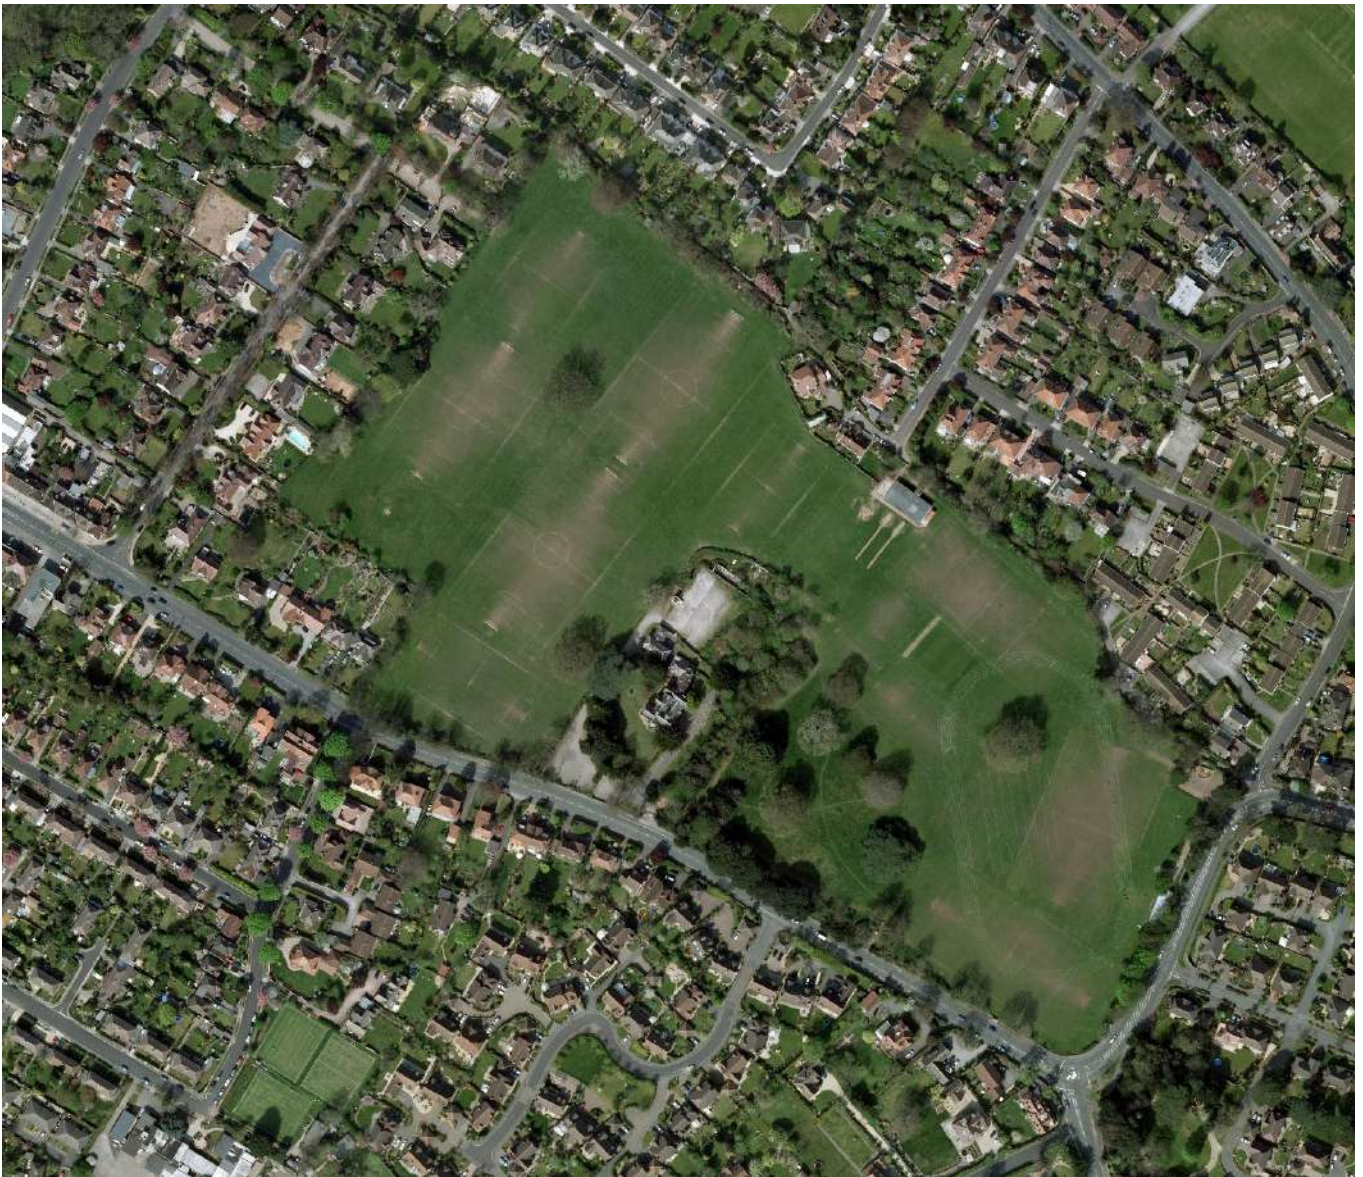
**FIGURE 29: 14 APRIL 2007**

145. In April 2007, the site was again marked out for intense and site-wide multi-sport use with no evidence for tracking over the claimed routes. A small item is visible on the ground and some wear near point G, but no tracking at all from this point. Again, these routes would have had to cross ball sports pitches and athletics areas as demonstrated in **Figure 29**, which they did not and were not visible. There was slight wear on the grass adjacent to point G but no tracking from this point over the claimed routes. There was a worn track from point H across to and round a

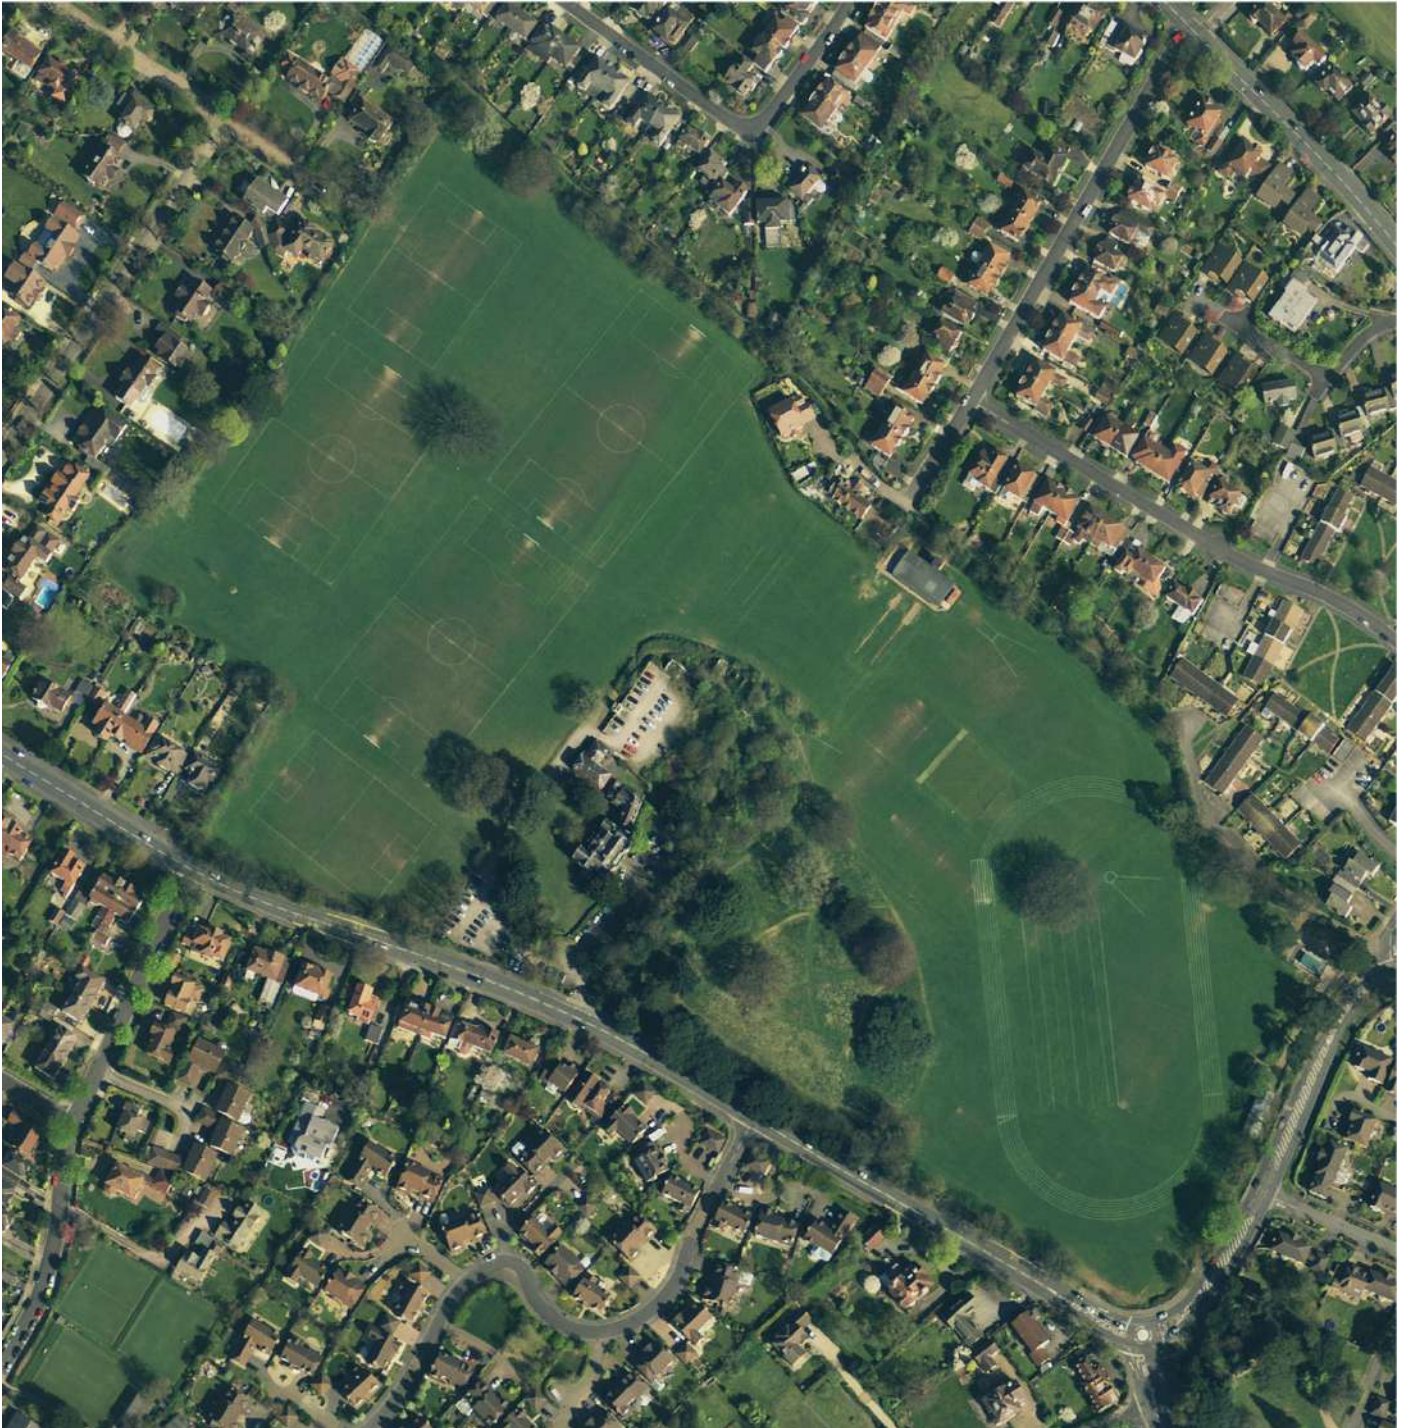
**FIGURE 30: SPORTS MARKINGS AND USE IN APRIL 2010**  
Copyright ©Bluesky International Ltd

147. As in previous years, the claimed routes, if present and visible, would have traversed these activity areas, which they did not, as shown by comparison of **Figure 30** and **Figure 31**. There were no signs of these routes on the ground surface. A light toned linear feature along the northwestern boundary was likely a maintained boundary hedge in blossom.

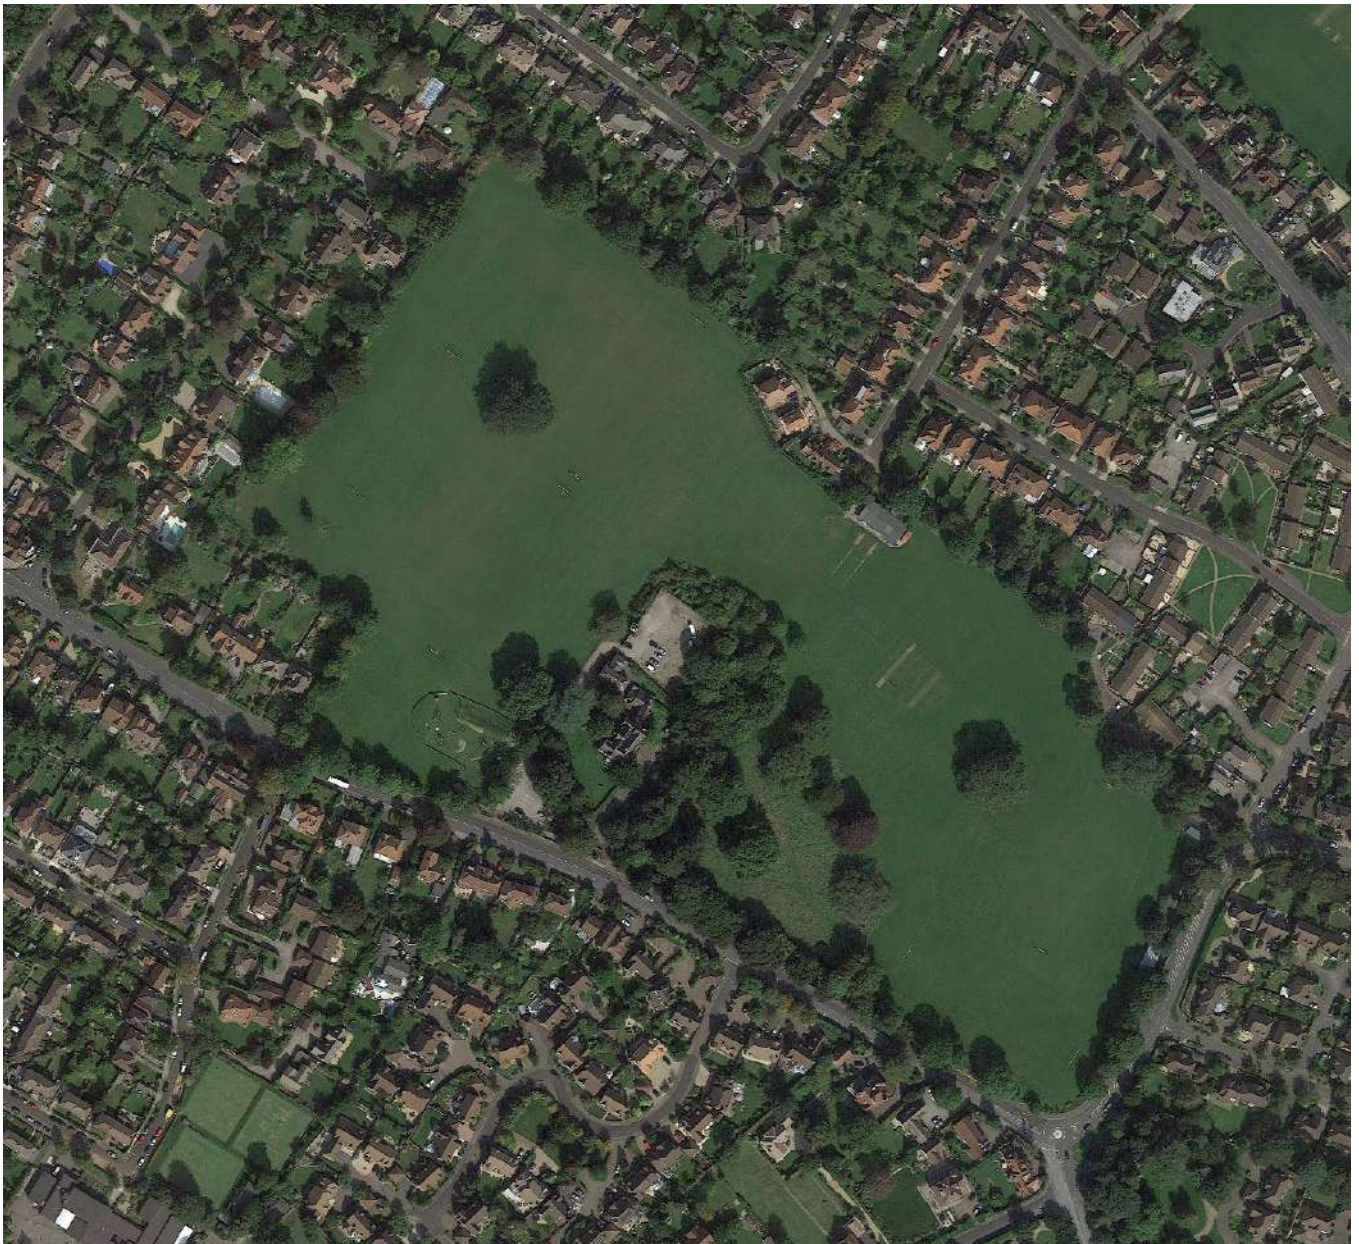
**FIGURE 32: 09 SEPTEMBER 2014**

- 148. An enclosed playpark area is visible in 2014 in the southern part of the site.
- 149. Again, there are no visible tracks over the claimed routes, as shown in **Figure 32**.
- 150. Ball sports goals are visible.

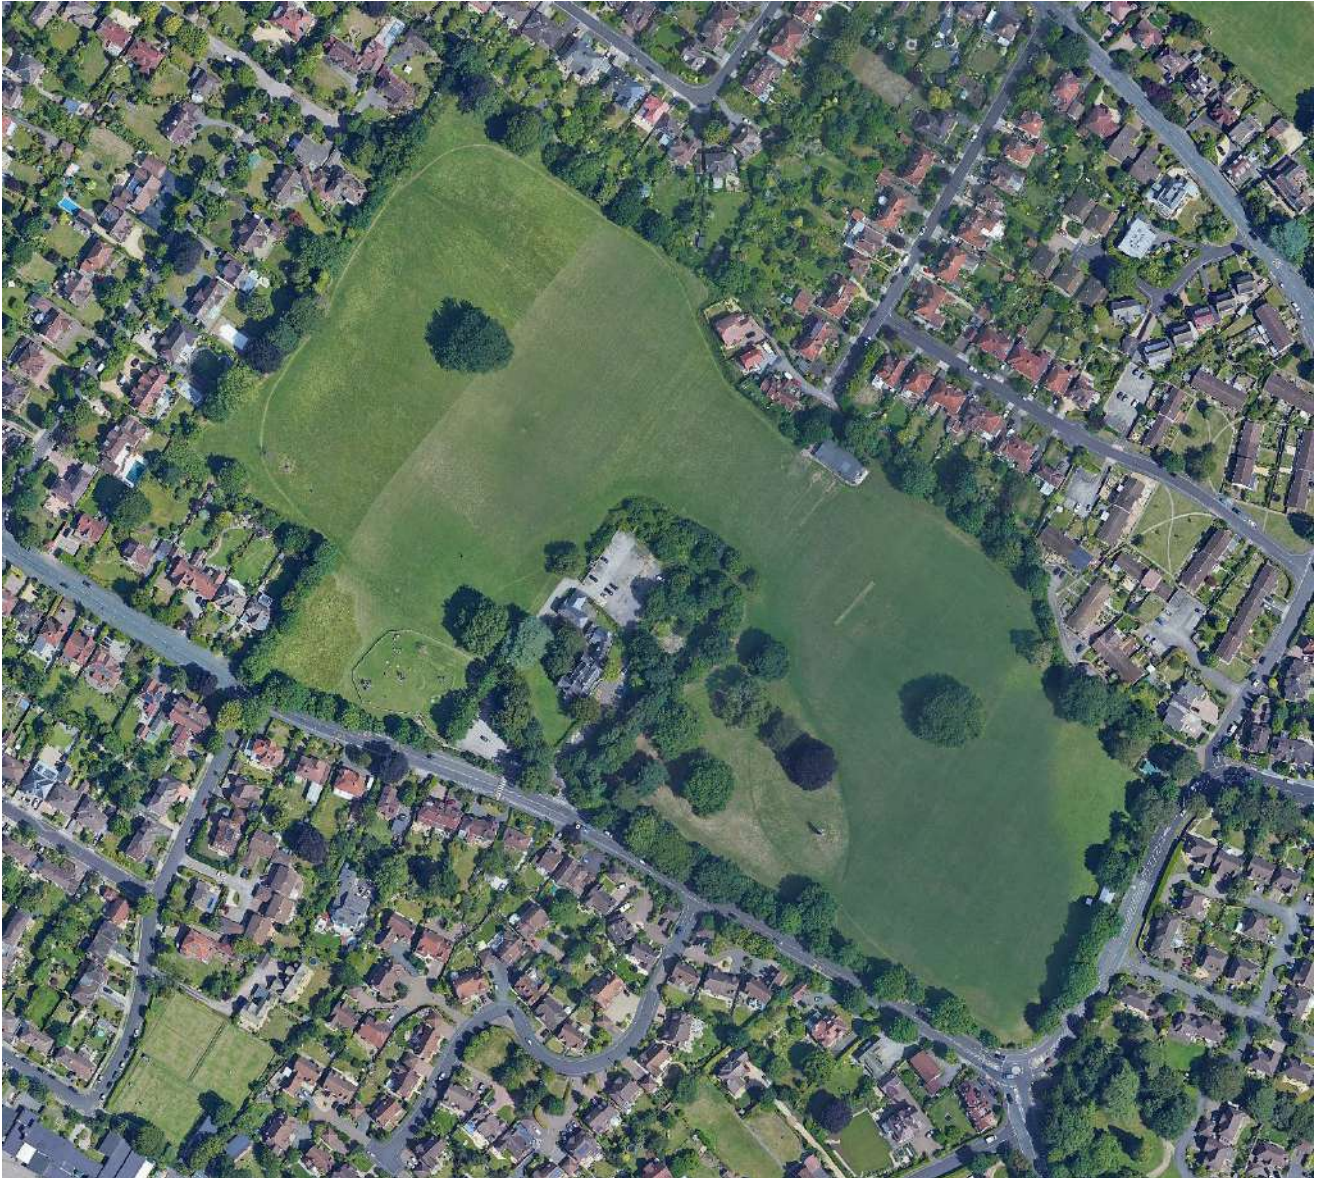
**FIGURE 34: 17 JUNE 2017**

166. Some perimeter tracking was visible as worn lines in the grass in 2017 alongside some tracking from the grass and wooded area to the east of Stoke Lodge. This newly visible tracking is shown in overview in **Figure 34**. These tracks did not coincide with all the claimed routes. Only the fan-shaped access from Point G, directly corresponding with part of route 683, has been identified as matching part of the claimed DMMO network.

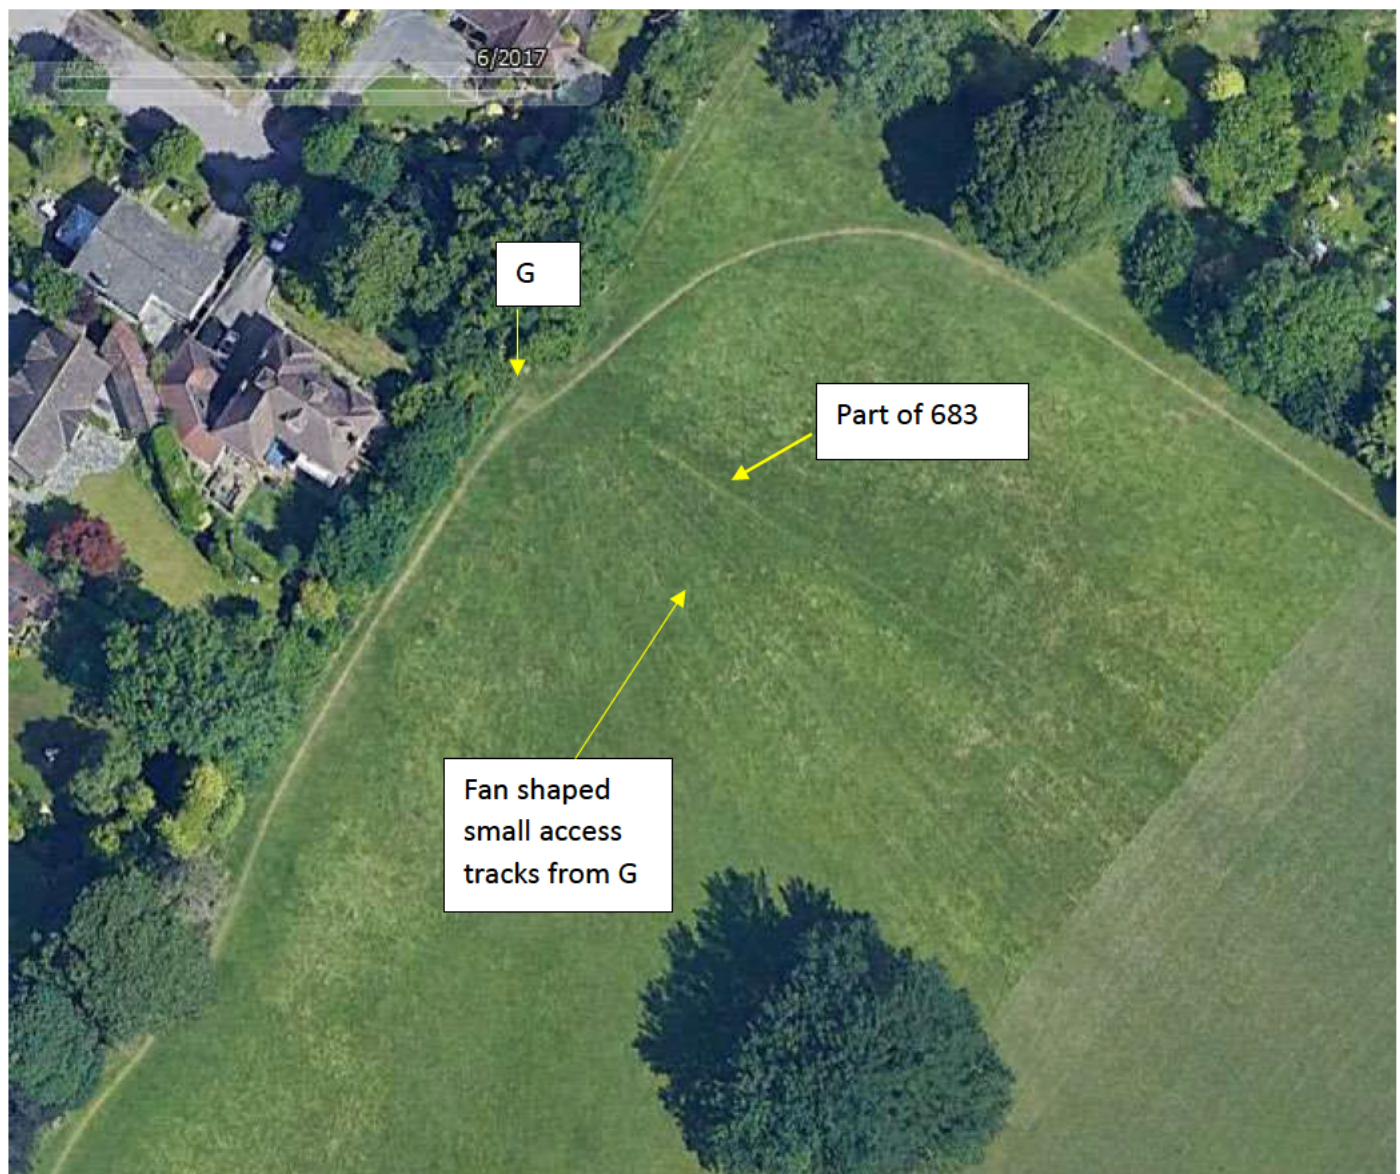
**FIGURE 35: 17 JUNE 2017 NORTHWEST OF SITE**

167. Figure 35 shows well defined tracking around and across the northwest part of the site.

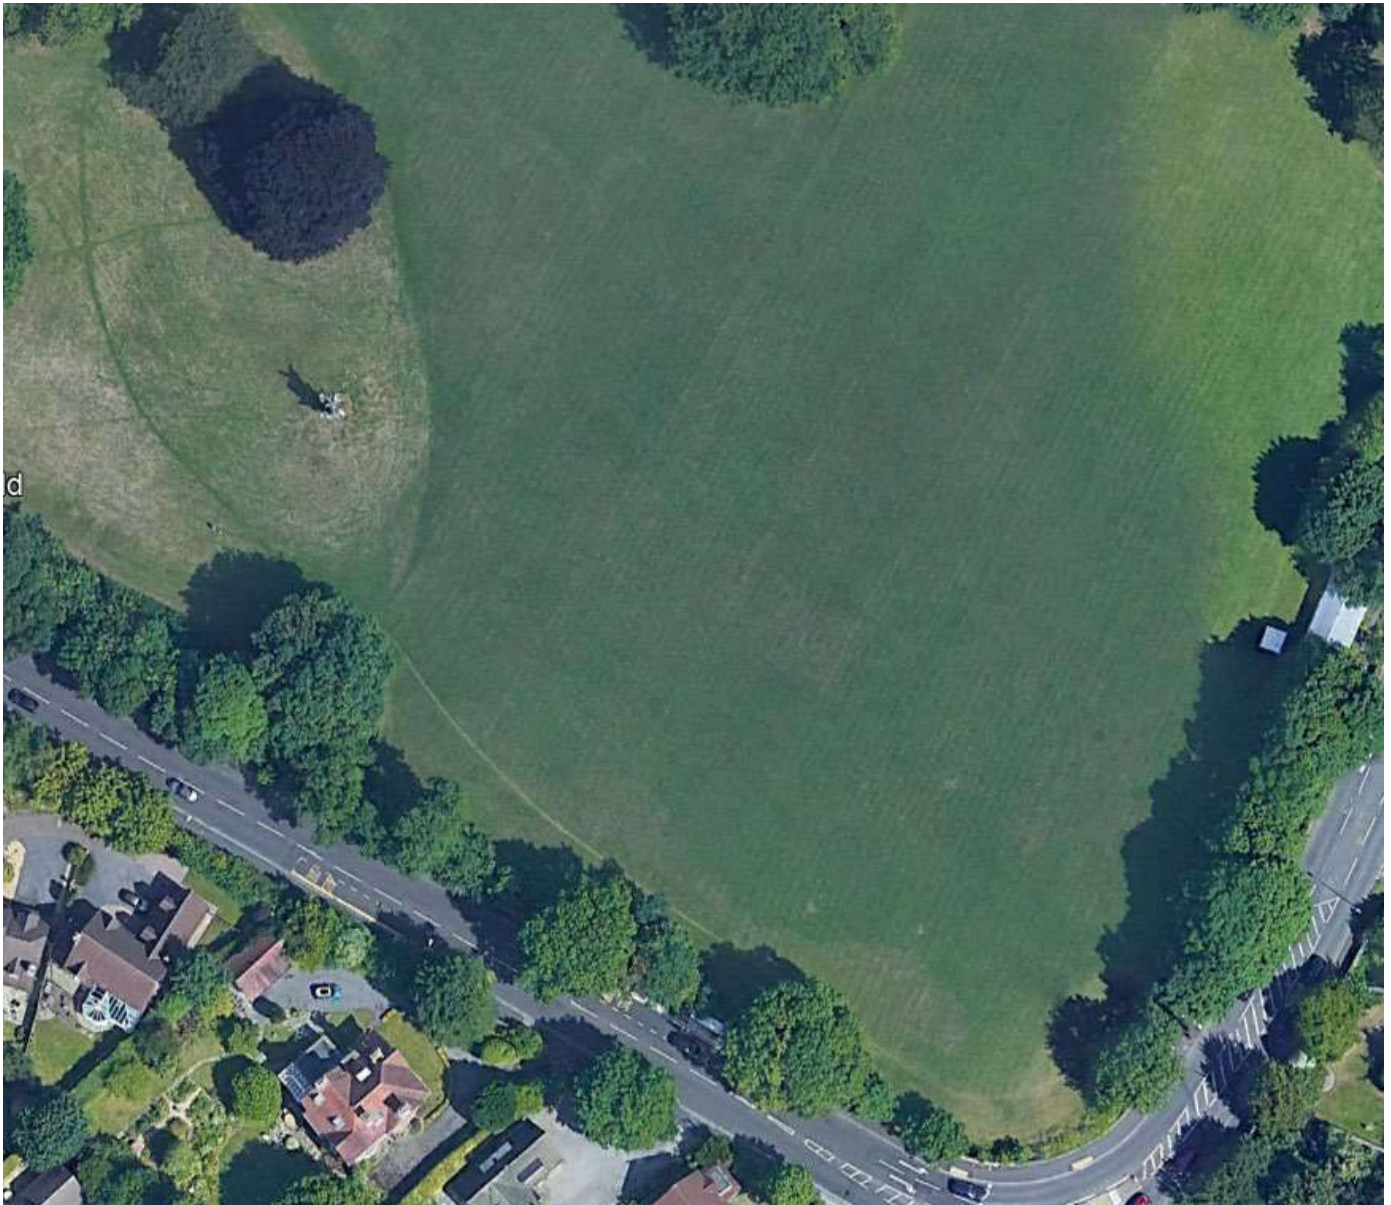
**FIGURE 36: 17 JUNE 2017 SOUTHEAST OF SITE**

168. **Figure 36** shows tracking around the southeast part of the site. Notably again there was no tracking to Point A, in a maintained grassed area which is receptive to showing tracking wear if it had been present.
169. It is notable that only the northeastern part of route 683 was visible as a worn line. If the remainder of the routes had been walked, then these would also have been visible, which they
