**EVIDENCE FROM AERIAL PHOTOGRAPHS AND SATELLITE IMAGERY  
STOKE LODGE PLAYING FIELDS, WEST DENE, STOKE BISHOP, BRISTOL, BS9 2BH**

**STATEMENT OF CHRISTINE DIANE COX BA MA MCIFA FSA**

**DATE** : 07 SEPTEMBER 2026

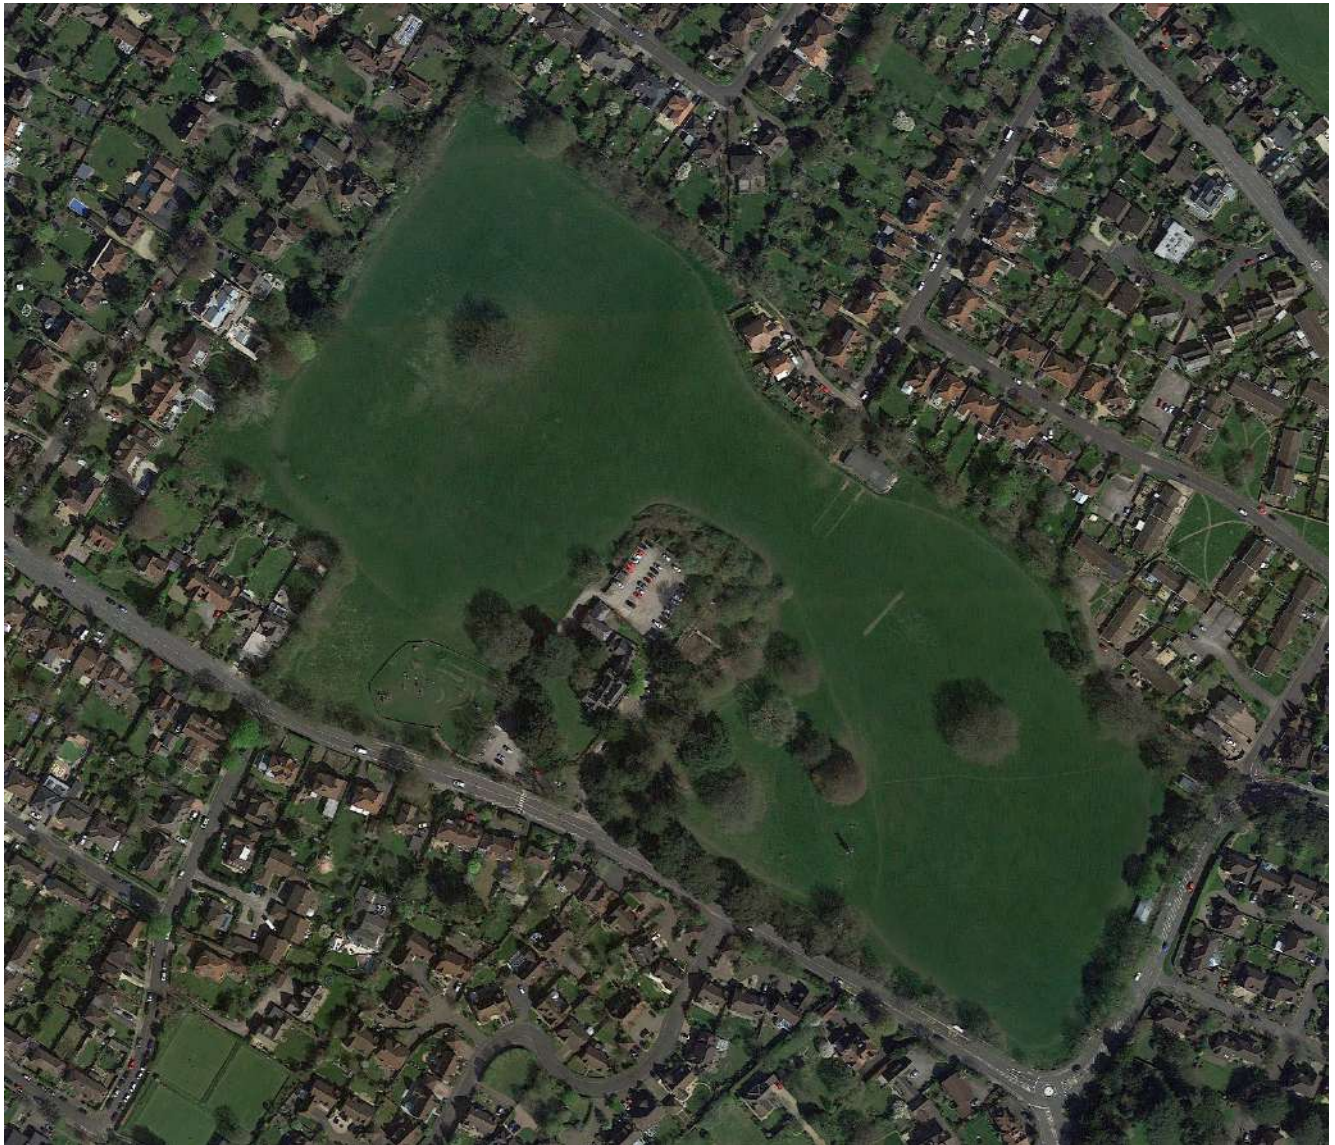
**FIGURE 37: 19 APRIL 2018**

171. No access was visible along or around any of the claimed DMMO routes in April 2018.

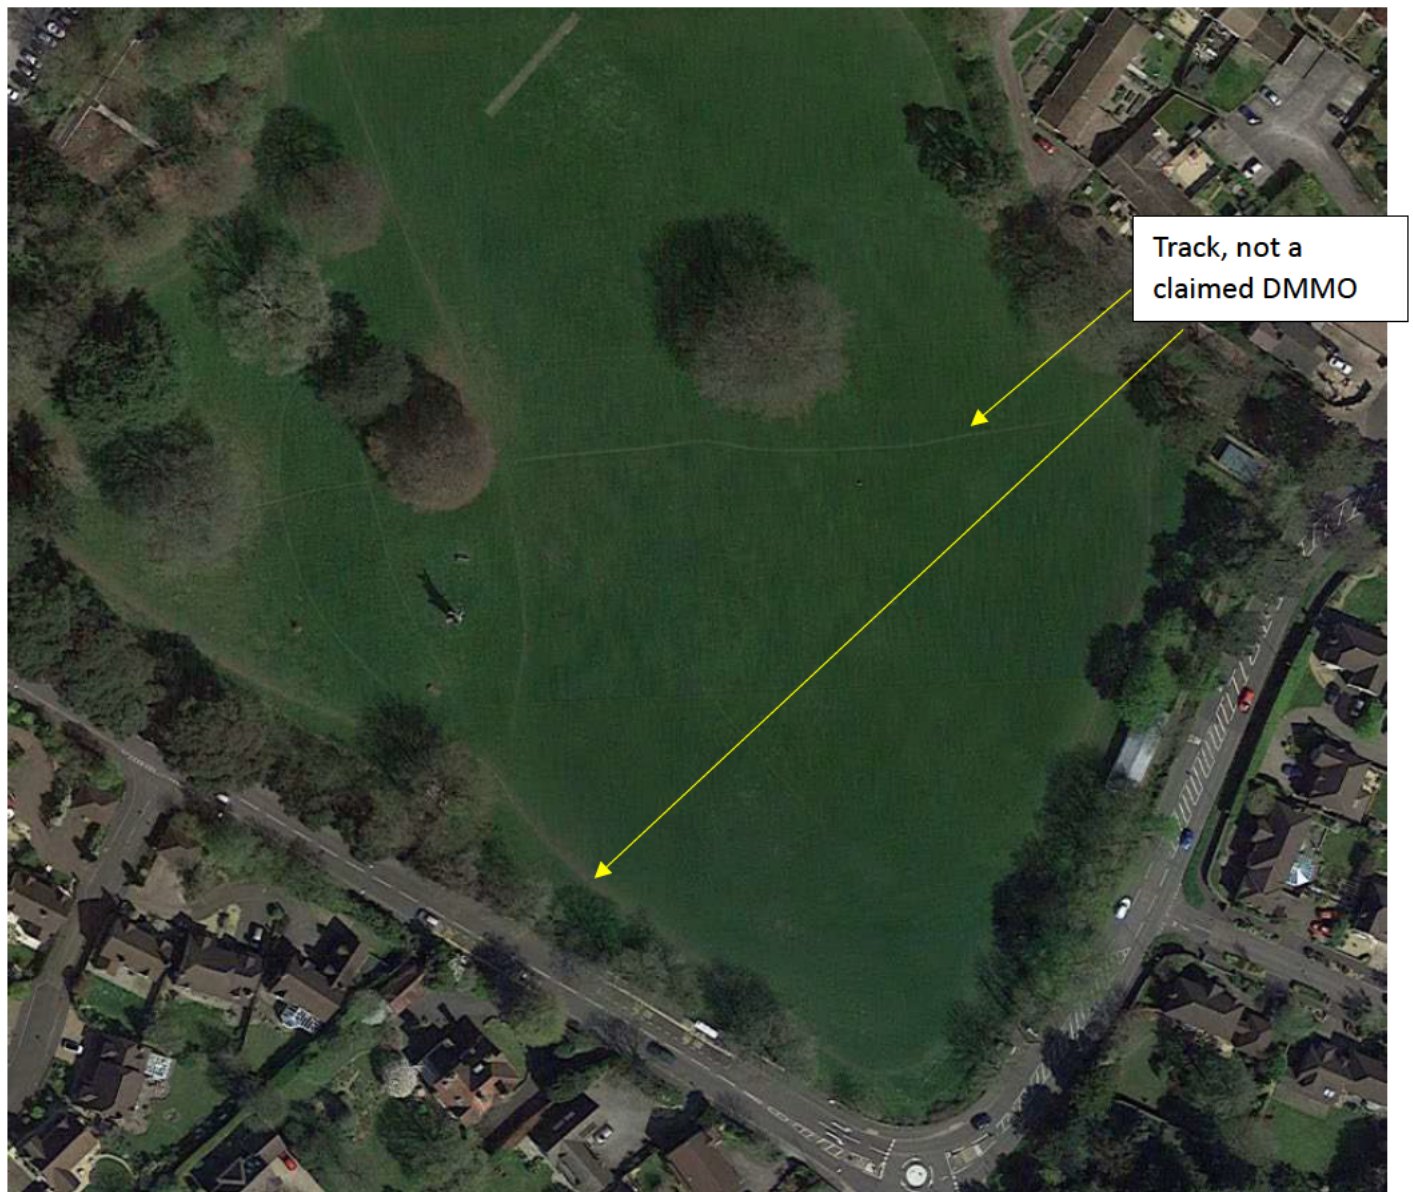
**FIGURE 38: TRACKING ACROSS THE SOUTHEAST SECTOR IN APRIL 2018**

180. Tracking extends to the southeast part of the site in April 2018, when access around Stoke Lodge area is also evident. This is shown in **Figure 38**.

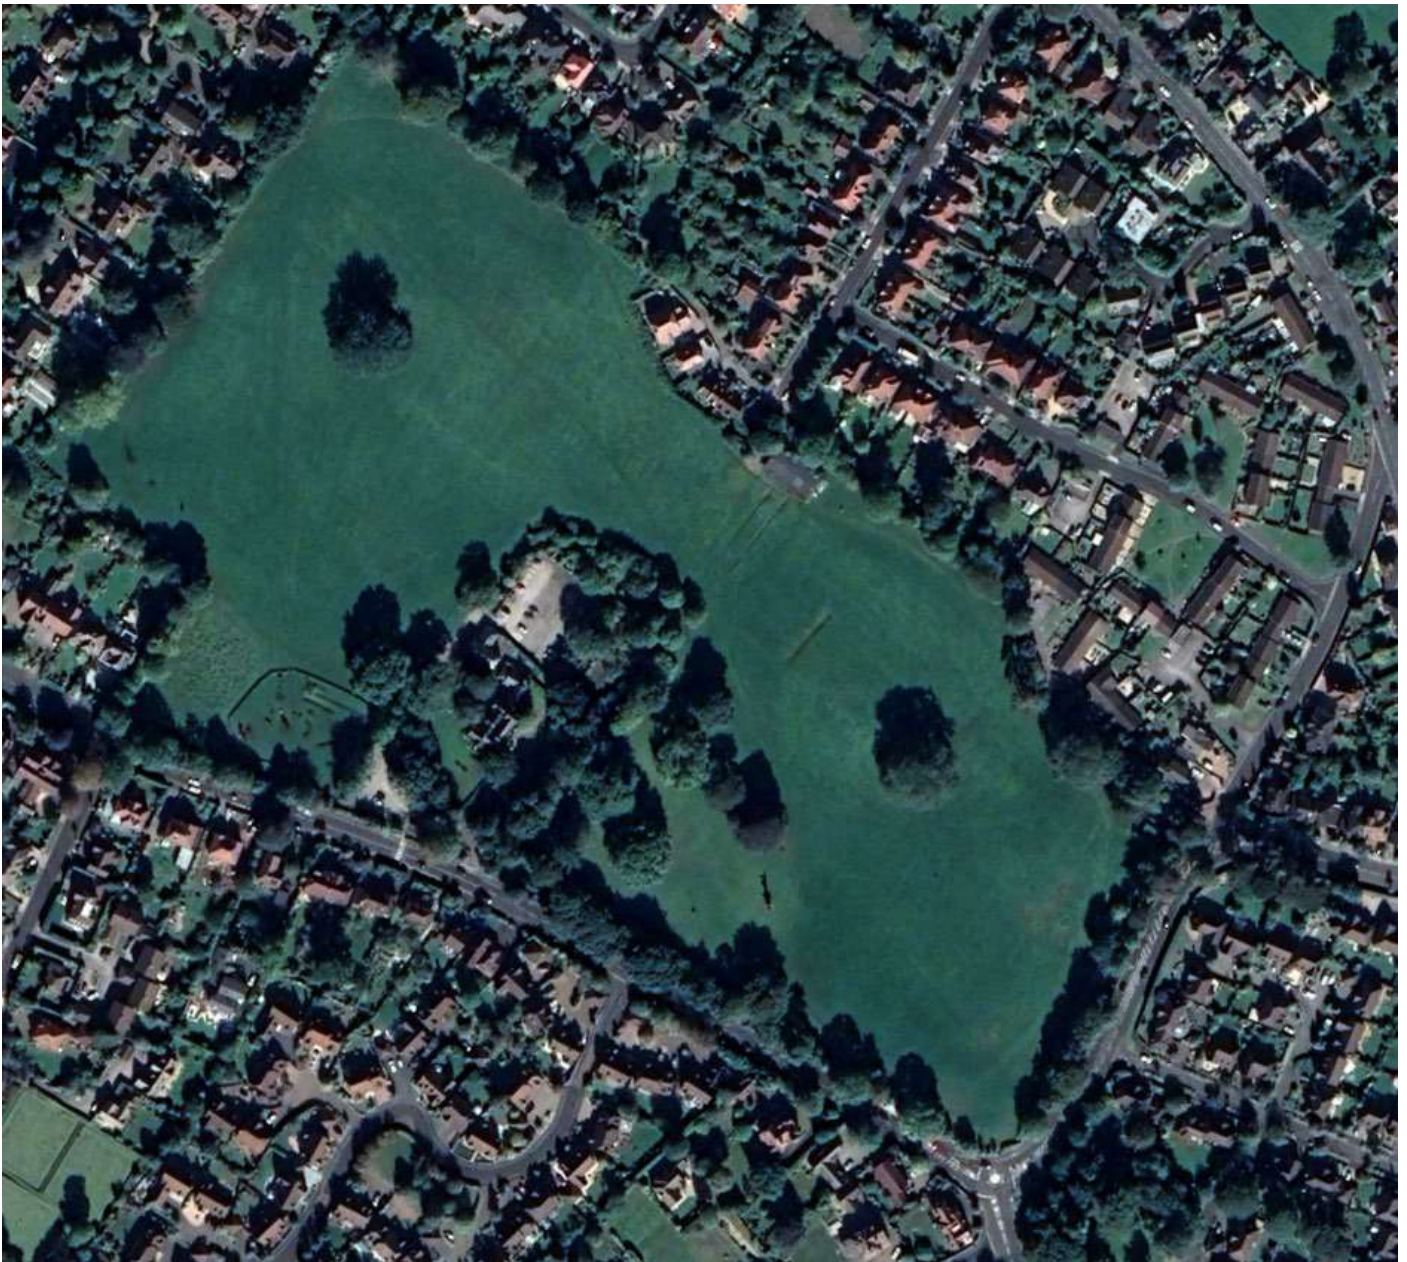
**FIGURE 39: 27 SEPTEMBER 2018**

173. No sports markings were visible and the athletics jumping areas were grassed over and visible as indentations in the ground.

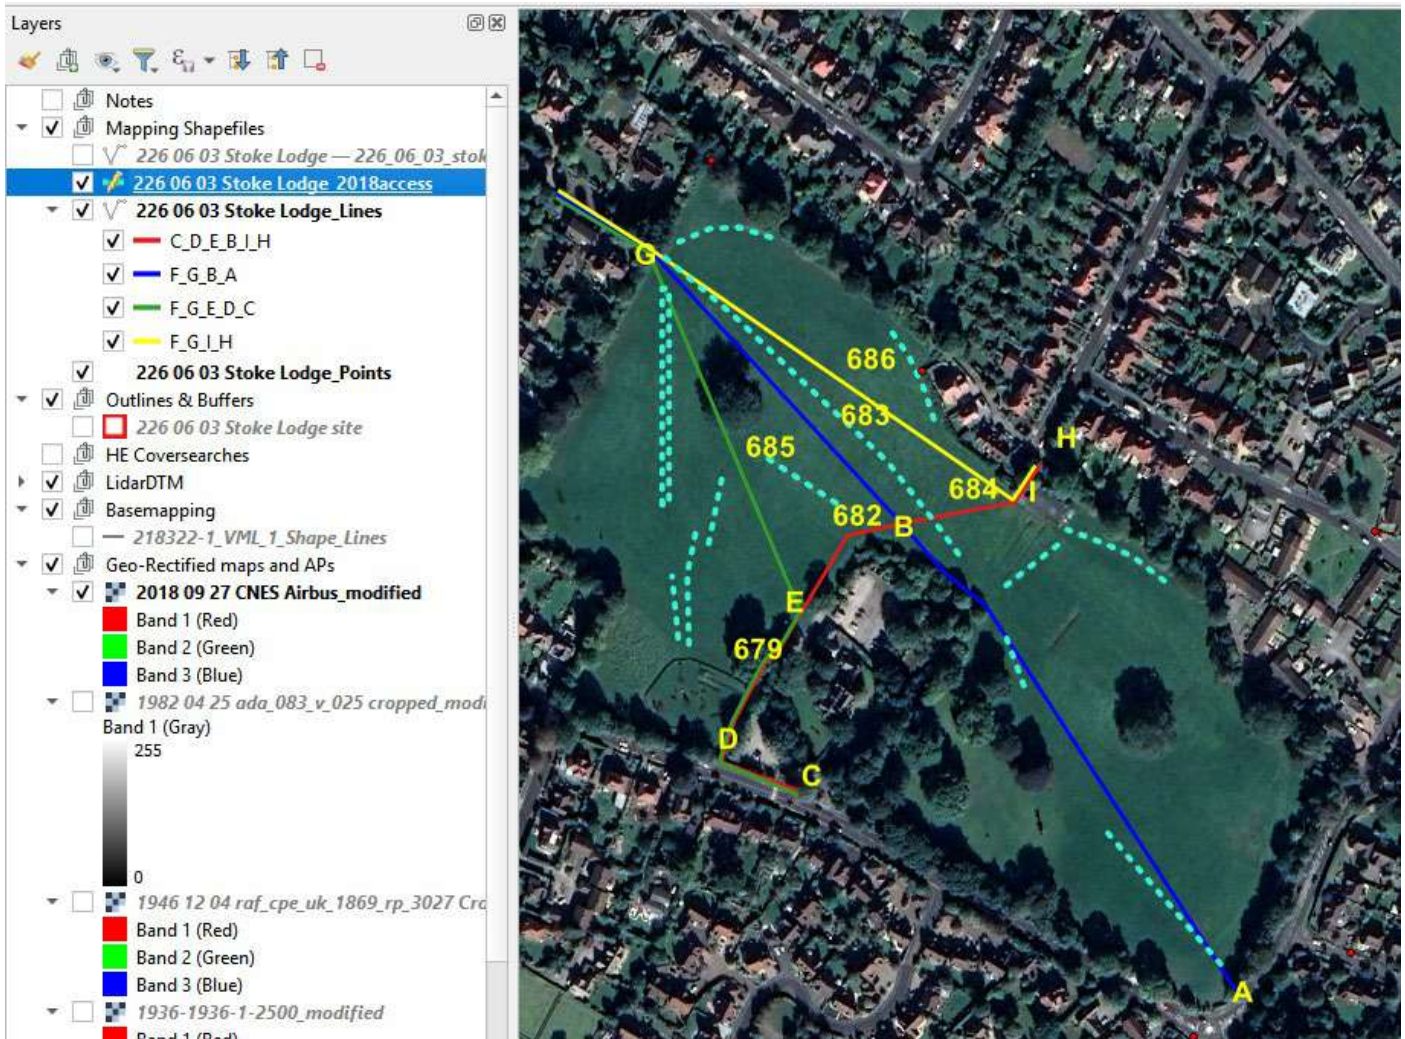
FIGURE 40: VISIBLE WEAR IN SEPTEMBER 2018

174. In **Figure 40**, the cyan coloured dashed lines show the visible linear tracking in September 2018 compared to the numbered claimed DMMO lines.

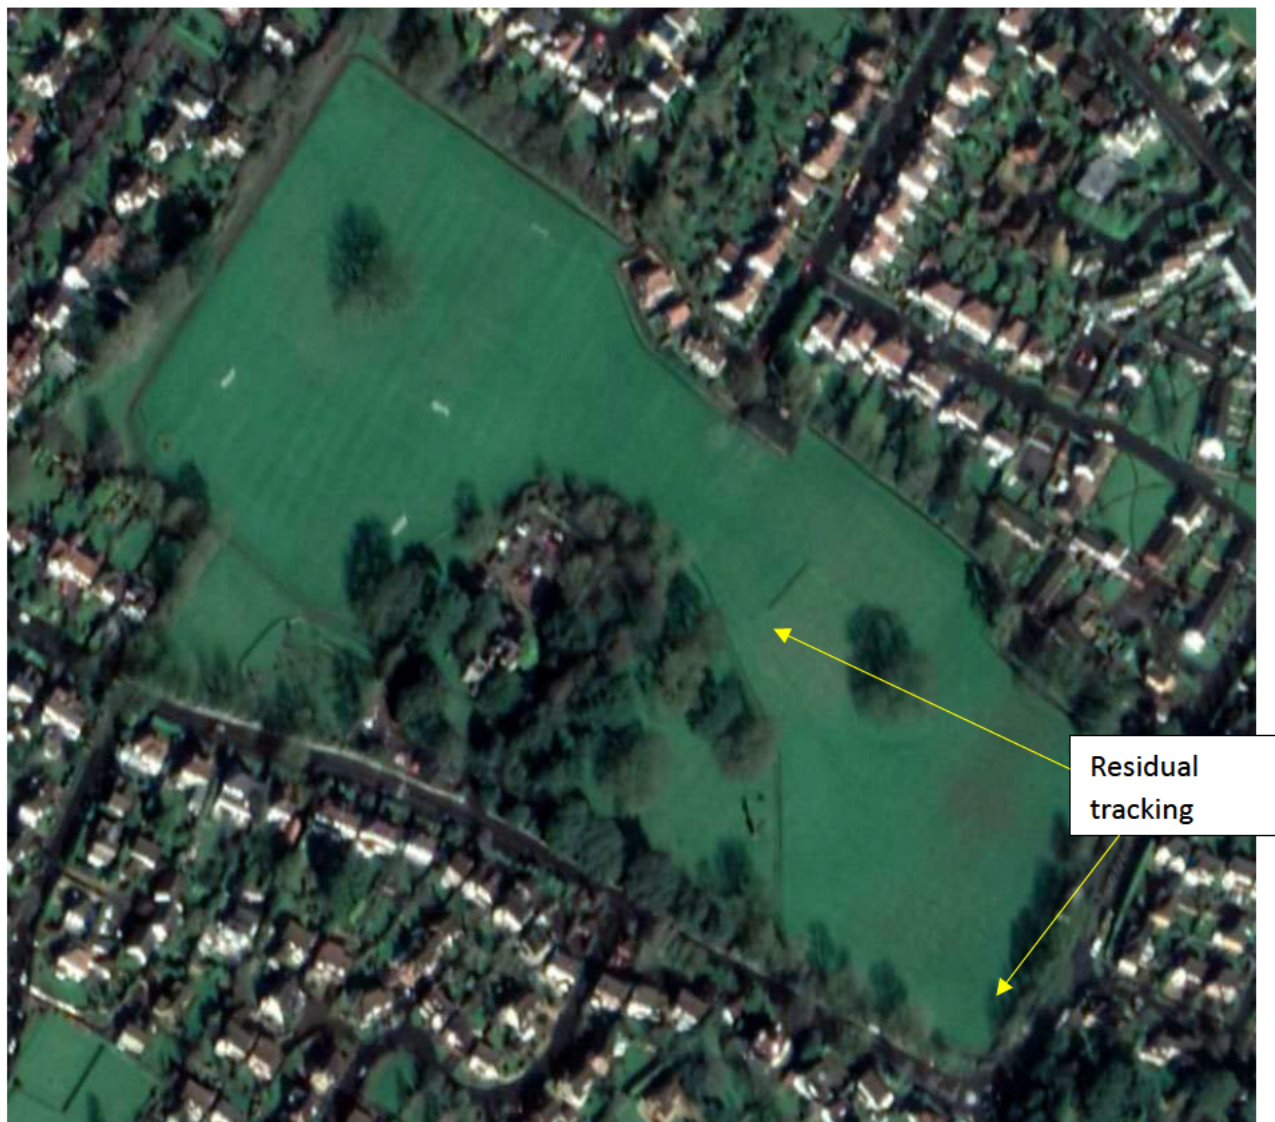
**FIGURE 41: 25 FEBRUARY 2020**

190. This 2020 lower resolution satellite image, **Figure 41**, shows the site had by this date been bounded.
191. There was some residually visible, not likely current, tracking between B and A.
192. Light toned linear features are likely to be ball sports goals, likely for football.

194. The grass was short and maintained.

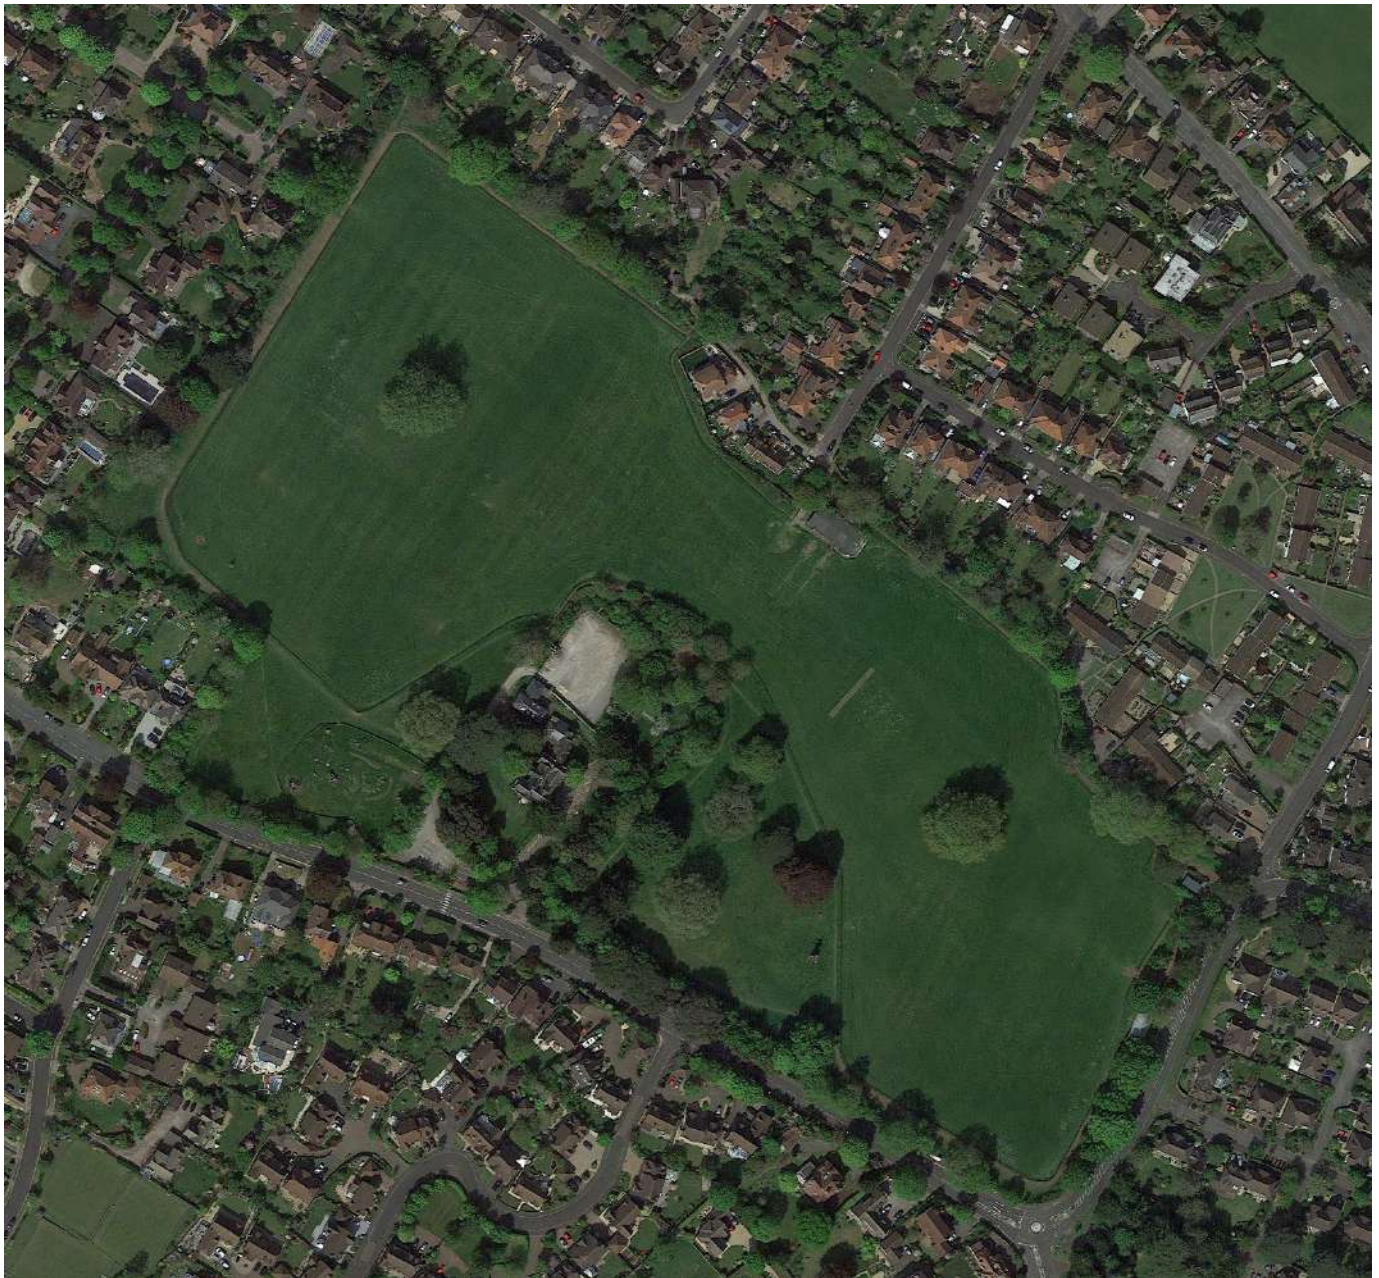
**FIGURE 42: 23 APRIL 2020**

193. **Figure 42** shows that the site was bounded in April 2020 with no signs of current pedestrian tracks or access, at the end of the winter football season. There are some signs of residual tracking from points G to B. Worn tracking outside the site boundary around the area was visible.

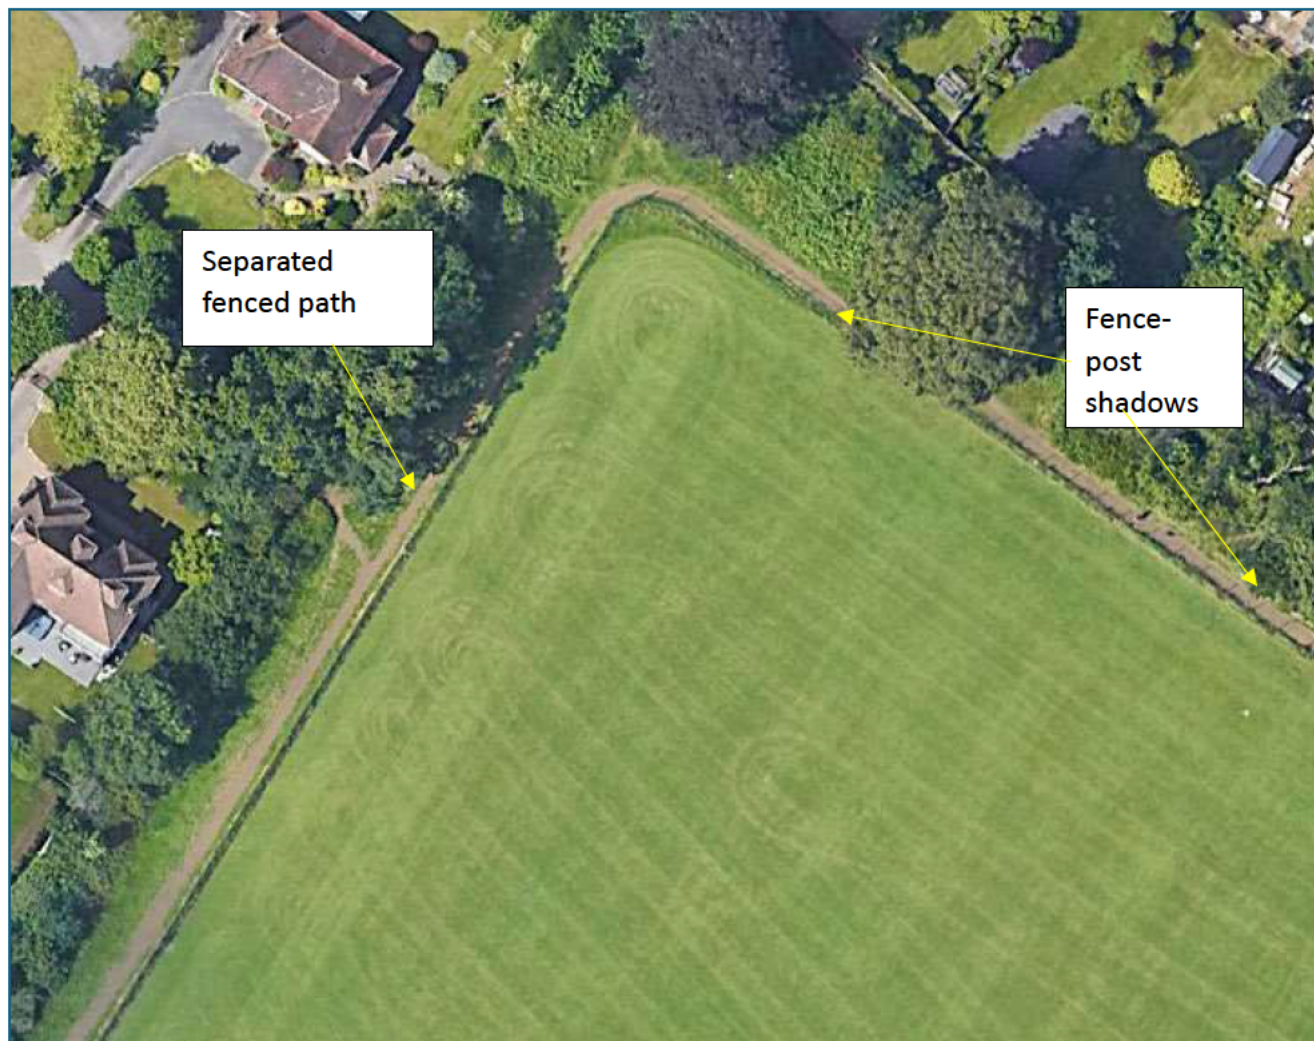
**FIGURE 44: FENCE AND PERIMETER PATH IN 2021**

196. Fence post shadows were variably visible when they cast shadows in the sunlight which shone from the south, as exemplified in **Figure 44**.

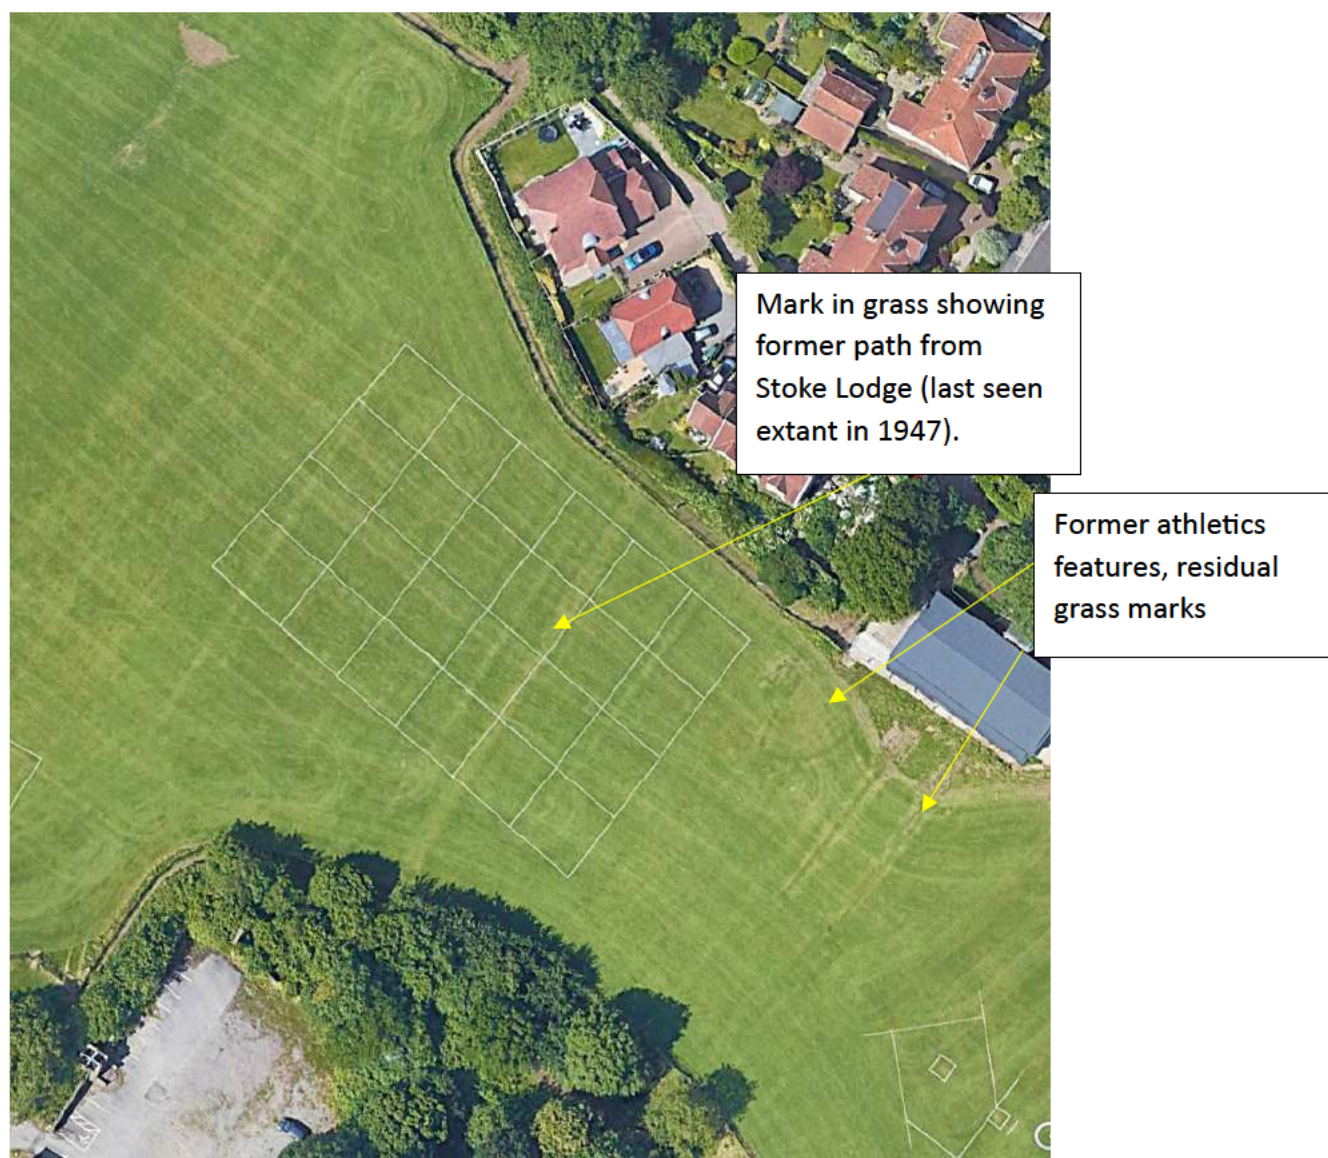
FIGURE 45: MARKS IN THE GRASS SHOWING FORMER FEATURES

197. Extensive ball sports and athletics markings are present.
198. A group of people congregate around the end of a running track in the southeast of the site.
199. Some residual grass marks show the site of former surfaces or compacted areas to the north of Stoke Lodge, alongside some temporary now disused athletics features as shown in **Figure 45**.

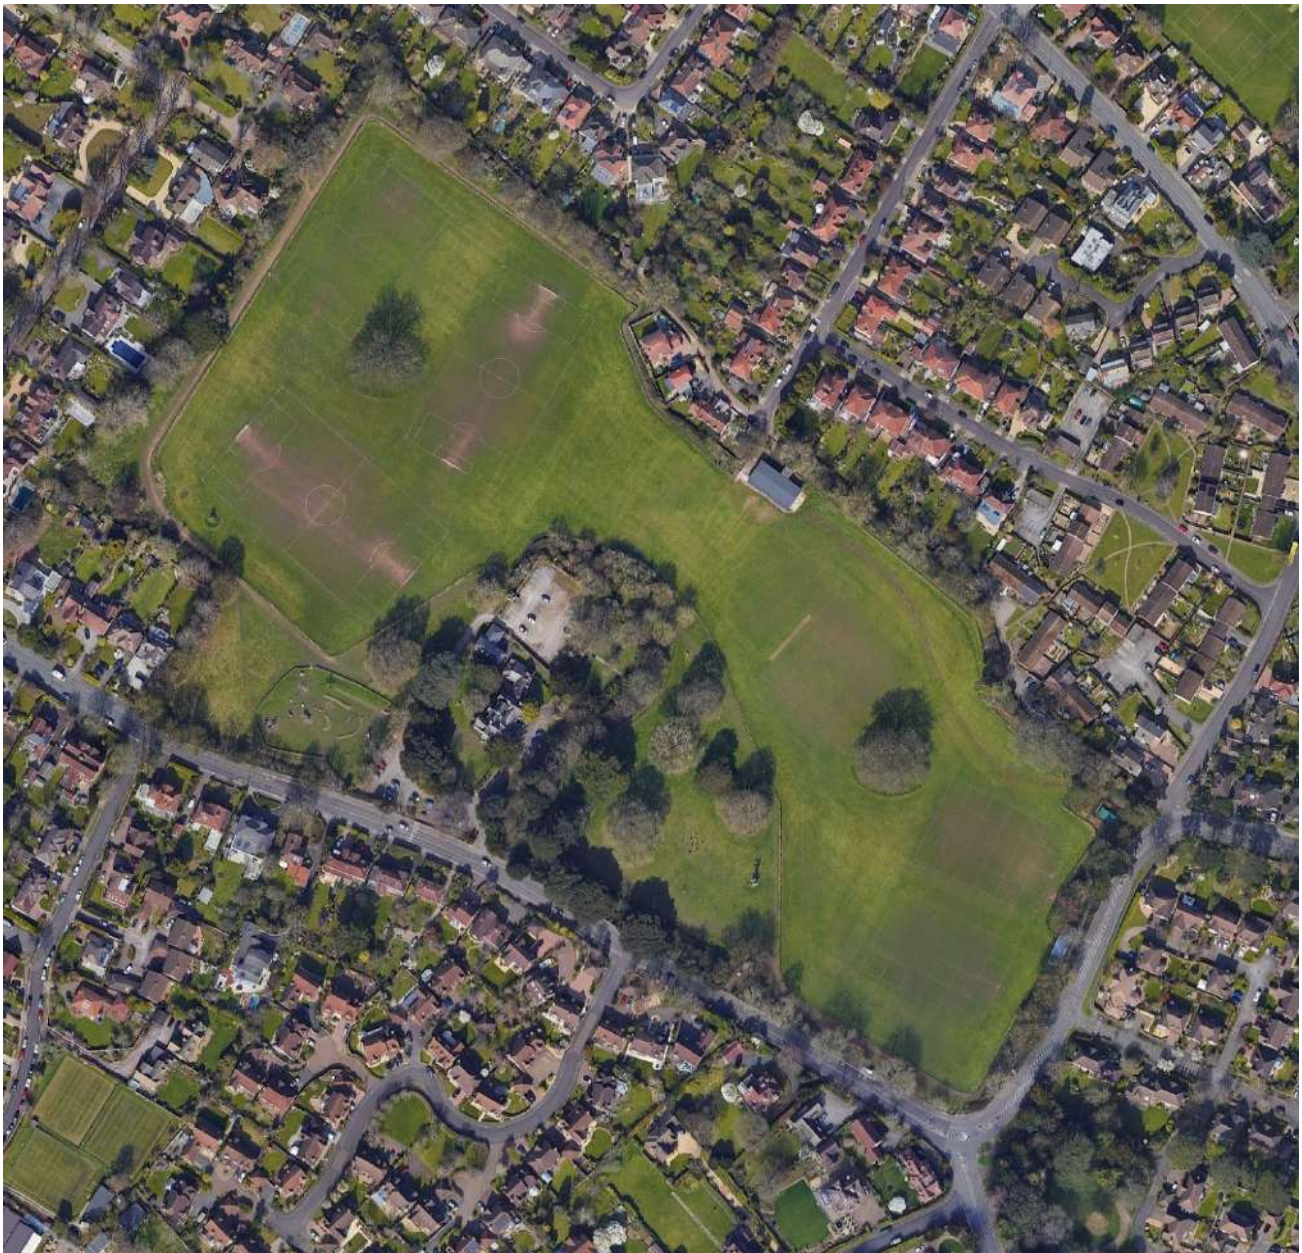
**FIGURE 46: 12 MARCH 2022**

201. In 2022, the boundary and active sports markings and surface wear associated with playing sport over a receptive surface which shows wear when crossed or played on were visible.
202. The site was used for active sports and no trace of active crossing from external points or wear over the claimed DMMO routes was evident.

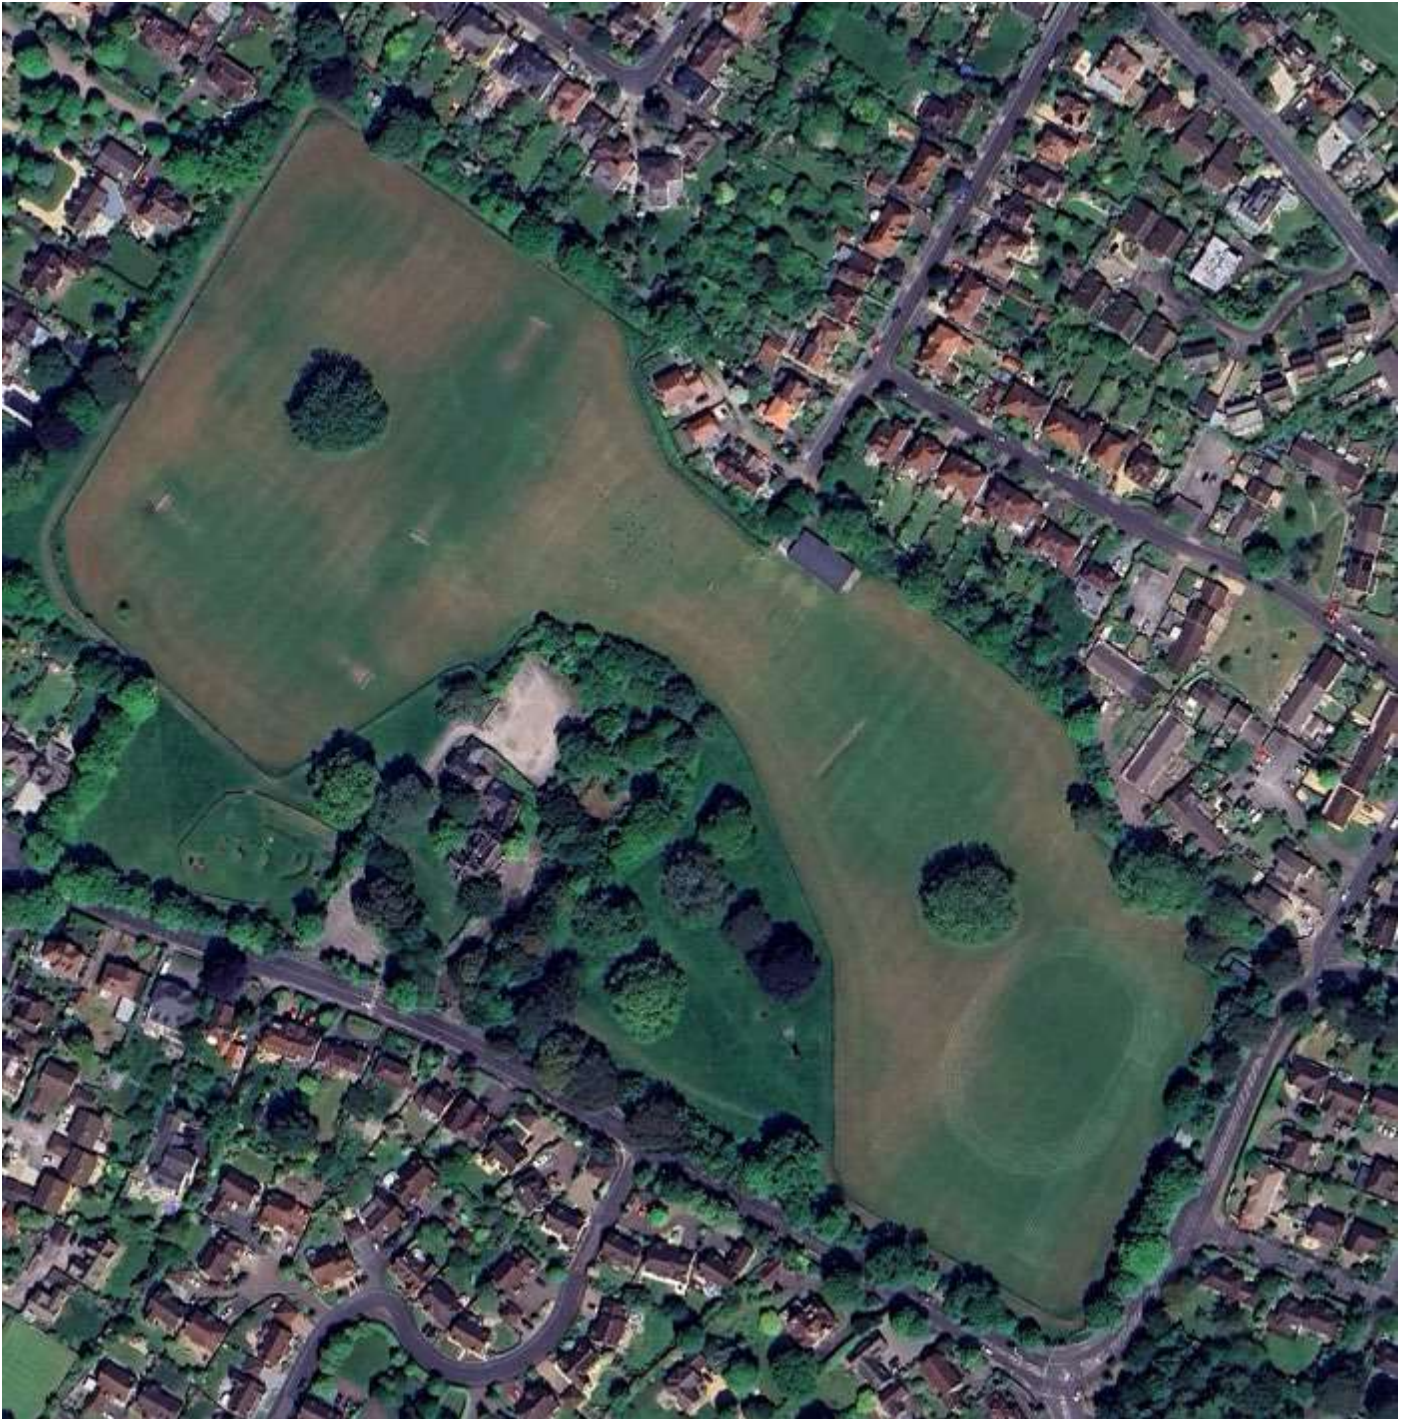
**FIGURE 47: 20 MAY 2023 (1 OF 2)**

205. No evidence for external access or tracking was visible and would indeed have had to traverse the active sporting areas if present.
206. There are no traces of tracking corresponding with the claimed DMMO routes across the site. A separate higher-resolution Bluesky aerial image, also captured on 20 May 2023, confirms the intensive sporting use and players visible on the site. **Figure 47** derives from the Airbus satellite acquisition, while **Figure 48** and **Figure 49** derive from the separate Bluesky aerial acquisition.

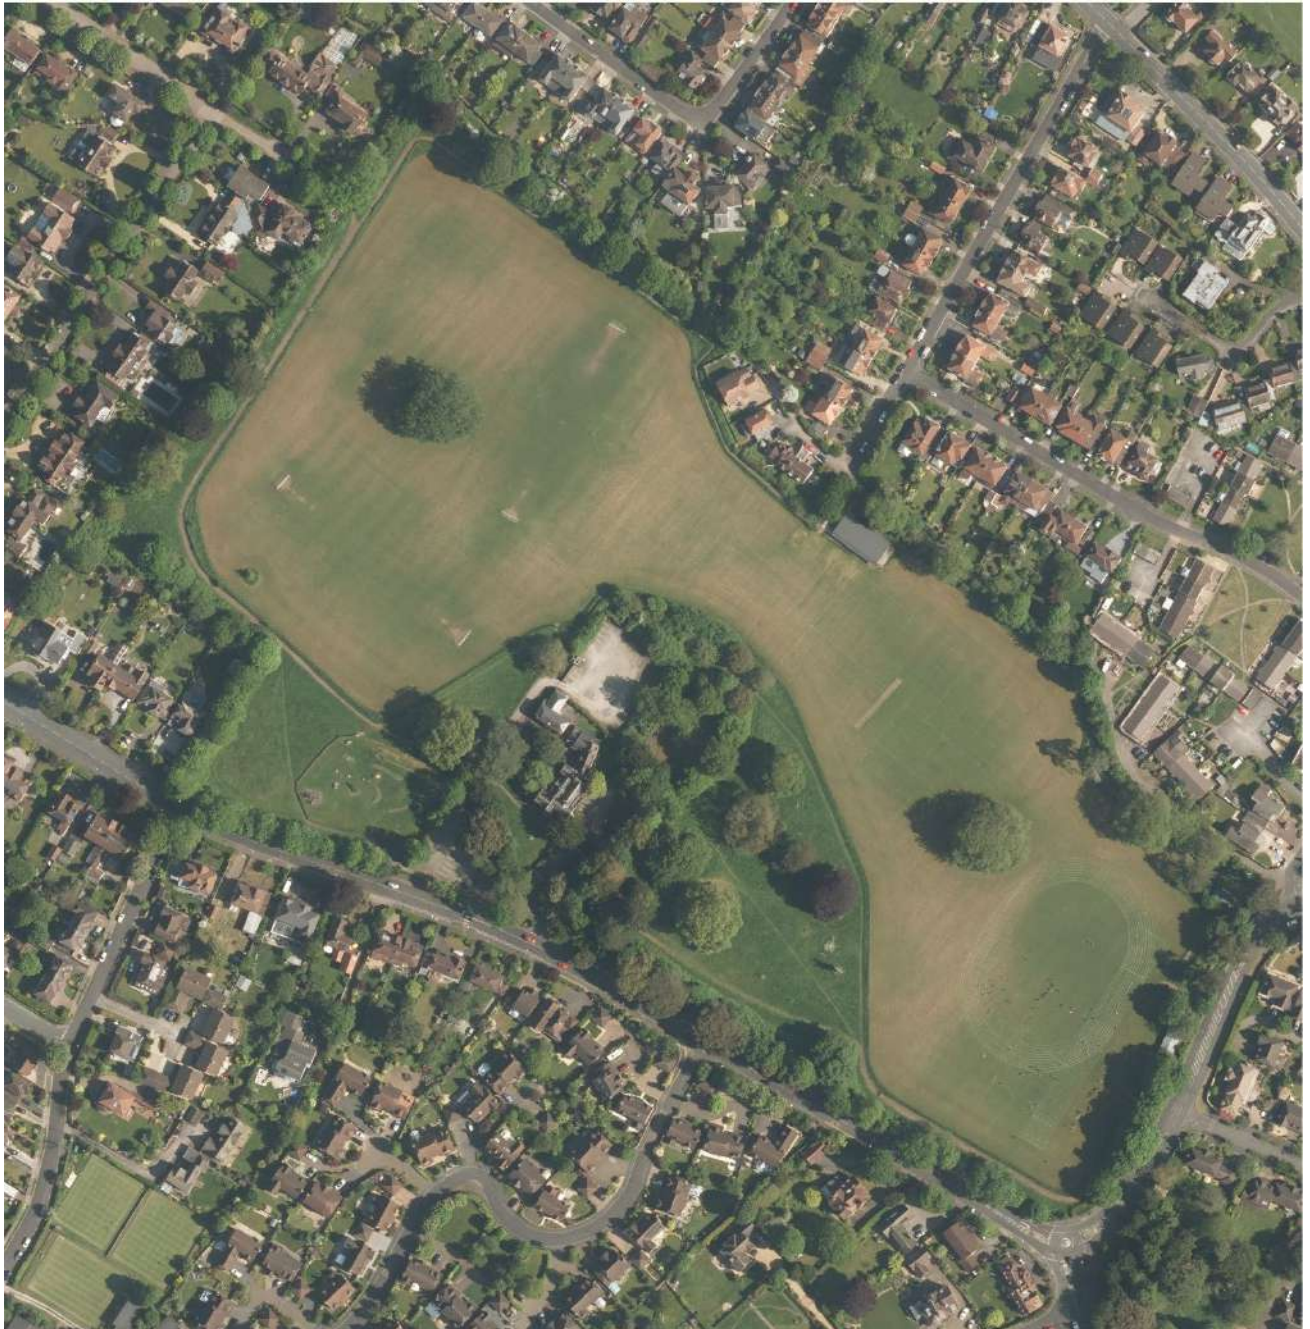
**FIGURE 48: 20 MAY 2023 (2 OF 2)**  
©Bluesky International

207. Notably, a group of people, likely engaged in active sport, was present in the southeast sector of the site on 20 May 2023, which would have been traversed by route 683 (blue). This is shown in **Figure 48** and **Figure 49**.

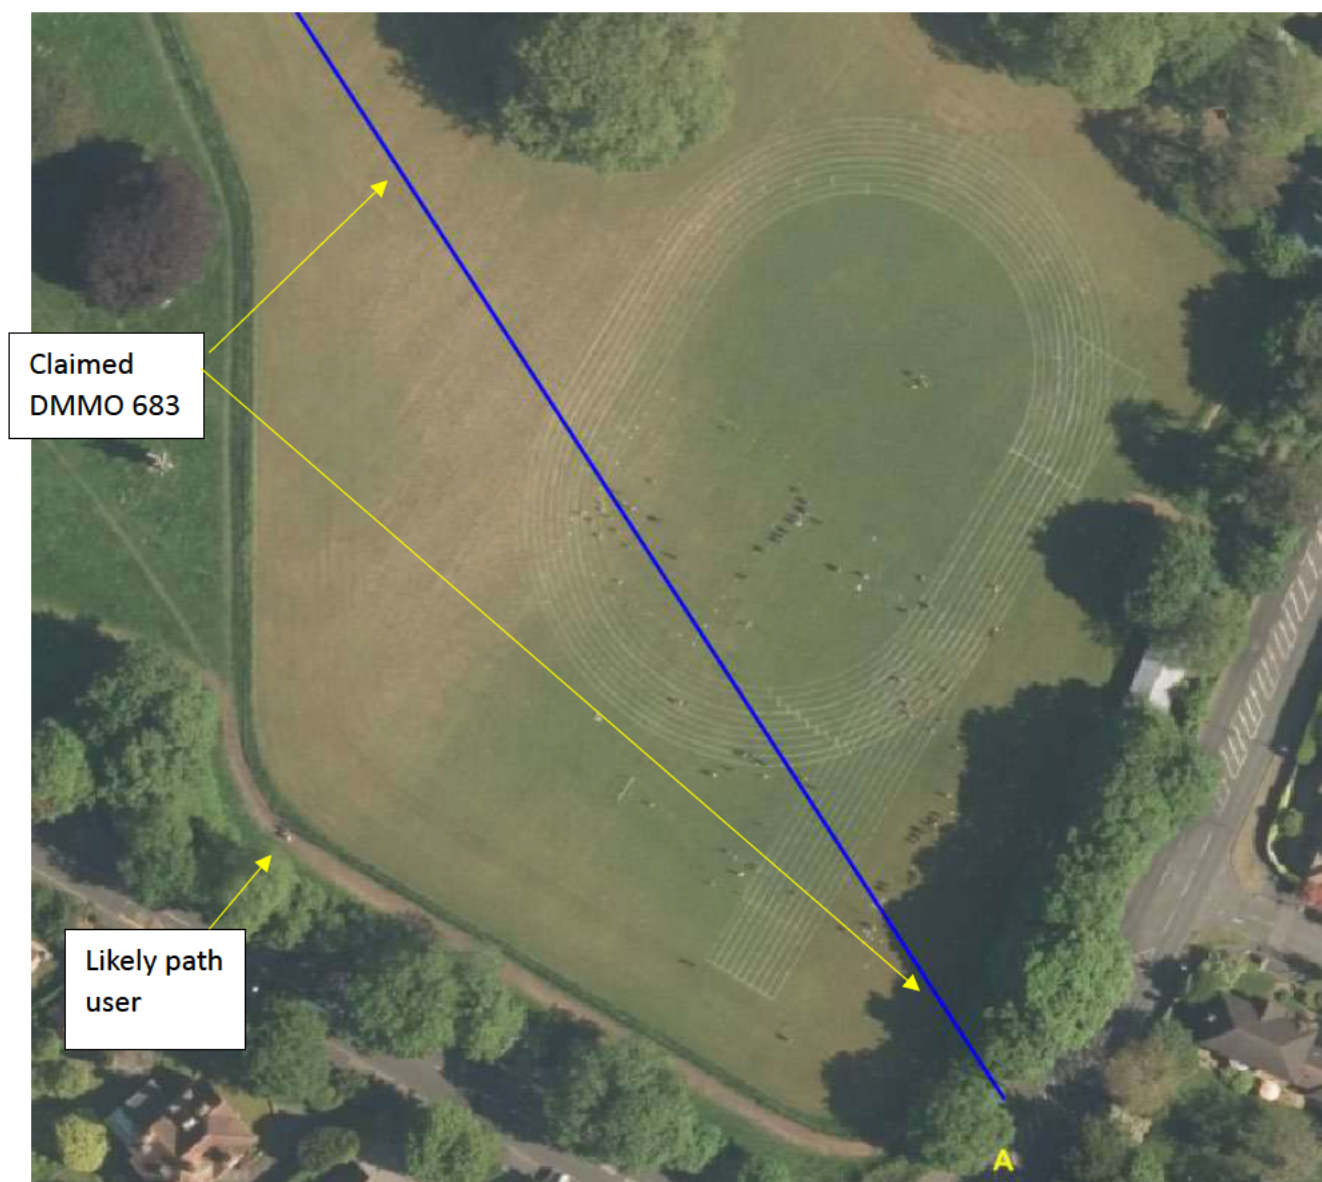
FIGURE 49: ACTIVE SPORTS ON 20 MAY 2023

208. Figure 49 shows active sports players within the claimed blue route 683, and a likely person on the path around the site outside its boundary.

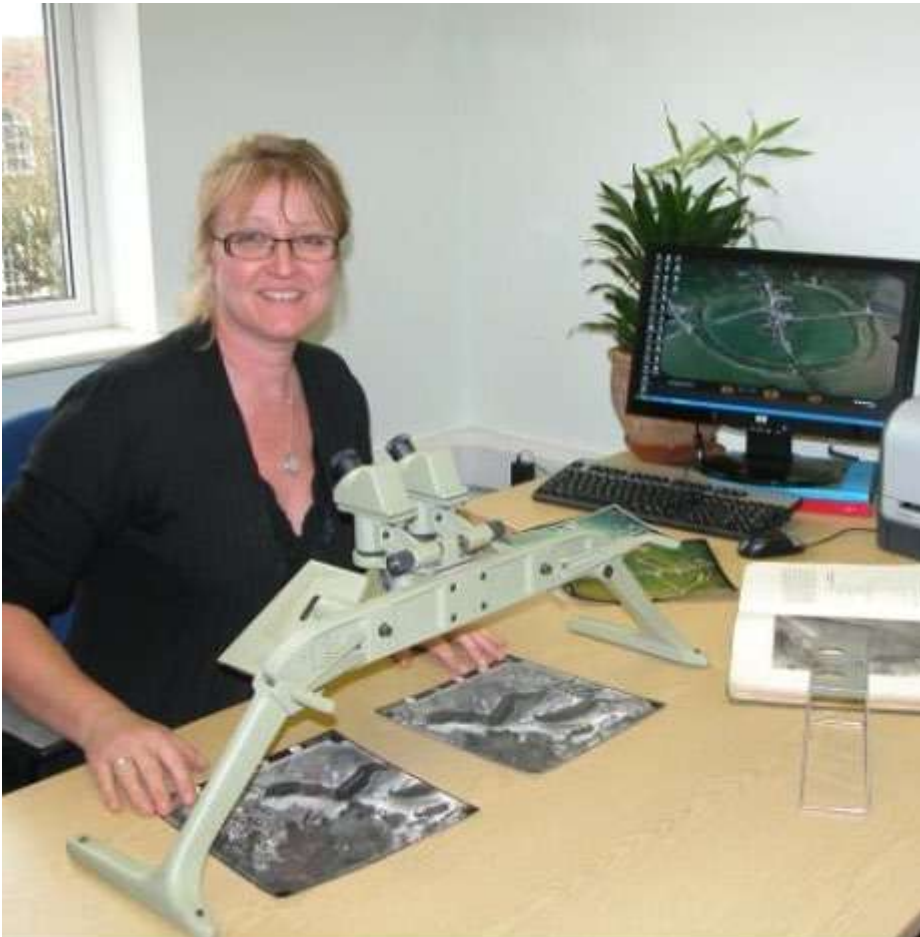
**FIGURE A2. 1 STEREOSCOPE IN USE**

257. Stereoscopic viewing uses a pair of overlapping aerial photographs to create the perception of three-dimensional terrain and surface features. Vertical aerial photographs are normally acquired with sufficient forward overlap to allow successive images to be examined stereoscopically.
258. Mirror stereoscopes enable the interpreter to view the overlapping image pair simultaneously, allowing subtle variations in relief, earthworks and other surface features to be examined in three dimensions. Digital imagery can also be examined stereoscopically using specialist software where suitable image coverage is available.
259. The following figures illustrate the principle of stereoscopic overlap and examples of the equipment used by Air Photo Services for stereoscopic examination of aerial photographs.

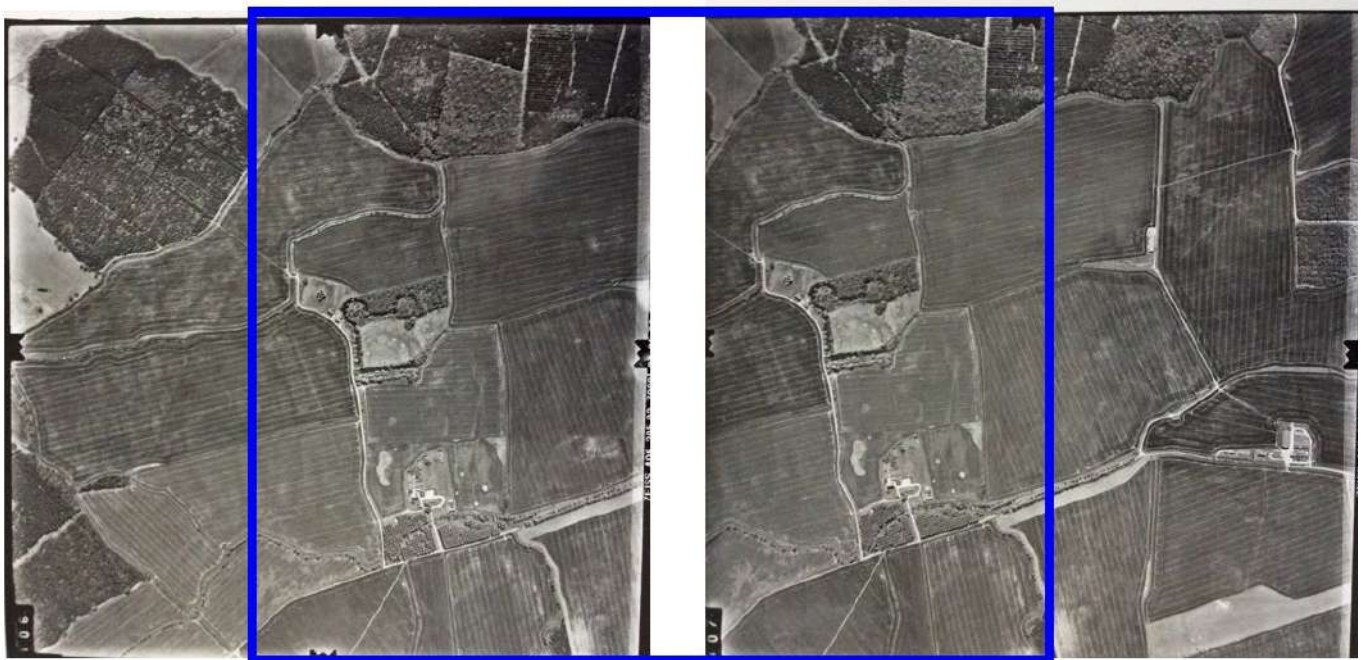
**FIGURE A2. 2 OVERLAPPING PHOTO PAIR**

Area of overlap between images allows stereo viewing
