Aztec West Business Park, South Gloucestershire

Retention ponds and detention basins, with fountains, to promote the aerobic degradation of hydrocarbons

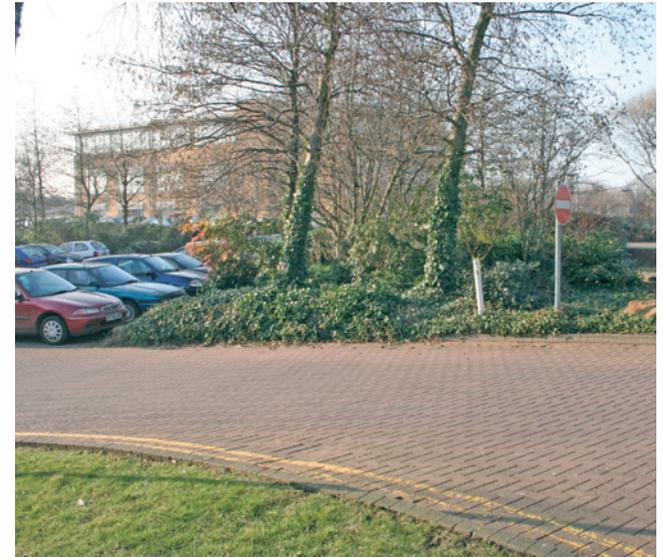
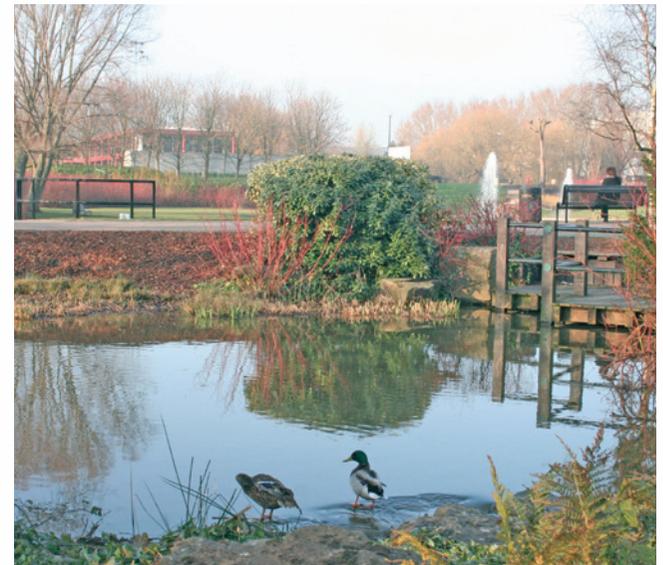
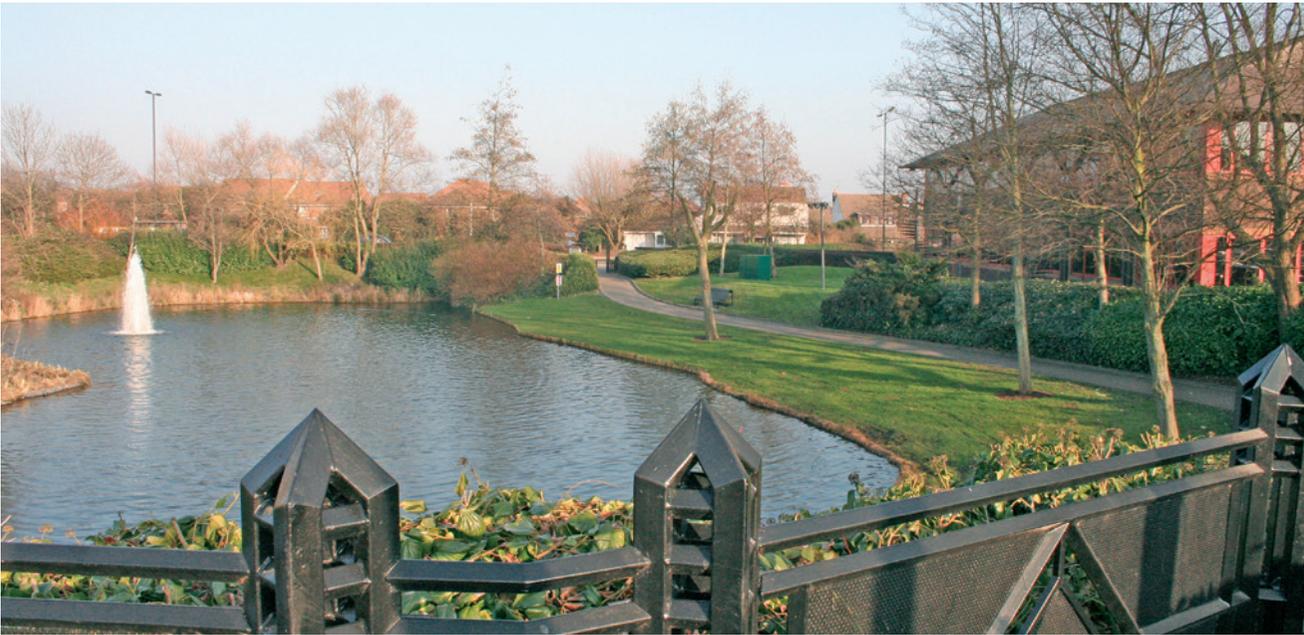
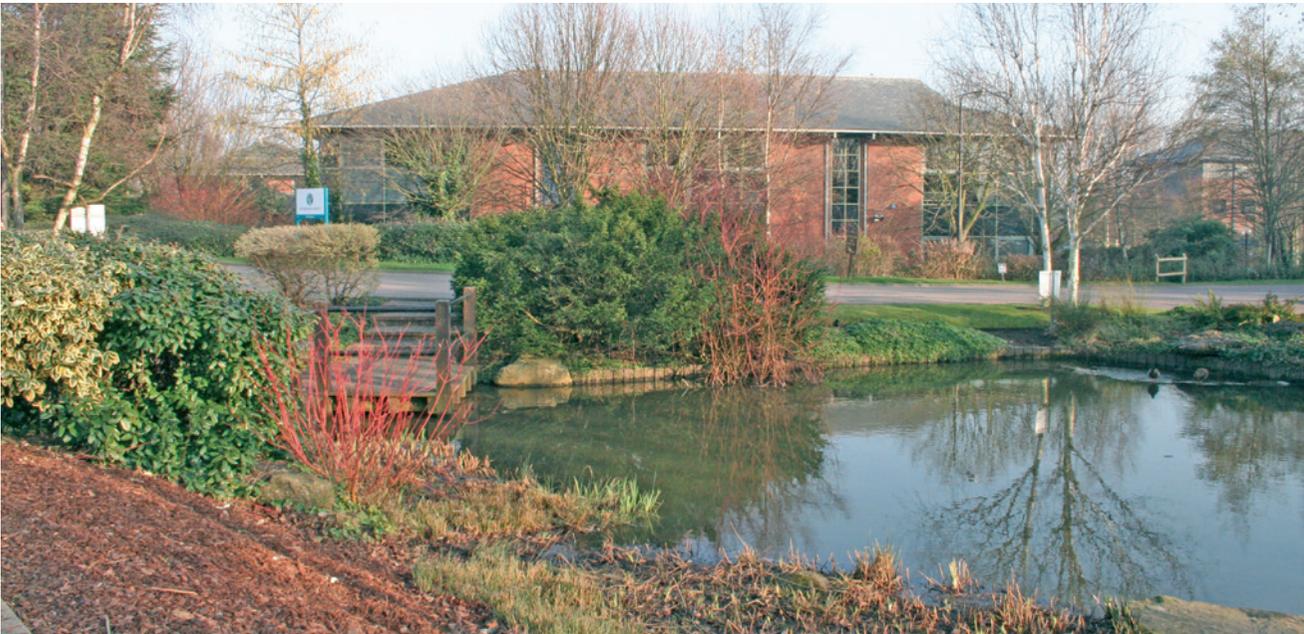
The local authority dictated a limited flow rate of site discharge. The client endorsed and encouraged this solution, whereby excess water is dealt with in a high quality, aesthetically pleasing way. The site has a series of ponds arranged in series, two retention ponds with permanent water and then a detention pond which remains dry most of the time.

The large amenity ponds were fed from road and car park drainage. Instead of costly oil separators to pre-treat runoff, large ornamental fountains were installed to aerate the water and promote breakdown of hydrocarbons.

The SuDS are an integral part of the landscaping, provide amenity and added value to the office development. The area provides an amenity for office workers. The ponds were stocked with carp and silver fish, with some being subsequently removed due to overpopulation. There are normally a large number of wildfowl in the vicinity of the ponds.
