## **Pedestrian & Cycle Audit**

# Technical Note

<b>Title</b>	Brislington Meadows - Pedestrian Audit		
<b>Prepared by</b>	DRT	<b>Checked by</b>	DRT
		<b>Reviewed by</b>	
<b>Date</b>	September 2021		<b>Version</b>

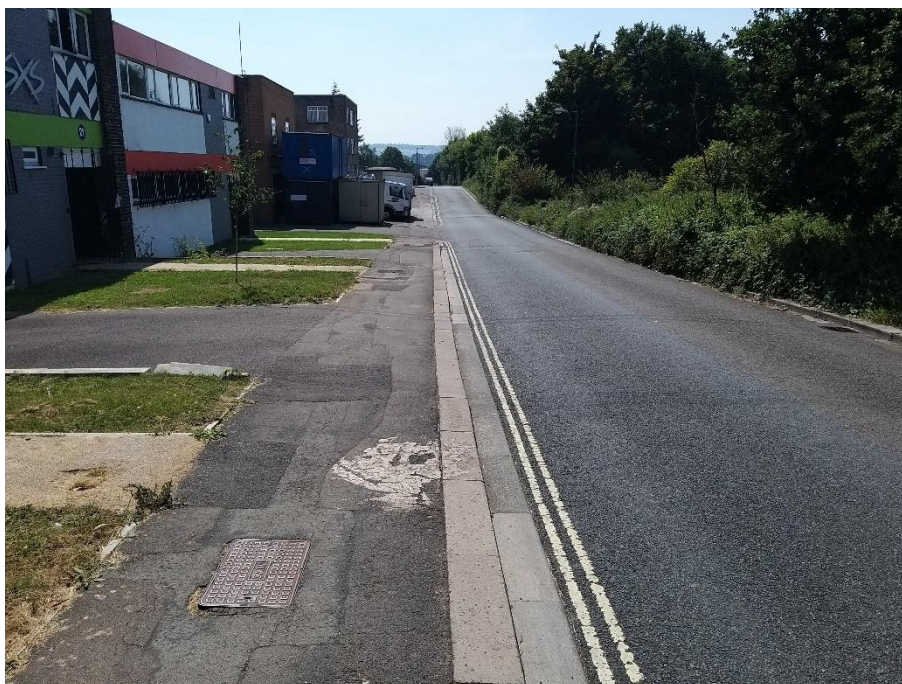
Image 1

- 2.1. The pedestrian route to Brislington Retail Park starts at the eastern boundary of the site, the precise location dependent on the site layout. Due to land ownership/highway boundary, the route would start with an uncontrolled crossing of Bonville Road as there is no room to accommodate a footway on the western side.
- 2.2. Bonville Road is lit and subject to a 20mph speed limit.
- 2.3. The footway along the eastern site is some 1.8m wide. Double-yellow lines on the eastern side help to prevent pavement parking. Buildings are set back from the back of footway with a grassed area with some off-street parking accessed by dropped kerbs.

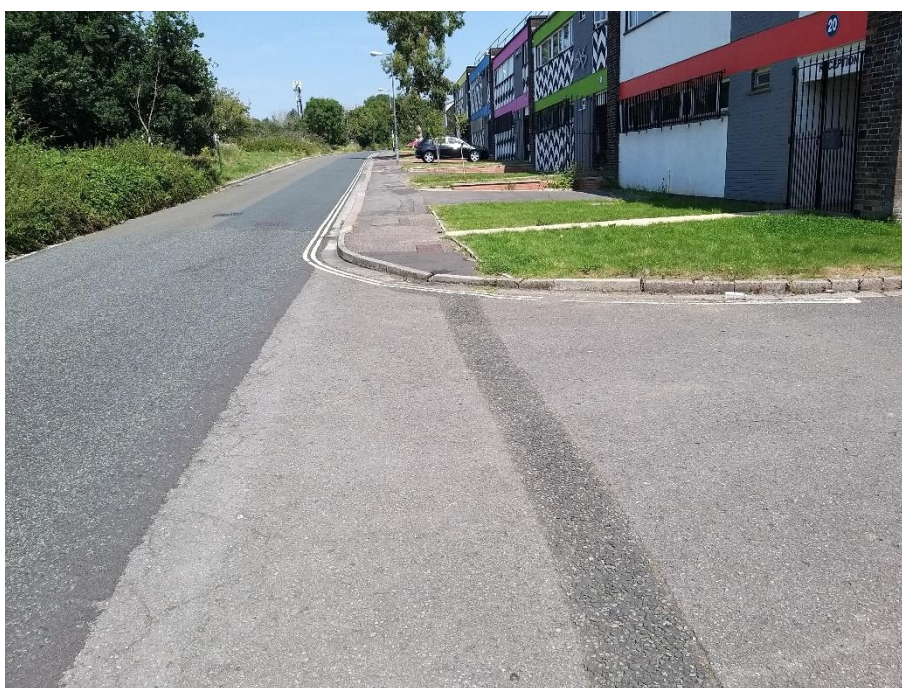
Image 2

- 2.4. Part way along the footway, a vehicular access to a rear yard as no dropped kerb on the northern side of the access.

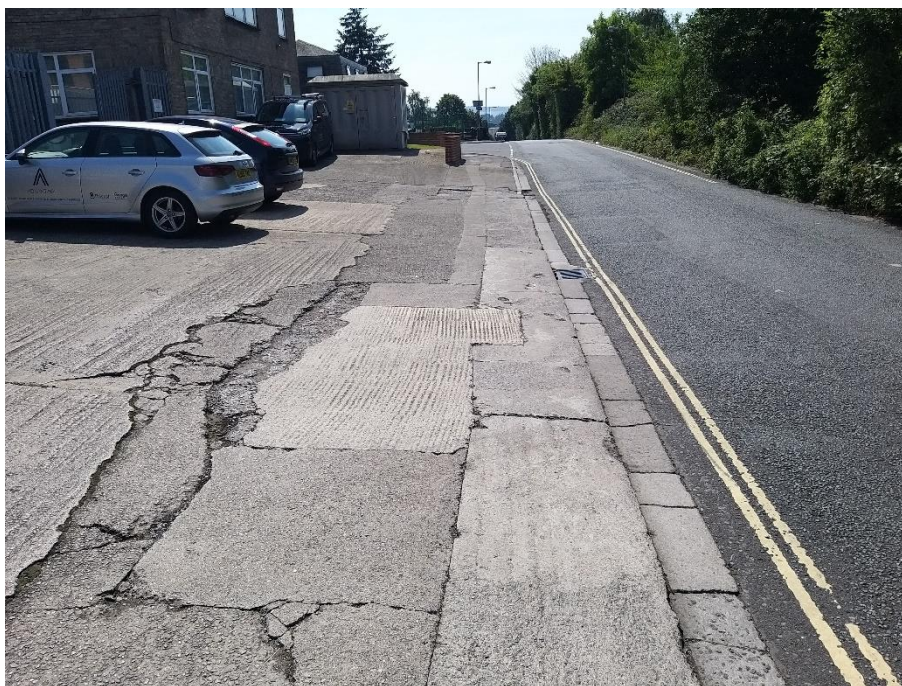
Image 3

- 2.5. To the south of the access the footway forms part of a concrete surfaced forecourt with a few poorly surfaced areas with cracks/potholes, and no demarcation between forecourt and footway, although cars were parked clear of the footway on the visit.

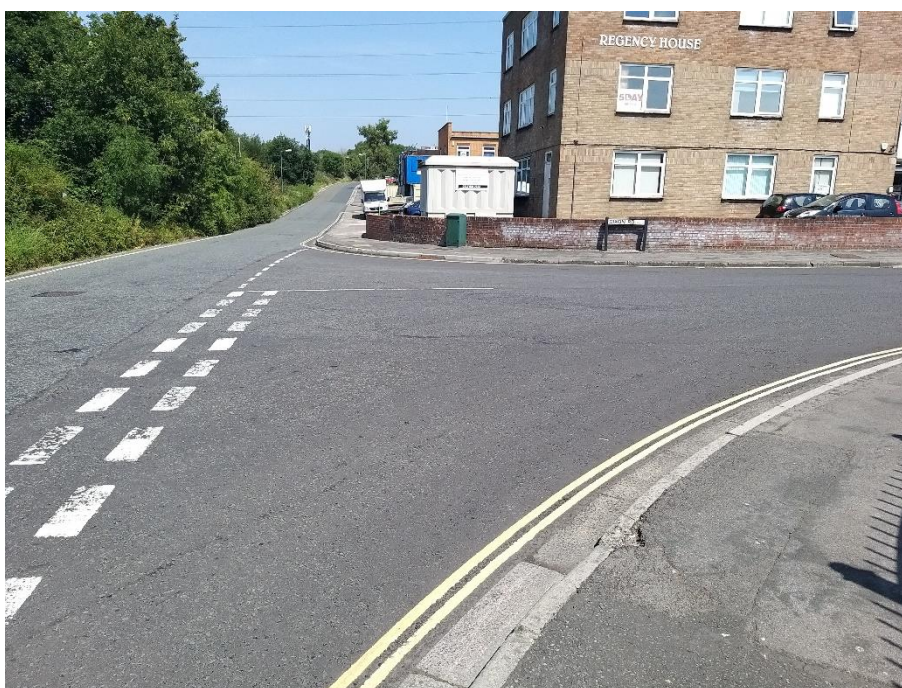
Image 4

- 2.6. At the junction with Dixon Road, there are no dropped kerbs or tactile paving, and as the access is used by HGVs, the resultant geometry creates a wide crossing distance for pedestrians.

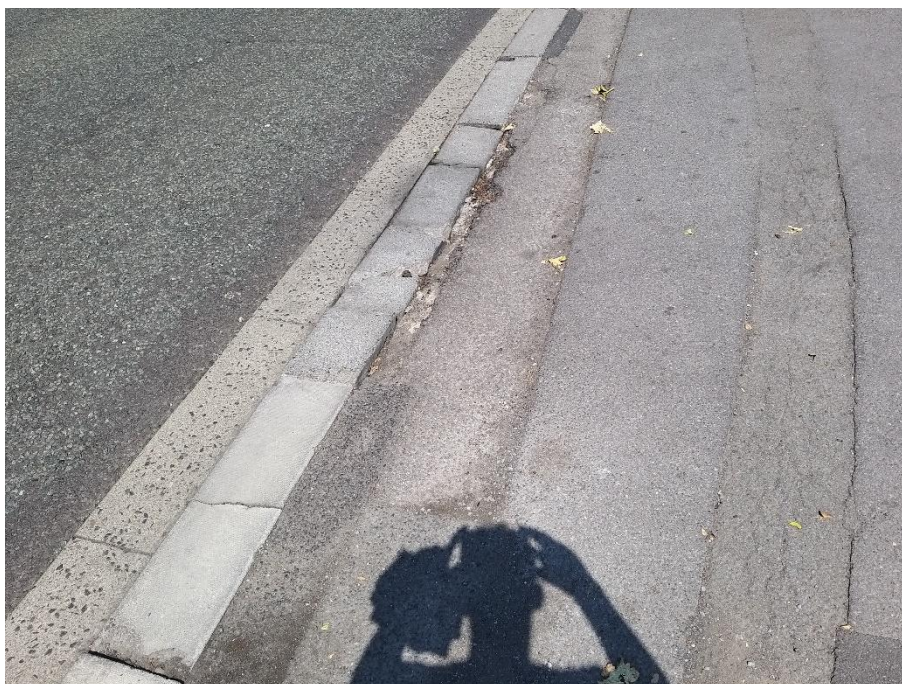
Image 5

- 2.7. South of Dixon Road, the footway is some 2.2m wide, and the footway is protected from the parking area behind by bollards/fence. There are a few areas of kerb/footway damage which may present a problem for pushchairs/scooters/wheelchairs.

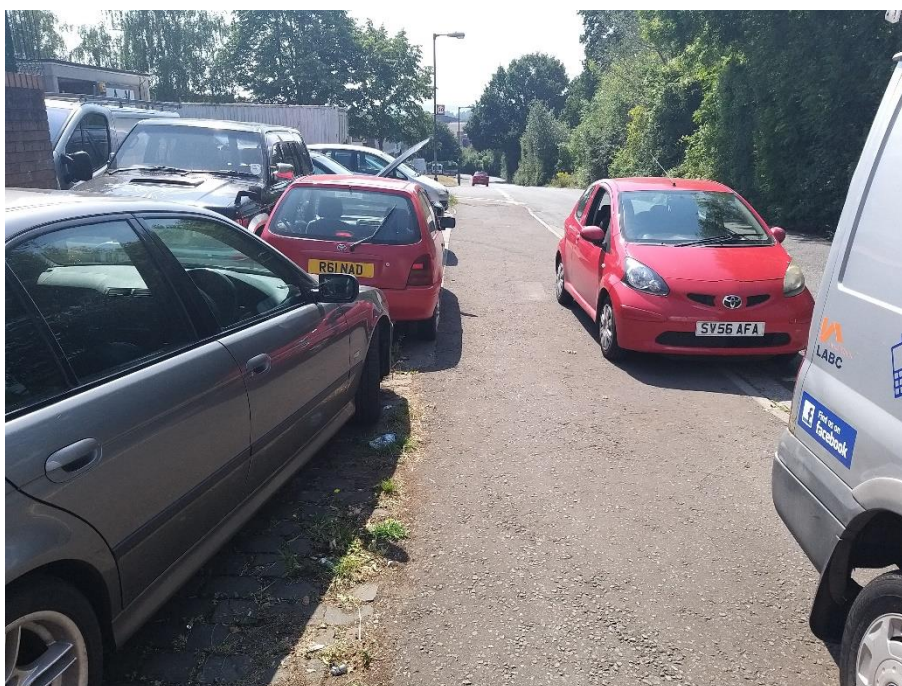
Image 6

- 2.8. Further south, the former fire station is now a vehicle service/repair garage, and as a result, vehicles are parked partly on the footway, and there is a forecourt which may see a higher number of vehicles manoeuvring over the footway.

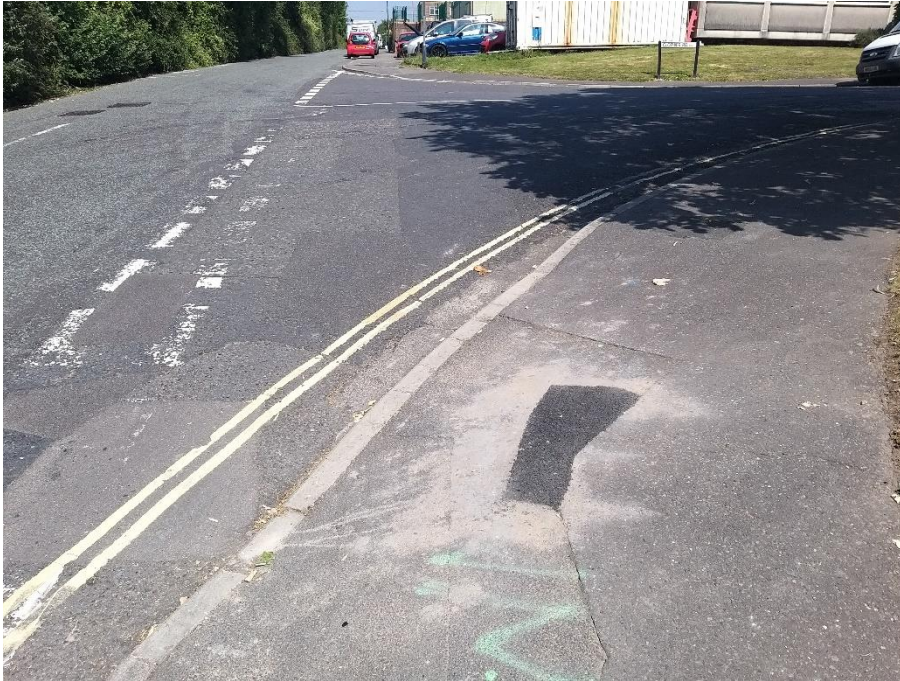
Image 7

- 2.9. The junction with Clothier Road has dropped kerbs on both sides, but no tactile paving. The footway on the northern side narrows to 2m.

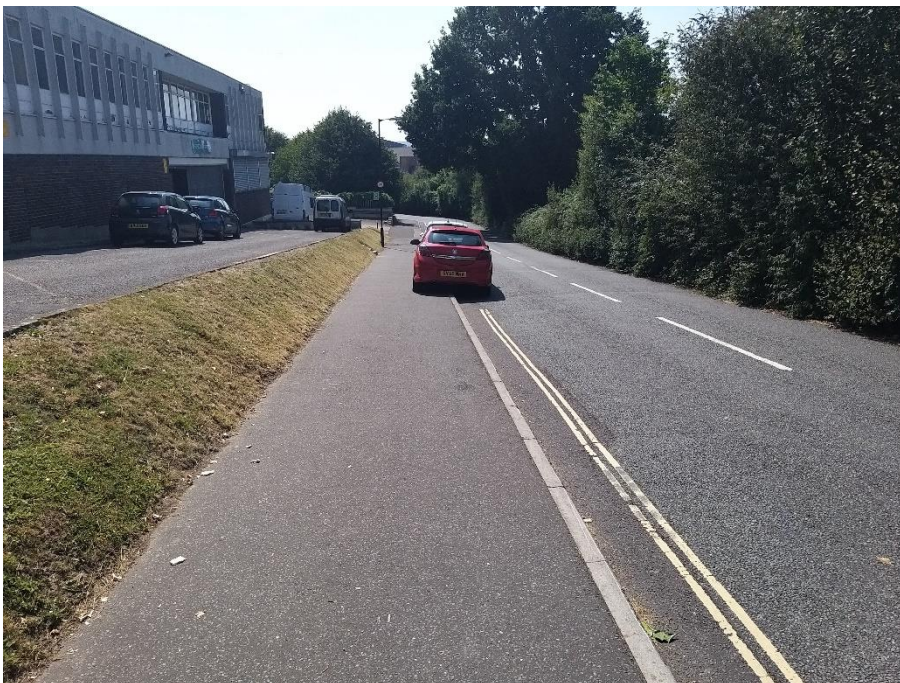
Image 8

- 2.10. South of Clothier Road, the footway is 2.3m wide and parking to the west is separated from the footway by a grass banked verge.

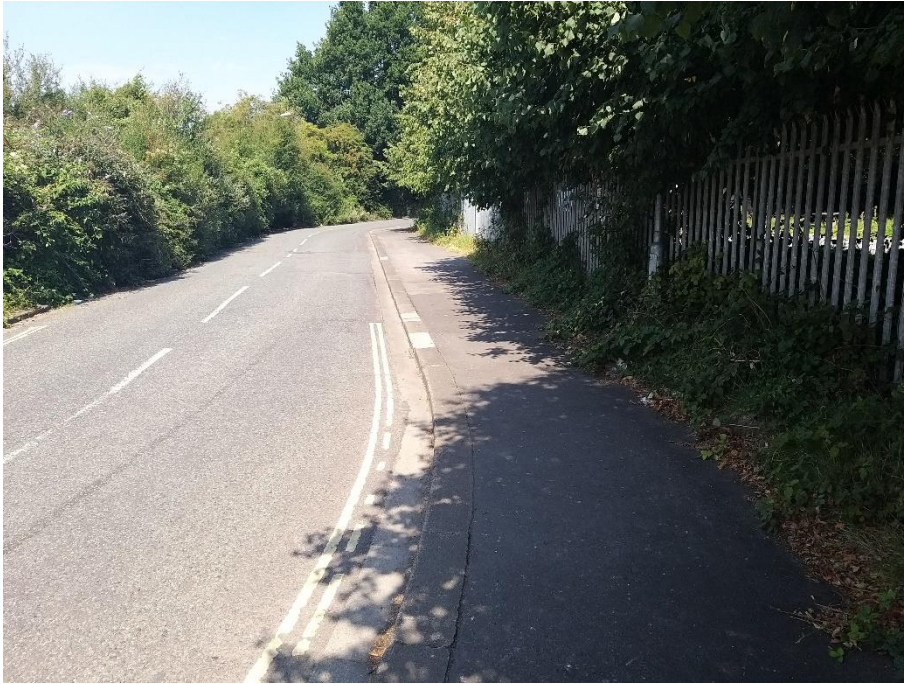
Image 9

- 2.11. Further to the south, where Bonville Road curves to the left, the footway narrows to 2m, although this could be widened if the vegetation at the back of footway was trimmed/removed

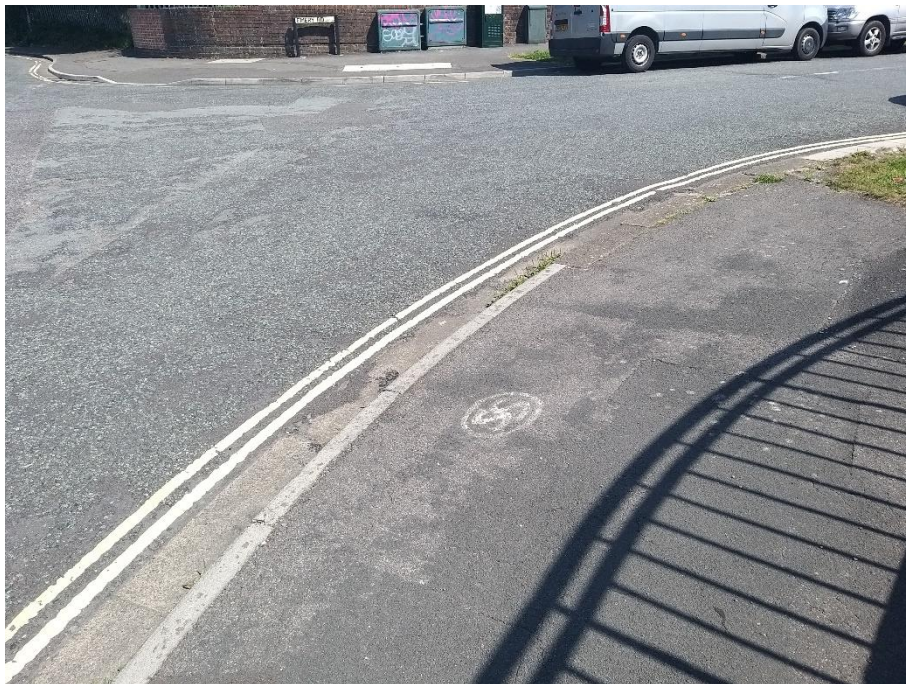
Image 10

- 2.12. At the junction with Emery Road there are dropped kerbs on the northern side, but nothing on the southern side.

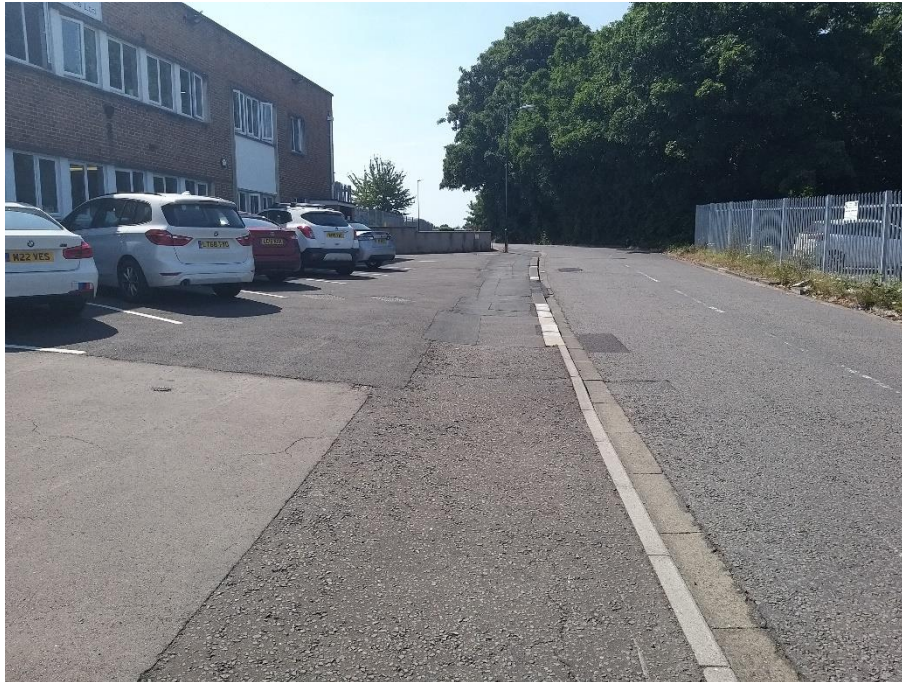
Image 11

- 2.14. The footway also passes behind some echelon parking with little visual markings to delineate parking and footway, although a change in colour of asphalt indicates the footway is 1.7m wide.

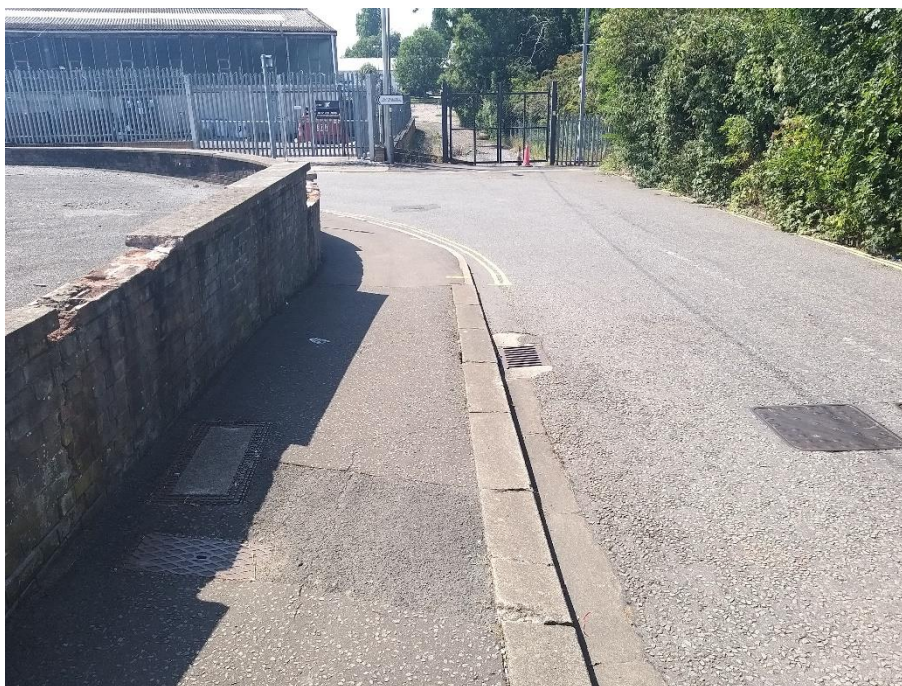
Image 12

- 2.15. The footway continues at a width of 1.8m with a few footway crossovers for access to industrial units.
- 2.16. As Bonville Road bend around to the south-east the footway starts on the southern/western side of the road, although there no dropped kerbs. This location seems the best crossing location of Bonville Road as it provides the best visibility in each direction. The footway from the crossing point to Bath Road is some 1.8m wide.

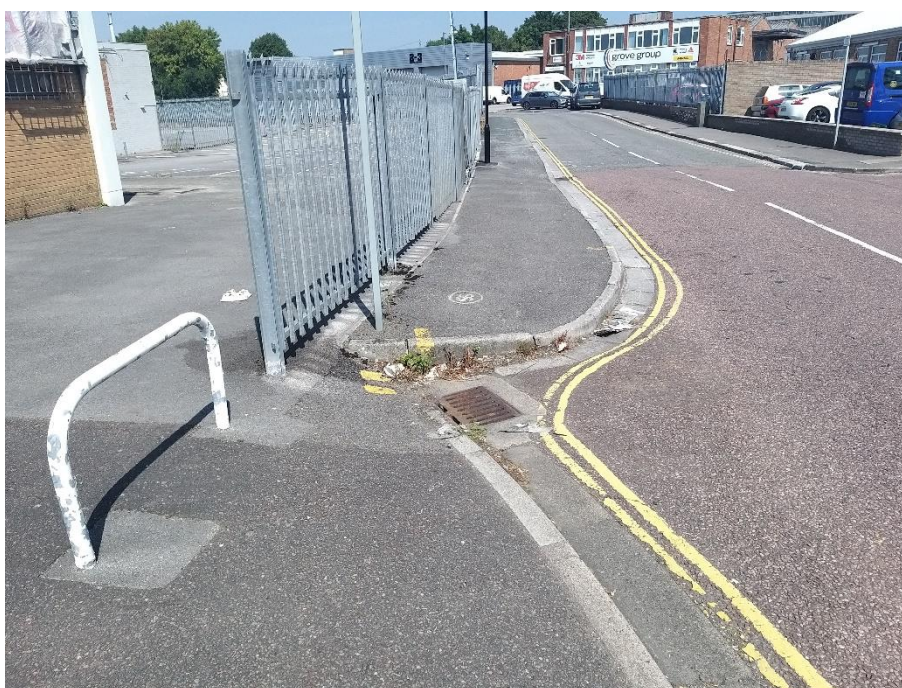
Image 13

- 2.17. At the access to the former car showroom the footway ends in a full height kerb before joining a footway crossover for the garage entrance.

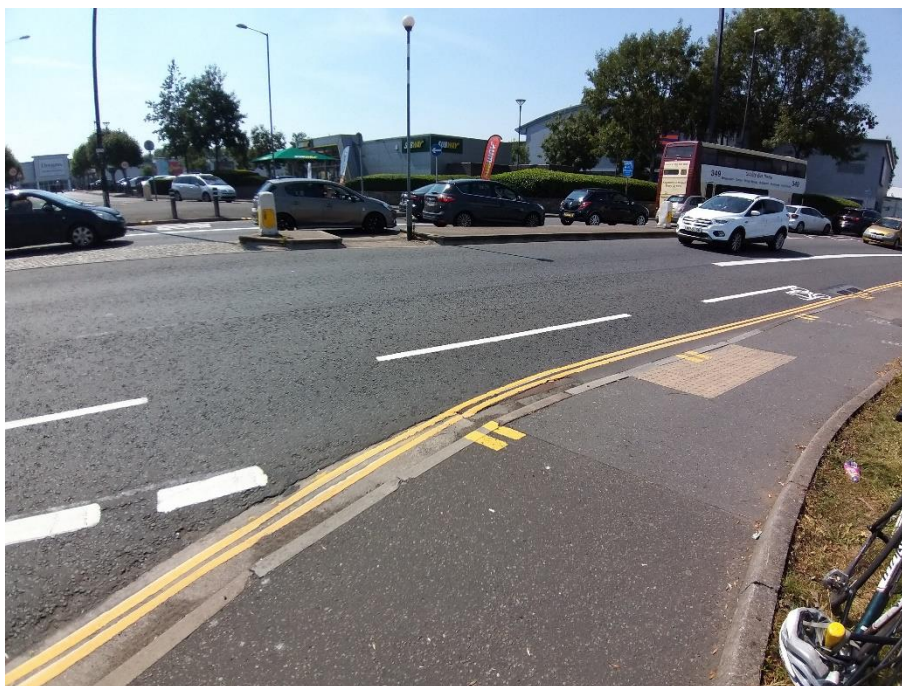
Image 14

- 2.18. The crossing of Bath Road to Brislington Retail Park is uncontrolled with a centre island. Traffic is normally slow moving along this section of Bath Road during shop opening hours, and crossing is relatively easy. A signal-controlled crossing is available at the West Town Lane junction some 200m to the west.

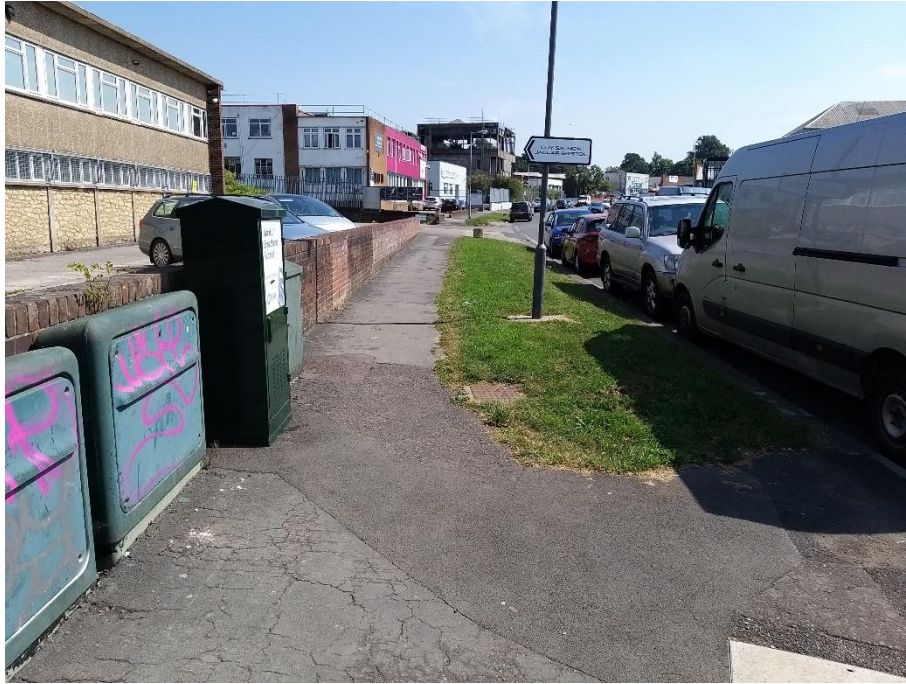
Image 15

- 3.1. Route 2 follows route 1 as far as the previous section 2.12 where the route then takes Emery Road.
- 3.2. Emery Road has footways on both sides with a verge separating the footway from the carriageway, which seems to deter pavement parking. In terms of pedestrian route, the northern footway seems most attractive with less forecourts to cross, and as shown later, a better surface.
- 3.3. The footway is some 1.6m wide, but the grass verge allows room for pedestrians to pass easily. The footway passes several concrete access points. Most parking areas are separated from the footway by dwarf walls.

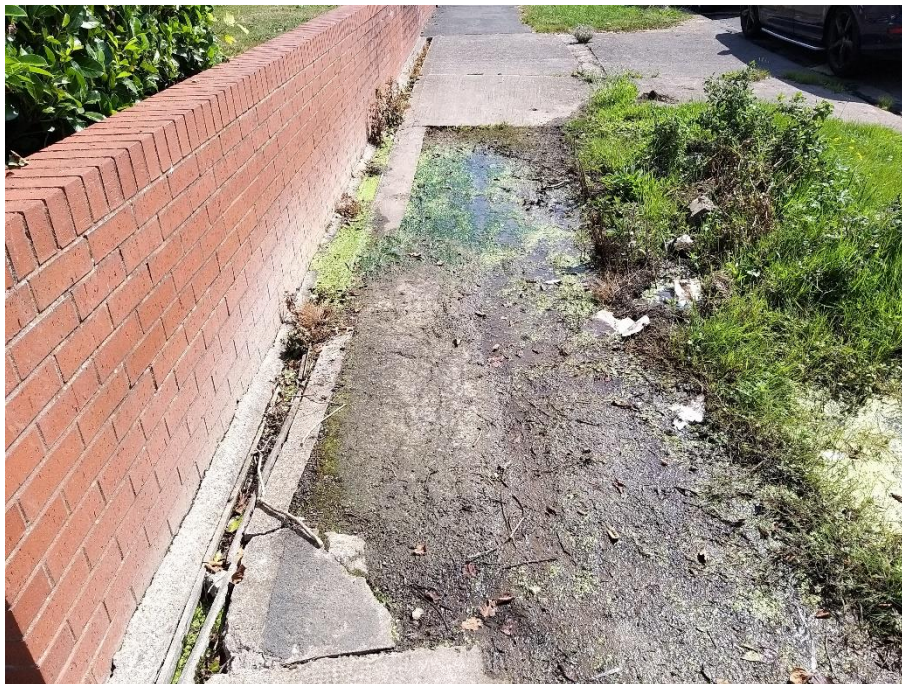
Image 16

- 3.4. Partway along the footway a historic water leak (based on Google Streetview images) has damaged the footway but is still passable.

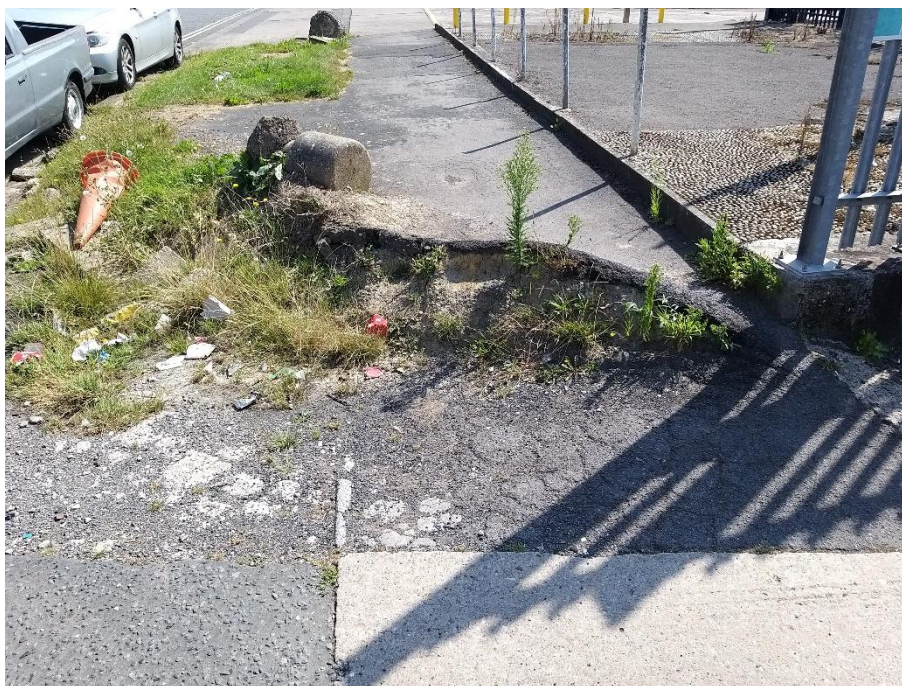
Image 17

- 3.5. On the day of the audit, domestic refuse and recycling bins blocked part of the footway.
- 3.6. On the southern footway, historic kerb damage has led to damaged footway that would be impassable to wheelchairs and cause problems for pushchairs.

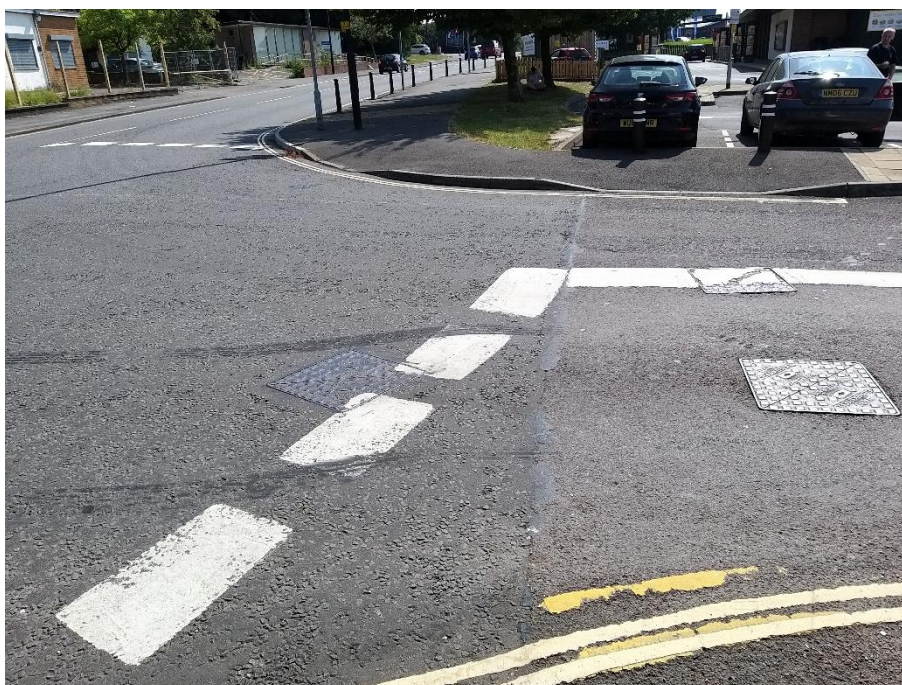
Image 18

- 3.7. At the junction of Emery Road and Broomhill Road is a 4-arm mini-roundabout, with the north and south arms being Emery Road, the eastern arm Broomhill Road and the western arm serving a small retail development including a drive-thru restaurant.
- 3.8. There are dropped kerbs only on the western arm, but no tactile paving.

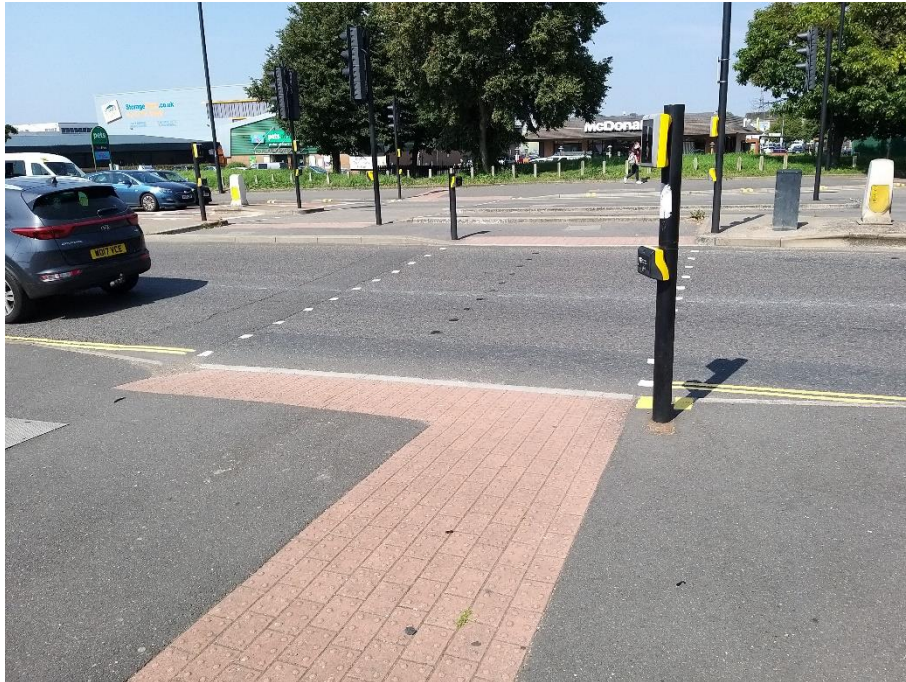
Image 19

- 3.10. The crossing of Bath Road is a two-stage crossing, and given the long cycle time, can lead to delays for pedestrians.

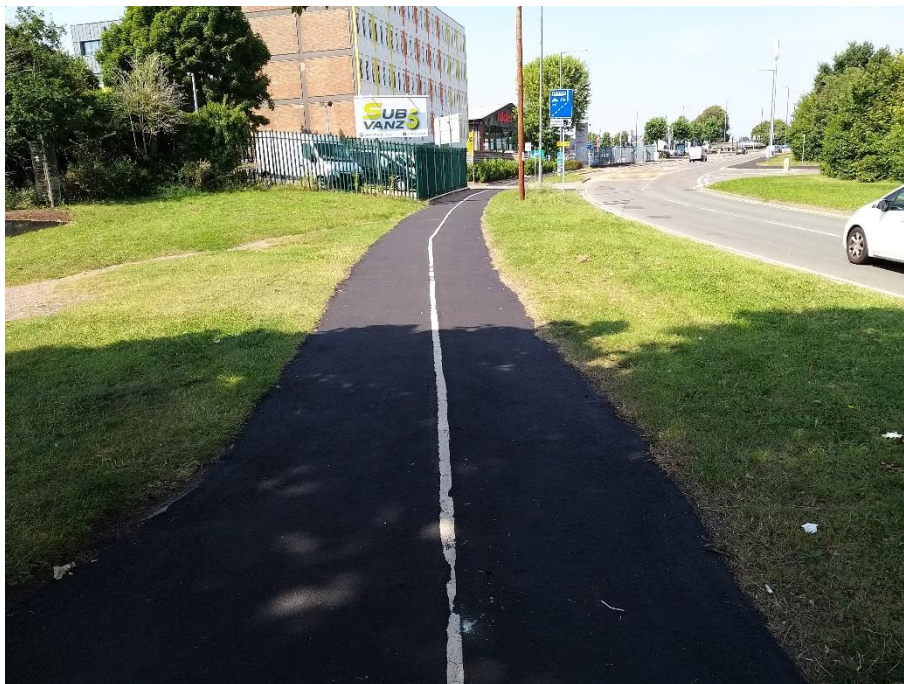
Image 20

- 3.11. South of the Bath Road junction the footway on the western side is a shared footway/cycleway some 4m wide before becoming a segregated footway/cycleway to the south some 2.7m wide and set back from the carriageway edge behind a grass verge.

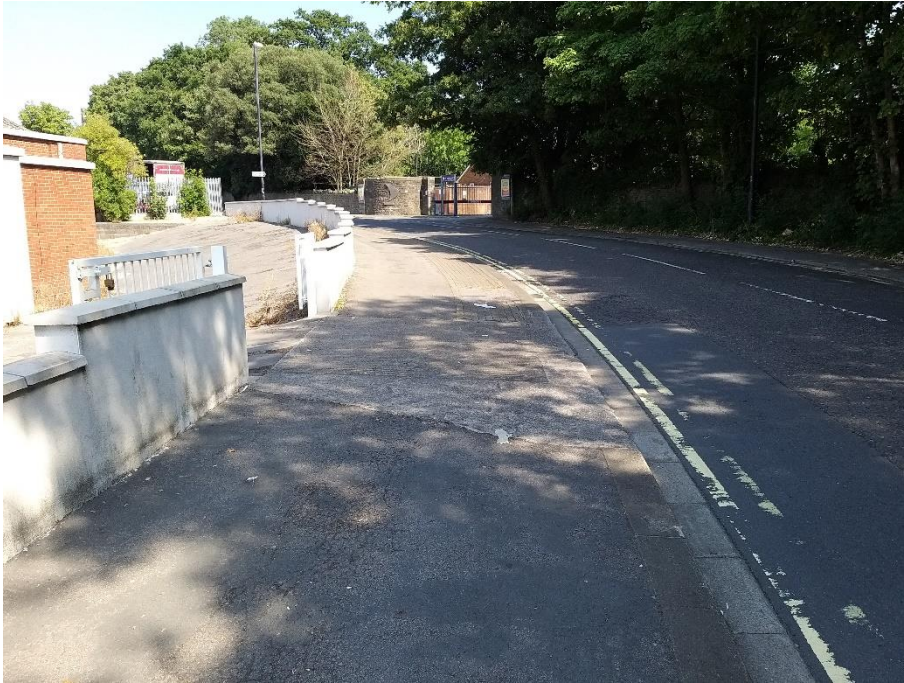
Image 21

- 4.1. Route 3 follows route 2 as far as 3.7 above then the route follows Broomhill Road. The footway on Broomhill Road is some 3m wide.

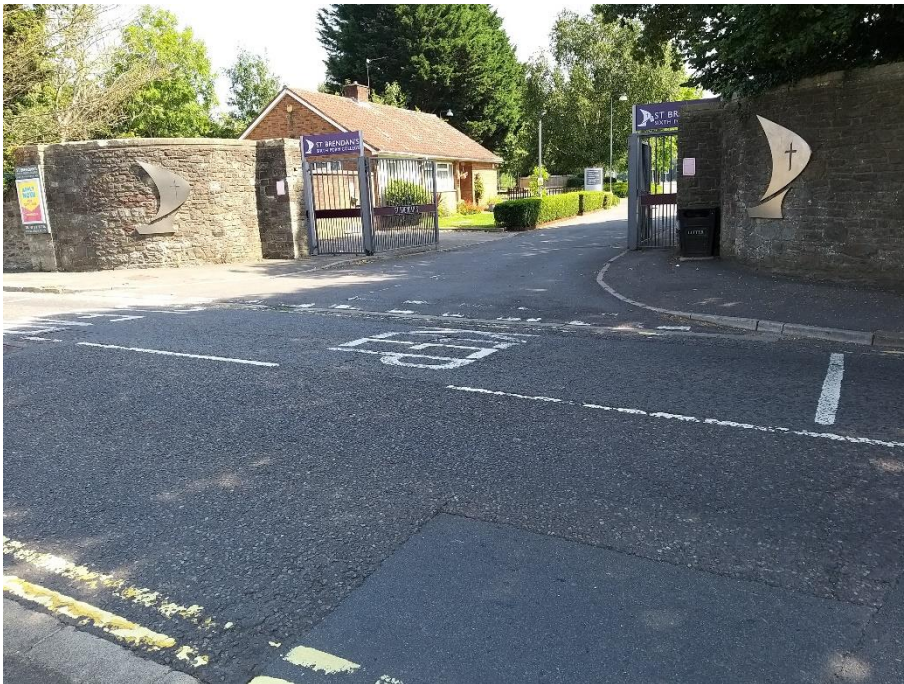
Image 22

- 4.2. There are no dropped kerbs or tactile paving to cross the road at the college entrance or dropped kerbs to cross Broomhill Road.

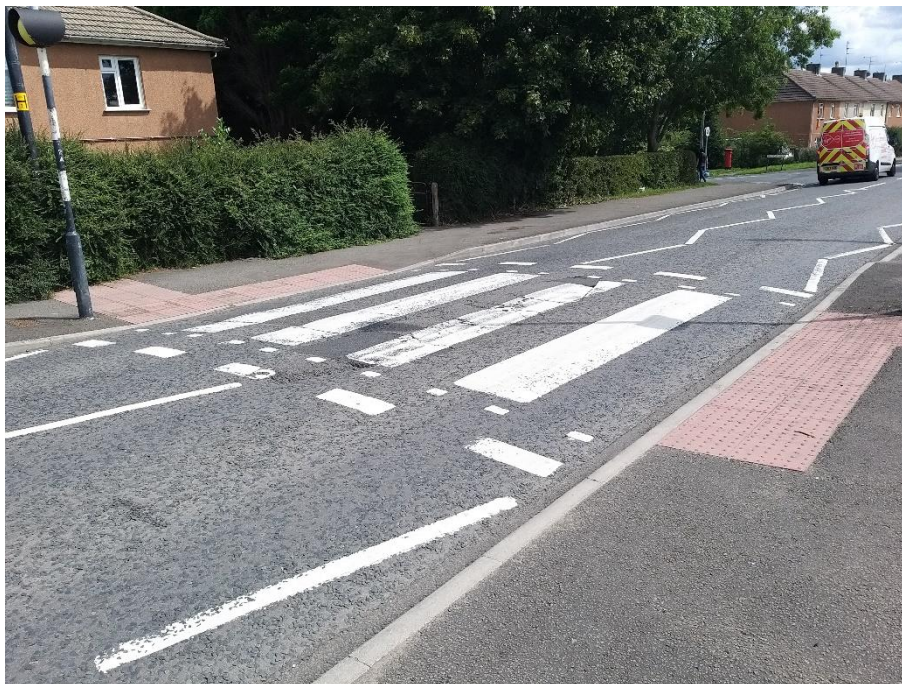
Image 23

- 6.1. To the north of the proposed access is a zebra crossing of Broomhill Road, which may need to be moved as part of the development, subject to detailed design. This provides access to the outbound bus stop on Whitmore Avenue opposite the proposed site entrance.

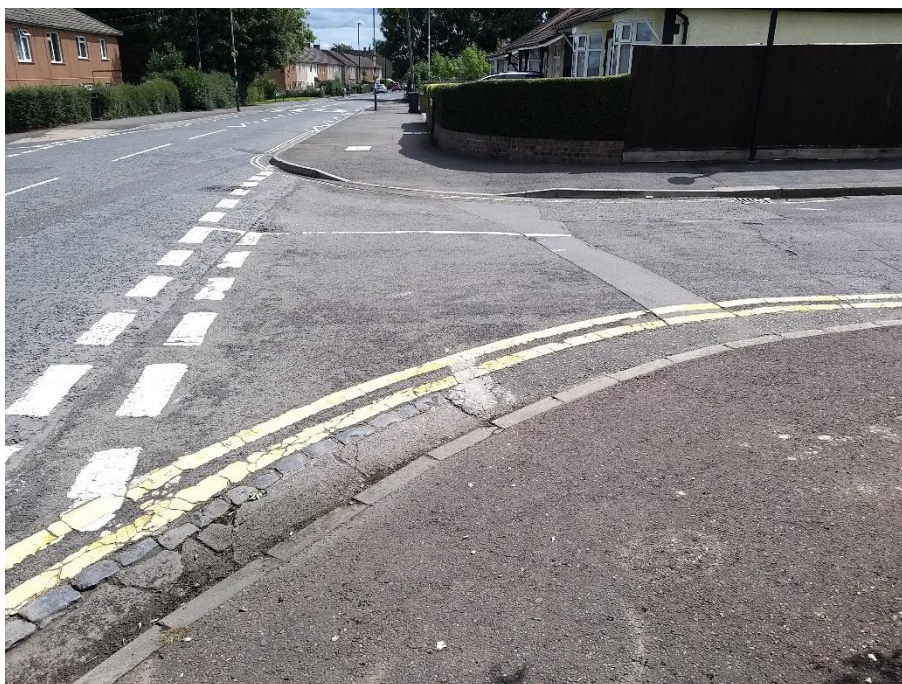
Image 24

- 6.2. The footway from the site northwards is some 3.4m wide. At the southern junction of Belroyal Avenue there are dropped kerbs but no tactile paving.

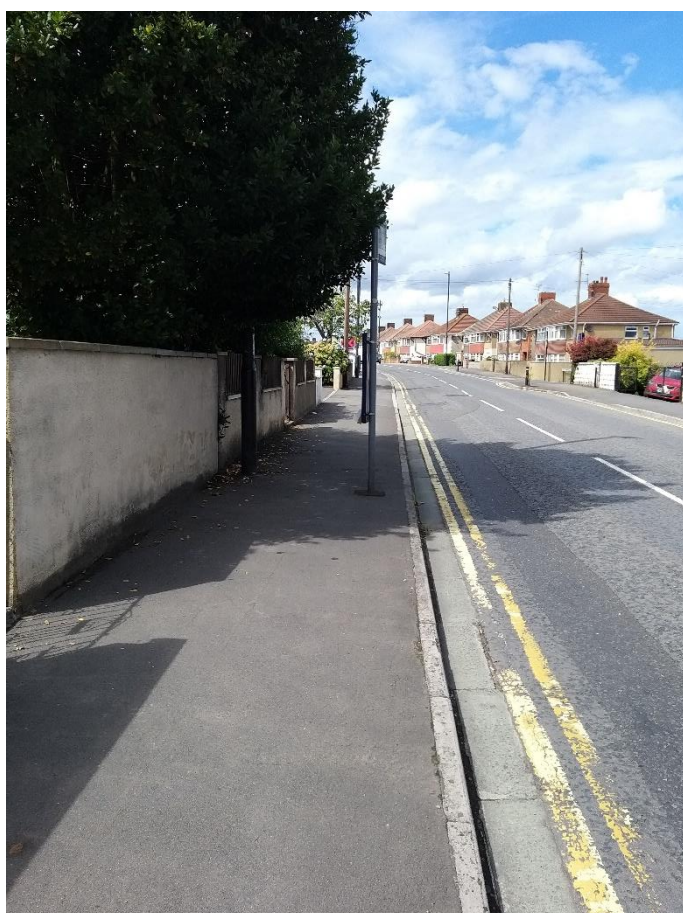
Image 25

- 6.3. From Belroyal Avenue northwards the footway is some 2.3m wide. The bus stop on Broomhill Road has a flag, timetable board, but no raised bus boarder or bus stop markings.

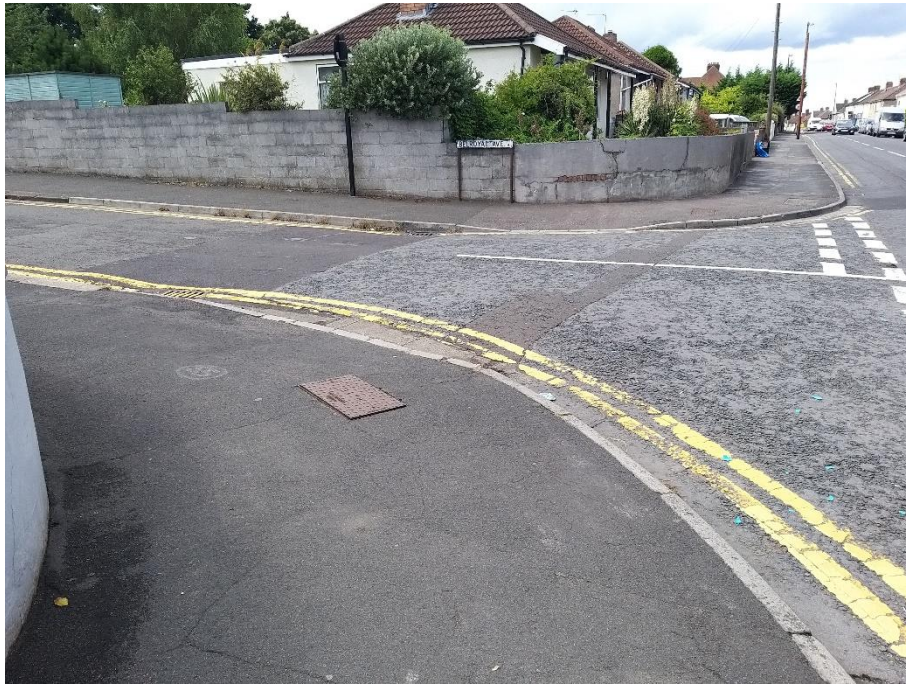
Image 26

- 6.4. The second junction with Belroyal Avenue has dropped kerbs but no tactile paving.

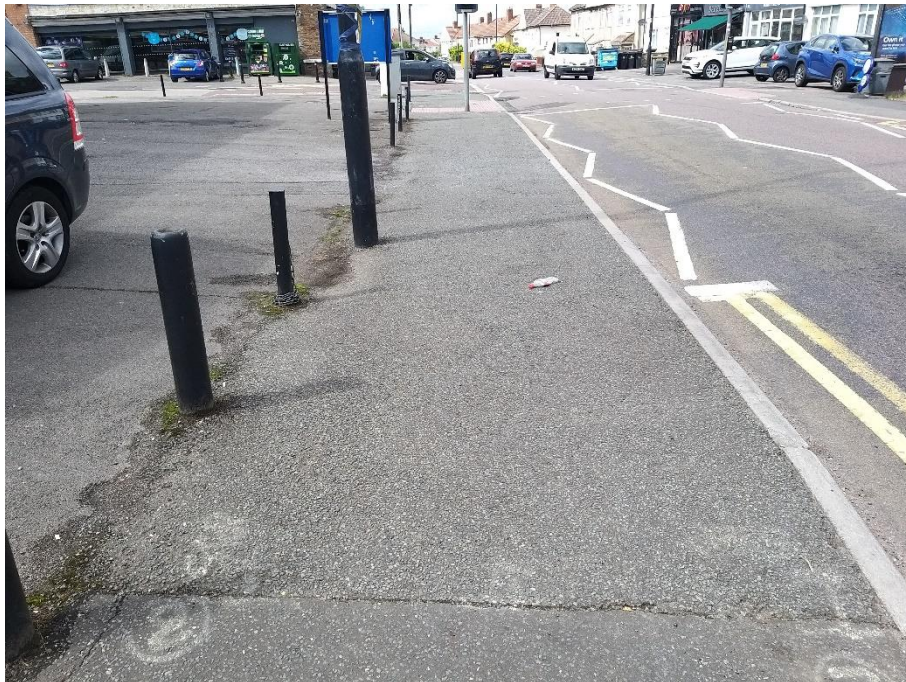
Image 27

- 6.5. The footway along Broomhill Road remains around 2.3m with footway crossovers accessing private drives.
- 6.6. The junction with Fermaine Avenue is on a speed table, with a pelican crossing to the south across Broomhill Road.

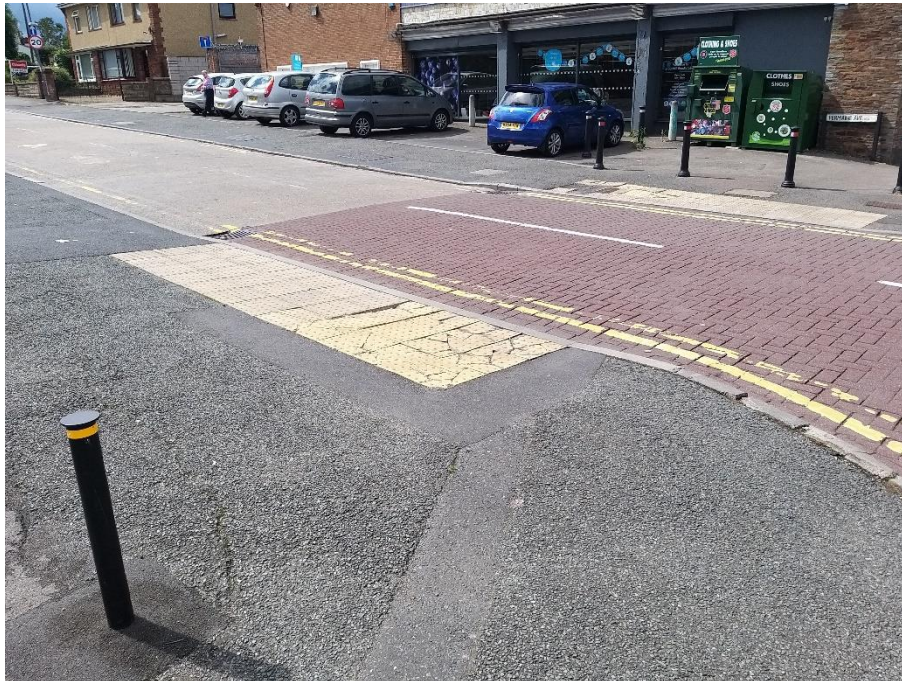
Image 28

- 6.7. There is a wide dropped kerbs and tactile paved uncontrolled crossing of Fermaine Avenue, although the tactile paving look to be damaged from vehicle overrun. **[NOTE – THIS HAS BEEN REPAIRED SINCE PHOTO TAKEN]**

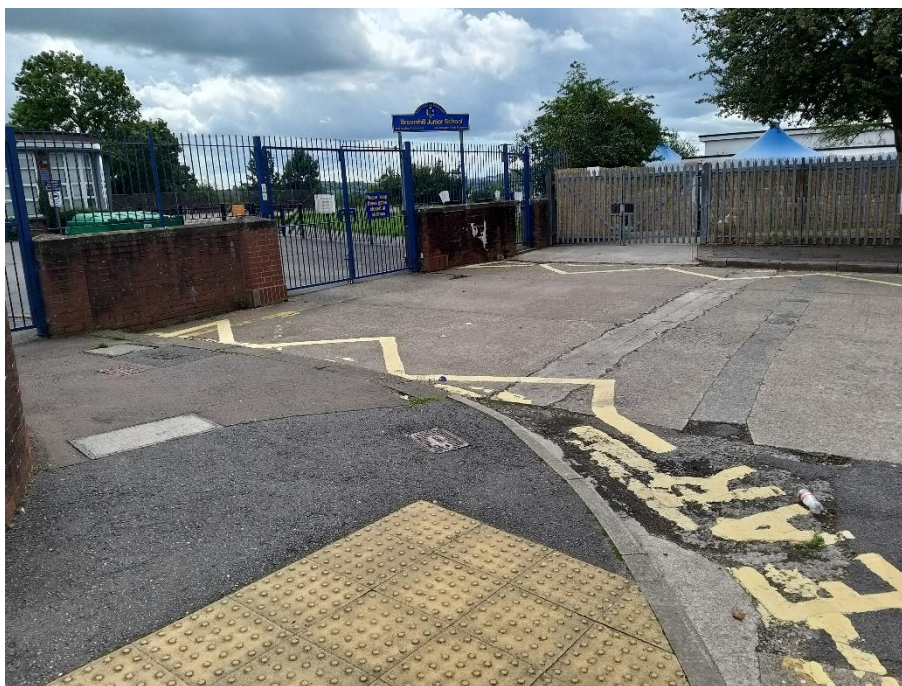
Image 29

- 7.1. This route is dependent on a pedestrian route being provided through Broomhill Junior School, which is outside the control of the developer. It is assumed the route would emerge onto Allison Road between the school and the nursery.
- 7.2. The access into the school is at carriageway level, and although there is a dropped kerb to the south, there is no dropped kerb to the north.

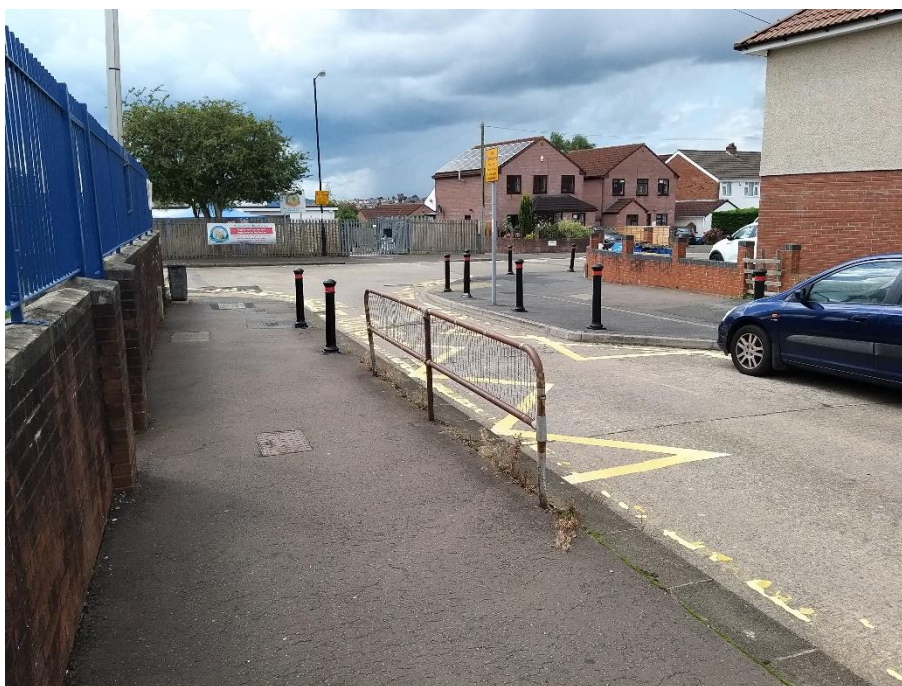
Image 30

- 7.3. The footway past the school is protected by bollards and a pedestrian guardrail at the school pedestrian access. The footway is some 2.7m wide at this point (excluding bollards).

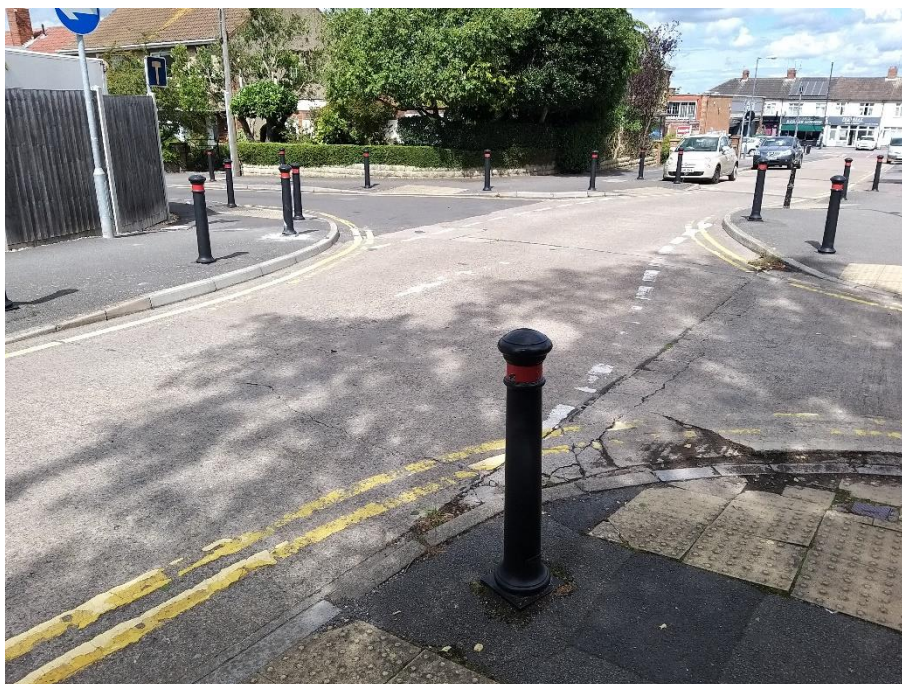
Image 31

- 7.4. Further to the north, the school passes the entrance to Broomhill Infant School where there is a chicane with bollards on both sides of the road and dropped kerbs and tactile paving at all arms. The footway away from the widening for the chicane is around 2.5m wide.

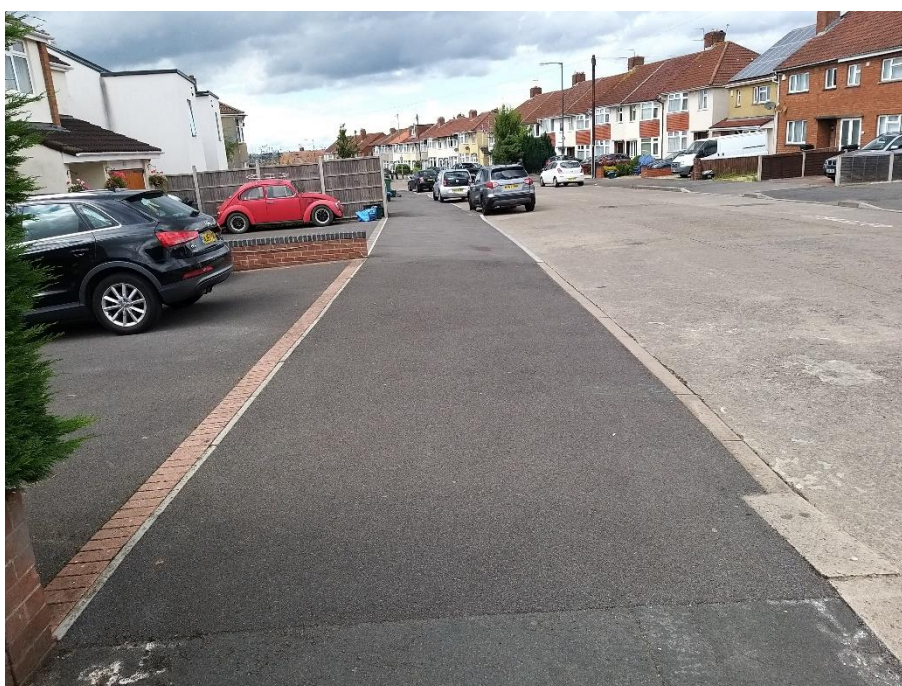
Image 32

- 8.1. The route from the Fermaine Avenue access to the west is along a footway some 3m wide, with lots of footway crossovers to private drives.

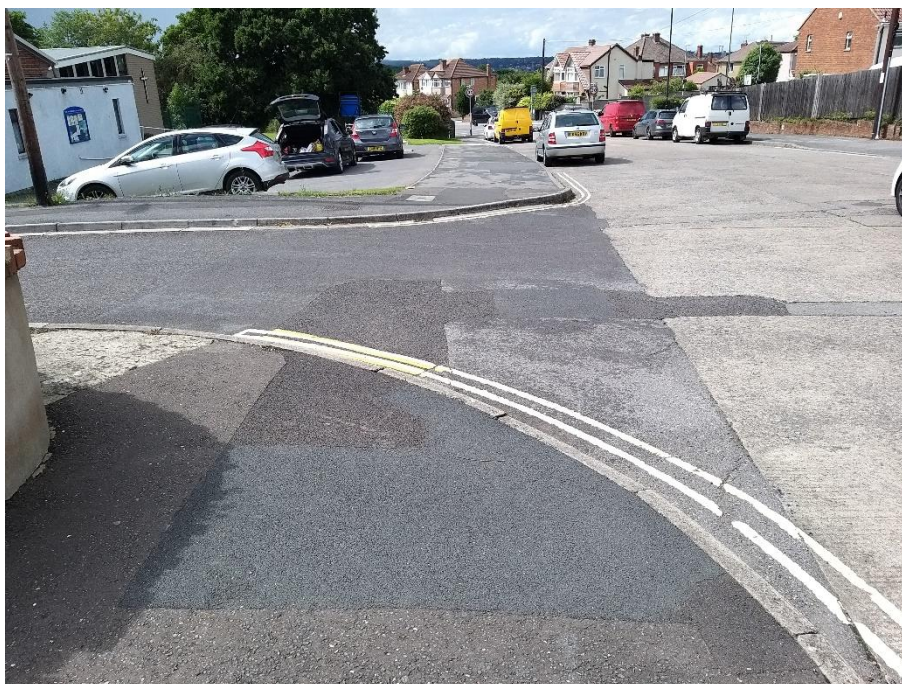
Image 33

- 8.2. At the access to Fox House, there are no dropped kerbs or tactile paving.
