## **Pedestrian & Cycle Audit**

# Technical Note

<b>Title</b>	Brislington Meadows - Pedestrian Audit		
<b>Prepared by</b>	DRT	<b>Checked by</b>	DRT
		<b>Reviewed by</b>	
<b>Date</b>	September 2021		<b>Version</b>

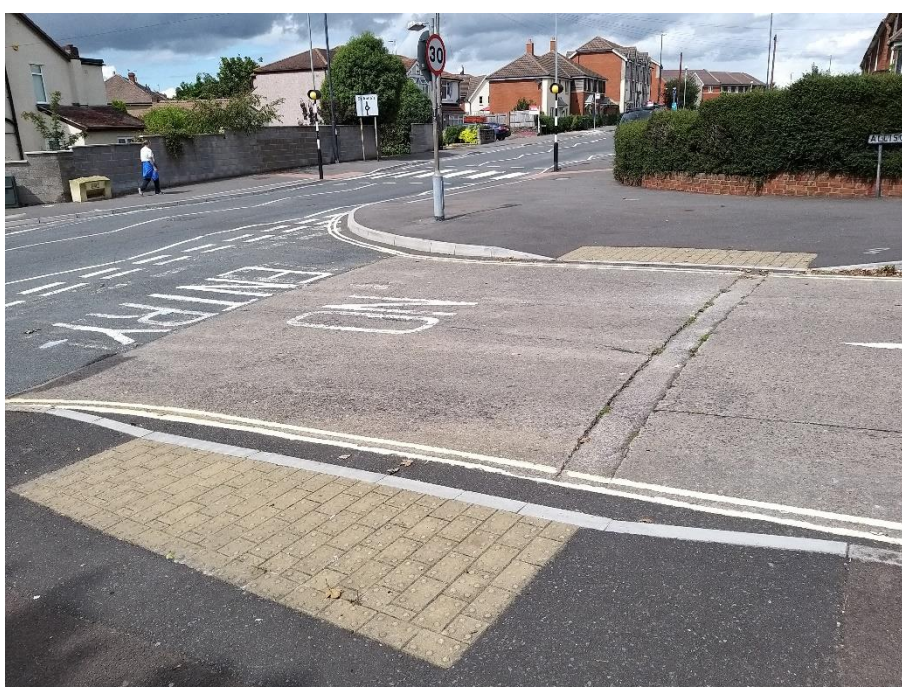
Image 34

- 8.3. At the junction of Allison Road and School Road, Alison Road is narrowed, and there are dropped kerbs and tactile paving, which provide access to a zebra crossing on School Road to the north of Allison Road.

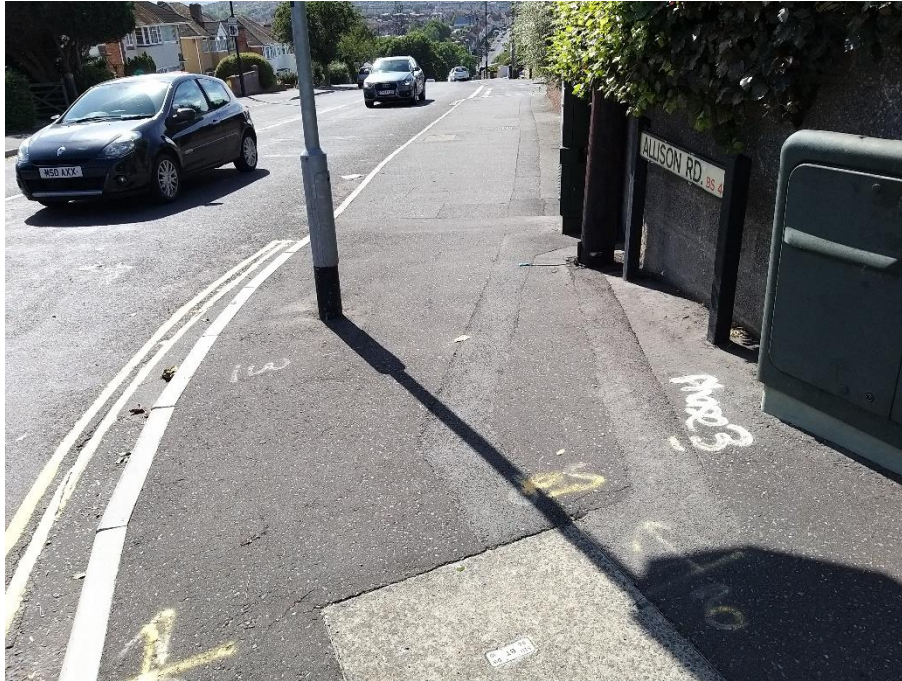
Image 35

- 8.4. Once across School Road, the footway is some 2.9m wide.

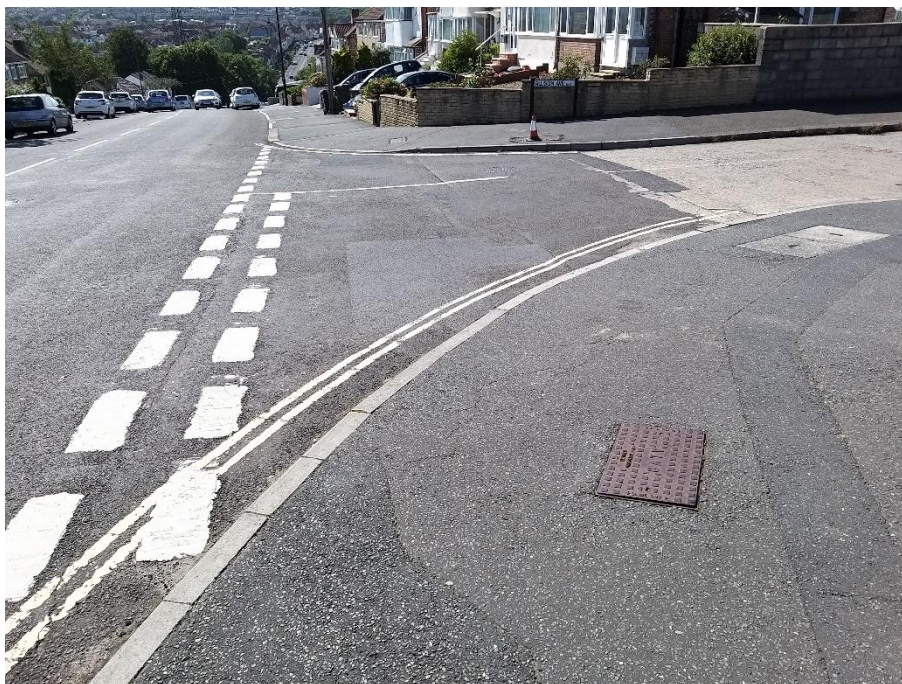
Image 36

- 8.5. The footway continues down the hill and varies in width between 2.9 and 3.0m. At the junction of Allison Avenue there are dropped kerbs but no tactile paving.

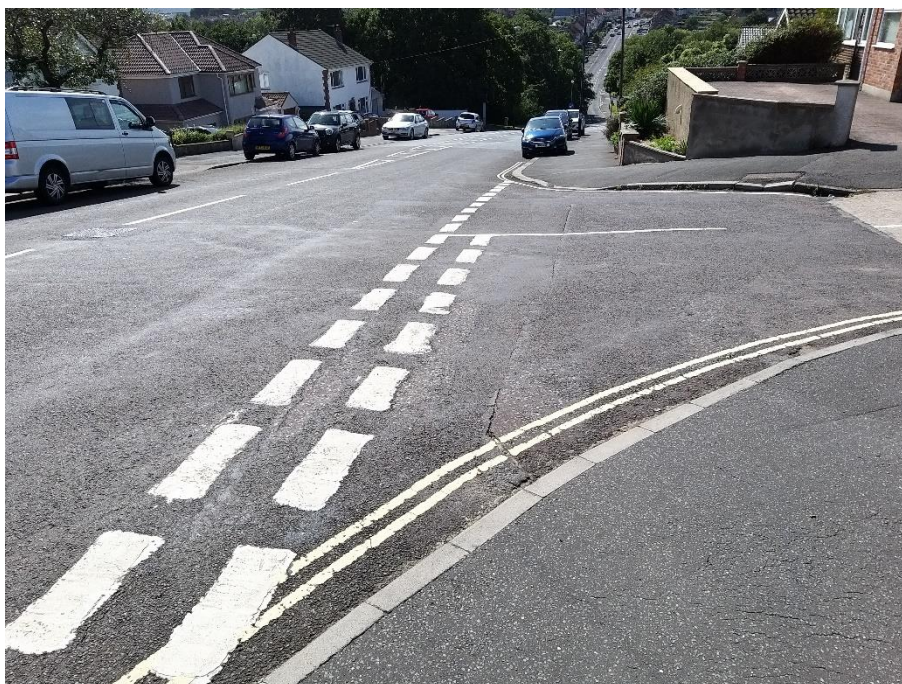
Image 37

- 8.6. The other access to Allison Avenue also has dropped kerbs but not tactile paving.

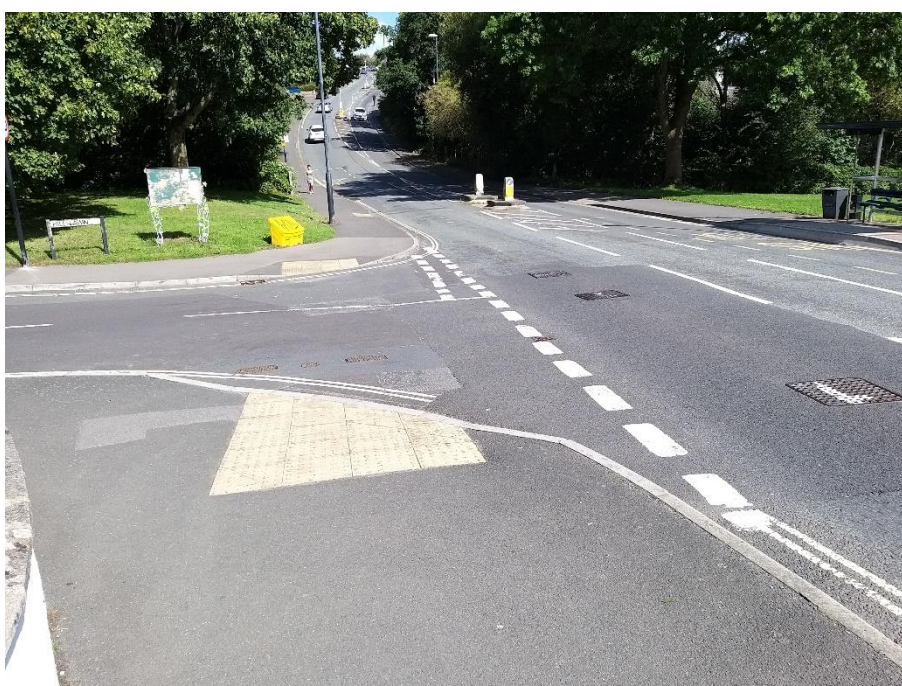
Image 38

- 8.7. As the road starts to rise, there are dropped kerbs and tactile paving at the junction with Hill Lawn.

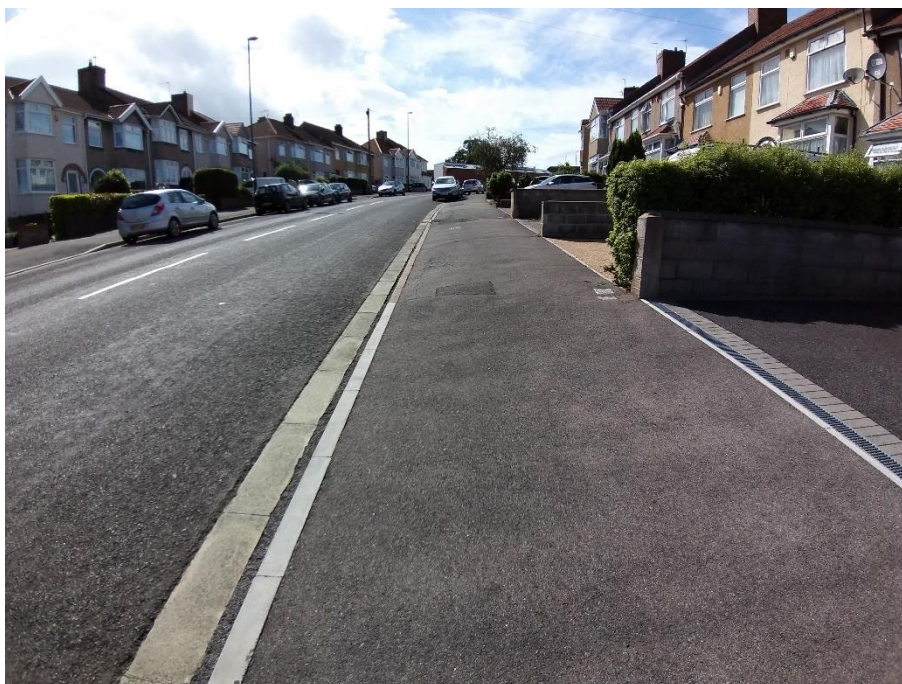
Image 39

- 8.8. The footway then widens to around 3m wide across footway crossovers leading to private drives.

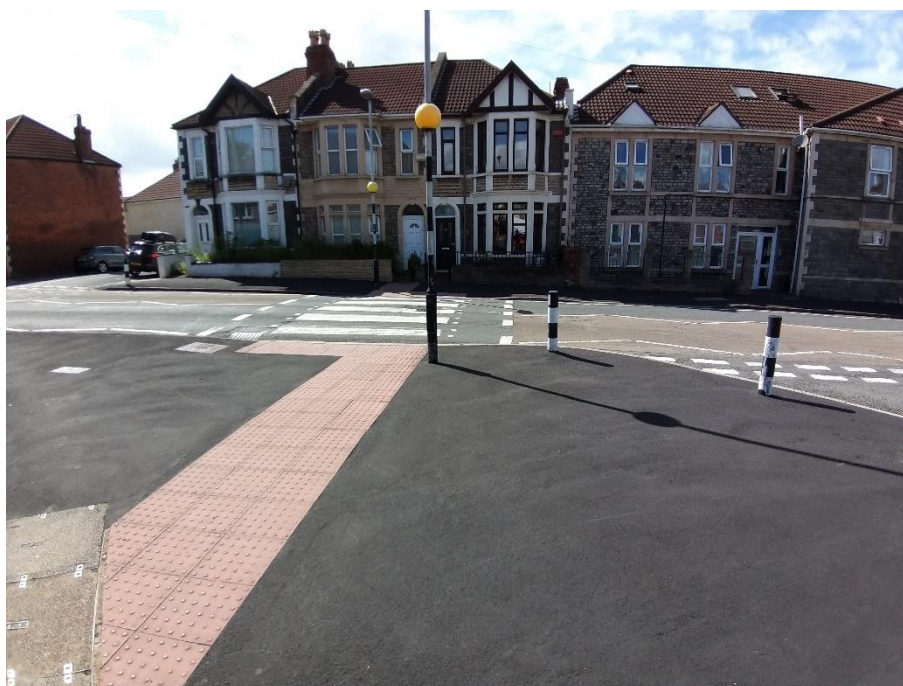
Image 40

- 8.9. At the junction of Allison Road and Wick Road there is a zebra crossing across Wick Road to the south of Allison Road, and a narrowing protected by bollards, dropped kerbs and tactile paving across Allison Road.
