Appendix C: 2022 Site Investigation

Brislington Meadows

EXPLOSIVE ORDNANCE DESK TOP STUDY

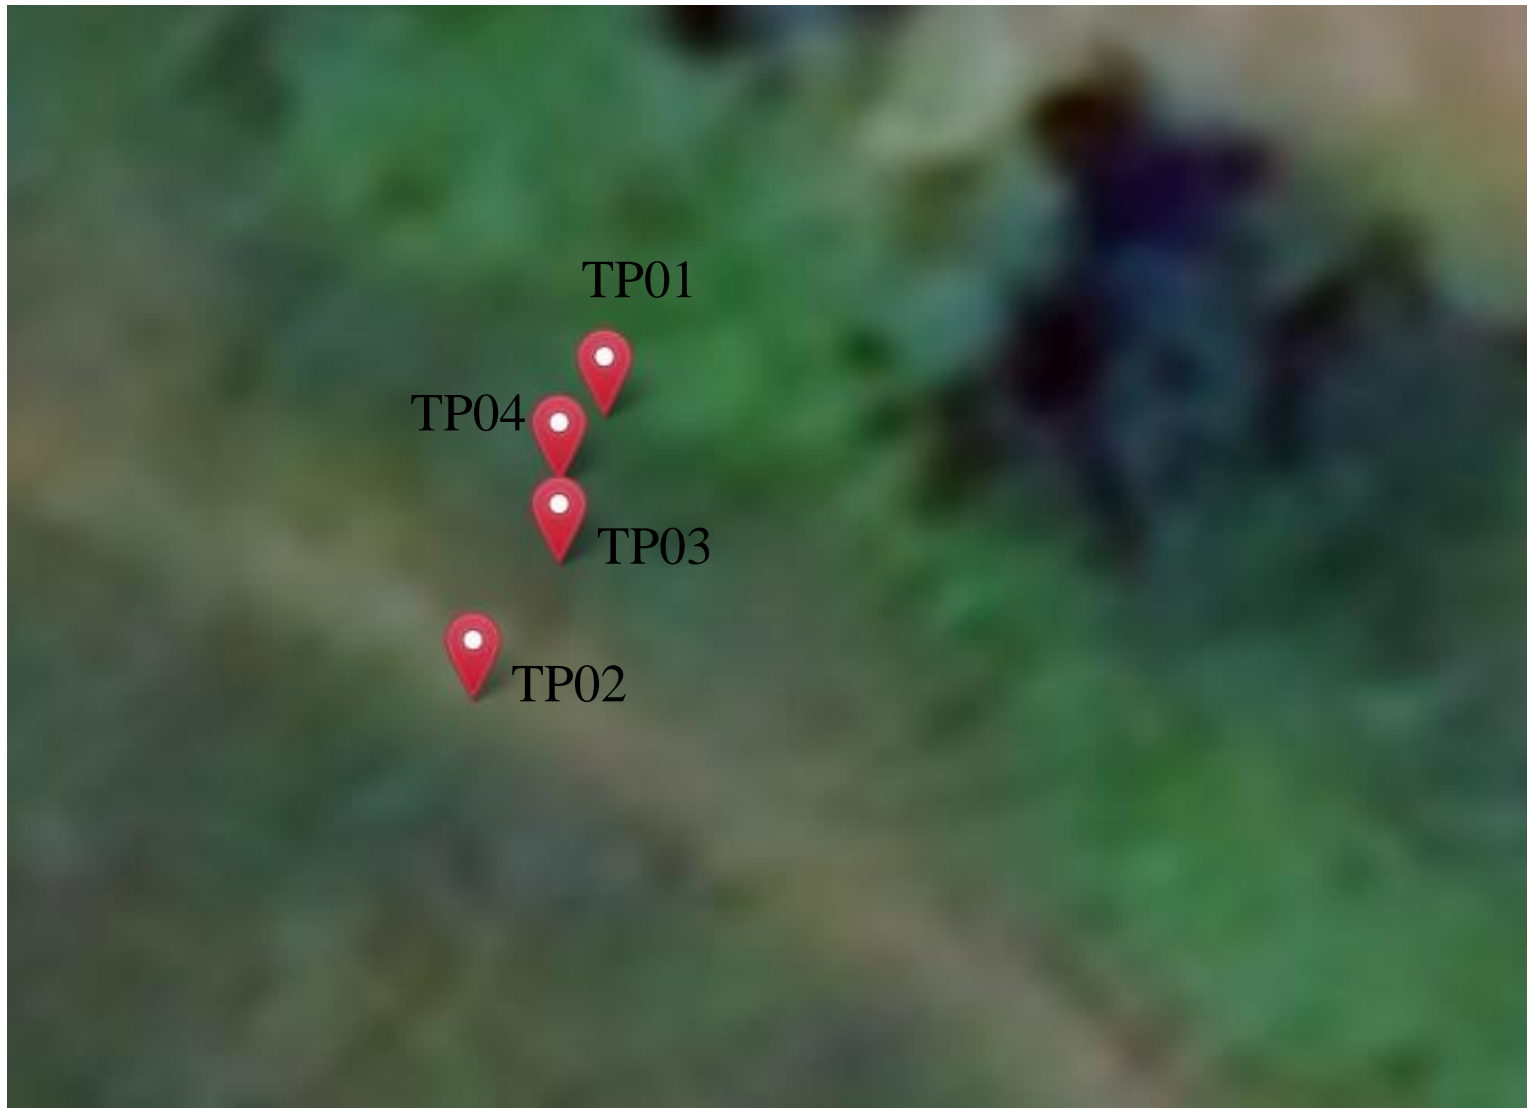
Figure 1

Trial Pits

Notes:
Locations indicative only.

Site Layout Plan

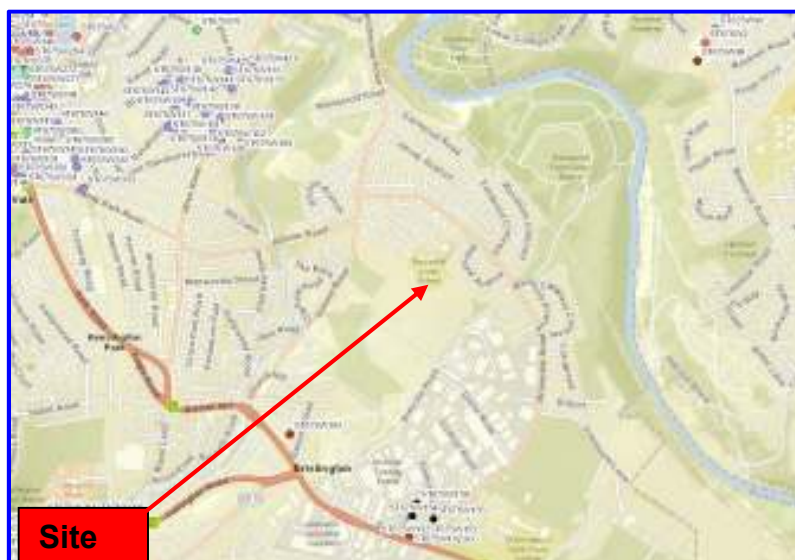
Figure 3.1 Borehole Location

Geological Unit Description	Anticipated Thickness (m)	Anticipated Depth (m bgl)
Top Soil	0.2	0.2
Sand	1.2	1.4
Sandstone	8.6	10 end of log

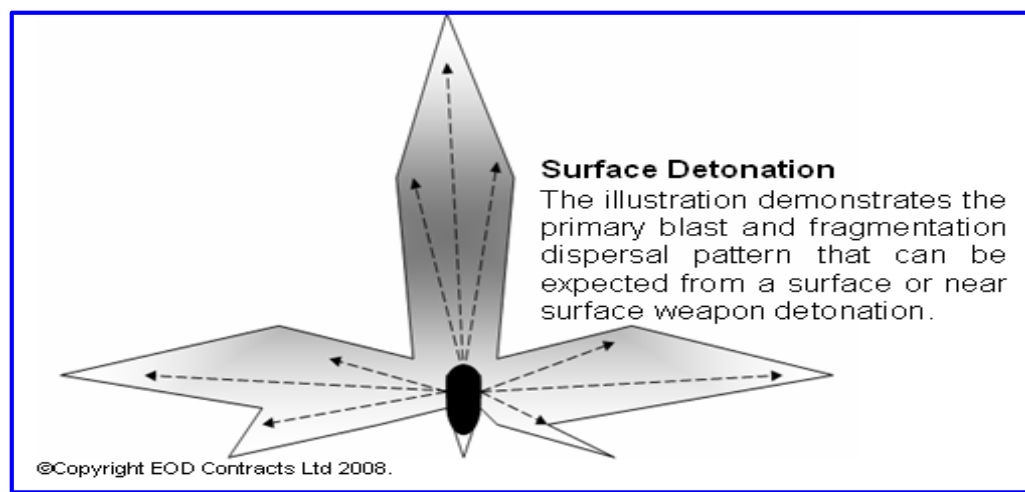
Figure 6.1: Primary Blast & Fragmentation on Land

Blast and fragmentation dispersal.

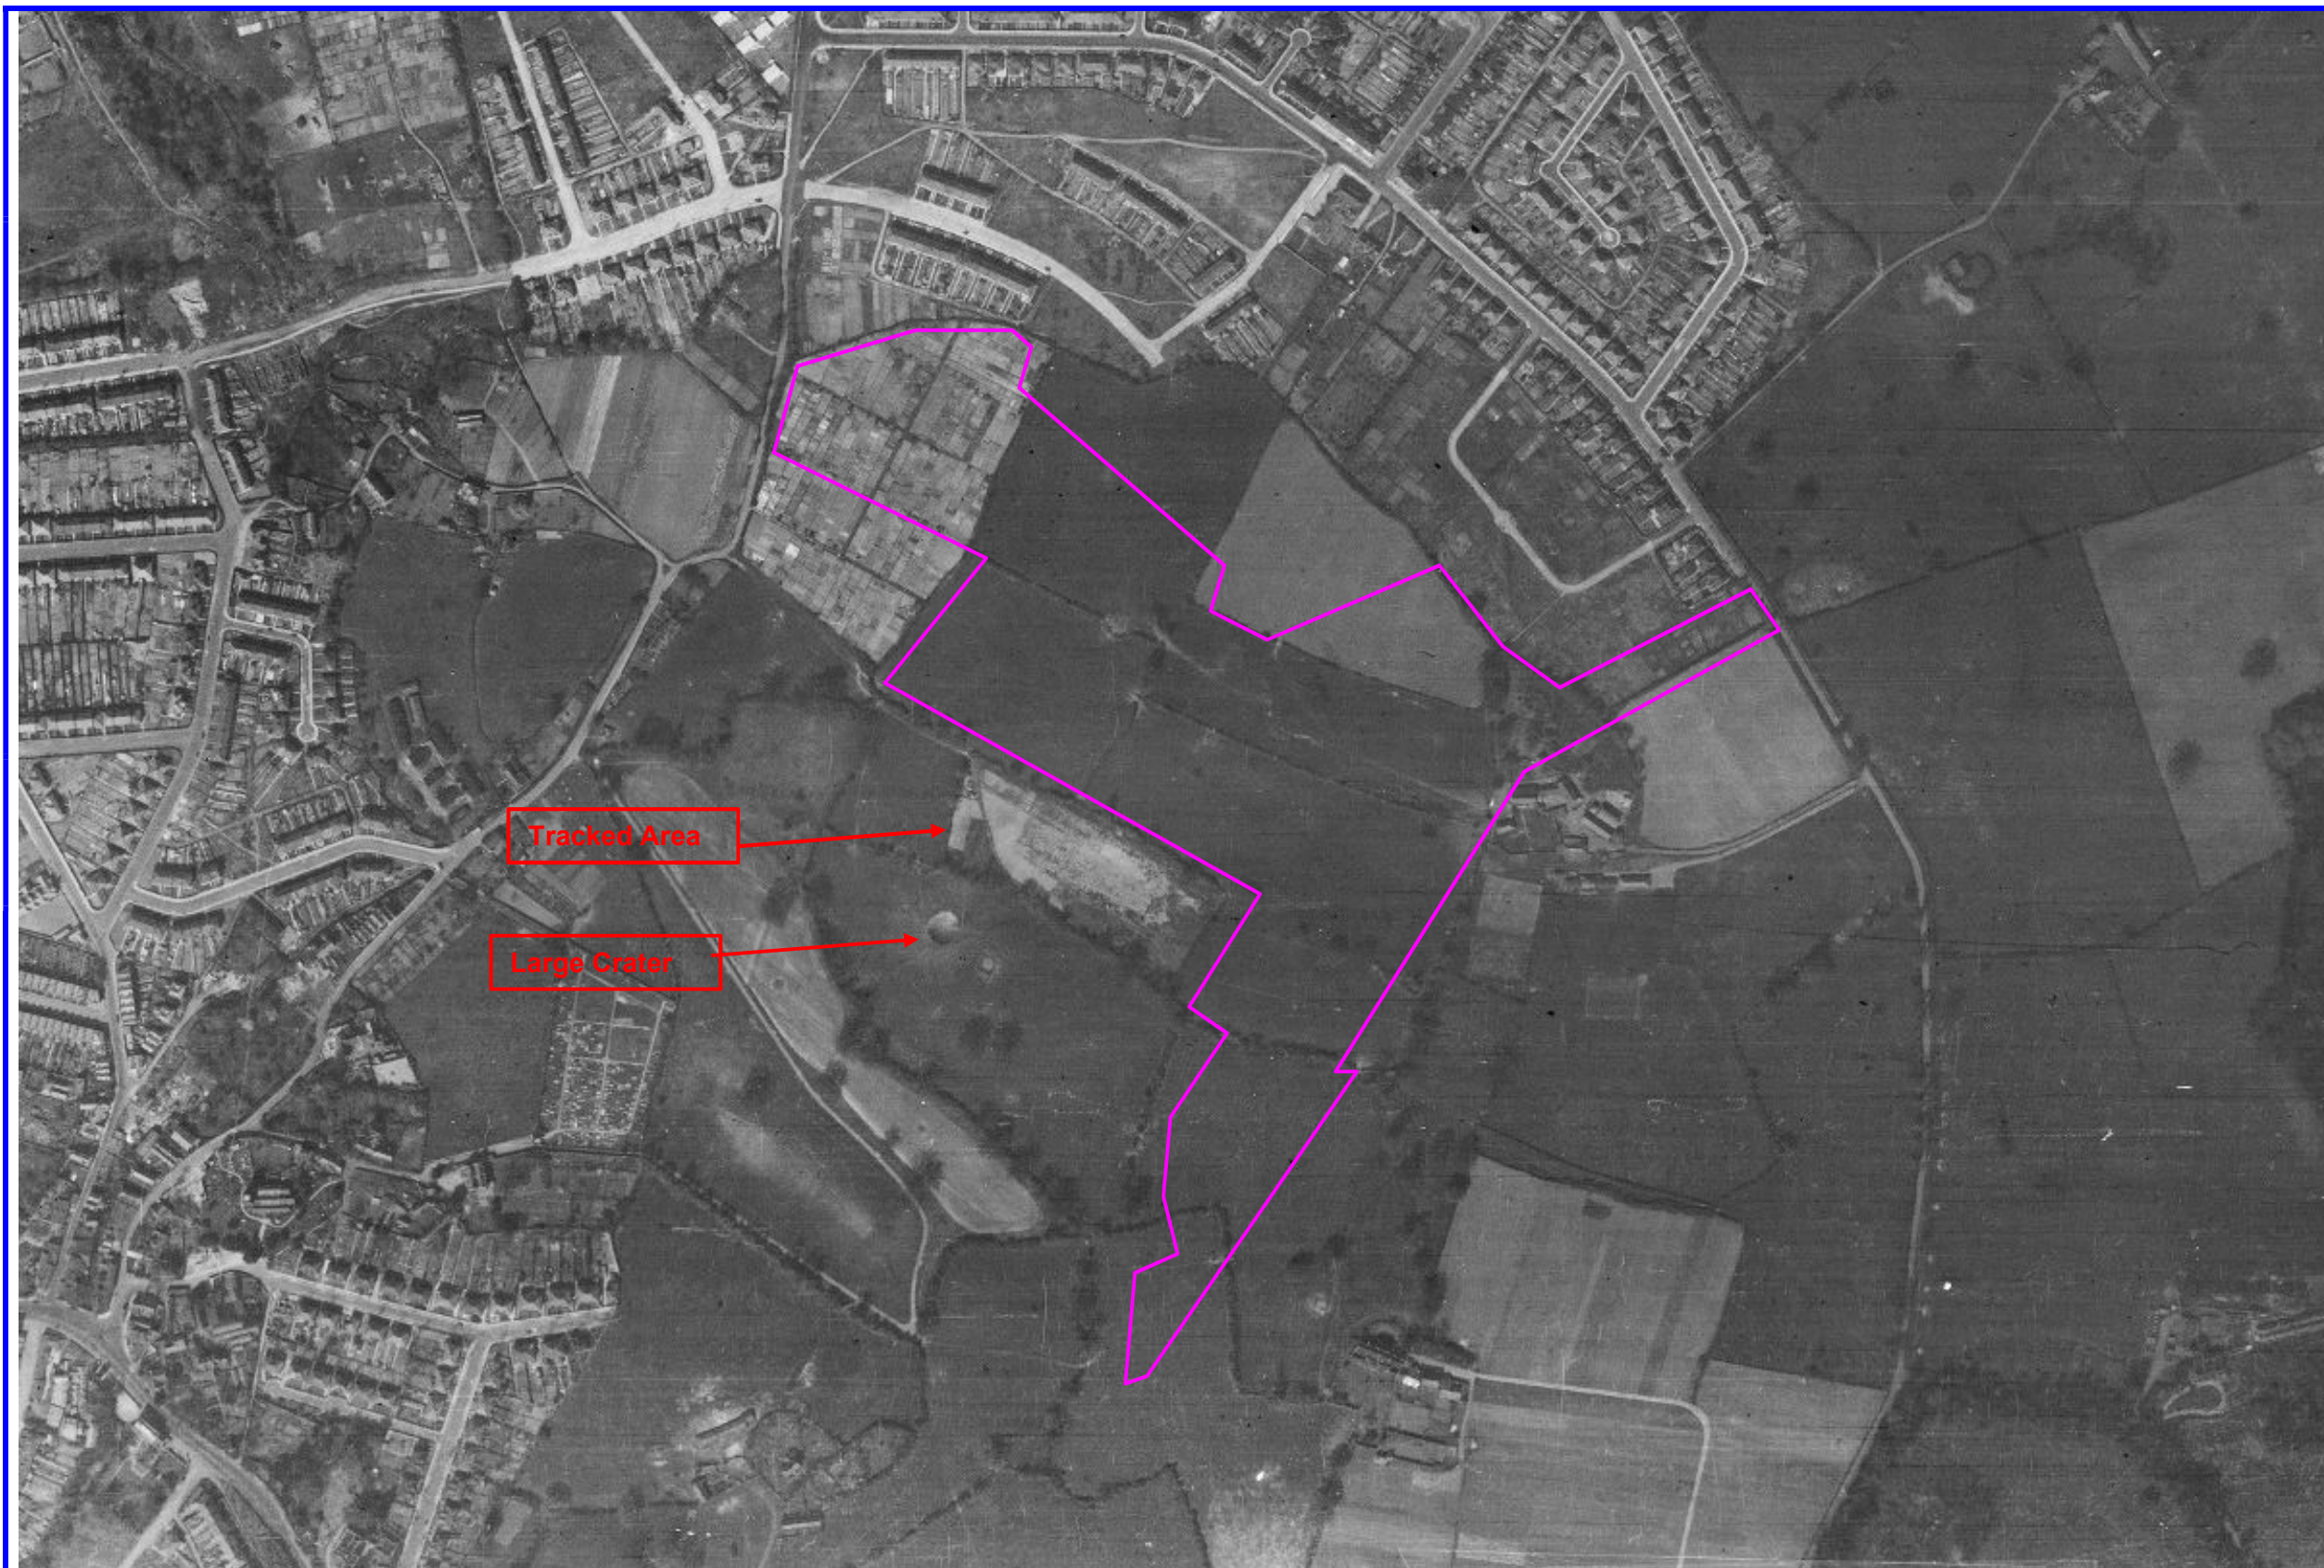
AERIAL PHOTOGRAPH

A large crater plus secondary craters are to the south and west as is an area that appears to be heavily tracked, minor scoring can be seen on the site, possibly indicative of bomb damage

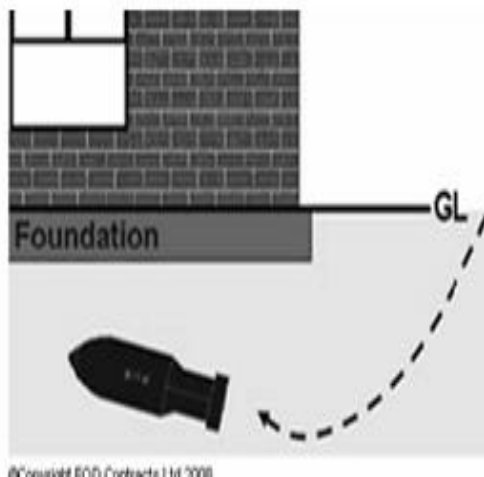
Common Sub-Surface Trajectory ⁶

Note; the common sub-surface trajectory will follow a path best described as a 'J' curve. The curve can result in a weapon coming to rest some distance from its impact point. The distance from impact point to resting place is referred to as the "Off set Distance and is normally considered to be 1/3 of the depth. This mechanism can permit a weapon to strike outside a building and travel below ground finally coming to rest within the building footprint. Where a strike is known to have occurred close to a building or structure such as a dock wall, a danger zone should be considered to exist around the area of the strike of sufficient size to accommodate the likely sub-surface travel distance for the weapon.

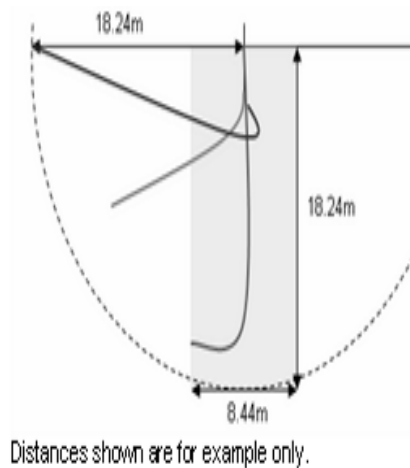
Anomalous Sub-Surface Trajectory ⁷

Note; the typical offset distance is shown as the shaded area, on rare occasions a near surface deflection of the weapon can occur and the offset distance can be substantially increased up to 5/4 of the penetration depth. This mechanism does however reduce the penetration depth considerably with the net result that while the offset is increased the overall travel distance is for the most part unaffected.

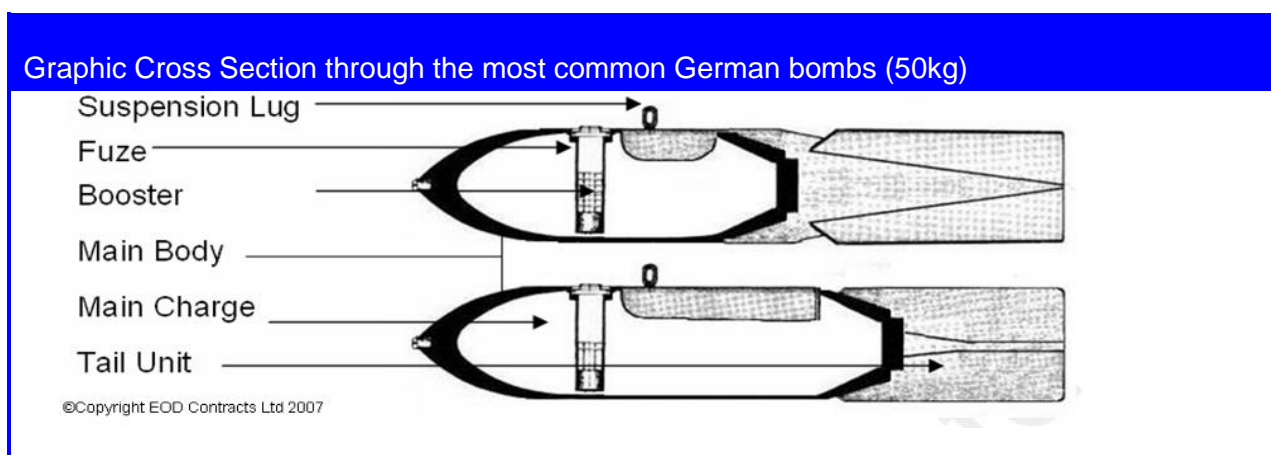
Figure 2: Generic German Bomb Design.

Note; the diagram shows that there can be a significant difference in the quantity of High Explosive contained within bombs of similar size and shape; the Grade 1 bomb on the bottom having 30% more HE than the Grade 2 shown at the top. This serves to demonstrate the importance of an accurate identification of any item of UXO.

Generic German Bomb Types. The majority of German bombs dropped were 50kg in weight, accounting for approximately 16% of the total bombs dropped. The range of common bombs increased in weight to a maximum of 1700kg. Regardless of size, German bombs were fitted with one or more Electrical Condenser Resistance (ECR) fuzes many of which included a mechanical component. The fuzes were mounted transversely in the bomb body with the booster directly below, and in contact with, the fuze. The booster; sometimes referred to as the Gaine, is composed of a sensitive explosive material (Picric Acid). Picric Acid is known to deteriorate over time becoming increasingly unstable. The internal layout of two common German bombs and a German fuze is shown in Figures 2 & 3.

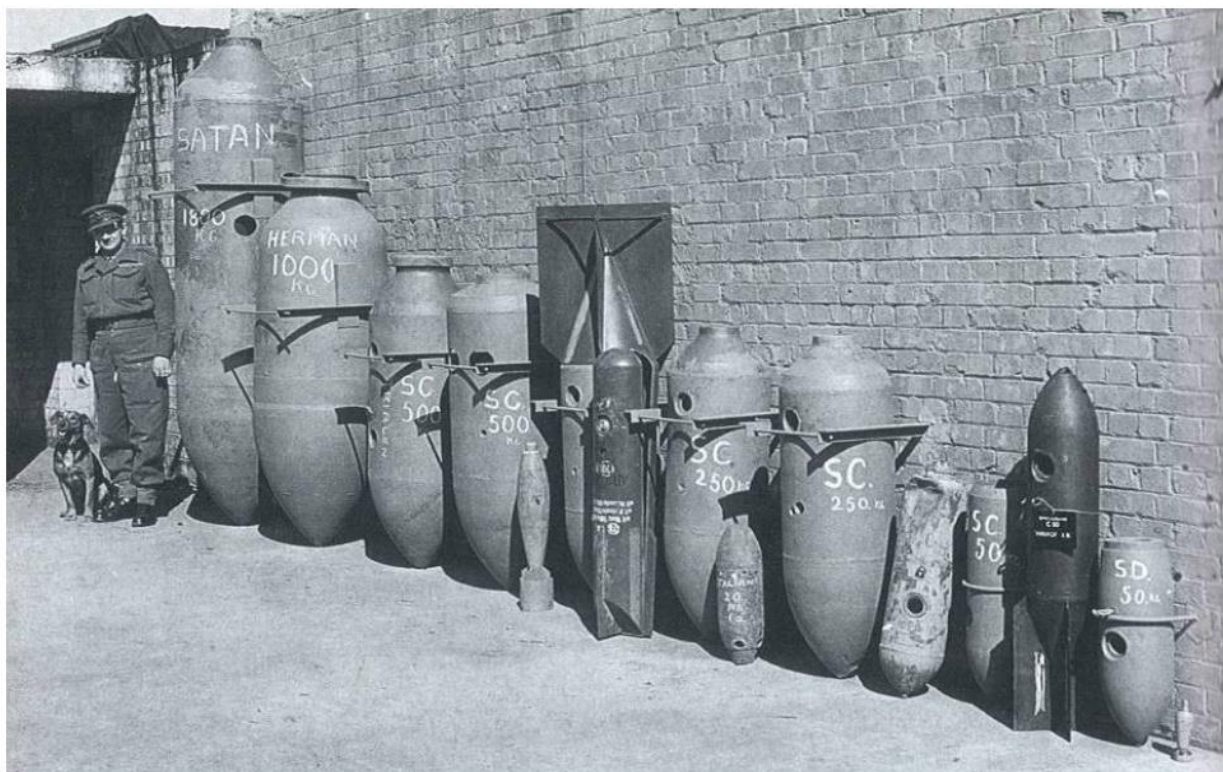
Figure 4: Range of HE bombs dropped on the United Kingdom.

NOTE: The smaller sub-munitions (Bomblets) seen to the right, ranged in size between 1 and 3kg, were dropped in large numbers and were intended as incendiary bombs, anti-personnel bombs or as bombs filling both roles. The smaller bomblets were dropped in larger container bombs designed to hold between 360 and 620 of the bomblets. The containers were designed to burst open at a predetermined height above ground level, dispersing the bomblets over a wide area. Air raid damage was far greater by using both incendiary, and HE bombs on a single raid. The fires started by the incendiaries being rapidly spread by the blast waves from the HE bomb. This scenario was shown to devastating effect on the 14th February 1945 in the German city of Dresden. Where fires started and spread by the bombing increased to a point where the oxygen was being sucked into the flames at such a high speed that the fire became a "Fire Storm". At the time the city's population had increased due to a high number of refugees fleeing the Russian advance to the east, the exact civilian death toll from fire and suffocation will never be known, but is considered to be somewhere between 25,000 and 100,000.

High Explosive (HE) Bomb. Some of the most common type of ordnance to be dropped on the United Kingdom, HE bombs are often the type encountered as UXBs. Relatively thick cased, they are still recovered in remarkably good condition. Ranging in size from 50 to 1700 kg, their typical release height (1,500m) allowed them to penetrate deep into the ground as a result of design or flaw. Towards the end of the bombing campaign, as steel became scarce the German Engineers produced a range of bombs that used steel reinforced concrete as the bomb body. Figure 4 shows the range of steel HE bombs dropped on the UK.

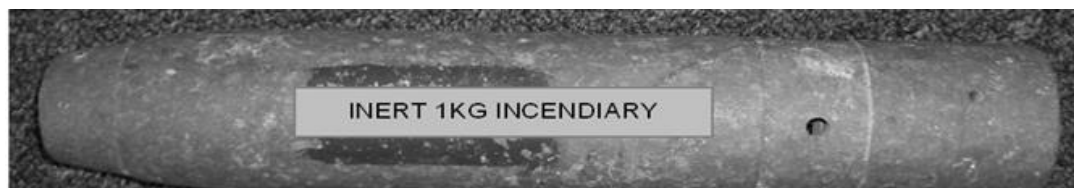
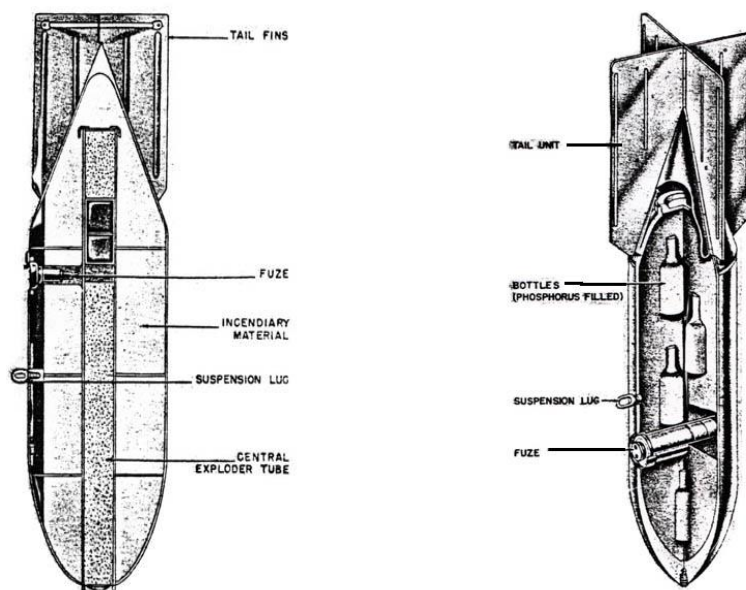
Figure 5: Incendiary Bombs.

Above 1kg incendiary bomblet, below left the larger 500kg incendiary bomb Below right a 50kg incendiary bomb containing bottles of white phosphorus.

Note; Incendiary bomblets were made of a flammable alloy similar in appearance to aluminium, which resists corrosion well. The tail unit was made of thin tin-plate steel and is more prone to have rusted away. Some Incendiary models were fitted with a High Explosive (HE) steel nose. With the tail and explosive nose attached the bomb was 480mm long.

Incendiary Bomb. The larger incendiary bombs, containing bottles of white phosphorus and an incendiary mixture contained within a thin steel case were designed to burst on contact with the ground. A fixed dispenser on the aircraft delivered the smaller type of bomb or 'Bomblet' to the target area in container bombs or; both types of container would open dispersing the smaller Incendiary bombs. Relatively small and light they were unlikely to penetrate the ground to any significant depth. However, once concealed in bomb damage rubble or below water they were easily missed and are still unearthed today from in-fill and drained land. Later versions of the incendiary bomb contained an additional explosive charge used as a short delay "Booby Trap" device that contained a significant amount of high explosive. The Booby Trap component was designed to kill or injure fire fighters and hinder the damage control. See Figure 5.

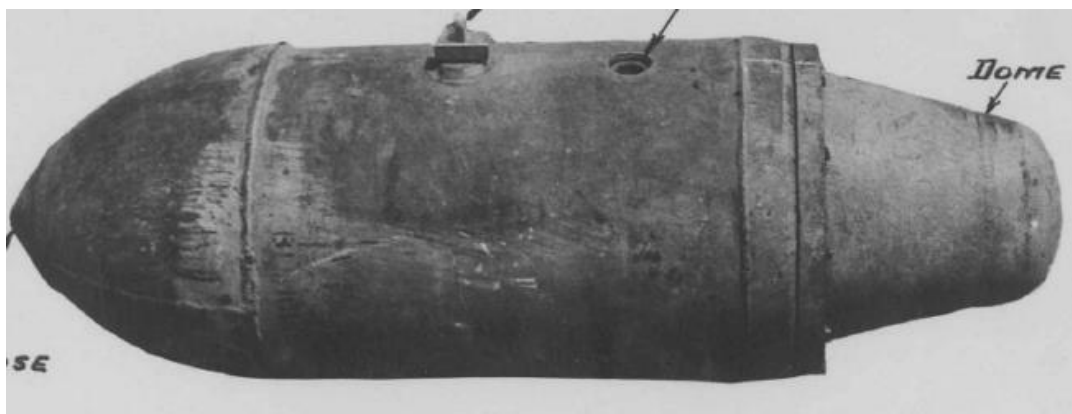
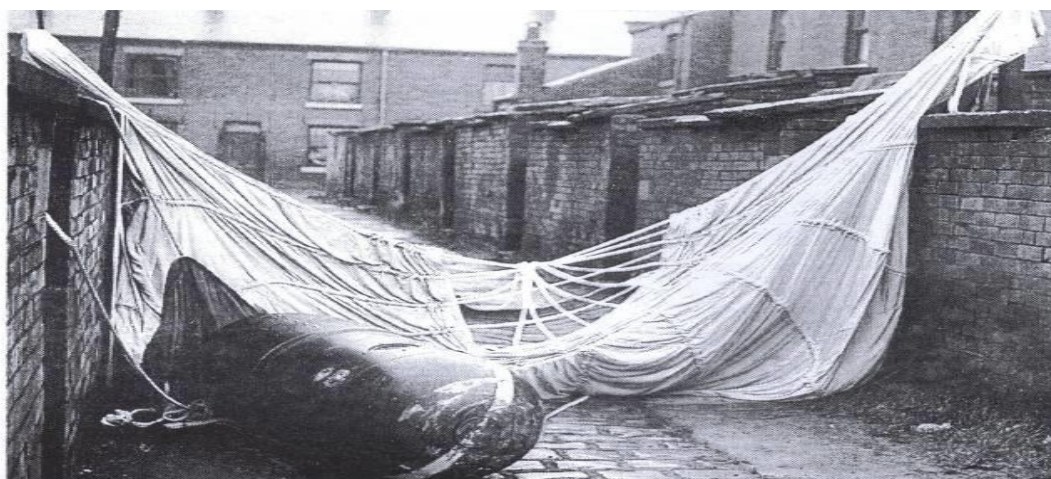
Figure 6: Common Airdropped Mines.

Note; all mine fuzes were designed to arm after deployment from the ship, submarine or aircraft, some fuze designs incorporated anti-removal booby traps. Unexploded mines found today are the result of a failure within the arming mechanism or procedure whereby the mine never fully armed. Sudden shock or jarring of a weapon in this state has the potential to complete the arming sequence and could result in the mine detonating with lethal consequences.

Blast Bomb / Parachute Mine. The parachute mine was extensively used on land and at sea and was fitted with specialist fuzes designed to trigger the weapon at a predetermined altitude, water depth or to switch on other magnetic influence mechanisms to trigger the weapon when a ship approached (Magnetic or Acoustic influence). While early versions were based on the standard 1000kg SD Bomb case others were specially designed and manufactured with an aluminium body, making them extremely difficult to detect using magnetometers. The thin cased versions would normally disintegrate on impact on land and are normally considered to pose little threat to work on land based projects, but the risk increases significantly on projects over water or in marshland. Thicker cased versions however will survive impact and pose a significant risk regardless of the local ground conditions. (See Figure 6)

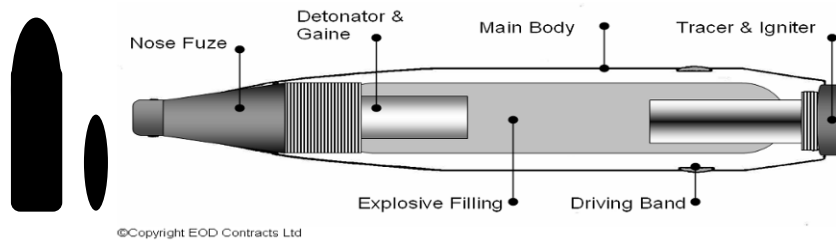
Figure 7: Generic Shell Design

Scale & Graphic Cross Section of a typical High Explosive (HE) Shell

Approximate size of a large shell used by battleships and coastal bombardment guns (Left) and Anti-aircraft shell (Right)
