**NON-INTRUSIVE UXO SURVEY  
REPORT**

**Client:** Campbell Reith  
**Project Location:** Brislington, Bristol  
**Project Ref:** CAMP11  
**Report Ref:** 20210421-NIREP-CAMP11  
**Revision:** 1  
**Status:** Final  
**Date:** 29<sup>th</sup> April 2021

**UXO TARGET INVESTIGATION  
REPORT**

**Client:** Campbell Reith  
**Project Location:** Brislington, Bristol  
**Project Ref:** CAMP13  
**Report Ref:** 20211206-TIREP-CAMP13  
**Revision:** 1  
**Status:** Final  
**Date:** 6<sup>th</sup> December 2021

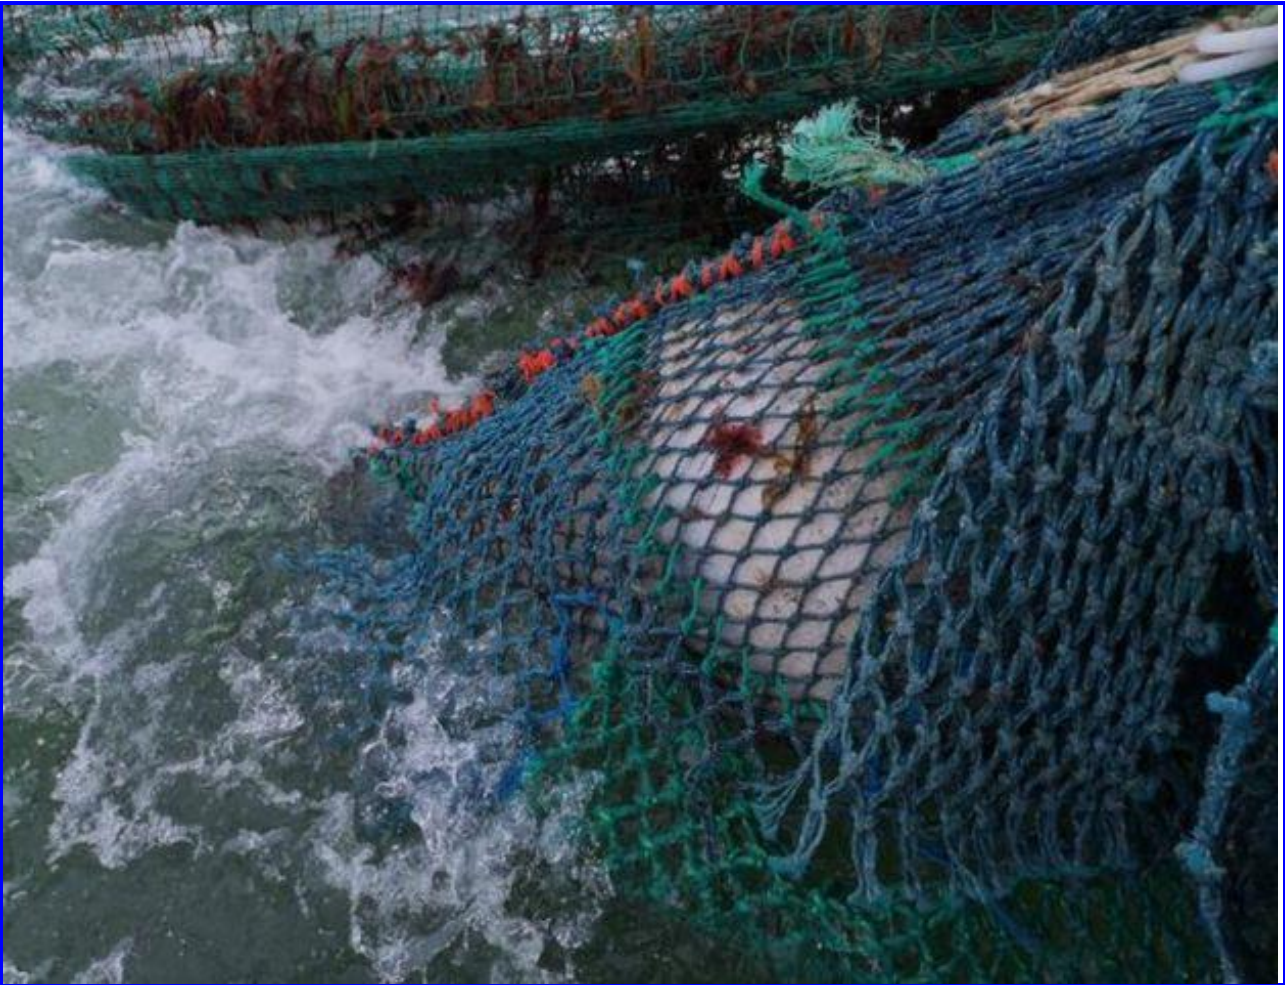
The bombs, which were designed during the 1940s, were glass bottles filled with phosphorus and petrol. Unlike traditional Molotov cocktails, they would ignite spontaneously when the glass shattered, and the phosphorus became exposed to air.

The grenades were issued to Home Guard units in the event of a German invasion; as that never happened crates of them have been left buried in unregistered hiding places.

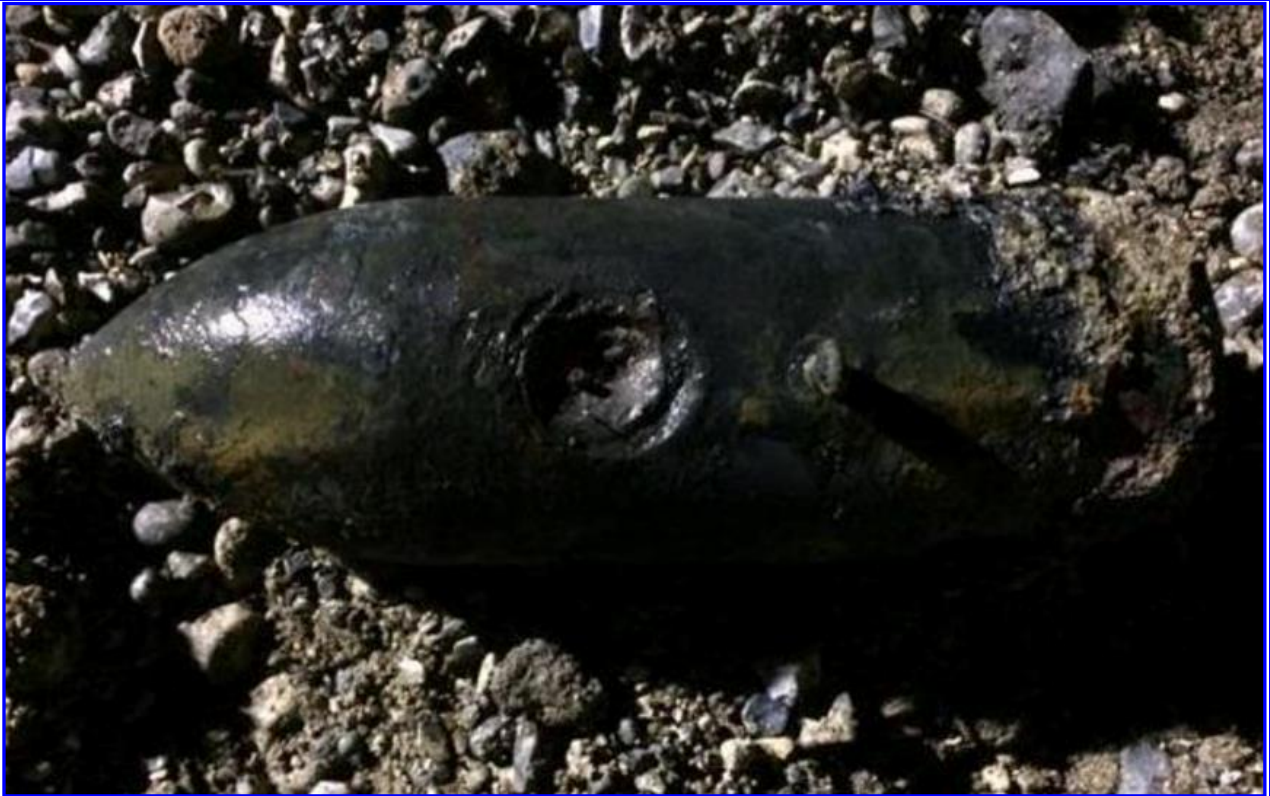
Discovery: the unexploded German SD 50kg bomb was dropped by an aircraft during the second world war.

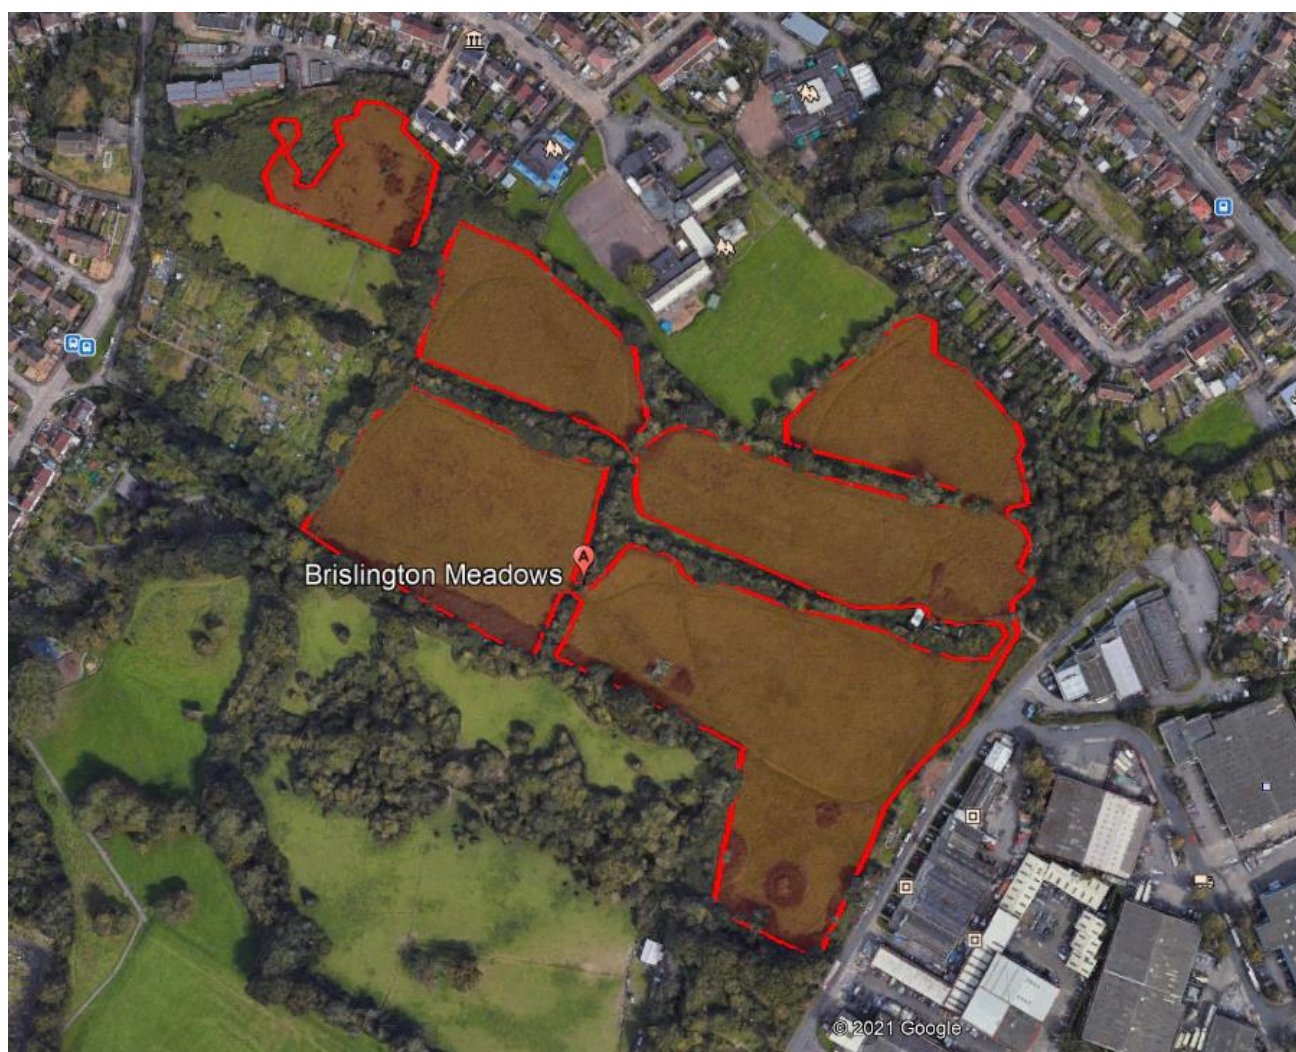
The project address is: Brislington Meadows, Brislington, Bristol, BS4 4FJ. The site boundaries are indicated in red below, and in further detail contained in Annex A.

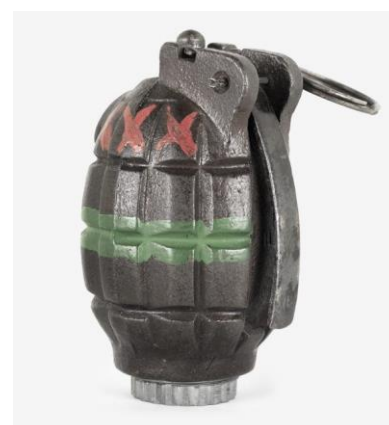
Figure 3. No. 36 Mills Grenade, source: IWM

A No.36 grenade, which is one of the smallest mass items we could find, has an overall mass of around 750g, and approximately 500-600g of iron. If UXO is found however, a 100% investigation of all targets would be recommended, to satisfy CIRIA C681 guidelines and the ALARP principle.

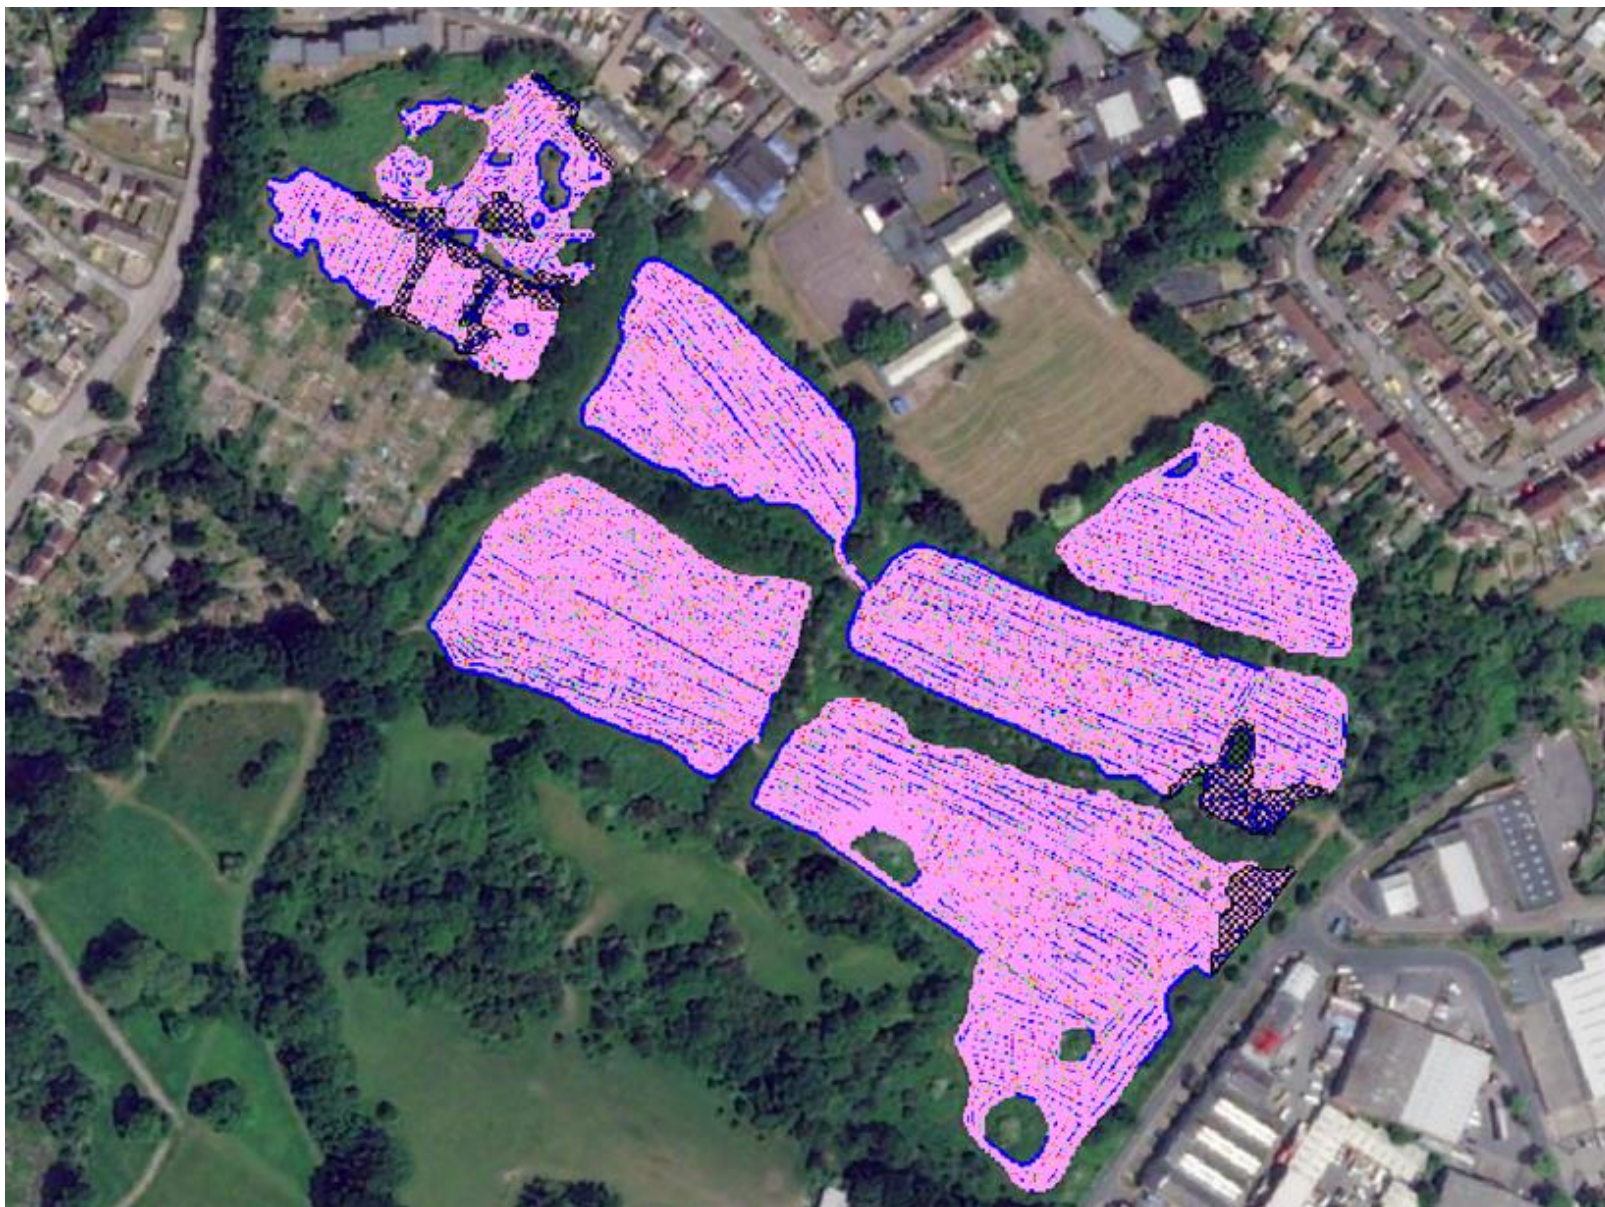
Raw Magnetic Field

In coordination with the client Brimstone recommended the completion of a non-intrusive magnetometry survey. The output of this survey is false colour maps of 'hotspots' overlain satellite imagery of the site. A non-intrusive survey is a survey style which does not require any manipulation or 'intrusions' into the ground. This means that specialist technical equipment is methodically moved across the surface of a given area without disturbing any possible buried objects. The benefit of this type of survey is wide area coverage, as consistent with the requirements for this project.

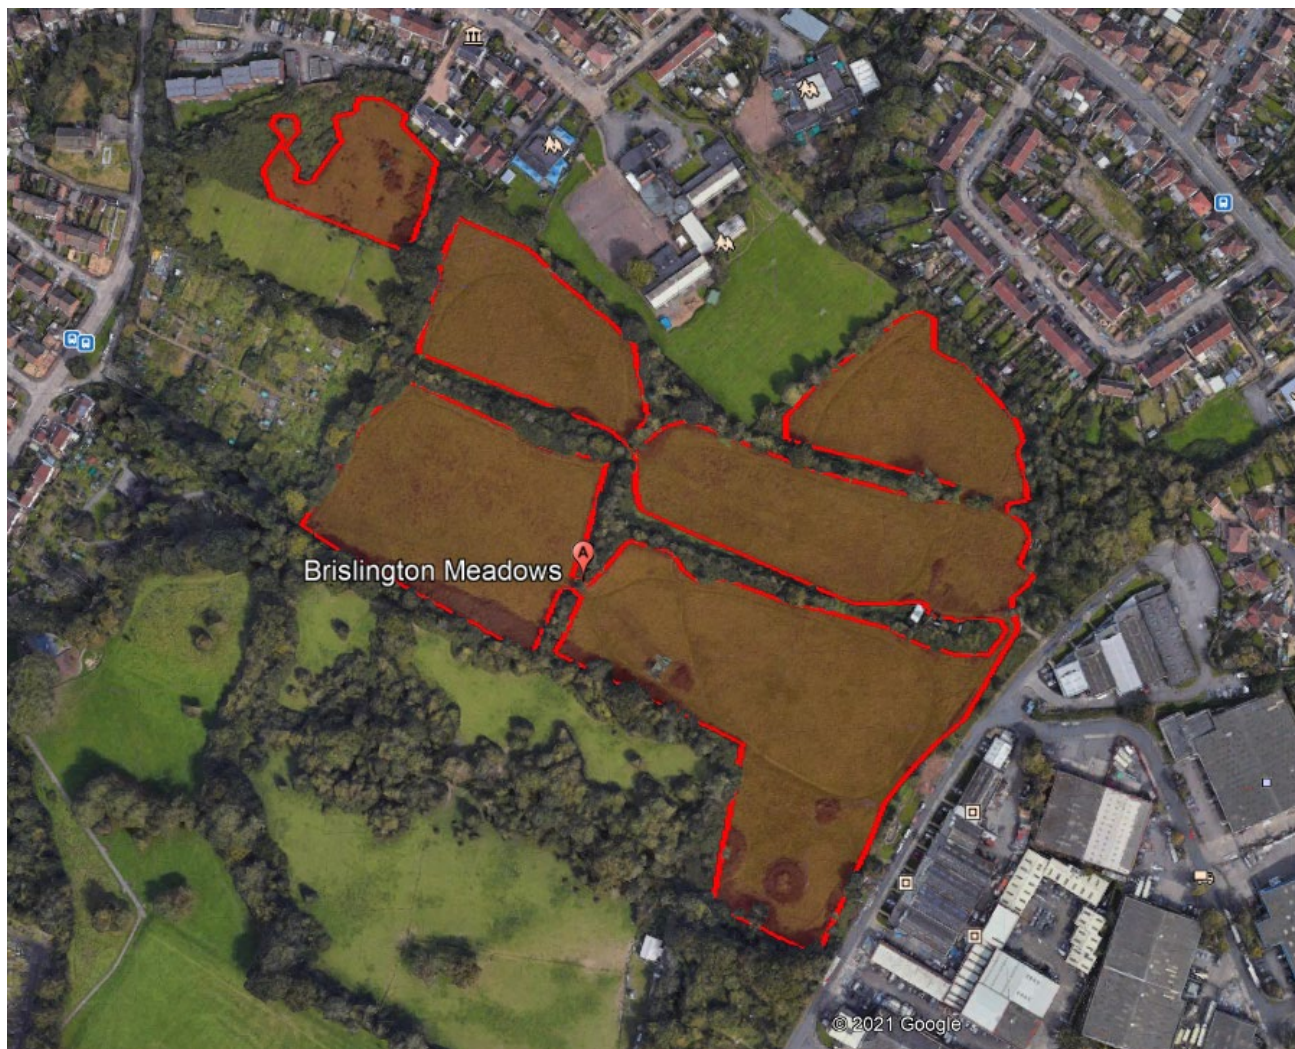
*Figure 3: Brislington Meadows, Brislington, Bristol, BS4 4FJ*

The project address is: Brislington Meadows, Brislington, Bristol, BS4 4FJ. The site boundaries are indicated in red below.

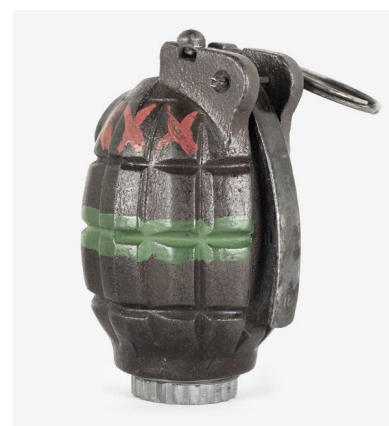
Figure 4: No. 36 Mills Grenade, source: IWM

A No.36 grenade, which is one of the smallest mass items we could find, has an overall mass of around 750g, and approximately 500-600g of iron. If UXO is found however, a 100% investigation of all targets would be recommended, to satisfy CIRIA C681 guidelines and the ALARP principle.

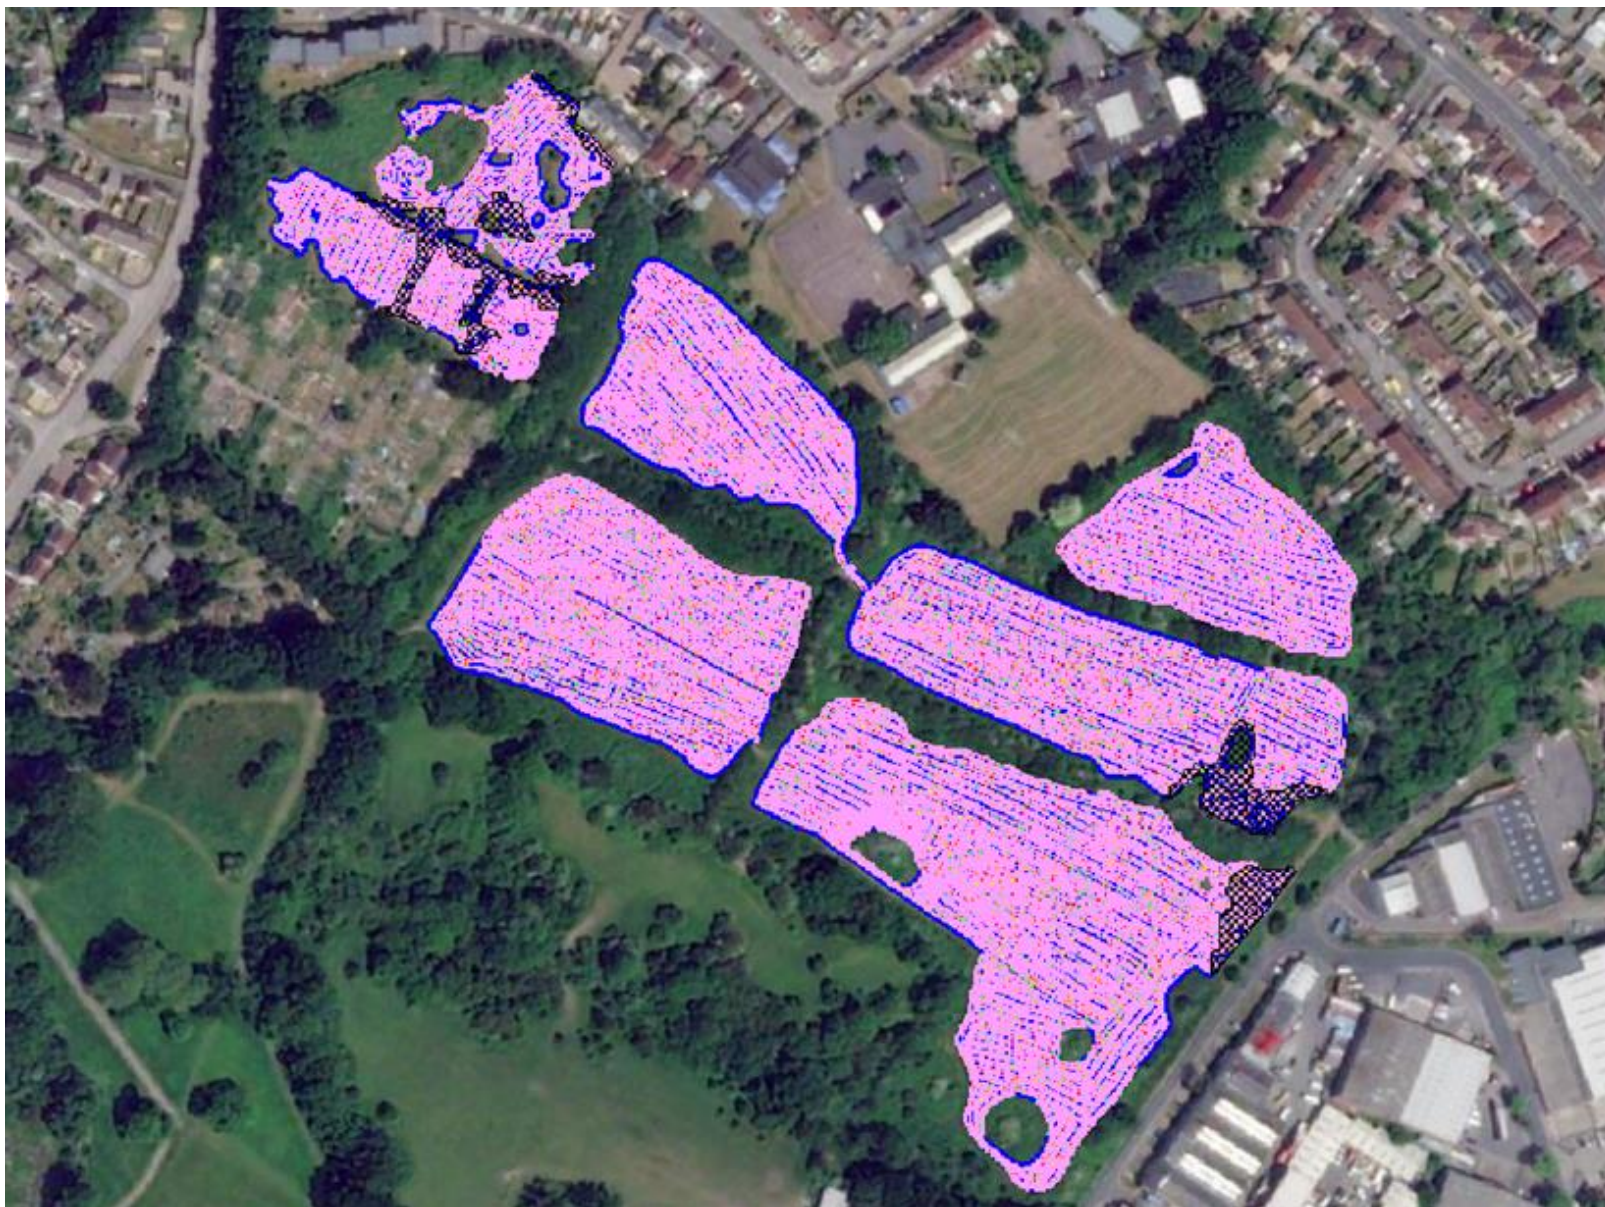
Raw Magnetic Field

In coordination with the client Brimstone recommended the completion of a non-intrusive magnetometry survey. The output of this survey is false colour maps of 'hotspots' overlain satellite imagery of the site. A non-intrusive survey is a survey style which does not require any manipulation or 'intrusions' into the ground. This means that specialist technical equipment is methodically moved across the surface of a given area without disturbing any possible buried objects. The benefit of this type of survey is wide area coverage, as consistent with the requirements for this project.
