**River Avon Tidal De Facto Flood
Defences Investigation**

**Visual Walkover Structural
Assessment**

REP/042/16

Rev1 | 03 May 2016

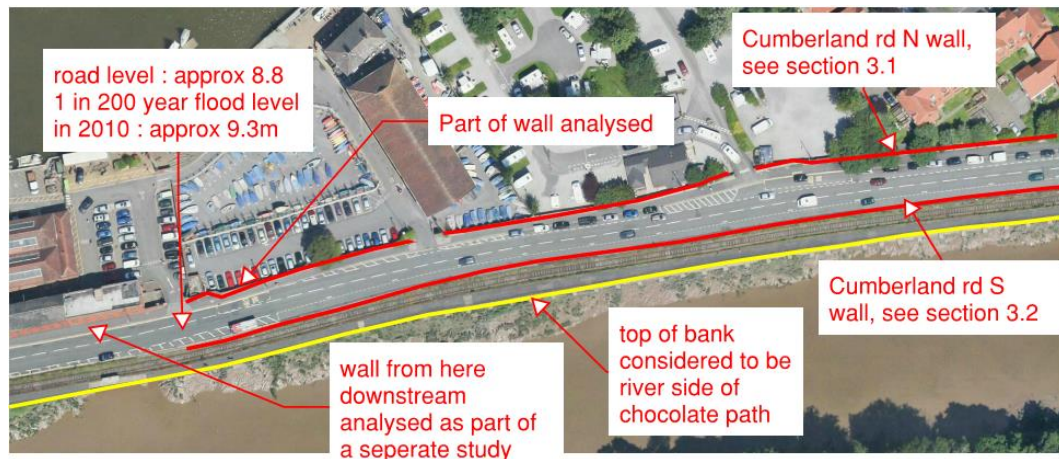
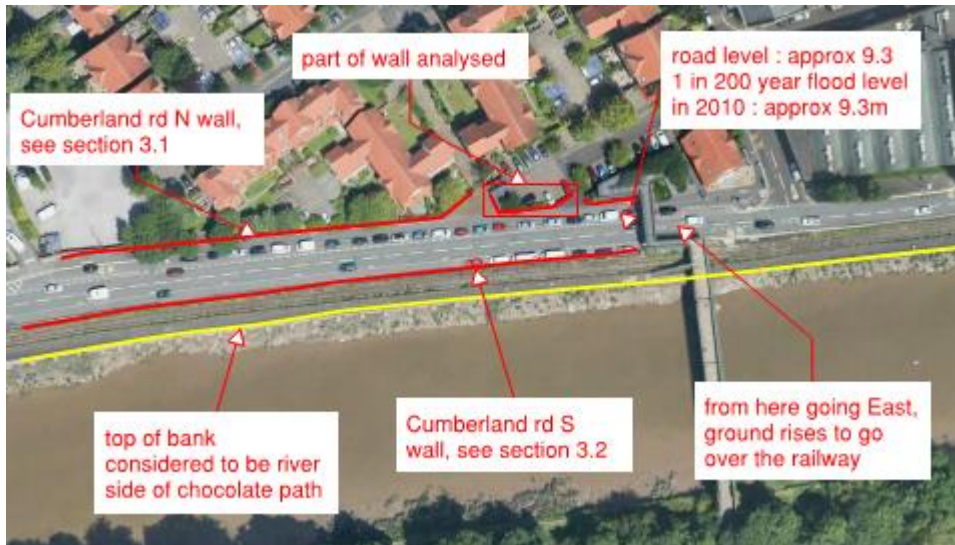
Figure 4 - West section of Cumberland Road, aerial image © Blom 2012

Most of the wall is a combination of random stone masonry and clay bricks. The wall is not continuous and has 4 gaps in it, these can be seen on figures 4 and 5 above. There are several places where former doors have been in-filled and a few where vegetation is growing on the wall. There are some signs of cracking and movement in the wall. While none of these suggest the wall is likely to collapse in the near future, there is a possibility that during a flood a small amount of water could seep through. It was also noted that particularly at the west end, there were numerous potholes in the adjacent road that could indicate soft ground in the area.

Heading east towards Vauxhall Bridge, the wall becomes a clay brick wall. This wall has several cracks in it that could allow water to pass through in a flood. It is also narrower and shorter than the random stone masonry walls.

Because of the cracks, condition of the wall is considered to be condition grade 4.

Table 2.3 of the EA guidance report SC060078/R1 suggests that for a masonry wall in a coastal environment, the expected time for deterioration to progress from CG4 to CG5 is 10-20 years. This wall is not subject to the same forces from waves, etc. as some walls in a coastal environment would be, but is showing signs of movement and it is possible that movement is continuing at a slow rate. It is not possible to say with confidence that the wall can continue to act as a defacto defence for more than 5-10 years.

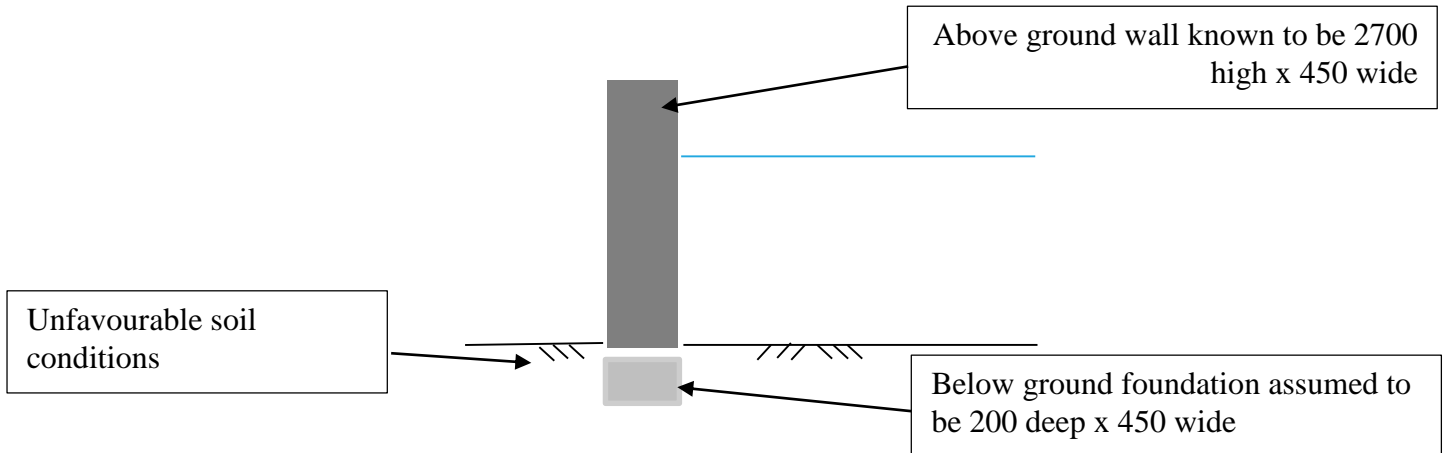
In this situation, it can be expected that the wall will remain stable up to a water height of around 0.85m, or 9.65m AOD. Above this point the wall is at risk of failure by sliding. This would lead to rapid inundation of the Floating Harbour.

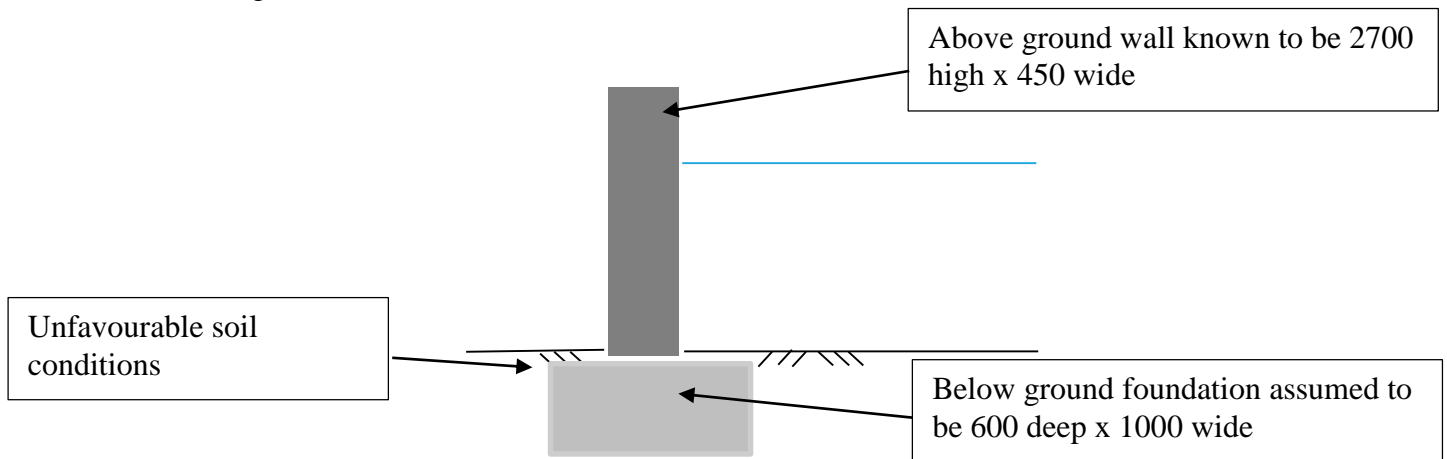
In this situation the wall can be expected to remain stable up to a water height of 1.05m, or 9.85m AOD, with sliding again the most likely mode of failure.

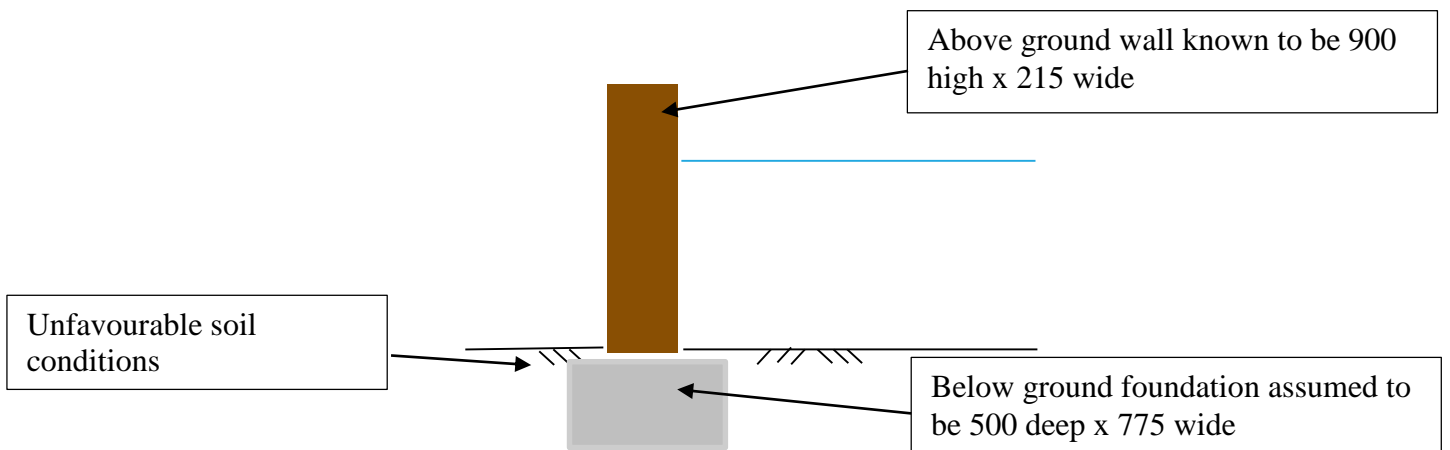
In this situation the wall can be expected to remain stable up to a height of 0.65m, or 9.85m AOD. Above this height failure by sliding and overturning are both possible.

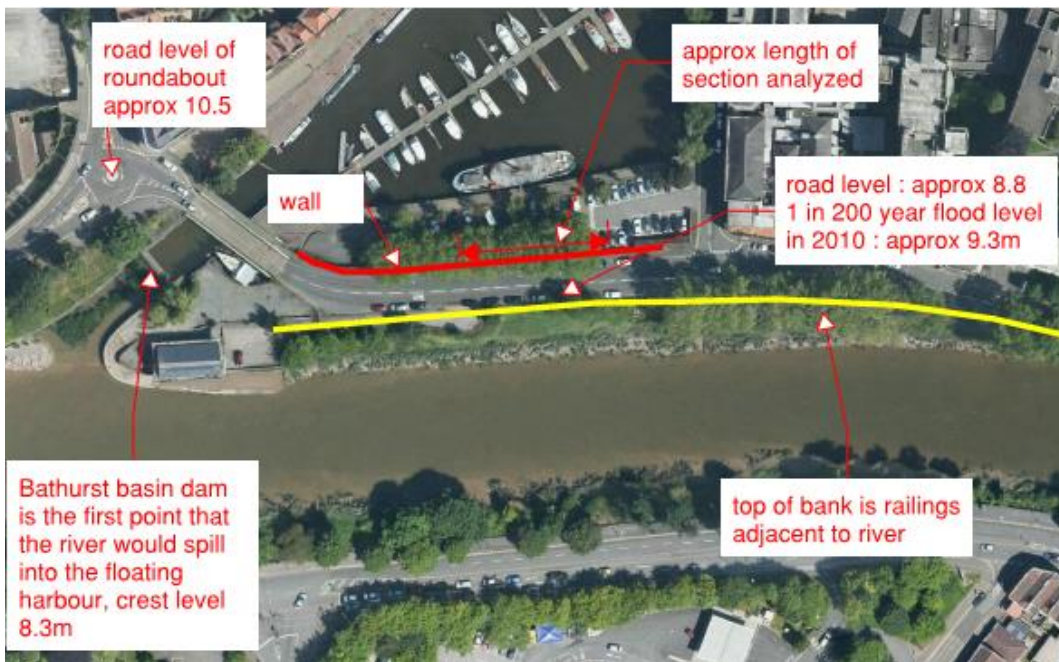
Figure 9 – Location of wall along Commercial Road, aerial image © Blom 2012

The wall has several vertical or near vertical cracks, probably caused by the lack of movement joints in the masonry. The lengths of wall with no vertical cracks in them vary from approximately 6m to approximately 20m, and some of them pass all the way through the wall. These cracks are wide enough to allow a small amount of water to flow through in a flood. There is also a narrow joint that is not filled in, this joint could also allow a small amount of water to flow through in a flood.

Because of the cracks, condition of the wall is considered to be condition grade 4.

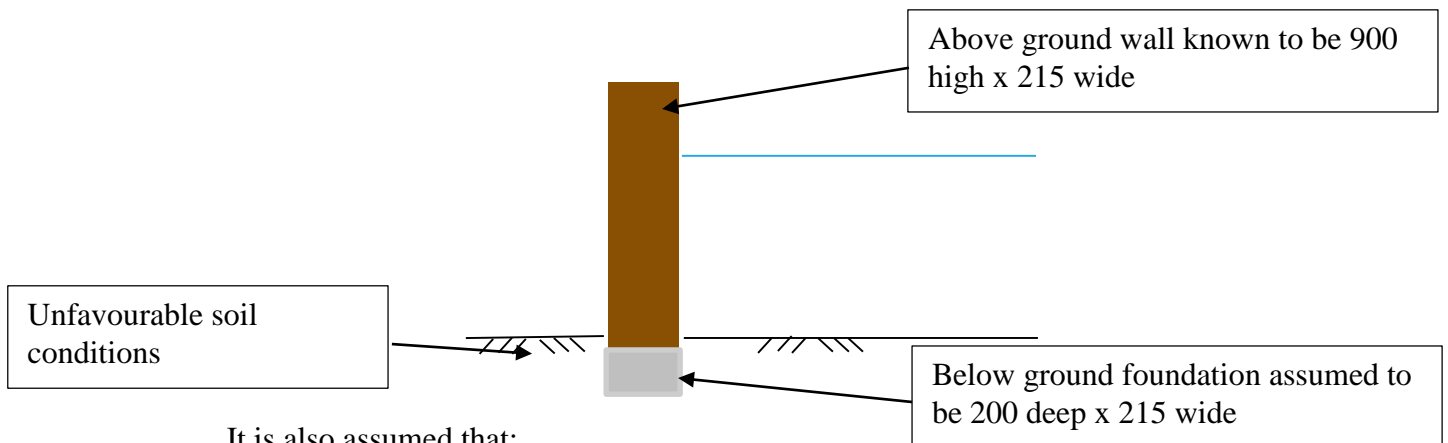
In this situation, it can be expected that the wall will remain stable up to a water height of around 0.3m above ground level. If the water rises above this level, failure could be by the wall sliding or overturning, or the stem failing. The

calculations show that none of these failure modes will happen at 0.3m, but any could happen at 0.4m. Any of these failure modes will lead to rapid inundation of the Floating Harbour.

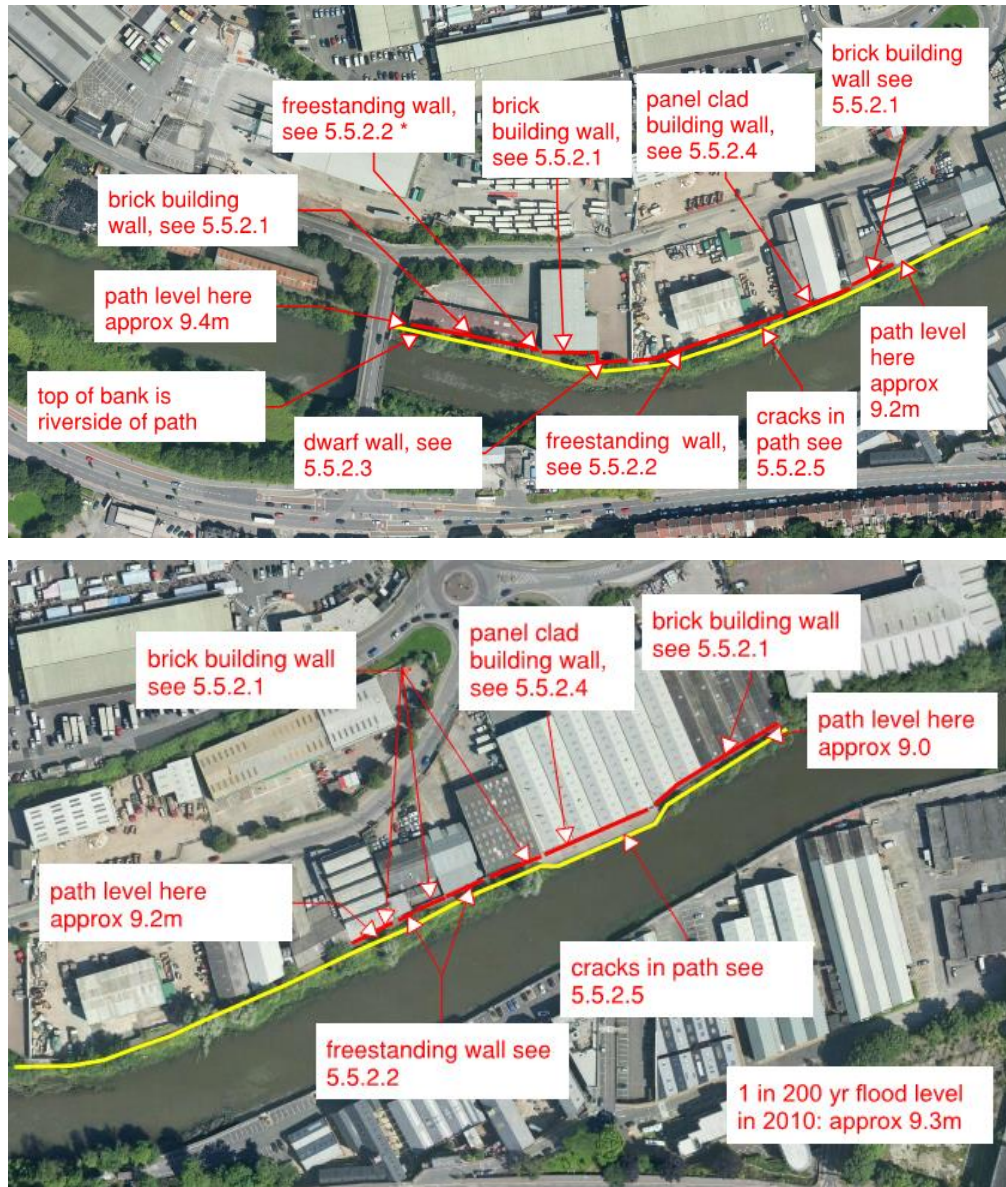
Figure 31 - Walls from Albert Road bridge to Travis Perkins building, aerial image © Blom 2012

One of the walls, marked * on fig. 31, is leaning towards the river. The gap between this wall and the adjacent building varies from around 15mm at the top to 0mm at the bottom.

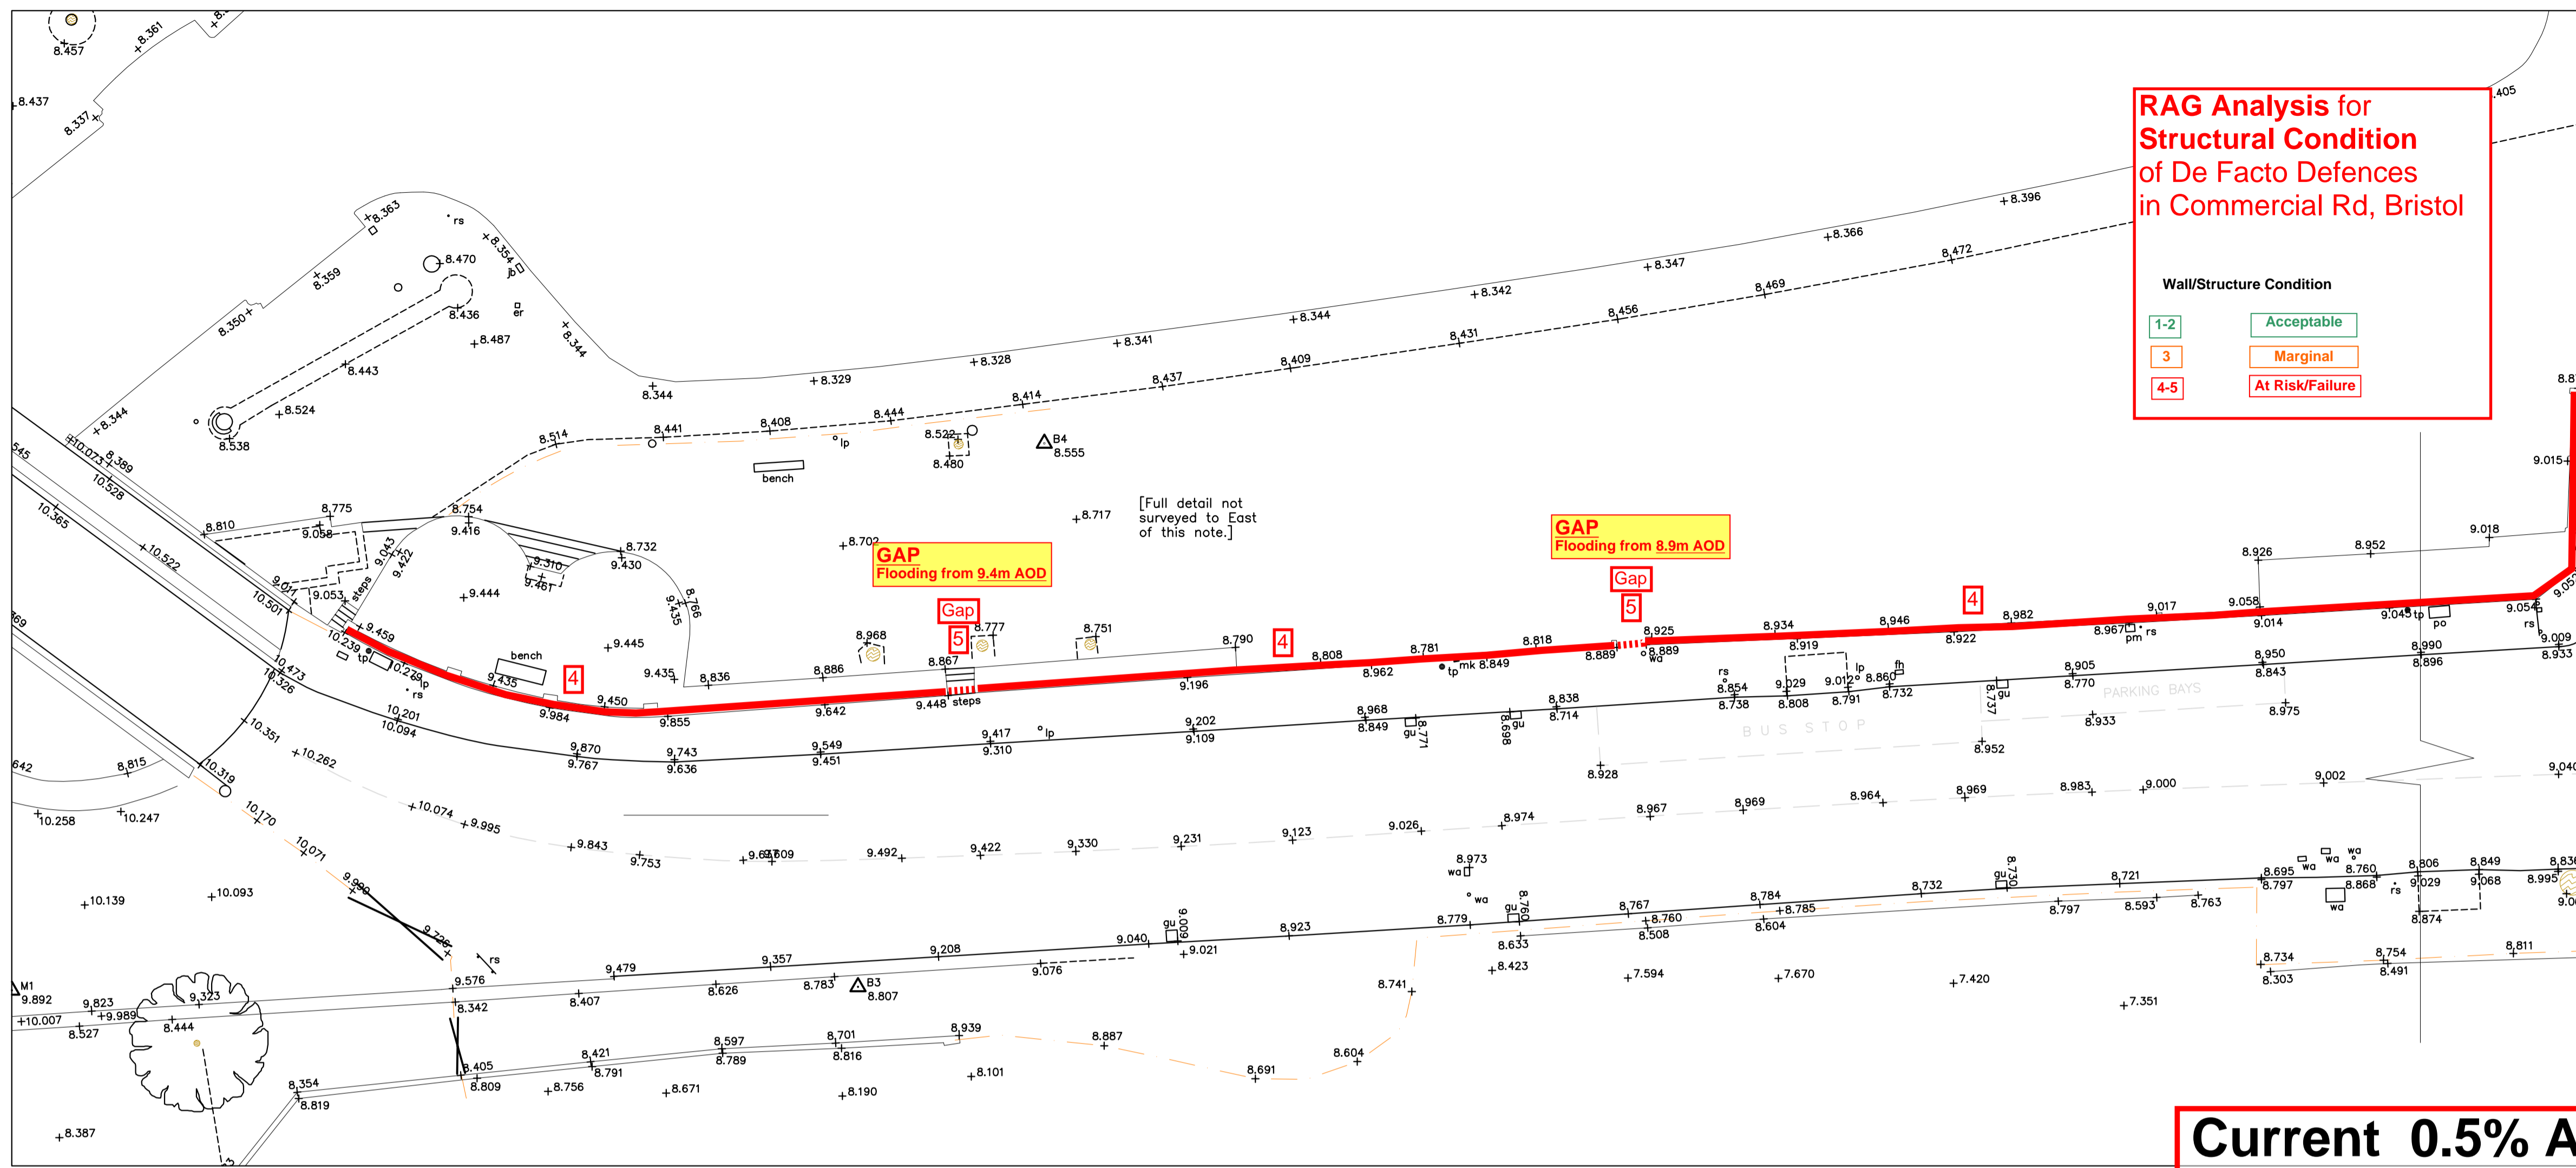
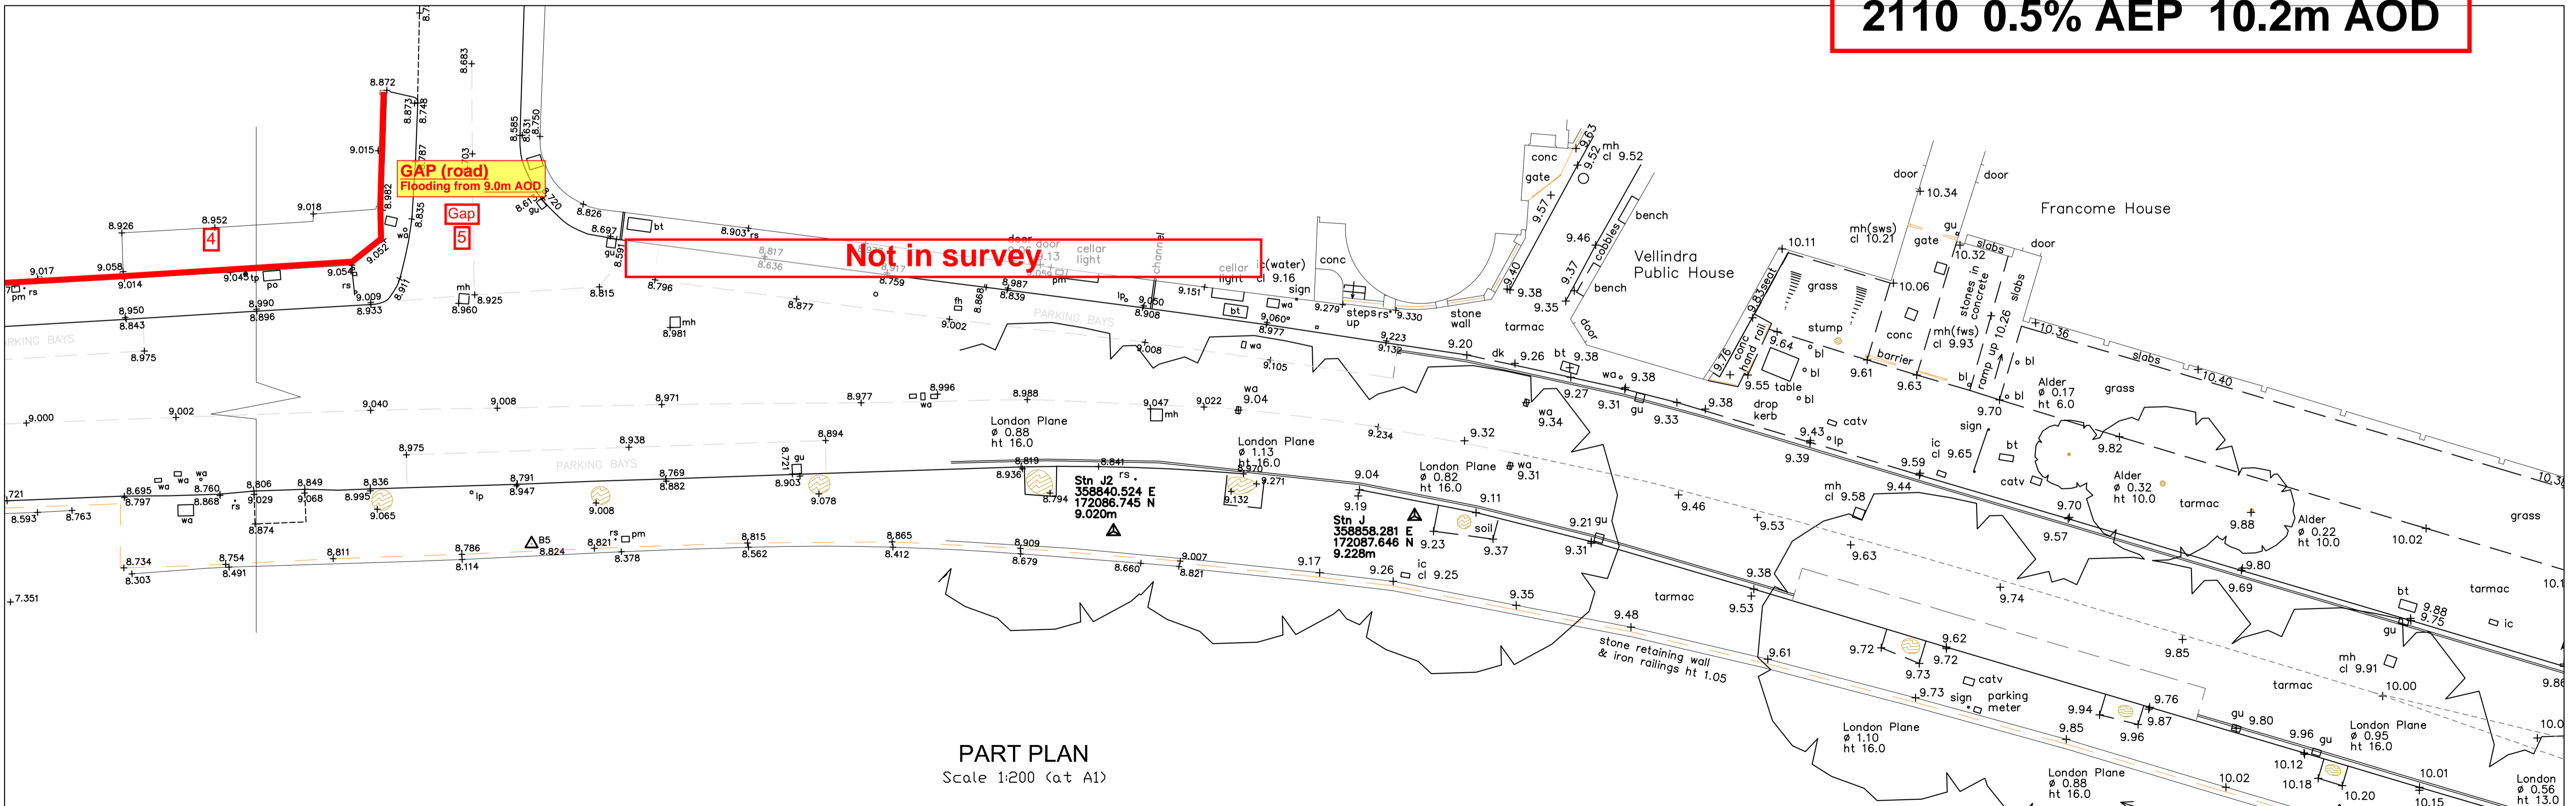
A1 **Structural Condition of De Facto Defences**

RAG Analysis for Structural Condition of De Facto Defences in Commercial Rd, Bristol

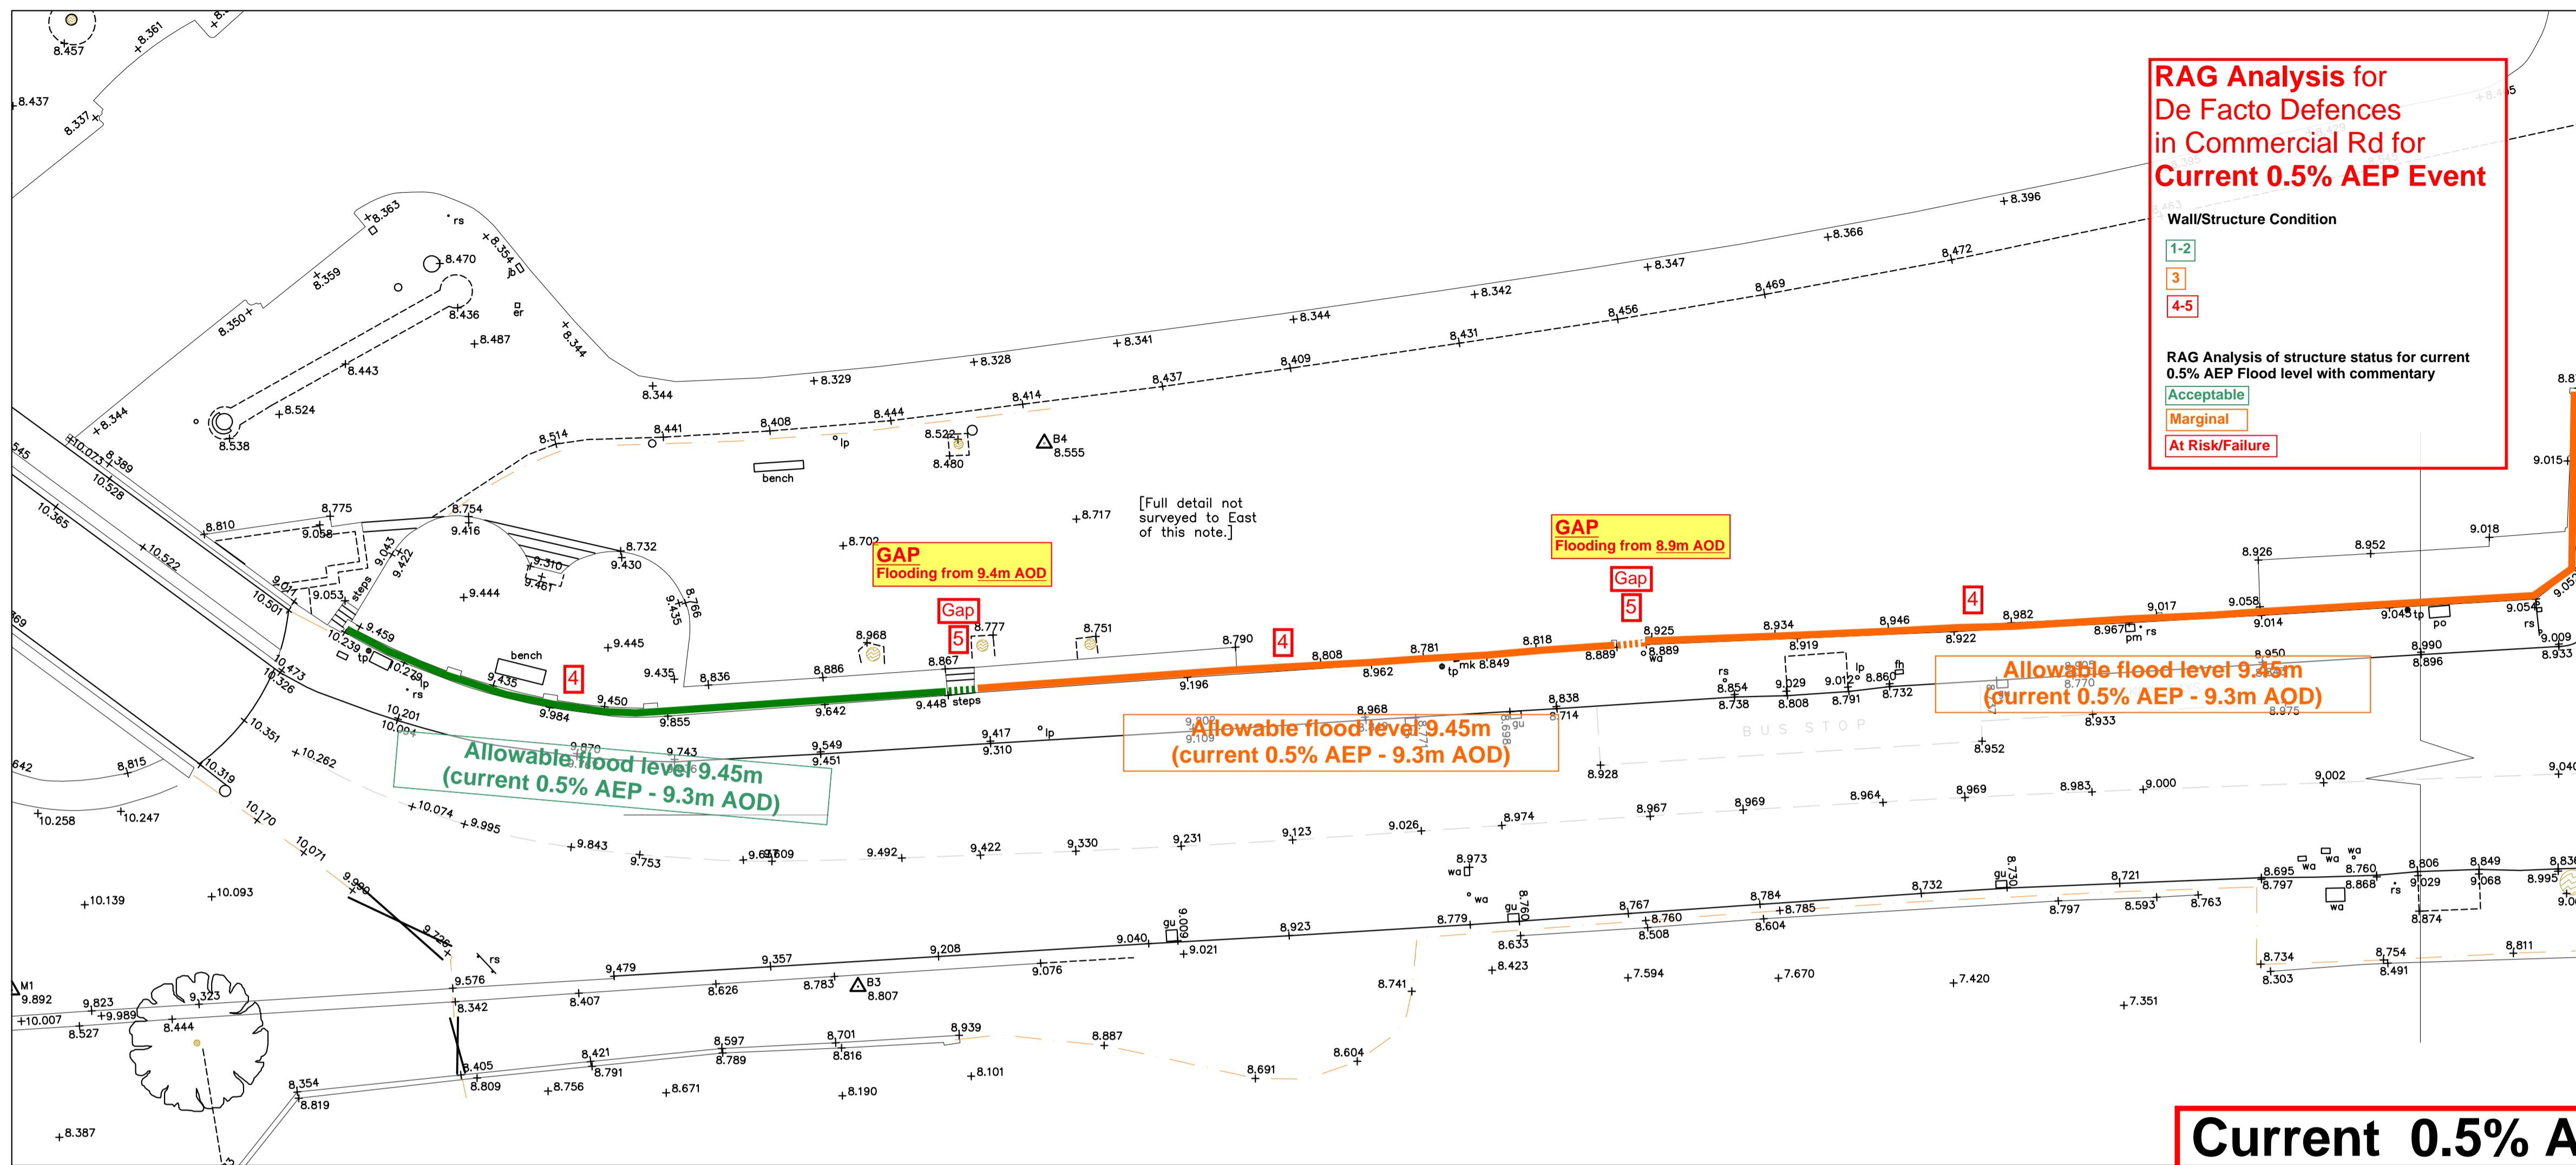
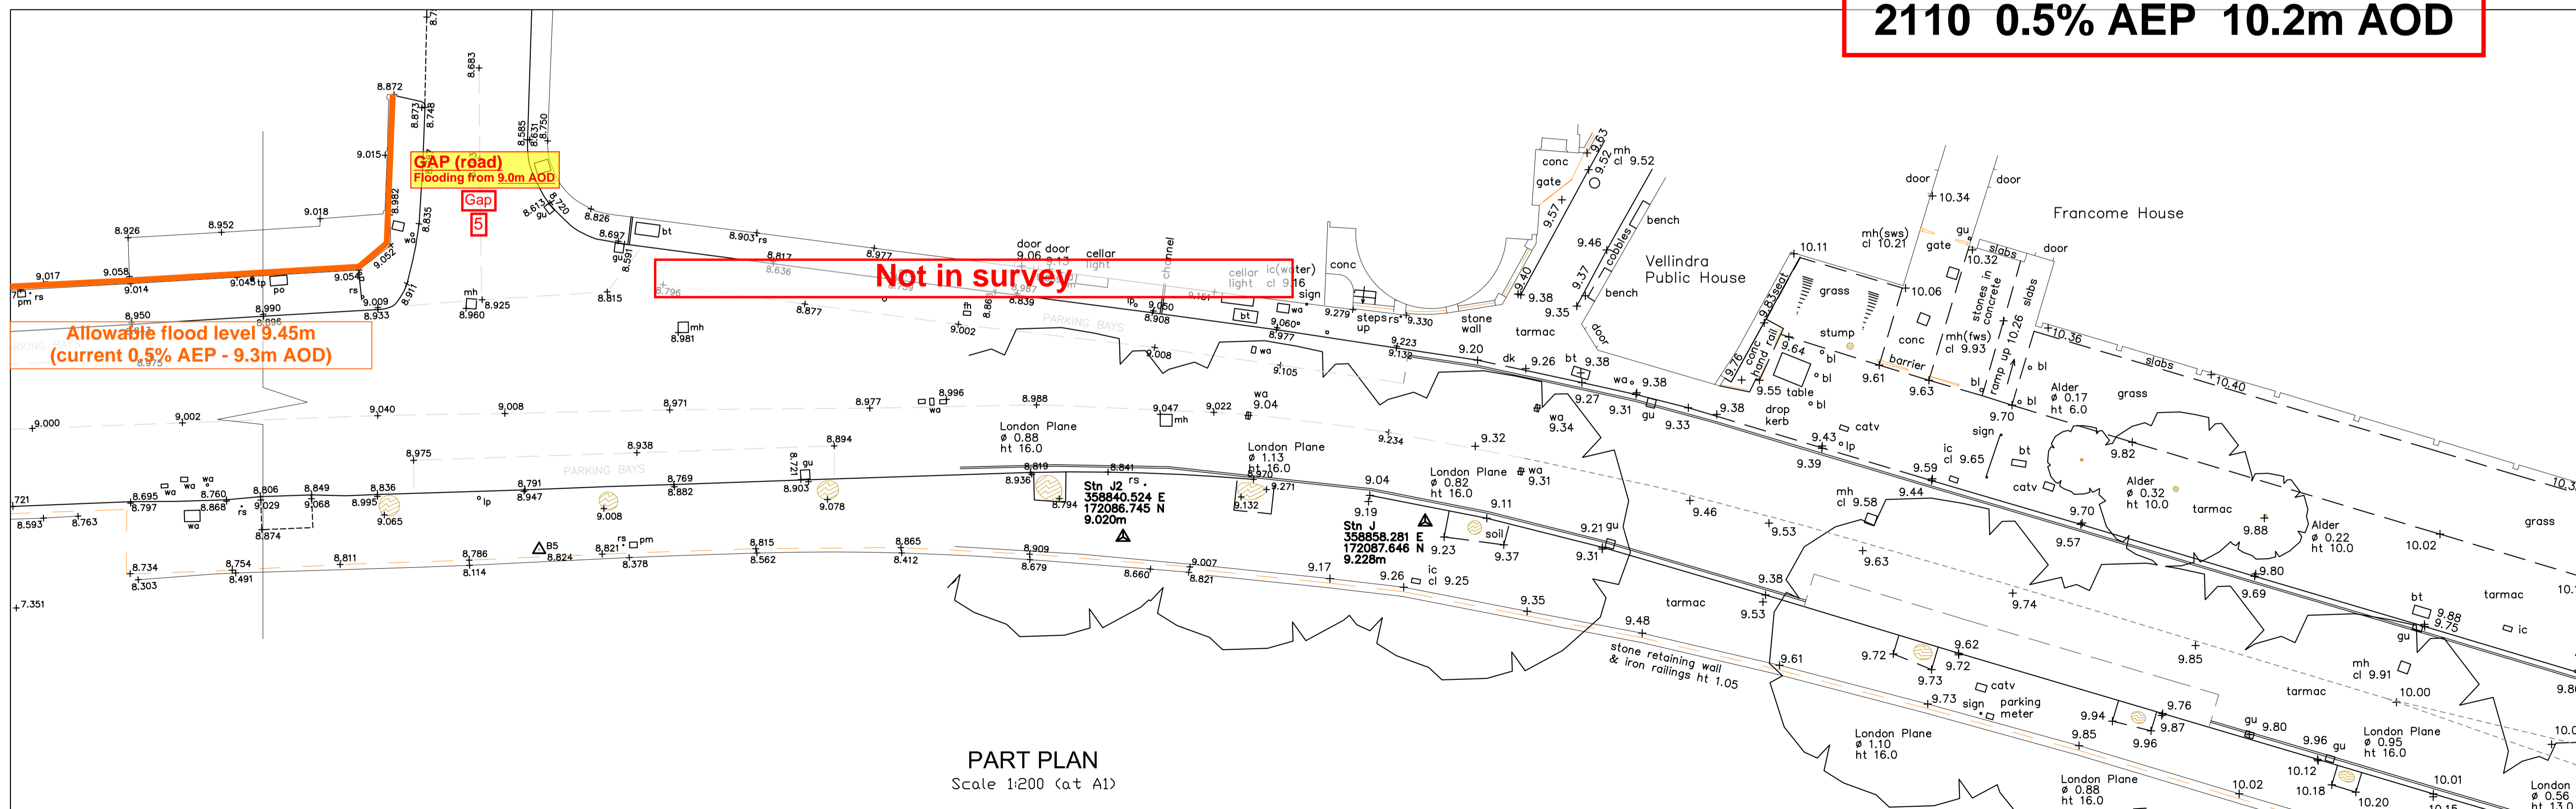
A2 Status of De Facto Defences in a current 0.5% AEP event (RAG Analysis)

GAP (road)
Flooding from 9.0m AOD
