**ST JUDE'S RESIDENTIAL BLOCKS
BRISTOL CITY COUNCIL
BUILDING SAFETY RISK ASSESSMENT**

April 2025

BRISTOL CITY COUNCIL

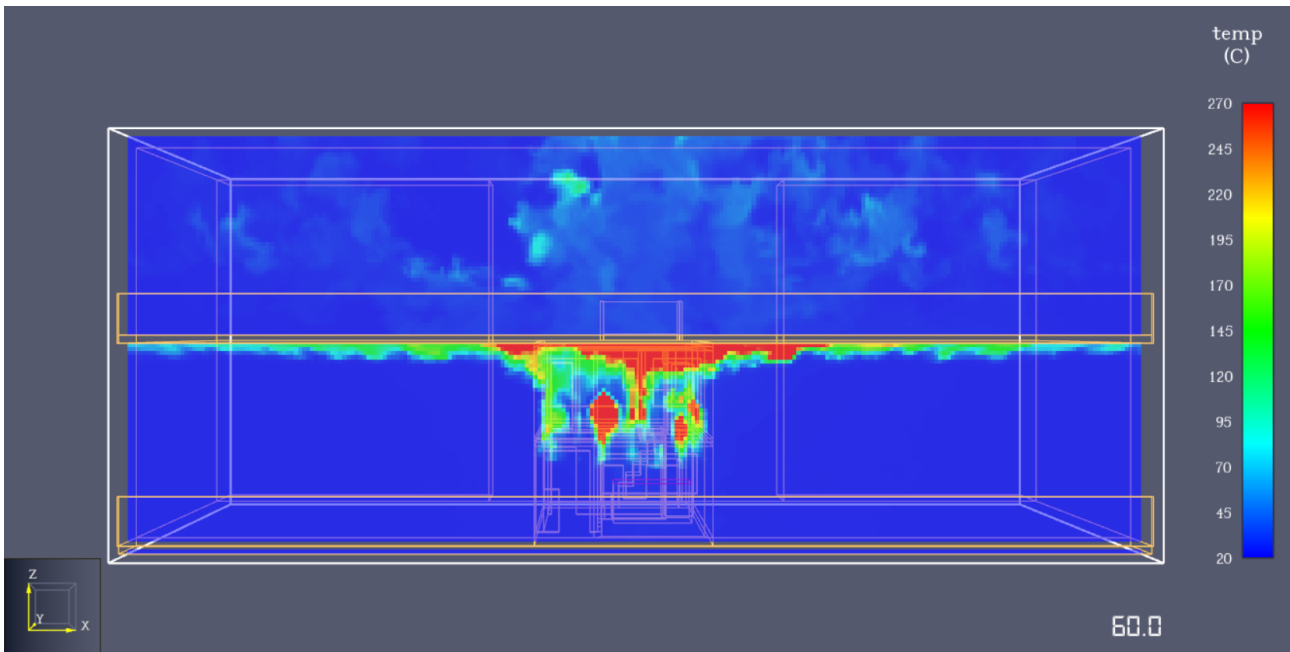
Figure 5 Walkways temperatures associated with a serious kitchen fire

There could be some lateral fire spread via the decorative timber cladding on the front elevation, albeit that the likelihood of vertical fire spread would be likely to be limited by the continuous overhanging walkway, which acts as an inherent fire break.

The likelihood of significant charring of the timber would be expected to principally affect the individual residential unit, rather than spreading to adjacent units, although this possibility cannot be discounted.

The walkways themselves could have improved protection through the installation of sprinklers to all flats and channelling screens, both of which in isolation are estimated to have a beneficial effect on visibility conditions on the walkways above a flat with a serious fire.

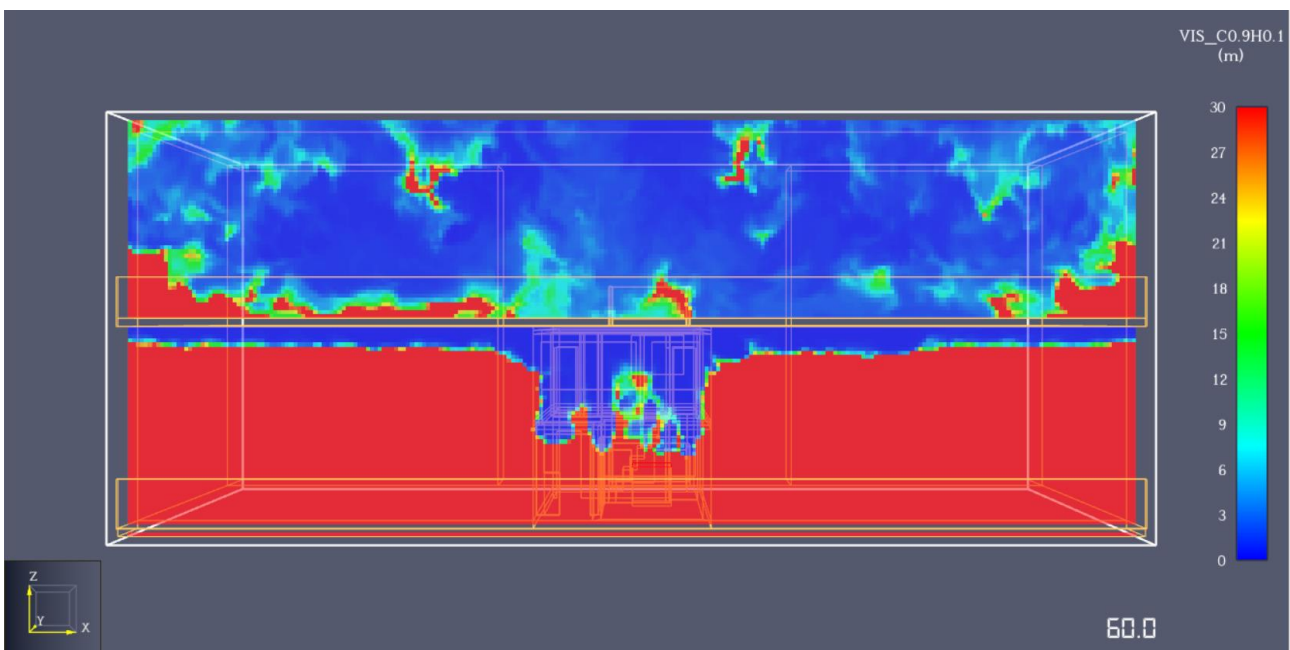
Figure 6 Visibility on walkway deck in case of sprinkler-controlled kitchen fire

As above, there is some potential for external fire and smoke spread between floors. Some scenarios that may lead to this include failure of the boxing to the wet rooms (particularly the kitchen, which is more likely to have a significant fire than the bathroom), leading to internal fire spread between flats. The likelihood of such failure depends on the nature of the fire, but it is foreseeable in the case of the kitchen that this could occur. The consequences could be mitigated by domestic alarm coverage in all flats, enabling warning followed by escape using the walkways.

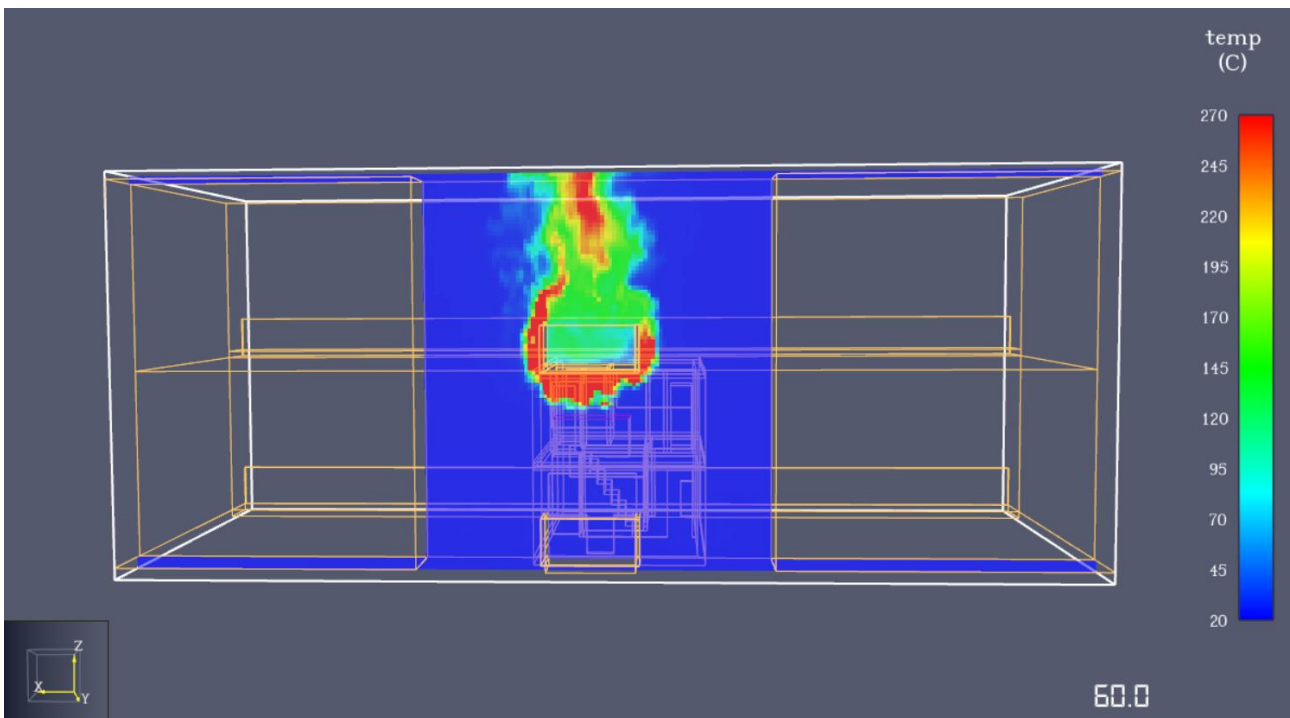
Figure 10 External temperatures associated with uncontrolled rear bedroom fire

To the rear elevation, the presence of combustible spandrel panels cannot be discounted as a route for vertical fire spread, and this could result in vertical fire spread between individual residential units in certain conditions. The consequences of such a fire could be mitigated through comprehensive domestic alarms within flats, supported by the open deck walkway escape arrangements. Sprinkler protection is likely, in certain scenarios, to achieve significant improvements in terms of risk reduction.

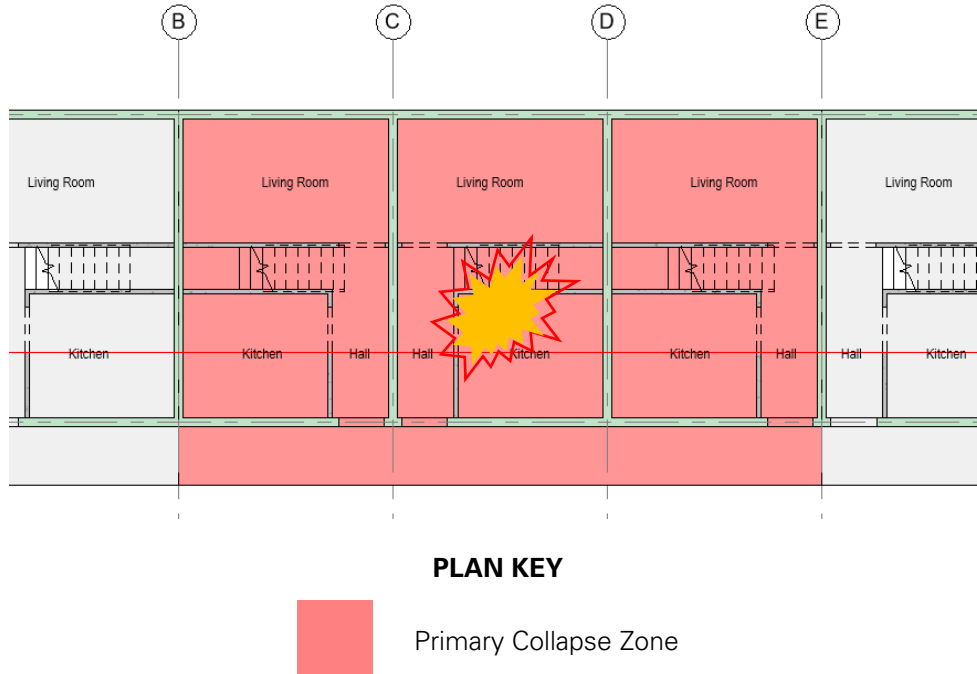
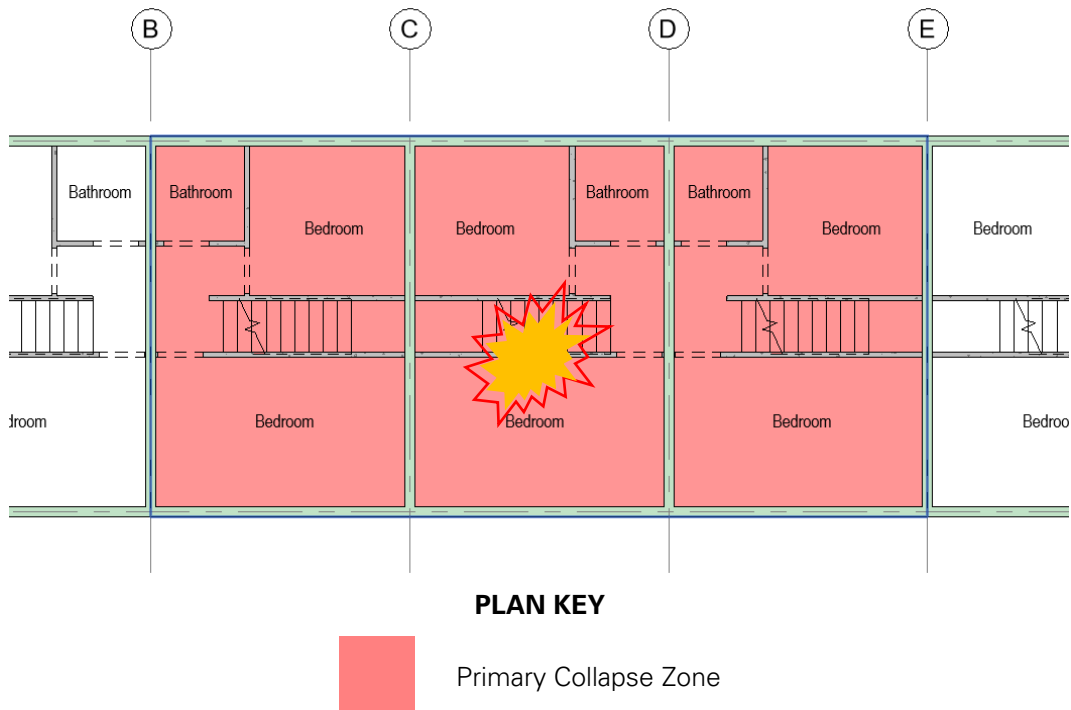
6.1.1. Scenario 1 – Internal Gas Explosion

An internal gas explosion within any of the blocks at St Judes leads to a failure of the walls and floor slabs above the 2nd floor leading to a disproportionate progressive collapse as shown in Figure 7. The associated number of potential fatalities and the probabilities can be seen below.

2.0 x 10⁻⁵ and 7.2 x 10⁻⁵ per annum (4.0 residence per flat) (1 in 138890)

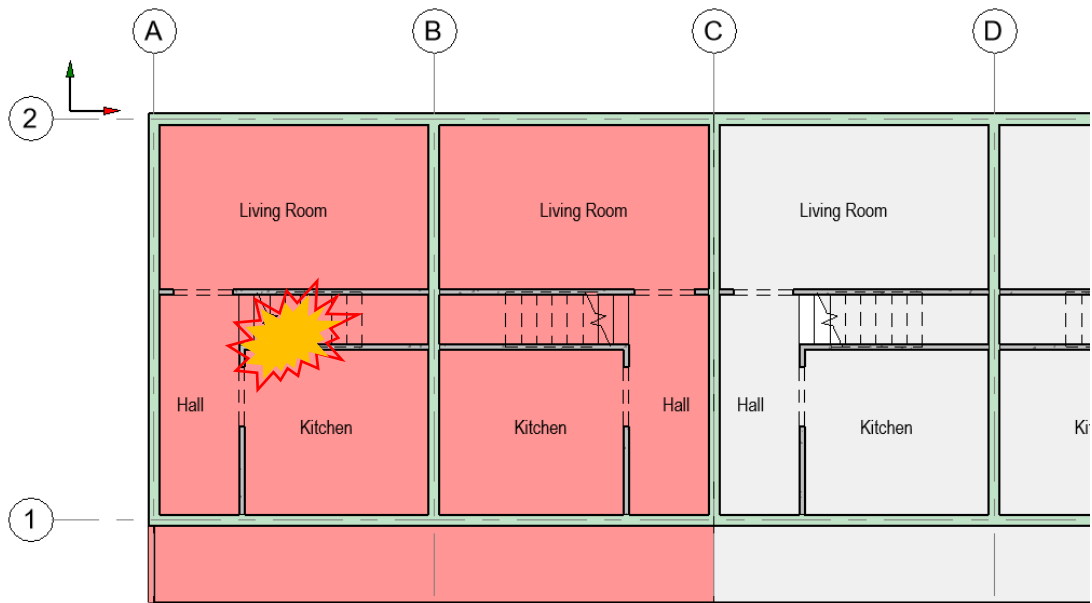
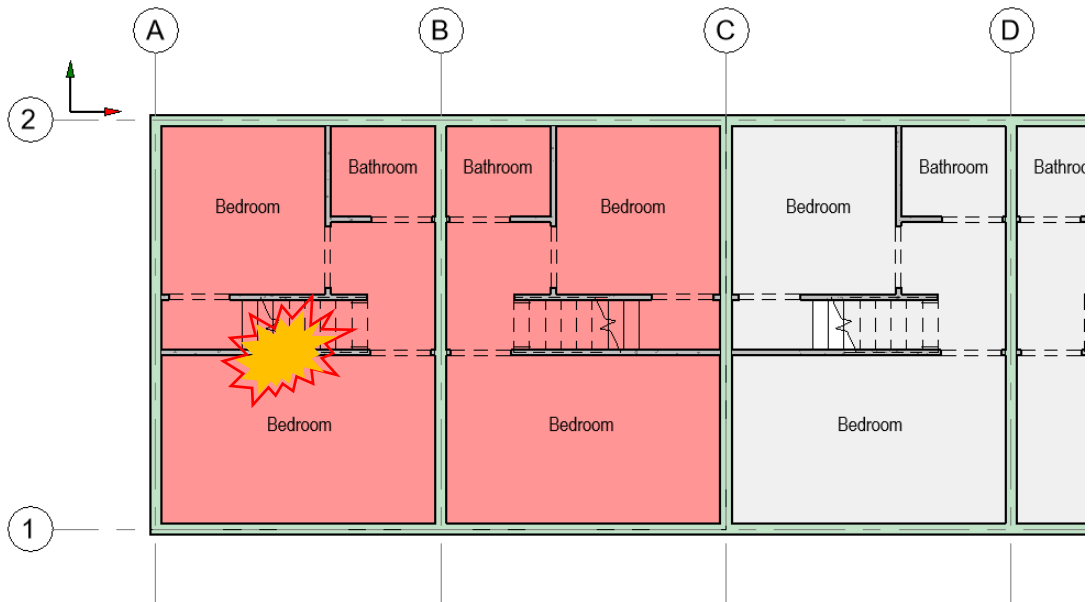
6.1.2. Scenario 2 – Flank Wall Explosion

A gas explosion within any of the flank wall flats of the blocks at St Judes would lead to a failure of the walls and floor slabs above the 2nd floor leading to a disproportionate progressive collapse as shown in Figure 10. The associated number of potential fatalities and the probabilities can be seen below.

6.0 x 10⁻⁶ and 3.6 x 10⁻⁵ per annum (4.0 residence per flat)(1 in 27778)

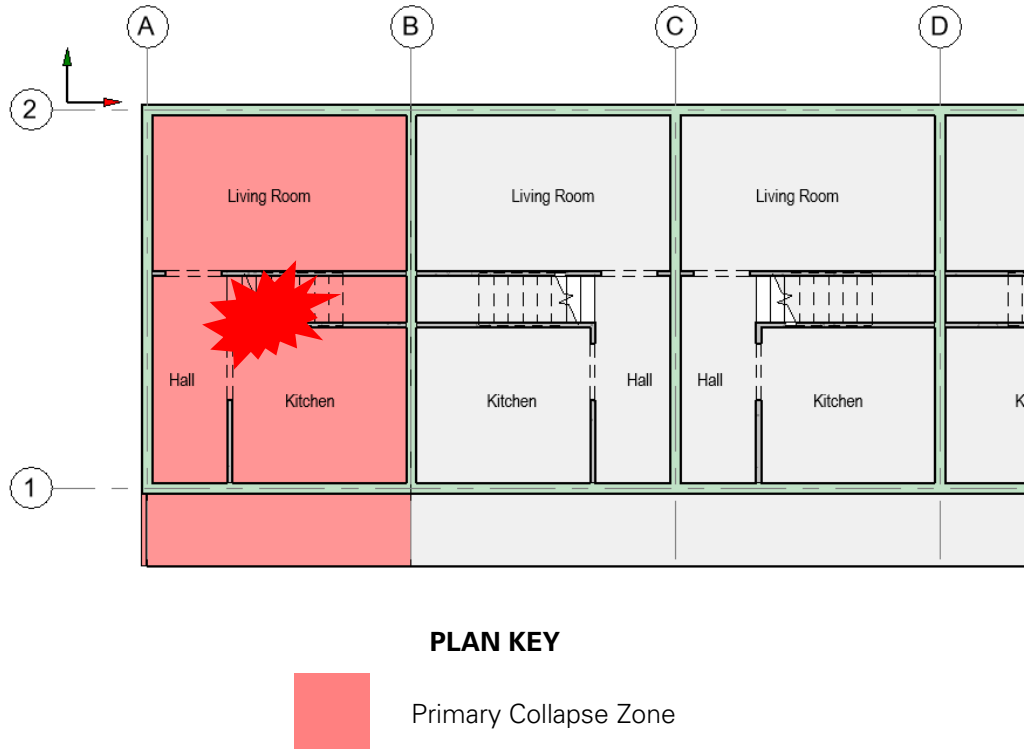
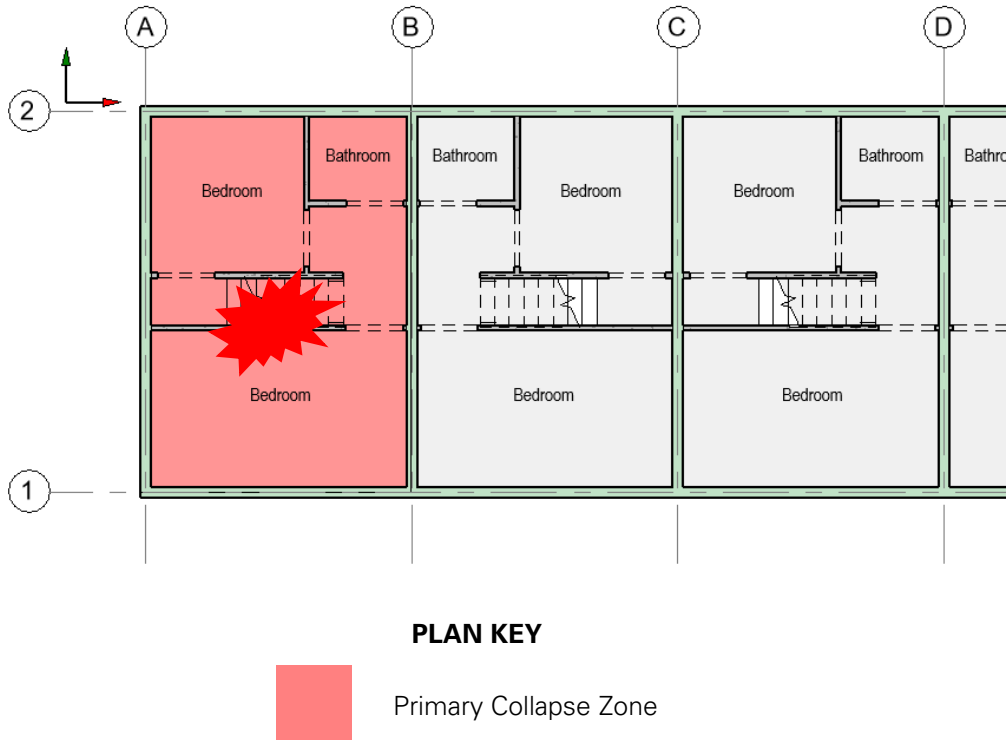
6.1.3. Scenario 3 – Flank Wall Fire

collapse of the full flank wall and floor supported by this as shown in Figure 13. The associated number of potential fatalities and the probabilities can be seen below.

5.04 x 10⁻³ per annum (4.0 residence per flat) (1 in 198)

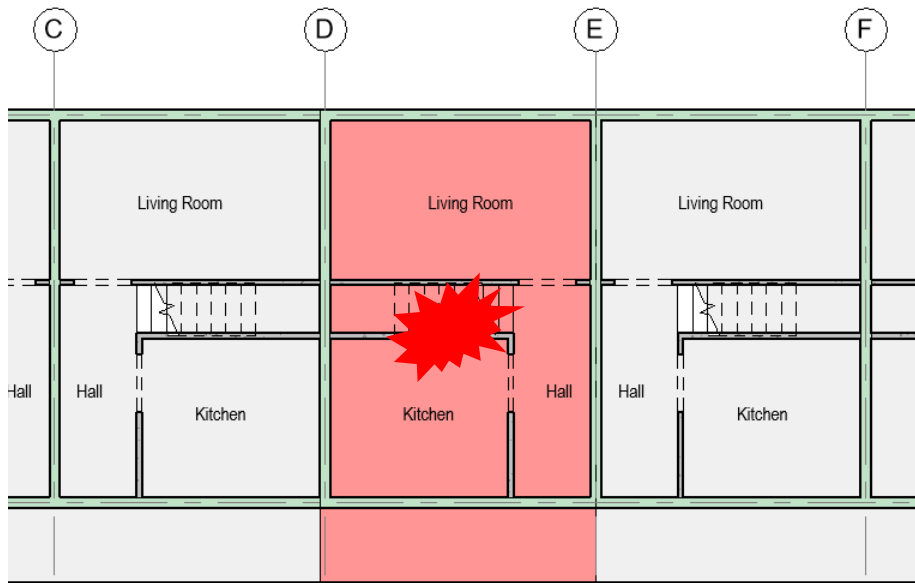
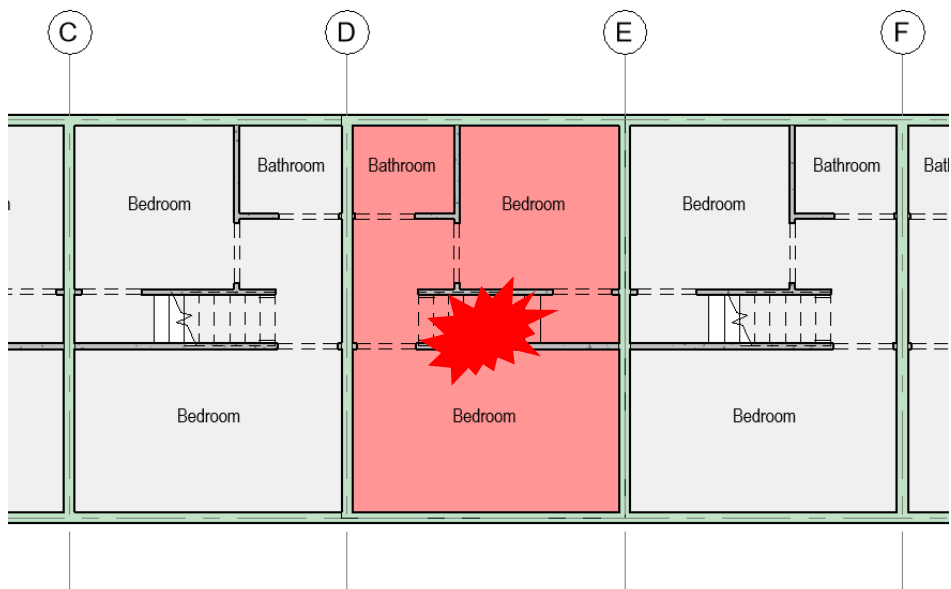
6.1.4. Scenario 4 - Internal Fire at level 1 Haviland & John Cozens

A fire event within any of the level 1 flats within Haviland house would lead to a failure of the floor slab above due to the low cover to reinforcement, this would then lead to the collapse of the floor below due to the overloading of the floor and collapse into the nursery below as shown in Figure 16. The associated number of potential fatalities and the probabilities can be seen below.

2.26 x 10⁻³ per annum (2.3 residence per flat) (1 in 442)
2.38 x 10⁻³ per annum (4.0 residence per flat) (1 in 420)

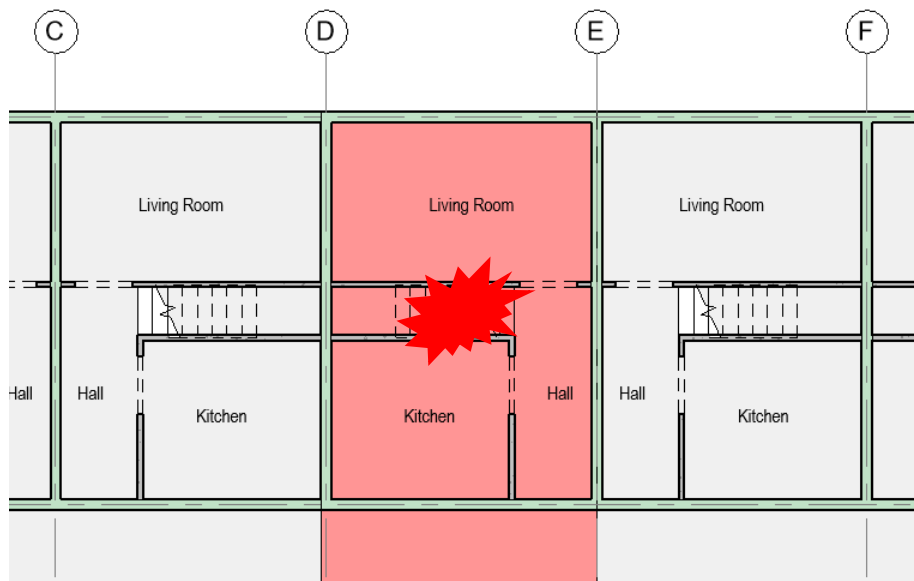
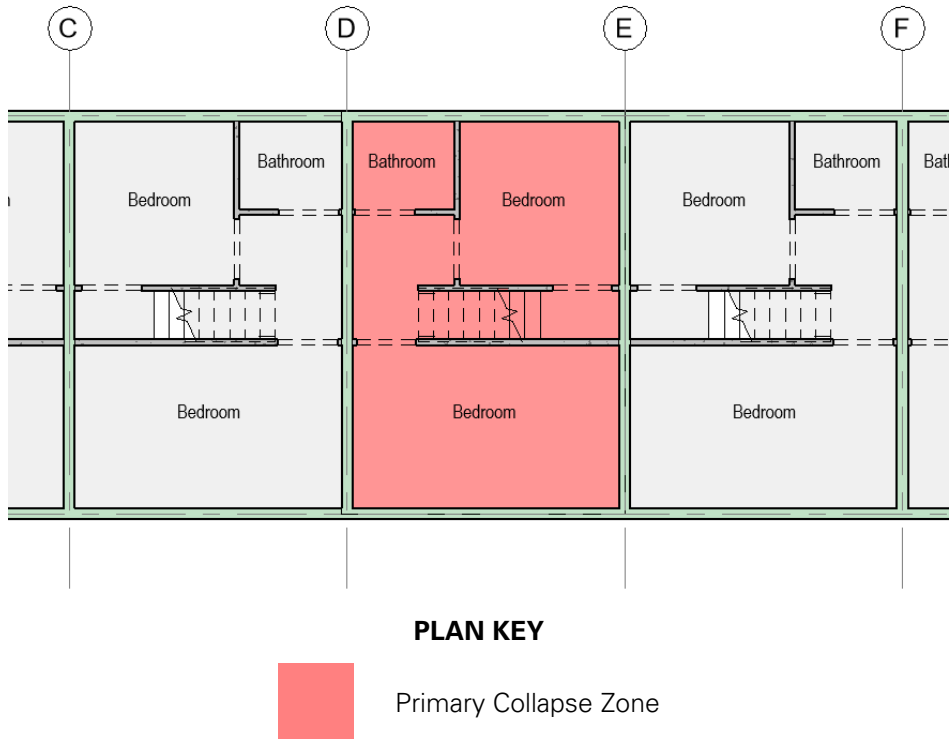
6.1.5. Scenario 5 - Internal Fire above level 1 – Haviland & John Cozens

A fire event within any of the flats of the Haviland & John Cozens blocks at St Judes, above level 1 would lead to a failure of the floor slab above due to the low cover to reinforcement. Due to the existing strengthening frame the collapse in this scenario would be limited to only one floor as shown in Figure 19. The associated number of potential fatalities and the probabilities can be seen below.

8.40×10^{-4} per annum (4.0 residence per flat) (1 in 1190)

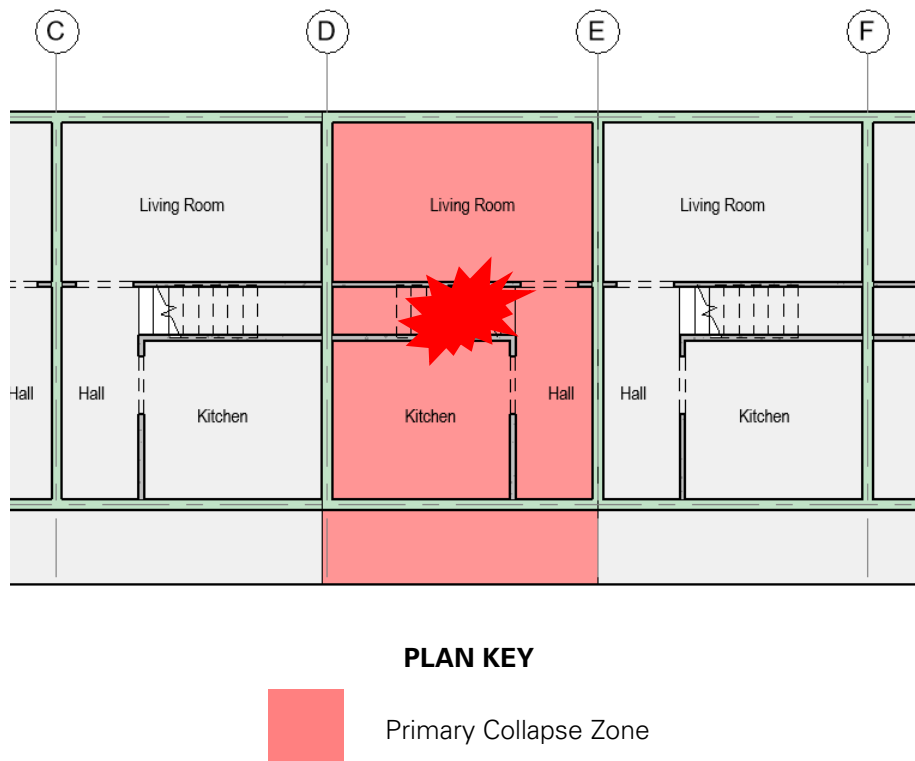
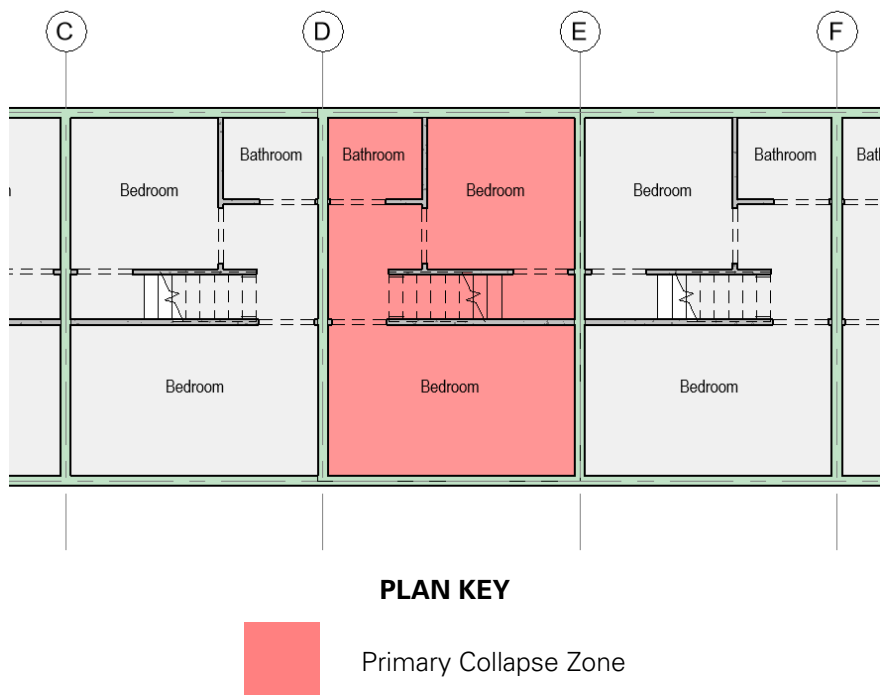
6.1.6. Scenario 6 - Internal Fire above level 1 – Charleton House

A fire event within any of the flats of Charleton House at St Judes, would lead to a failure of the floor slab above due to the low cover to reinforcement. Due to there being no strengthening frame in this block a pancaking effect would occur where the collapse of the slab above leads to the collapse of the slab below due to the weight of collapsed floor as shown in Figure 22. The associated number of potential fatalities and the probabilities can be seen below.
