# FIRE RISK ASSESSMENT

## **Charleton House** **St Jude's, Great Ann Street, Bristol, BS2 0DS**

CLIENT	Bristol City Council
ASSESSED BY	Bob Birtles Keith Todd
ASSESSED ON	24/07/2024
ASSESSMENT REF.	LS 422354
RECOMMENDED REVIEW DATE	24/07/2025
VERSION	1

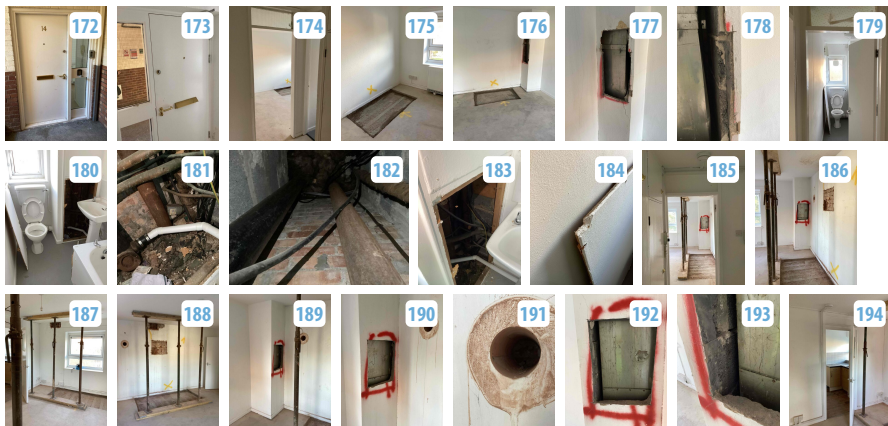
LOCATION Flat 14, accessed from the staircase, 17/10/2024

Flat survey escorted by Synergise staff.  
 Intrusive survey works have been carried out, with additional support to the lounge (6x props and timber planks).  
 Access to the ductwork leading through the flat.  
 Structural elements have been exposed.  
 Walls are of brick, shafts are blockwork, floors are reinforced concrete.
