Case Study 06 Bristol Business Park

Bristol Business Park (North Bristol) Coldharbour Lane, Bristol, BS16 1EJ

Permeable paving, swales, wet detention ponds, control feature

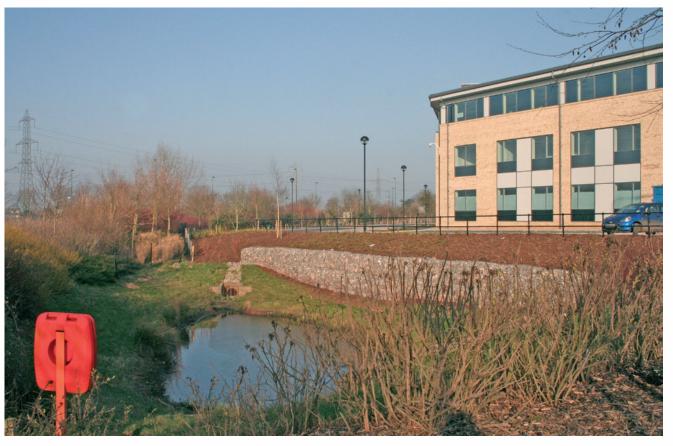
Phase 3 of the development includes 1.2ha of permeable paving which discharge to swales which run to a conventional gravity piped system conveying earlier phases conventionally paved through a wet detention pond and hydrobrake control feature, to discharge into an off-site watercourse. Later phases include permeable paving which either discharge to an off-site watercourse or a surface water sewer.

The car park areas are surfaced by both permeable and impermeable paving with a porous sub-base layer throughout. Runoff from impermeable areas is channelled to the permeable areas and into the sub-base layer. Roof downpipes

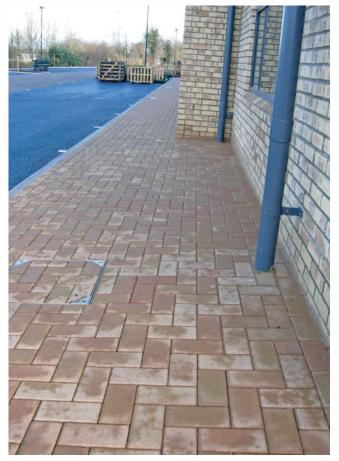
When the SuDS system was initially installed in 2008 the proposed maintenance was to avoid weed growth between blocks and vacuum brushing once a year plus maintaining the landscape areas. Since its instalment maintenance issues arose with the main swale as it became overgrown with reeds, making it difficult to maintain and to observe the outlet, which tended to block frequently with vegetation.

To rectify this issue, the reeds were cleared and replaced with grass slopes. The permeable paving has received little maintenance with some areas developing moss between the joints. However, there has been no evidence of ponding or flooding, illustrating its resilience and indicating that the permeable paving is still working effectively.
