Flood Investigation: March 2020

Tidal Flooding

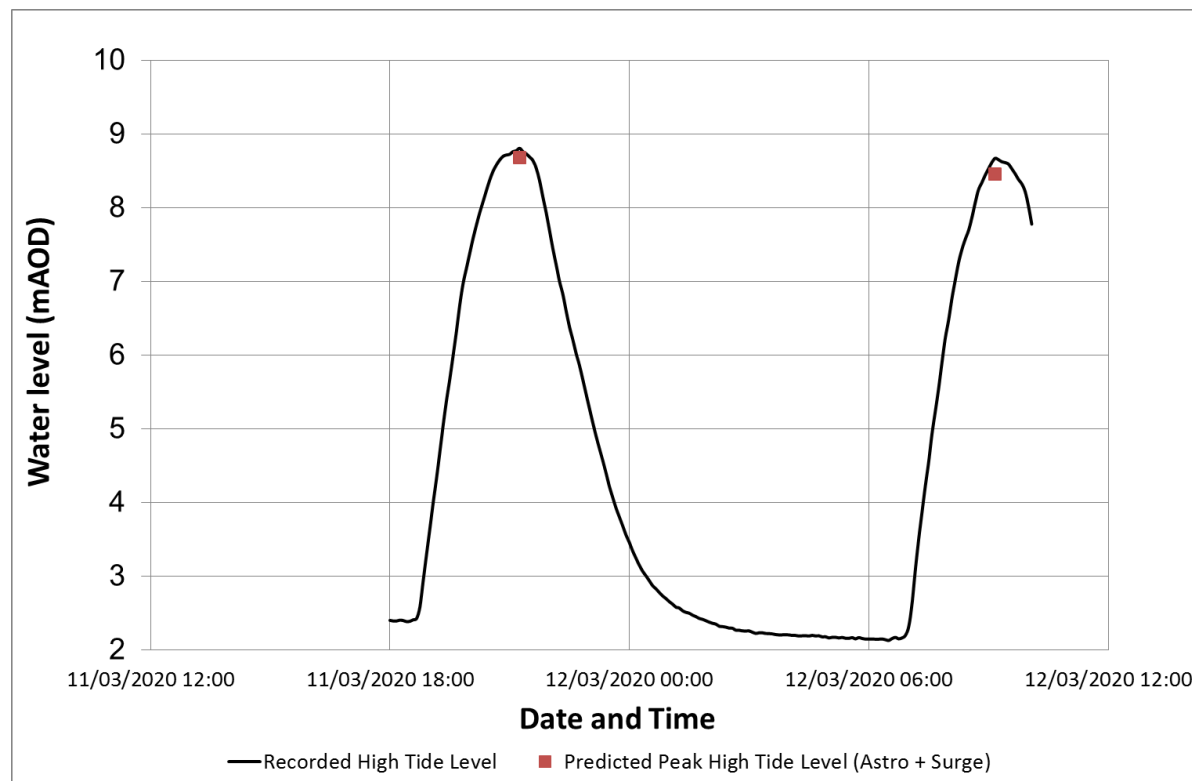
Figure 2 shows the peak high tide levels predicted by the EA prior to the high tide events (with BCC 150mm adjustment for city centre predictions) and the recorded tidal curve on the 11th and 12th March at Bedminster Bridge.

Figure 2. Scatter graph comparing predicted (astronomical and surge) city centre (Bedminster Bridge) peak high tide levels, with recorded city centre high tides on the 11th and 12th March 2020.

Predictions were relatively close to the recorded tide levels, however there was still some underestimation of the peak high tide level for both events (Figure 2), despite manual uplift being added to the Avon Flood Forecasting model prediction by the EA's (MFDO). For example, during the 11th March, the maximum predicted (Flood Forecasting model plus manual uplift) high tide level at Bedminster Bridge was 8.68mAOD, however 8.81mAOD was recorded (0.13m under estimated) (Table 4). Furthermore, on the 12th March, the maximum predicted high tide level at Bedminster Bridge was 8.45mAOD, however 8.67mAOD was recorded (0.22m under estimated) (Table 4). The 12th March event had the biggest difference between the predicted and recorded high tide, which could be associated with the change in wind direction from south-westerly (on the evening of the 11th March) to westerly (on the morning of the 12th March); the surge on the 12th could have been higher due to westerly winds having a greater impact upon pushing water up the River Avon, when compared to south-westerly winds on the 11th.

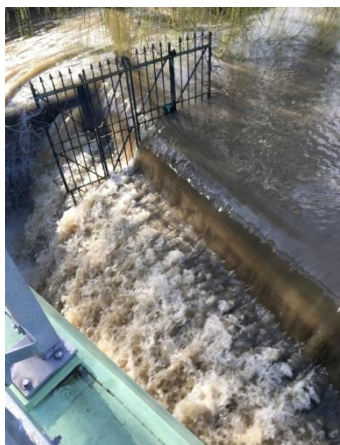
Plate 1. Overtopping at Bathurst Basin.

During tidal flood conditions, water can flow into the Floating Harbour via two primary routes; firstly, direct overtopping of tidal water from the River Avon via low spots at Entrance Lock, Bathurst Basin and St Philips Marsh and secondly from the River Frome which flows directly into the Harbour.

In preparation for both the high tides events, Bristol City Docks team pre-lowered the level of the Floating Harbour; this was to allow for extra capacity within the Harbour for floodwater. In addition, the EA kept all four of the Eastville Sluices open, thus reducing the fluvial flood flows entering the Floating Harbour. During the two flood events discussed in this report, tidal flood water flowed into the Harbour at Bathurst Basin (Plate 1) and Junction Lock (Plate 2). The existing formal defences and buildings that act as de-facto defences located in St Phillips Marsh, prevented flooding of Albert Road and surrounding areas.

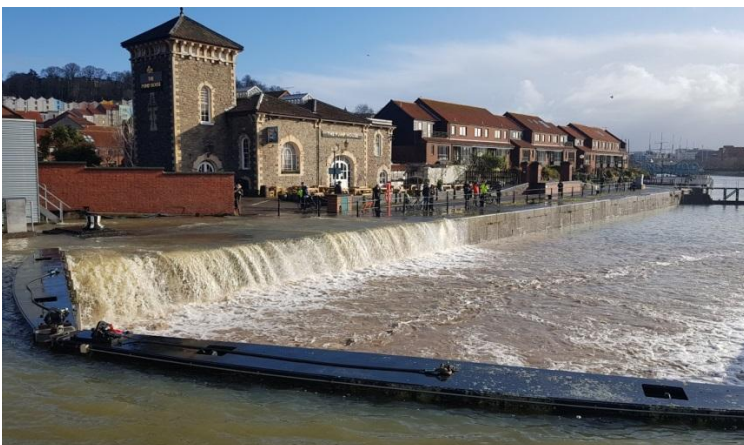
Plate 2. Overtopping at Junction Lock (Cumberland Basin).

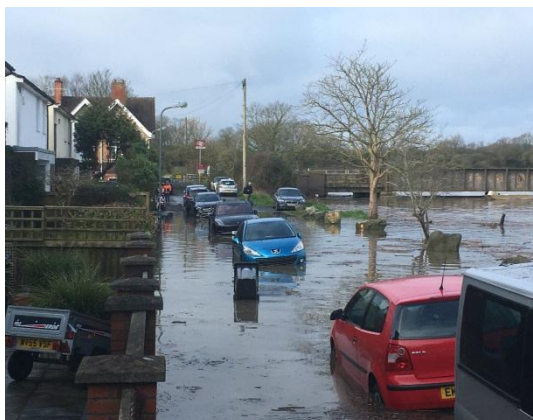
Plate 3. Flooding along Sea Mills Lane at 8:30 am on the 11th March 2020.

Flooding of the road, parked cars and a property along Sea Mills Lane, combined with many properties deploying their own individual flood barriers/gates, highlights that Sea Mills is an area which is particularly vulnerable to flooding during high tide events. Furthermore sea level rise from climate change will inevitably mean that this area will be at an increased risk from tidal flooding in the future. Currently BCC only has limited 1D modelling of this area, so the area's flood risk is relatively poorly understood, when compared to the understanding of flood risk to the city centre and Avonmouth. Therefore, BCC and the EA need to focus upon gaining a better understanding of the tidal flood risk posed to Sea Mills through commissioning a model of the area (an aim of the emerging Bristol Avon Flood Strategy). This model can then be used to inform on the current and future flood risk to the area, before investigating what flood risk interventions could be implemented and their feasibility.

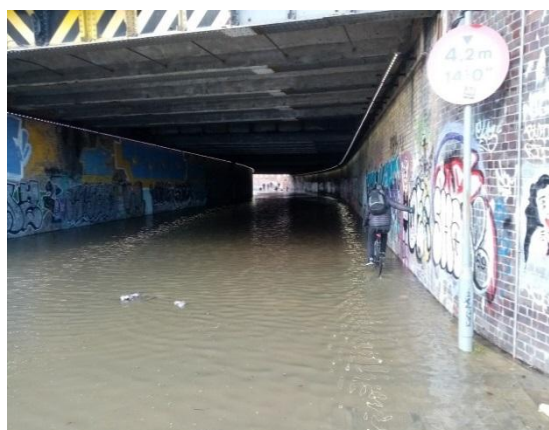
Plate 5. Flooding along Cattle Market Road (time taken unknown).

Cattle Market Road is considered to be the most vulnerable location according to Table 6, with the highest estimated tide level received and one of the lowest levels of protection.

The Portway and Cattlemarket Road were significantly affected by tidal flood water and had to be closed; as suggested in the above paragraph, sea level rise from climate change will mean these roads will become more regularly
